SH1, Karo Drive Wellington Crash Reduction Study

A REPORT PREPARED FOR
New Zealand Transport Agency

Reference: 12334
January 2013

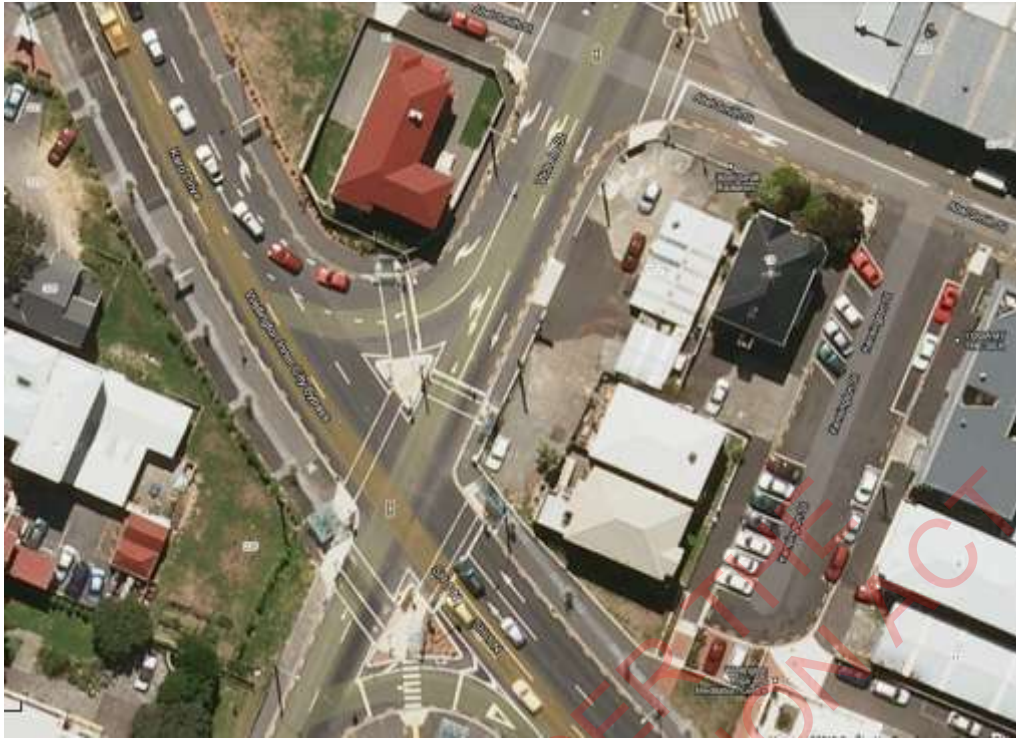
Figure 3

As noted in section 1.1, Karo Drive is one-way westbound whilst Victoria Street is one-way southbound. The two roads do not intersect at 90° due to the curvature of Karo Drive (see **Figure 2**). The current intersection layout can clearly be seen in **Figure 3**, with three westbound through lanes on Karo Drive and two southbound through lanes on Victoria Street. The double right turn lane from Victoria Street is signalised whilst the left turn lane from Karo Drive is priority controlled (Give Way).

5. On Victoria Street, only 60m separates the signalised intersections of Abel Smith Street and then Karo Drive (see **Figure 3 and Photo 6**). It would normally be expected that the linking of the signals would be that Abel Smith Street goes red before Karo Drive, giving drivers green signal progression through these two sets of

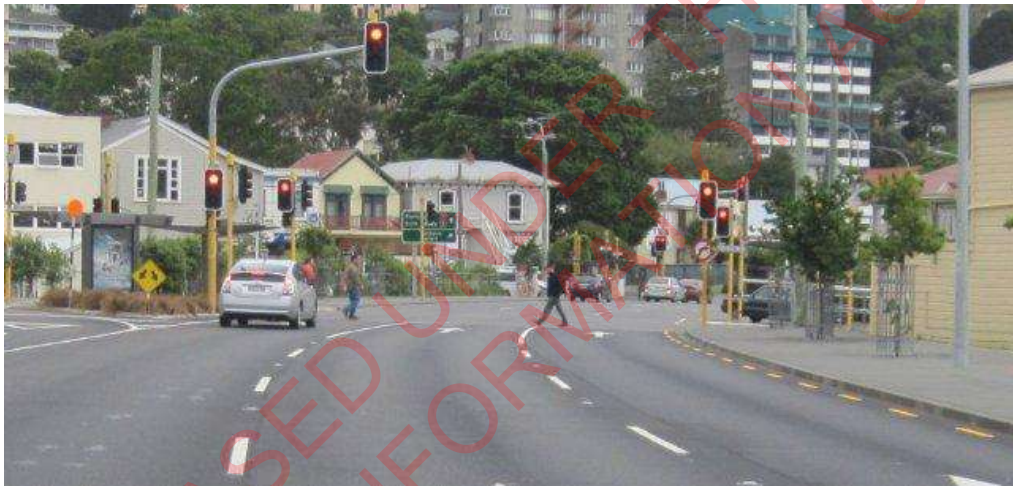
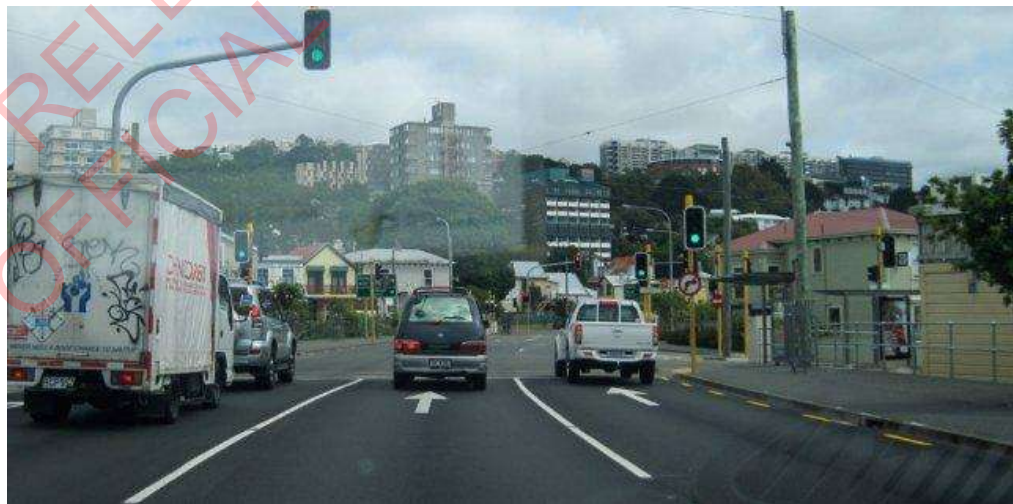
3. In addition to the curvature of Karo Drive affecting advance visibility and recognition of the intersection ahead, the building and infrastructure at the northeast corner of the intersection mean that drivers do not see the northern leg of Victoria Street or the traffic on it (see **Photos 4 and 5**). This can exacerbate the perception of the intersection and also means that drivers on either the Karo Drive or Victoria Street approaches would not get an early view of any vehicle proceeding through a red signal on the conflicting approach.

- d. In conjunction with Wellington Inner City Bypass works improve the visibility of the full intersection on the Karo Drive approach; in particular improve visibility at the NE corner so that drivers on both the Karo Drive and Victoria Street approaches can see each other as well as the intersection being more obvious.

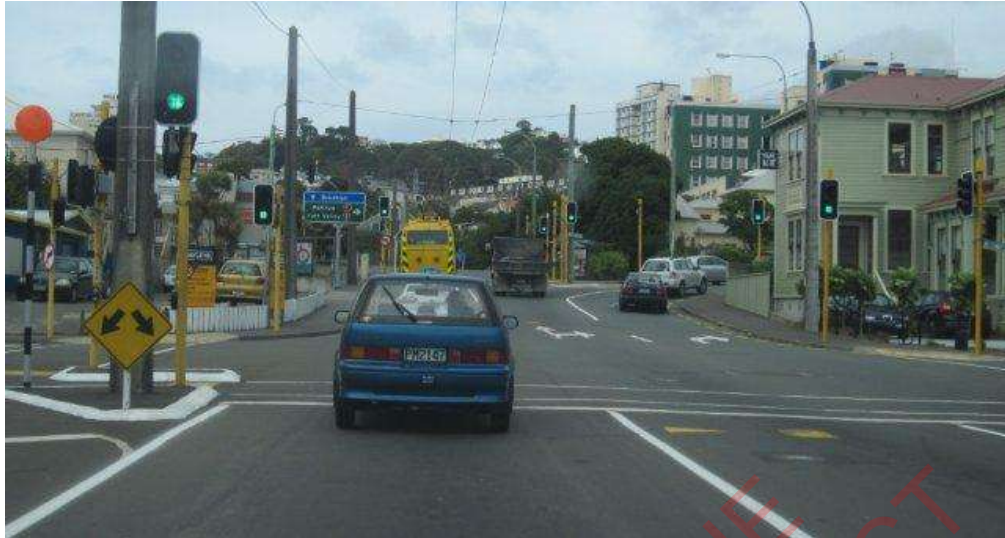
Photo 6 – Victoria Street approaching Abel Smith Street

signals. Observation was that Karo Drive sometimes displayed red before or concurrently with Abel Smith Street – this can generate the risk of drivers expecting progression and proceeding though a red signal display at Karo Drive.

- g. Review the phasing of the linking on Victoria Street from Abel Smith Street through Karo Drive to minimise the risk of Victoria Street drivers continuing thorough Karo Drive on a red signal after crossing Abel Smith Street on a green signal².

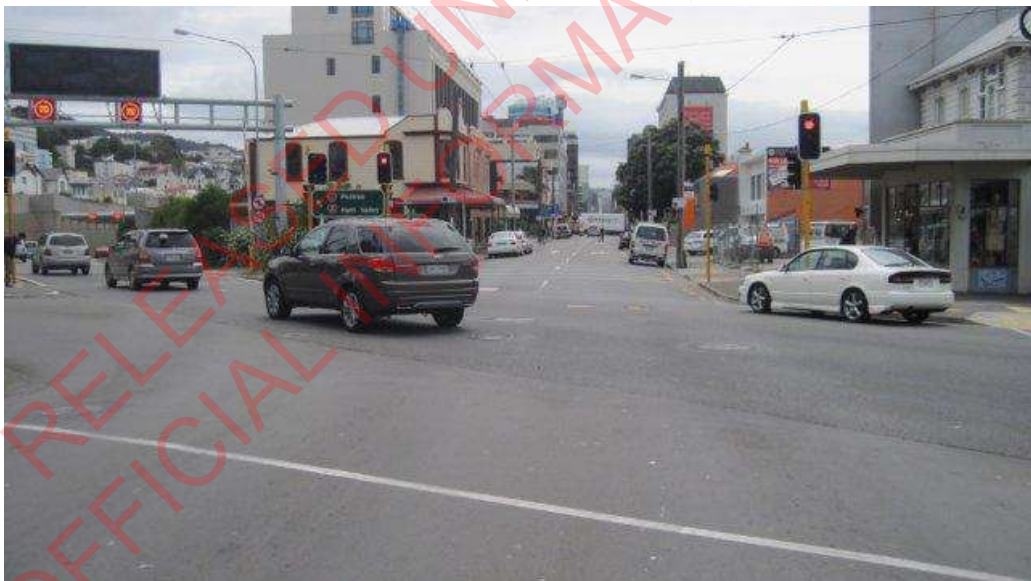
1. The 5-leg intersection layout is confusing for some users and lane guidance through the intersection is poor (see **Photo 7**).
2. The speed limit signs on the Terrace Tunnel gantry at the intersection can encourage higher speeds on Karo Drive prior to and through the intersection which in turn can lead to red light running and/or rear end crashes (see **Photo 8**).

Photo 7 – Lack of tracking/continuity lines within Karo Drive/Willis Street intersection

- a. Install additional lane continuity (tracking) lines through the intersection for movements from both Willis Street and Karo Drive.
- b. Default the speed limit signs on The Terrace Tunnel gantry at Willis Street to a blank display unless the tunnel speed limit is to be 50 km/h or less.
- c. Install a red light camera on the Karo Drive approach to the intersection together with associated warning signage.

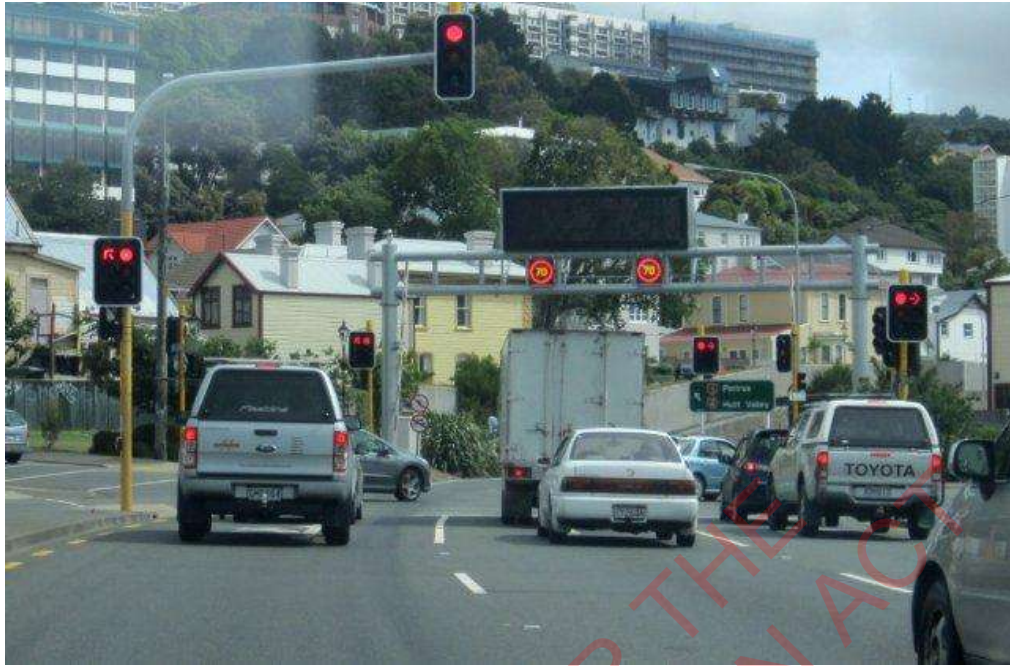
Photo 8 – Speed limit signs on gantry
