SH1: MacKays Crossing to Peka Peka, Kapiti Coast Expressway

ROAD SAFETY AUDIT of the TOC DESIGN

**Reference: 10341
August 2012**

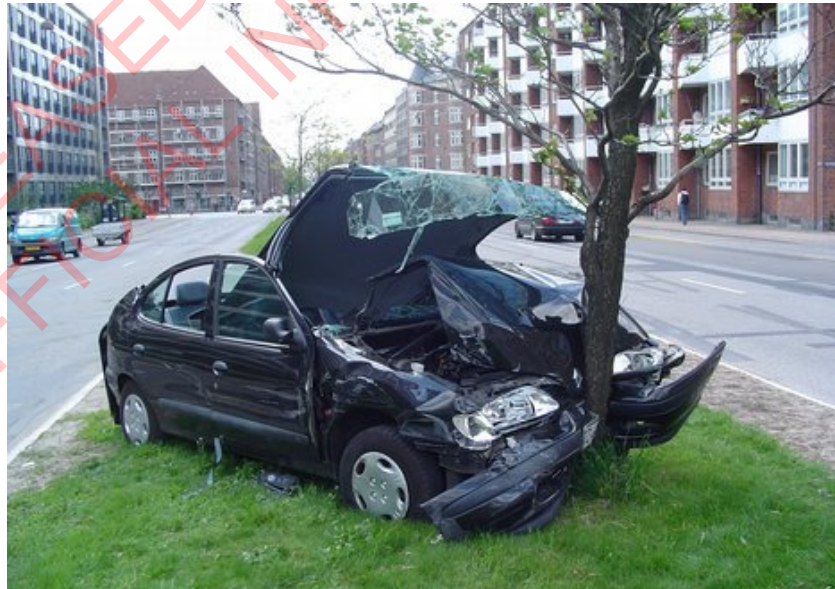
- 6) Drawing UD-LV-214: any trees in the “mass planting with tree enrichment” that are planted alongside Mazengarb Road may be a hazard and if on the inside of the curve could restrict forward sight distance

- 7) Drawings UD-LV-230 and 231: “mass planting” or trees planted near the roundabouts can be a hazard for any errant vehicles as well as restricting sight line requirements

Even small trees can be a significant hazard for errant vehicles:

Recommendation: Ensure that the detailed landscaping proposals take account of road safety requirements, especially any potential effects on visibility and the locations of unprotected trees that could be hazards.
