**Mackays to Peka Peka (M2PP)  
Kāpiti Expressway  
SH1/OTAIHANGA ROAD  
ROUNDAABOUT  
POST CONSTRUCTION  
ROAD SAFETY AUDIT**

**A REPORT PREPARED FOR  
NZ TRANSPORT AGENCY**

**Reference: 10341  
July 2014**

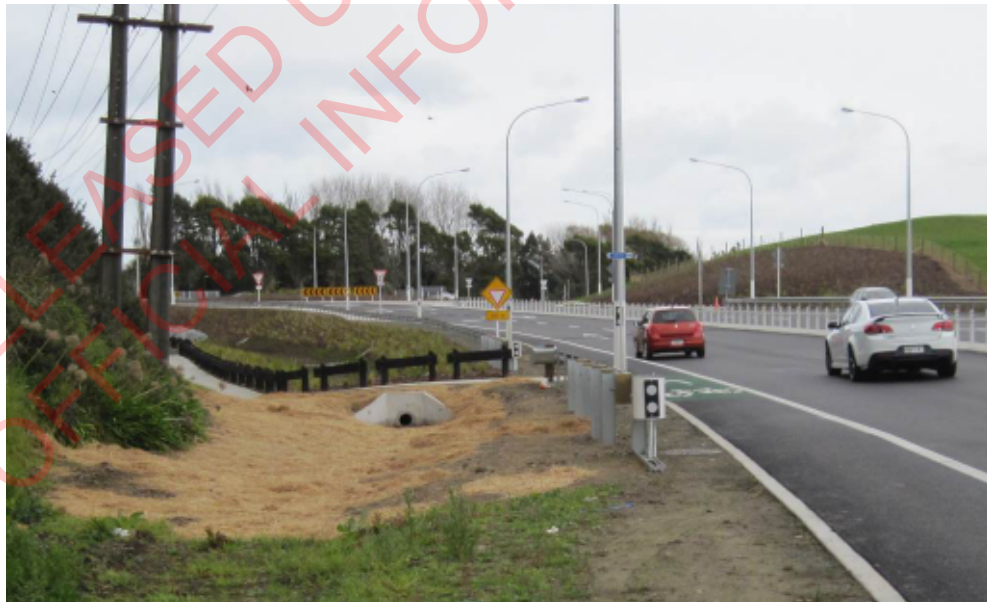
On the east side of the southbound approach guardrail has been installed that only partially protects a culvert headwall and substantive double concrete power pole (see **Photo 1**). Any loss of control on the approach curve and over-correcting can lead to a vehicle leaving the carriageway on the inside of the curve.

**Photo 1 – Lack of protection for headwall and power pole**

*Extend the guardrail on the east side of the SH1 southbound approach northwards to protect the exposed headwall and power poles.*

<b>Designer Response:</b>	<p>There is a 150mm AC water main in close proximity to the barrier that restricts extending the barrier further north.</p> <p>The measures to mitigate the hazards shall consist of the following:</p> <ul style="list-style-type: none"> <li>• Replace the headwall with a traversable headwall.</li> <li>• Create an earth bund around the power pole shown in Photo 1 to avoid filling in swale.</li> <li>• Locally fill around the base of the power pole shown in Photo 2.</li> </ul>
<b>Safety Engineer:</b>	Agree with Designers solution to the issues identified by the SAT
<b>Client Decision:</b>	Further to the advice of the Safety Engineer confirm agreement with Designers solution.
<b>Action Taken:</b>	<p>Measures to mitigate the hazards have been implemented as follows;</p> <ul style="list-style-type: none"> <li>• Headwall replaced with a traversable headwall.</li> <li>• An earth bund around the power pole shown in Photo 1 has been created to avoid filling in swale.</li> <li>• Locally filled around the base of the power pole shown in Photo 2.</li> </ul>

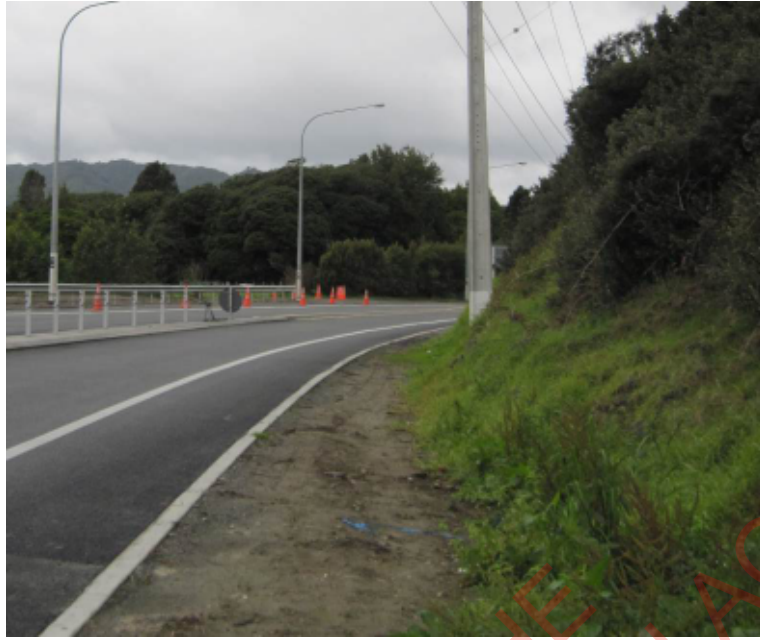
**NB** Extending the guardrail northwards could also provide protection for the next concrete power pole to the north located on the inside of the southbound approach curve after the start of the solid median (see **Photo 2**).

**Photo 2 – Concrete power pole on the inside of the southbound approach curve**

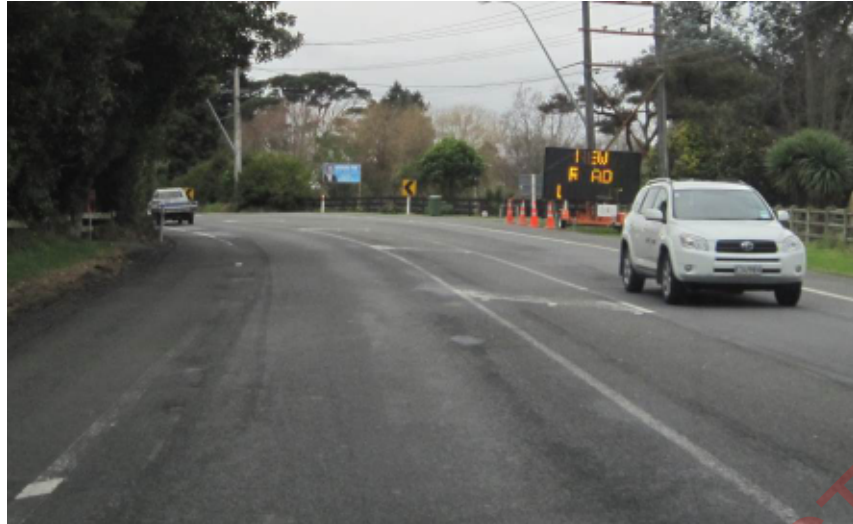
Northbound, there is no permanent advance warning of the roundabout until drivers have negotiated a left hand curve some 250m prior to the roundabout, the ADS sign also being located around the curve. Whilst there is good visibility of the roundabout and adequate stopping distance after negotiating the curve, the SAT considers that some advance warning signage of the roundabout prior to the curve is desirable to replace the temporary VMS sign advising “new road layout” (see **Photo 3**).

**Photo 3 – Curve on northbound approach prior to roundabout**

- a. Install gated PW-8 roundabout warning signs with supplementary 300m signs prior to the left hand curve on the northbound approach.
- b. In the meantime change the message on the temporary VMS signs to “new r’bout ahead” (or similar) to more positively identify the change.

<p><b>Designer Response:</b></p>	<p>The ADS sign was designed to be installed prior to the left hand curve. However, when it came to be installed it was found the verge was not wide enough in this location. A decision was made to install this sign after the left hand curve.</p> <ol style="list-style-type: none"> <li>a. The Alliance agree with the SAT recommendation to install a gated PW-8 roundabout warning signs with a supplementary plate 300m prior to the left hand curve.</li> <li>b. The VMS sign message was updated to suit SAT recommendation, for the period it remains in place as agreed with the NZTA.</li> </ol>
<p><b>Safety Engineer:</b></p>	<p>Installing additional warning signs prior to the curve is unlikely to increase awareness of the roundabout due to the large distance to the roundabout and drivers ability to remember the information on advanced warning signs.</p> <p>Speed surveys undertaken, but not available to the SAT at the time the audit was undertaken, indicate that approach speeds are appropriate for the design.</p> <p>Based on this additional PW-8 signs are not considered necessary.</p> <p>Agree with change to VMS sign text.</p>

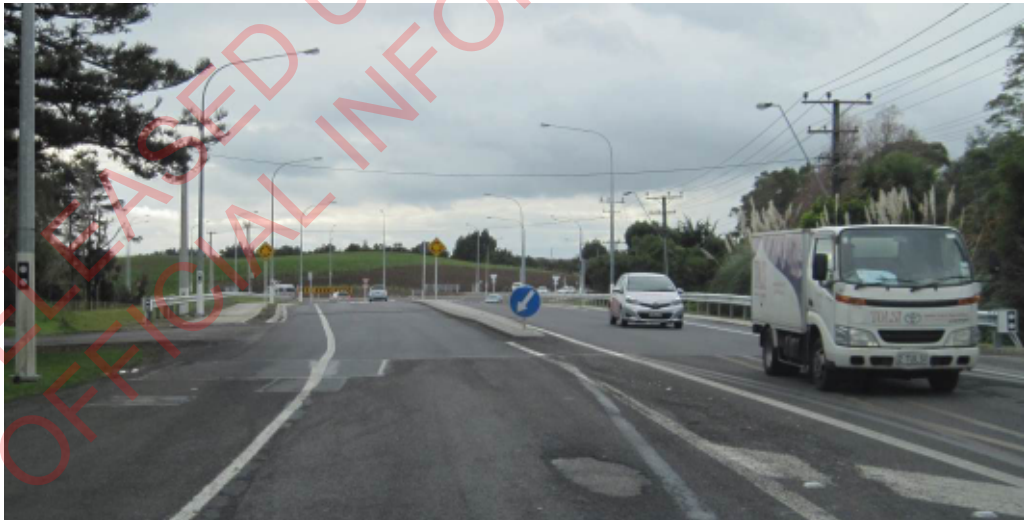
There is a short section of SH1 carriageway on the northbound approach that is in poor condition and on which the road marking is equally poor (see **Photos 3 and 4**). This area is between the new seal for the roundabout approach and reseal of existing carriageway. In wet and/or dark conditions poor road surface and poor road markings can lead to some drivers failing to correctly stay within their traffic lane, especially as the poor surface is partly on a curve.

**Photo 4 – Poor condition of carriageway and markings**

*Reseal the short section of the SH1 northbound approach between the roundabout works and the reseal of the existing alignment.*

<b>Response:</b>	of works. The Alliance agree with the SAT recommendation and this information has been passed on to the NZTA for consideration.
<b>Safety Engineer:</b>	Agree the current surfacing could cause confusion for drivers in certain light conditions as well as in the wet and should be resurfaced. Our understanding is that this will be undertaken prior to Labour Weekend.
<b>Client Decision:</b>	Confirm that this work has already been instigated and will be undertaken by the Transport Agency Network Outcomes Contractor before 27 Oct 2014 (Labour weekend)
<b>Action Taken:</b>	The proposed surfacing work is scheduled to be undertaken by NZTA network maintenance contractor before 27 Oct 2014 (Labour weekend).
<b>STATUS</b>	CLOSED

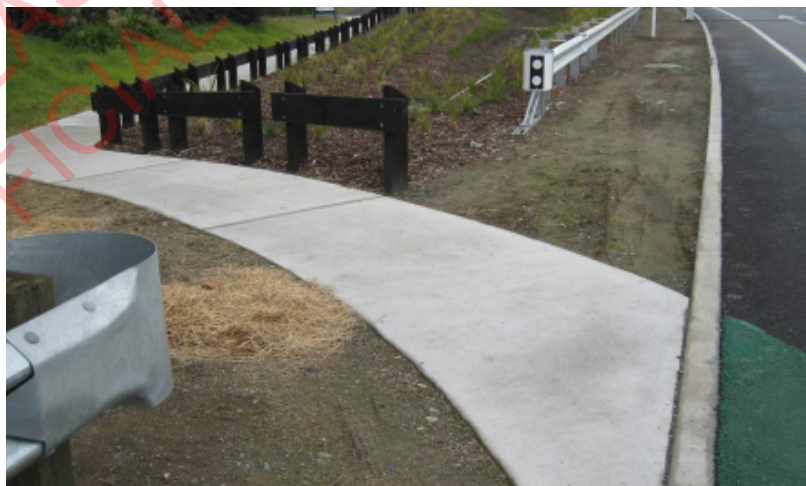
1. Adjacent to the exit to the access road on the east side of the roundabout is a low wooden fence/barrier with substantial posts which are not frangible. Any vehicle, including a motorcycle, losing control on the circulating carriageway and hitting any of these posts is likely to result in injury for the occupant(s).
2. The above type of fence/barrier has also been constructed along the west side of the cycle path where the path exits the southbound approach (see **Photo 5**). Any vehicle losing control and going through the gap between the barriers will hit the fence/barrier posts. (**NB** It is noted that the fence/barrier is also a potential hazard for cyclists turning onto the path and at the curve in the path.)

**Photo 5 – Low fence/barrier at cycle exit from southbound approach**

*Make the fence/barrier posts frangible where they may be hit by an errant vehicle (ie adjacent to the roundabout exit to the access road and adjacent to the cycle path exit from the southbound approach).*

<b>Designer Response</b>	The Alliance agree with the SAT recommendation.  The constructor is to drill a 40mm hole through the first six wooden posts on the 150mm edge to create a frangible post system in accordance with the orientation criteria in NZS 3845. The hole needs to be at ground level.
<b>Safety Engineer:</b>	Agree with Design team's solution.
<b>Client Decision:</b>	Further to the advice of the Safety Engineer confirm agreement with Designers solution.
<b>Action Taken:</b>	The constructor has drilled 40mm holes through the first six wooden posts on the 150mm edge to create a frangible post system as noted above.
<b>STATUS</b>	CLOSED

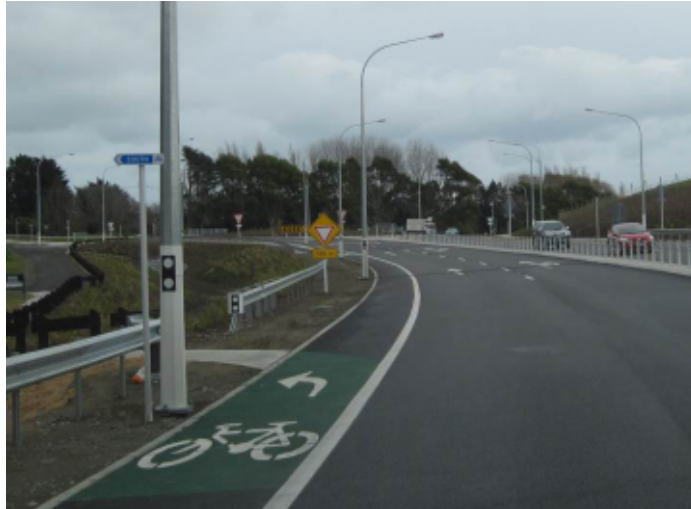
1. At the first southbound cycle exit there is a left turn arrow in the shoulder which theoretically requires all cyclists to turn onto the path at that point even though the shoulder continues (see **Photo 6**). There should be an ahead arrow as well or preferably remove the left turn arrow. It would also be helpful if there was a sign advising cyclists to continue ahead for Otaihanga Road.

**Photo 6 – First southbound cycle exit**

- a. Review the markings where the shoulders terminate at the cycle exits on the southbound and northbound approaches having regard to the concerns raised in items 1 and 2 above.
- b. Review the direction signage for cyclists to provide consistent and continuous directions at all decision points.
- c. Mount all cyclist direction signs at a height that can be readily seen by cyclists.

<b>Designer Response</b>	<ul style="list-style-type: none"> <li>a. The Alliance agree with the SAT recommendations. An ahead arrow will be painted along with the left turn arrow. A sign will be provided to inform cyclists to continue ahead to Otaihanga Road. The edge line will terminate immediately after the cyclist exit and the arrow will be removed. Instruction to be sent to site.</li> <li>b. The Alliance agree with the SAT recommendation that all cyclist direction signs will be moved to the decision points.</li> <li>c. The Alliance agree with the SAT recommendations that cyclist direction signs will be lowered so they are visible to cyclists.</li> </ul>
<b>Safety Engineer:</b>	<ul style="list-style-type: none"> <li>a. Agree with SAT</li> <li>b. Agree – Once the signs are moved it would be useful to test the signs by asking a cyclist unfamiliar with the route to cycle through and check that the directions make sense and are provided in sufficient time to be useful.</li> <li>c. Agree.</li> </ul>

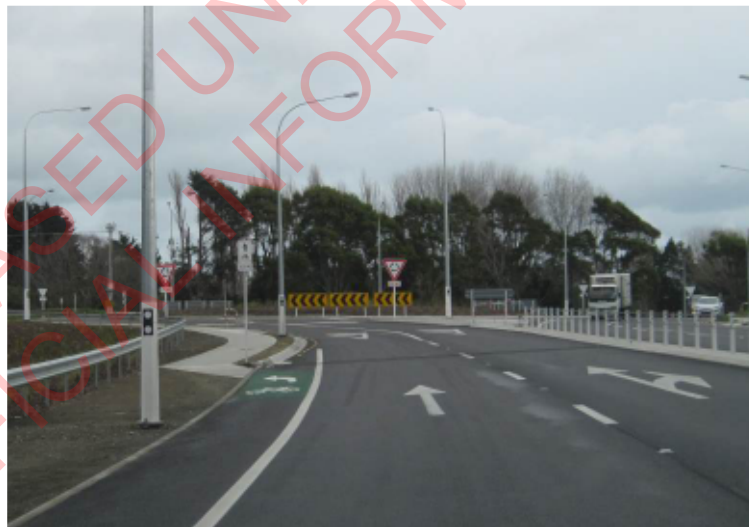
2. At the second southbound cycle exit where a left turn arrow in the shoulder theoretically requires cyclists to exit, the edge line does not terminate at the cyclist exit (see **Photo 7**). Also there is no sign advising cyclists to exit at this point for Otaihanga Road. Some cyclists proceeding south may wish to stay on the carriageway and take “ownership” of the adjacent traffic lane. The arrow does not convey this choice and the edge line marking directs them into the kerb. A similar situation occurs on the northbound approach.

**Photo 7 – Second southbound cycle exit**

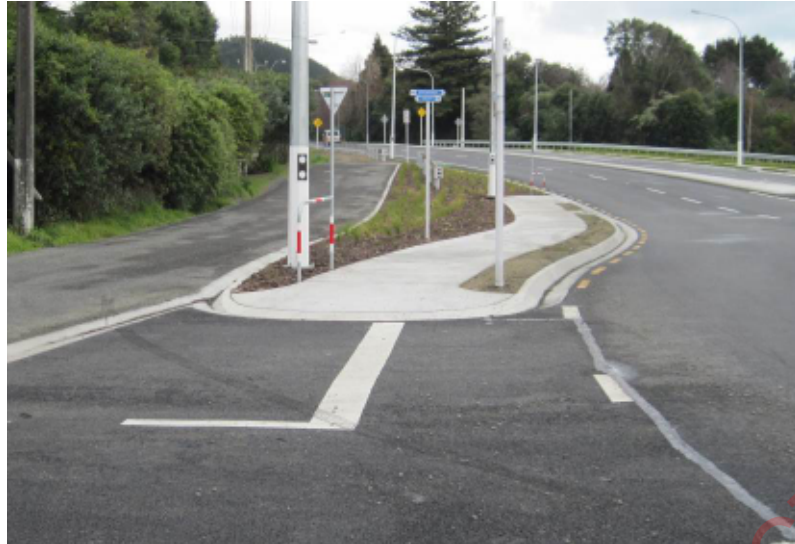
3. The existing cycle direction signage does not provide for continuous and consistent directional advice for cyclists who are not familiar with the roading layout. Apart from the signage issues noted above, the SAT also noted that the sign on the cycle path located south of the exit to the access road is located too far from the decision point for a cyclist needing to either use the access road to head south or the cycle path to head to Otaihanga Road (see **Photo 8**).

**Photo 8 – Cyclist direction sign too far from decision point**

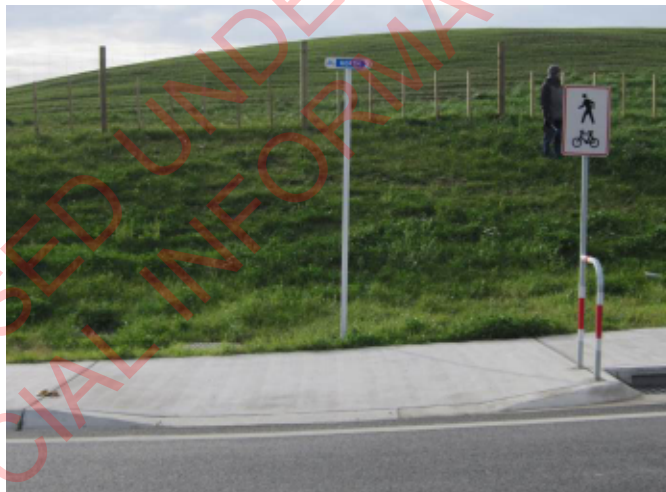
4. All of the cycle direction signs are mounted too high for cyclists to clearly see. Given the head position of cyclists and the peaks on many helmets, the signs have been mounted at a height that they are not readily seen when cyclists are in a position to be able to read the small lettering (see **Photo 9**).

**Photo 9 – Example of cyclist direction sign mounted too high**

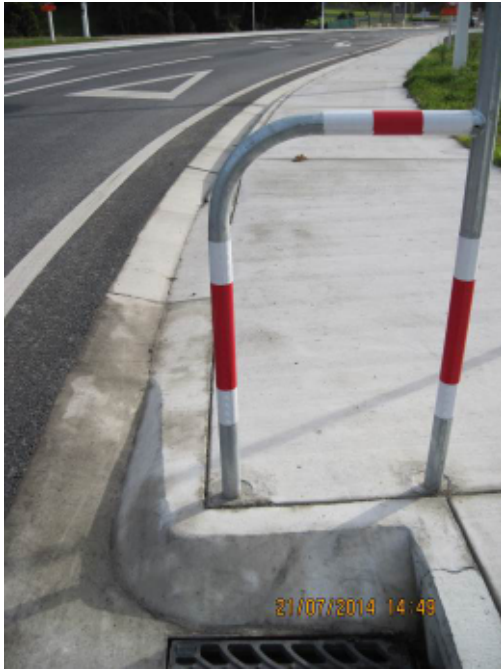
Short holding rails are located at each cyclist/pedestrian crossing point. However, these holding rails are generally impractical to use and could potentially be a safety hazard for cyclists. Their location is adjacent to where the kerb is not fully flush with the carriageway and as a result the front wheel of the cycle is likely to extend over the kerb when a cyclist is holding onto the rail (see **Photo 10**). It was also noted that the proximity of the holding rails to the kerb has already resulted in one of the holding rails being hit (see **Photo 11**). The above factors would put a cyclist using the holding rails at risk.

Photo 10 – Holding rail at kerb

Remove the short holding rails at each crossing point and provide longer holding rails located more appropriately for ease of use by cyclists.

<b>Designer Response</b>	The Alliance agree with the SAT recommendation.  All short holding rails will be removed from site. The cycle/footpath sign posts will remain, but will be installed on a new post.
<b>Safety Engineer:</b>	Agree with SAT concern, Design team need to consider if there is room to accommodate longer hold rails at more appropriate locations.
<b>Client Decision:</b>	Agree with the Safety Engineer that the Design team should assess the practicality of installing hold rails at locations where they will be useful. Suggest that the Safety Engineer and client is consulted further when the assessment is complete.
<b>Action Taken:</b>	The short holding rails have been removed from site and the cycle/footpath sign posts installed on new posts.
<b>STATUS</b>	CLOSED

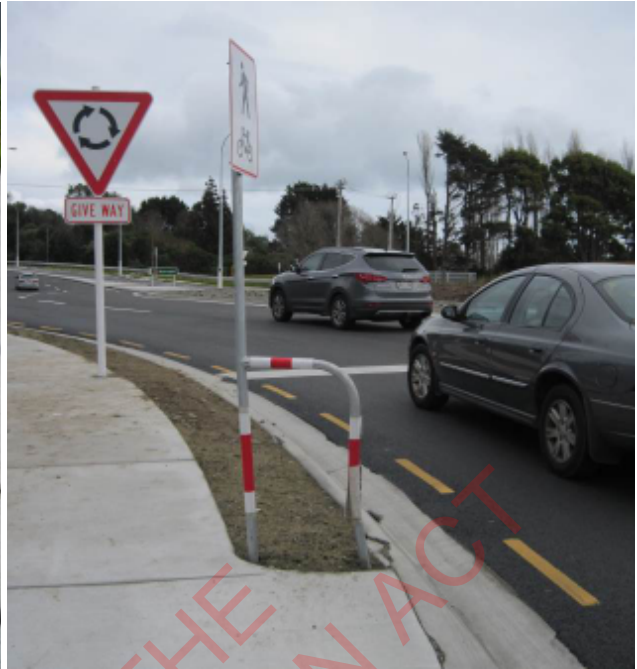
Photo 11 – Damaged holding rail

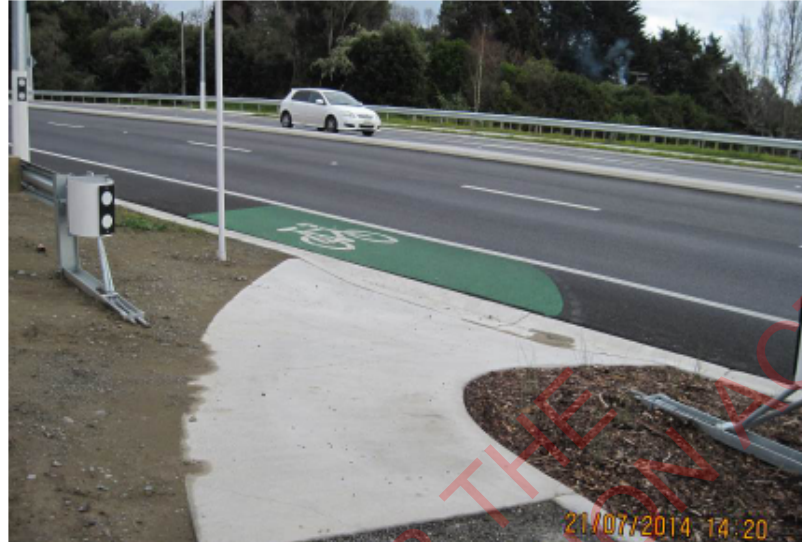
The shape of the cycle exit onto the SH1 southbound shoulder south of the roundabout (see **Photo 12**) would appear to force cyclists to make a wider turn onto the shoulder than the equivalent 45° exit onto the northbound shoulder north of the roundabout. It

**Photo 12 – Cycle exit southbound onto SH1**

*Amend the shape of the southbound cycle exit onto SH1 to ease the left turn onto the shoulder.*

<b>Designer Response</b>	The intension of the design radius is to slow the cyclists down so they can look to the right and safely merge with the State Highway 1 traffic.  It is not proposed to amend this exit where it is considered to operate safely.
<b>Safety Engineer:</b>	Agree with the SAT. The drop kerb should be extended to the south and additional concrete path provided to allow cyclists to move smoothly on the carriageway.
<b>Client Decision:</b>	Further to the advice of the Safety Engineer confirm agreement with the SAT recommendations.
<b>Action Taken:</b>	In discussion with the client, it was agreed that the operation of the cycle lane exit would be monitored in the period up to Christmas. The Alliance will also consult with local cycle group representative(s) to determine the safest arrangement before issuing any instruction to alter the pavement and kerb arrangement.
<b>STATUS</b>	ACTIVE

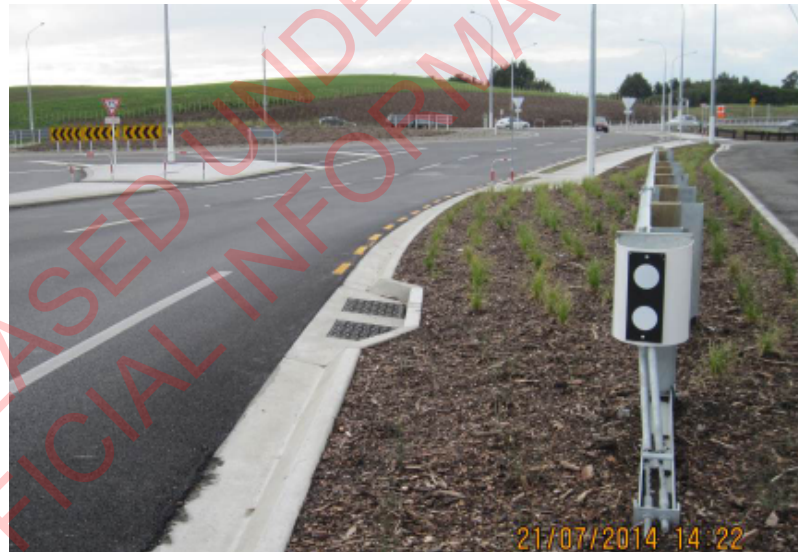
is acknowledged that this exit was constructed with input from a cyclist organisation, but the safety concern is that a cyclist making a speedy turn onto the shoulder may swing wide and be in conflict with a vehicle exiting the roundabout close to the kerb line (see **Photo 13**).

**Photo 13 – Southbound exit from roundabout**

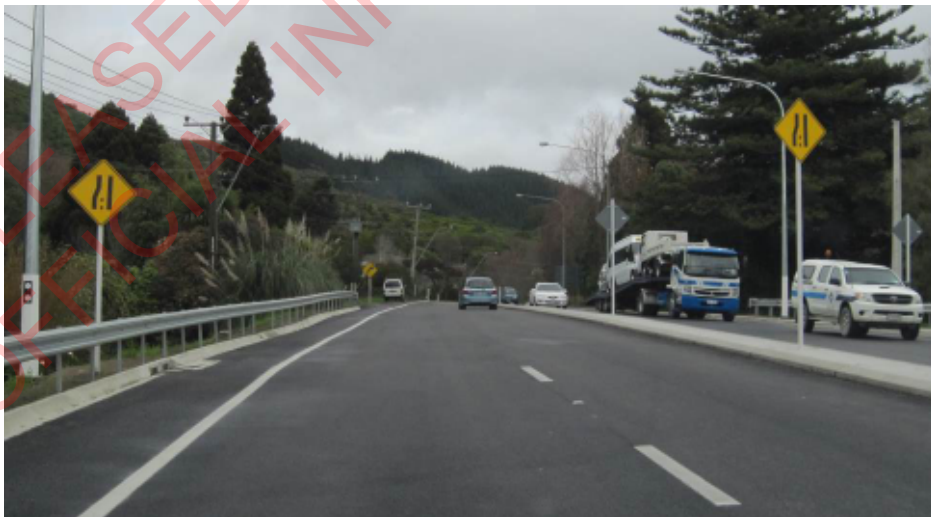
1. The SAT noted that the PW-43.3 sign mounted on the median facing southbound traffic on the SH1 southbound exit is mounted higher than the sign on the left hand side and is not so easily seen (see **Photo 14**).

**Photo 14 – Right hand side PW-43.3 mounted higher than left hand side**

*Address the signage issues noted above.*

<b>Designer Response</b>	<ol style="list-style-type: none"> <li>The Alliance agree with the SAT recommendations. The Constructor will mount the left hand side sign higher so it is at the correct mounting height in accordance with MOTSAM. The median sign will also be changed to the correct height.</li> <li>The Alliance agree with the SAT recommendation. The "Give Way" supplementary signs will be removed from these locations.</li> </ol>
<b>Safety Engineer:</b>	<ol style="list-style-type: none"> <li>As the sign on the right is likely to be hit by trucks if it is lowered, leaving the sign at its current height would be acceptable. Increasing the height of the sign on the left would make it less visible and therefore should also be left at its current height.</li> <li>Agree with Designer response.</li> </ol>
<b>Client Decision:</b>	Confirm the recommendation of the Safety Engineer.
<b>Action Taken:</b>	<ol style="list-style-type: none"> <li>As per the Client's decision the signs are to be left at their current height.</li> <li>The constructor has been instructed to remove the "Give Way" supplementary signs at this location. Confirmation that this has been completed shall be forwarded to the designer to close out this item.</li> </ol>

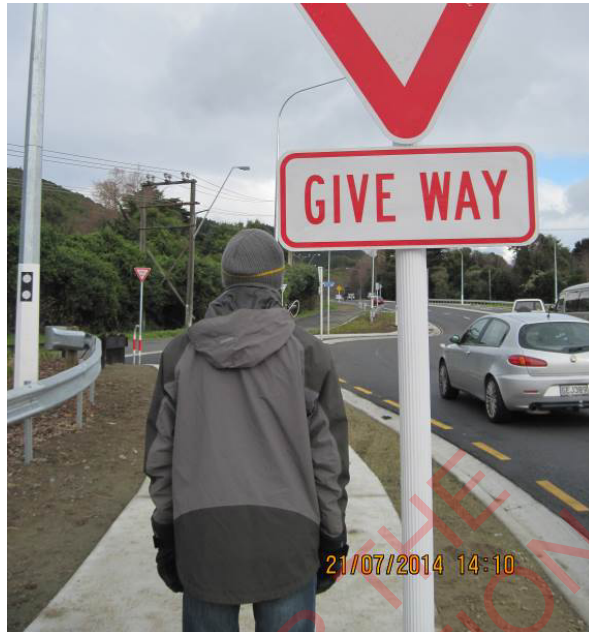
2. All the roundabout Give Way signs have a supplementary “Give Way” wording which is not strictly needed. The concern that the SAT noted is that for the extra-large signs on the southbound approach, the supplementary “Give Way” wording

sign is below head height (see **Photo 15**). This could be a hazard for a pedestrian or a cyclist.

**Photo 15 – Low mounting of supplementary sign**
