Structures maintenance/ renewal funding request form

Network area South Canterbury		Structure name Ashburton (Hakaterere) River Bridge			Highway 1S	RP 430/0 6	BSN 4306			
Priority High (year 1)	Work category 215B Structural Bridge Component Replacements		Year constructed: 1931	Map ref. (easting): 1498819	Map ref. (northing): 5137422					
Proposed Works Inject cracks in beam ends. Jack all beams at every second sliding pier (i.e. every fourth pier) and install an elastomeric bearing pad to reinstate 'sliding'/movement ability. Undertake conventional joint repairs with a sealant.			One Network Road Classification (ONRC): Secondary Collector	Vehicles per day: 23,904	Owner: NZTA	RCA: NZTA				
Structure description 342m long, 32 span, two lane reinforced concrete T-beam bridge founded on reinforced concrete wall piers and driven RC piles. Simply supported detailing with 'sliding' joint over every second pier (although high friction interface may be resulting in some beams no longer 'sliding'). Timber decked and steel joist clip-on footway on the upstream side.			Problem description Failure and leaking of the expansion joints and breakup of the surfacing within the joints. This is start

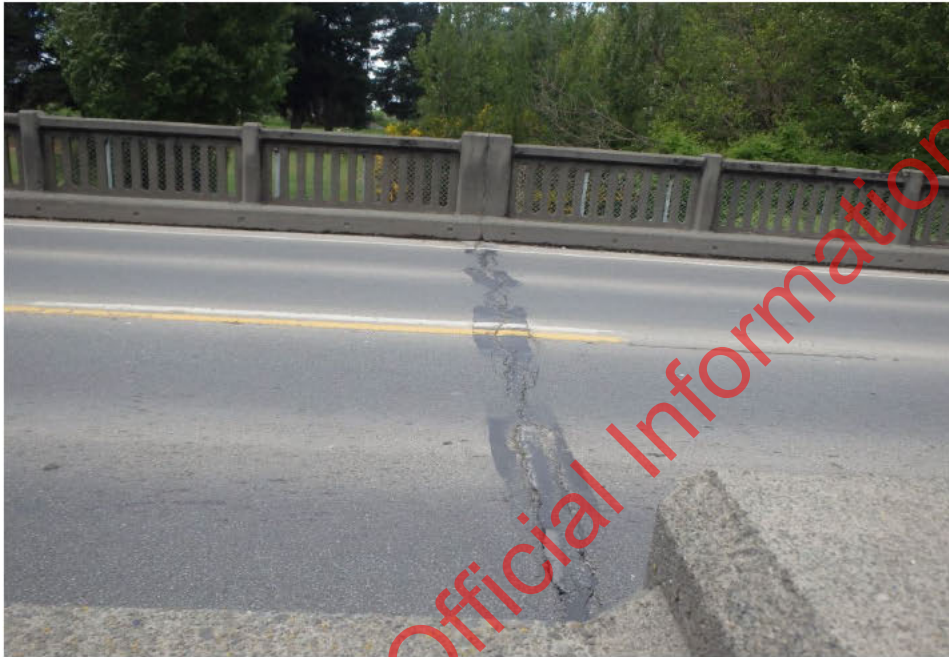
Figure 1 - Typical deterioration of deck joints

Proposed works and methodology			Prioritisation (see Prioritisation Tables worksheet for details)			Justification				
Crack seal the joints with PMB (low cost). Jack all beams at every second sliding pier (i.e. every fourth pier) and install an elastomeric bearing pad to reinstate 'sliding'/movement ability. Undertake conventional joint repairs with a sealant.			Category	Safety	Level of service	Cost deferral	Legal/ environment	If the joints continue to deteriorate, there will be a higher cost for repairs and increased driver discomfort. Safety and capacity of the bridge could also be compromised if the end of the beams spill off and their seating is reduced. In the worst case, this could cause a beam to settle, which has occurred on other similar bridges in the past.		
			Priority	Medium (years 2-4)	High (year 1)	High (year 1)	Low (year 5+)			
Consequences of not doing work If repairs are not undertaken, beam end failure similar to observed on the SH67 Orowaiti River Bridge is possible. This could result in the ends of the beams spalling off and possibly failure and settlement of the beams due to their limited seating. Joint leakage is exacerbating this, and is also starting to lead to breaking up of the asphalt and driver discomfort.

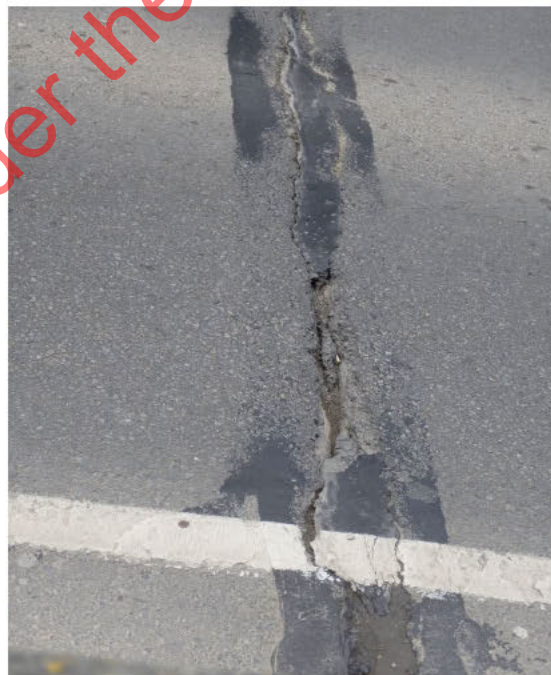
Figure 2 - Typical deterioration of deck joints, showing breakup and leakage.

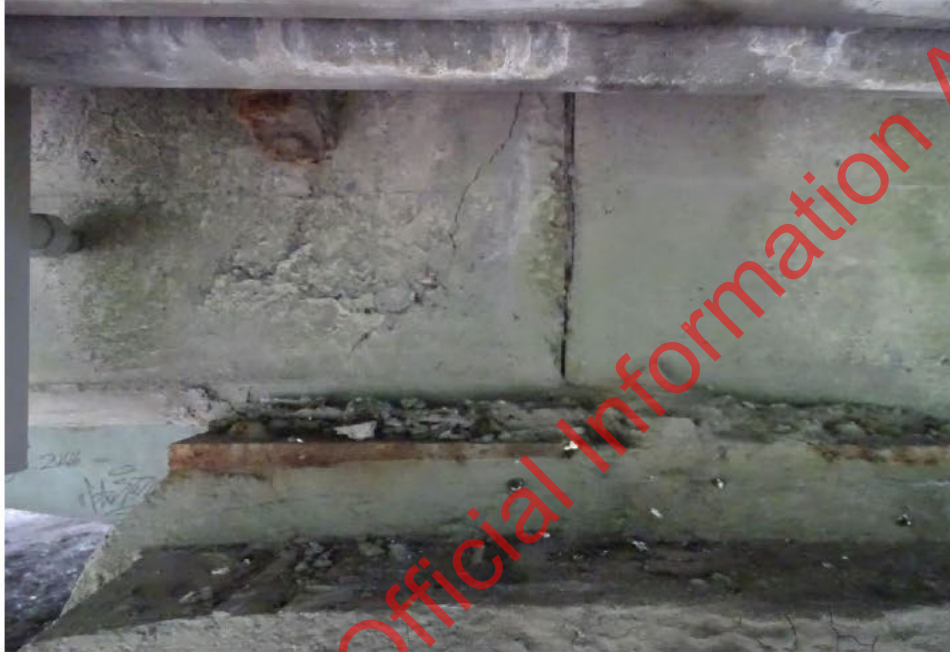
Figure 3 - Cracking at beams ends like due to thermal movement (lack of appropriate sliding surface) and exacerbated by water leakage

Option 3:	Inject cracks in beam ends. Jack all beams at every sliding pier (i.e. every second pier) and install an elastomeric bearing pad to reinstate 'sliding'/movement ability. Undertake conventional joint repairs with a sealant.	No	10-20 yrs	Effective	Stakeholders	Severe	Rare	Low		
Recommended option	Option 2: Inject cracks in beam ends. Jack all beams at every second sliding pier (i.e. every fourth pier) and install an elastomeric bearing pad to reinstate 'sliding'/movement ability. Undertake conventional joint repairs with a sealant.									
Reason for recommendation:	Joints are in poor condition and will continue to break up and deteriorate, resulting in driver discomfort. Leakage is also exacerbating the cracking and spalling of the beam ends. Repairing the cracks in the beam ends alone does not address the cause of the cracking and it is expected that the repaired cracks will reopen due to thermal movement. Installing an upgraded bearing at every second sliding pier is recommended initially. The elastomeric pads would be designed to cater for the thermal movement of four spans. The beam ends at the untreated sliding piers would continue to be monitored. If these beam ends start to deteriorate, the beams at these untreated piers can be jacked and bearings upgraded in the future as required.

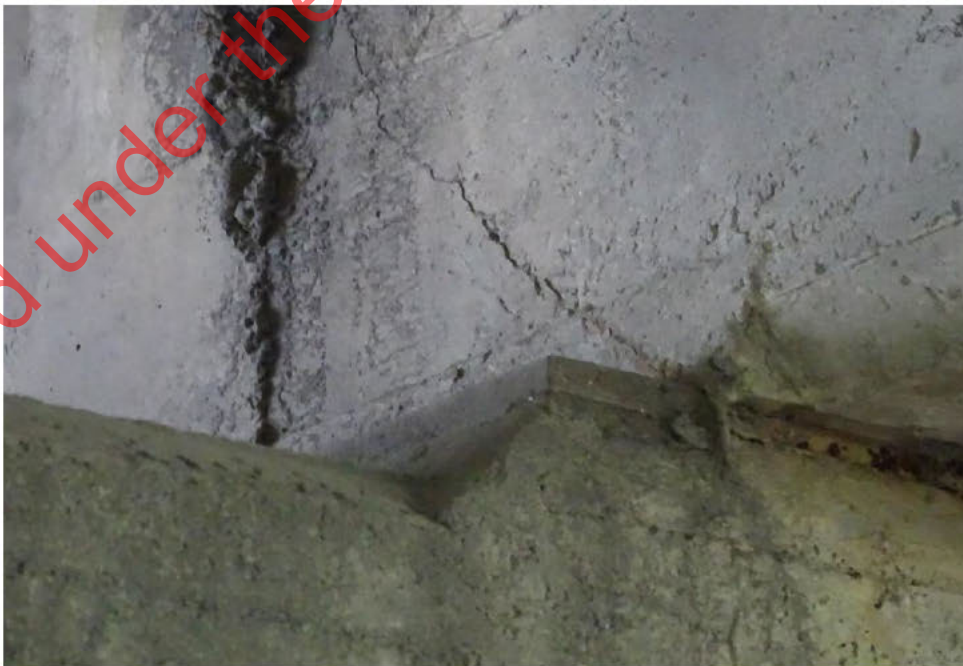
Figure 4 - Cracking at beams ends like due to thermal movement and exacerbated by water leakage. Could lead to spalling and seating

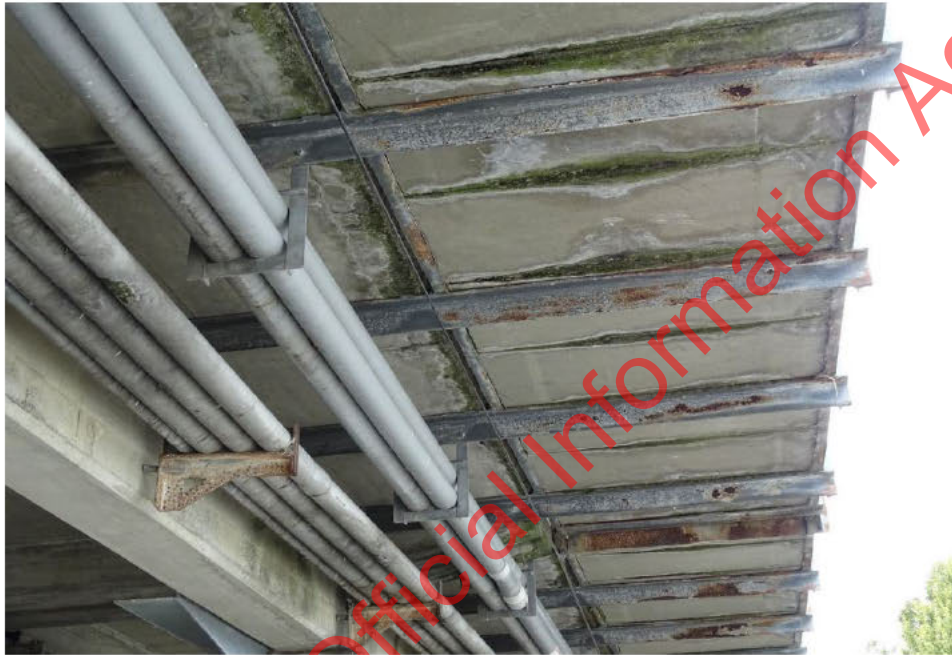
Figure 5 - Typical corrosion of footway joints. Will require recoating in a few years (at risk of section loss in a few areas).
