Puhoi to Warkworth

N1A Remediation Options - Technical Review Comments

P2WK-TAS-GE-TM-0010 | A

04 April 2023

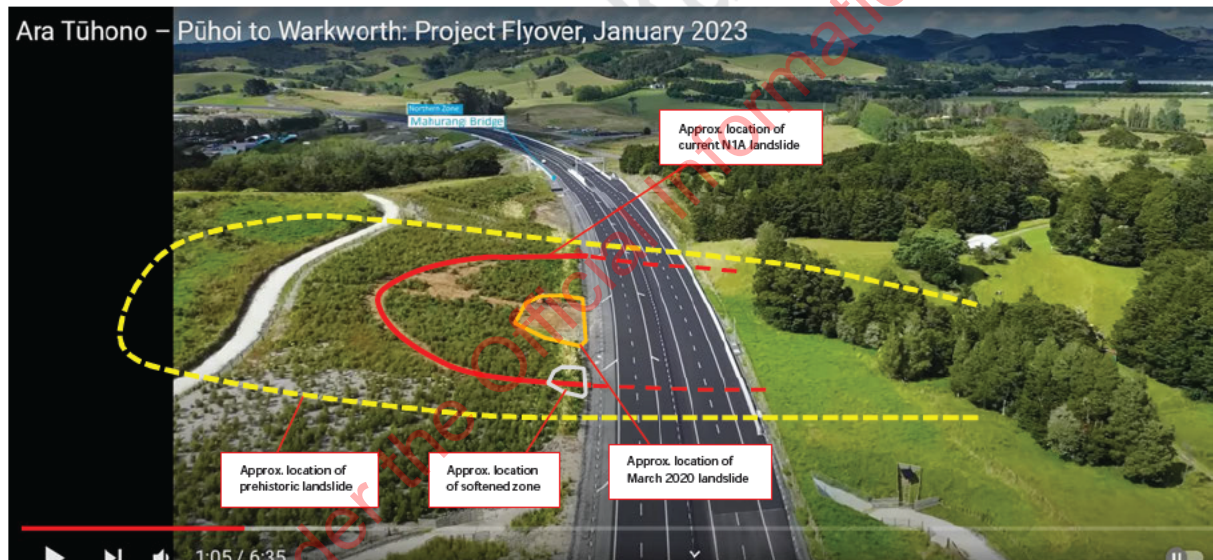
Figure 1 Screen capture of NX2's January 2023 drone flyover, with sketches of approximate locations of (a) March 2020 N1A landslide (b) current N1A landslide (c) prehistoric landslide. View towards the south-west.

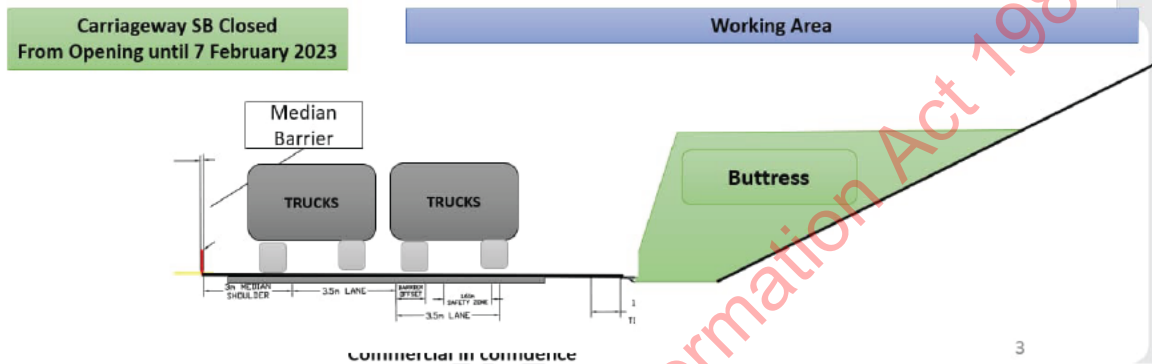
Figure 2 NX2 Option 1 section.

- We note that NX2 have also shown an interpreted ground model section with two landslide slip surfaces at depth extending beneath the carriageway (Figure 2).

- Option 1 involves placement of a fill buttress at the base of the cut slope.
- In their presentation NX2 have shown an interpreted ground model section with two landslide slip surfaces at depth extending beneath the carriageway (Figure 2). The deepest shear surface is interpreted to be at a depth of about 6-8m below the base of the buttress. Therefore, if option 1 was implemented as shown by NX2 the buttress will not be ‘keyed’ into stable bedrock at depth.

NX2's Option 1 is an earthwork solution, comprising reprofiling of the N1A cut slope (to a slightly steeper gradient), and constructing a fill buttruss at the toe of the N1A cut slope. Earthworks appear to be limited to the eastern side of the carriageway. Option 1 is indicated by NX2 to necessitate closure of both southbound lanes.

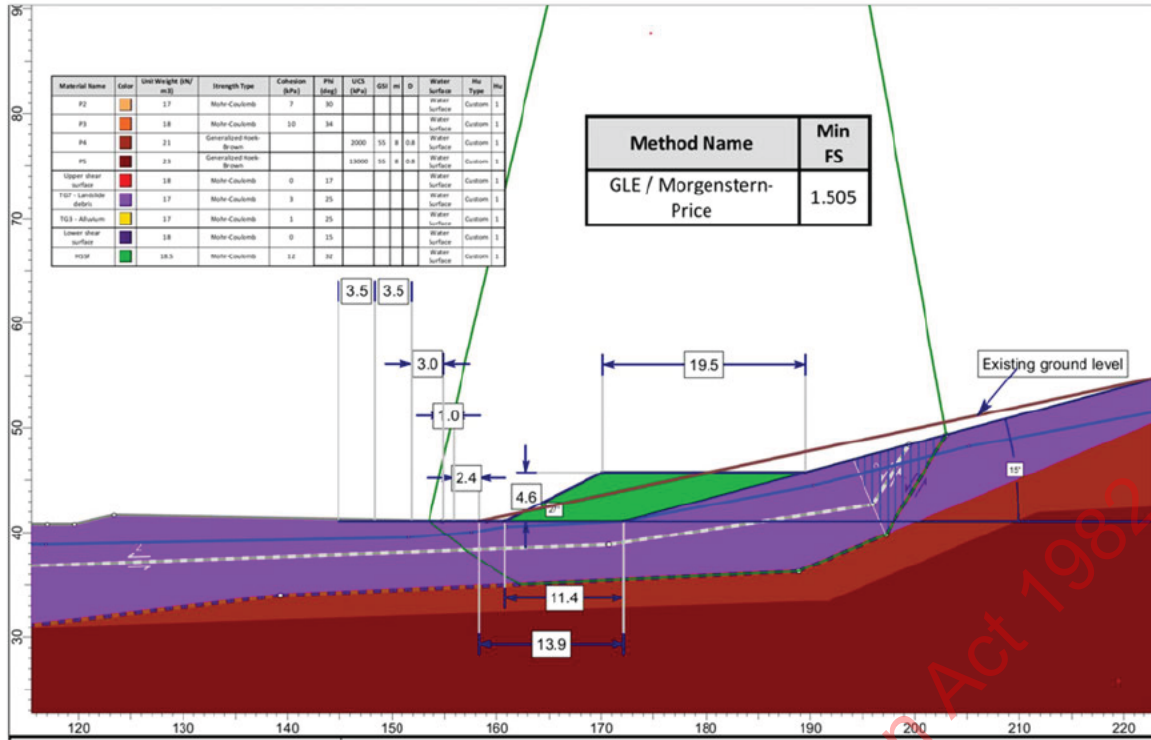
Figure 3 NX2's stability section for Option 1

- While reprofiling the cut slope removes some of the material in the upper part of the cut, and the buttress acts as a toe buttress to further stabilise landslides involving the slope (red slip surfaces in Figure 3), there is the risk that the buttress destabilises potential slip surfaces existing beneath the carriageway (purple slip surfaces in Figure 3).

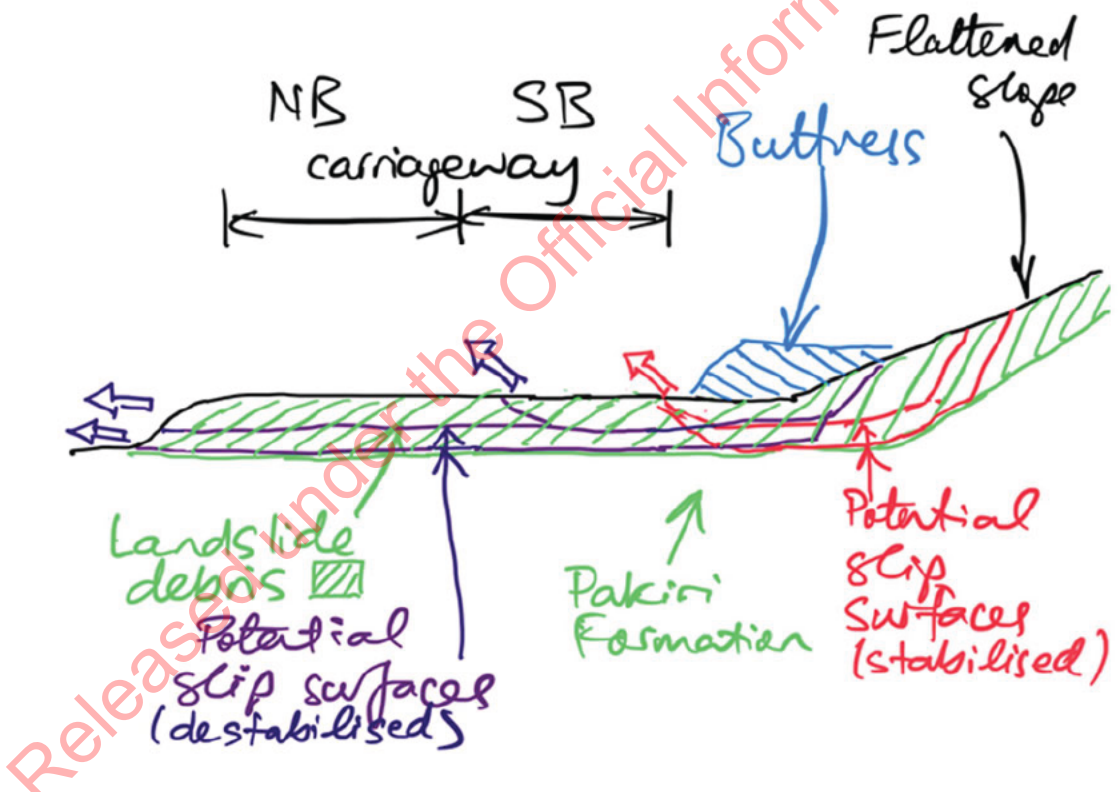
Figure 4 TAS's interpretation of stability for Option 1

- The performance of the buttress to stabilise the landslide when not keyed into stable bedrock requires a very robust knowledge of the ground model, slip surfaces and the landslide behaviour, with as many uncertainties as possible eliminated.

- Thus there is a risk that a fill buttress could have both positive and negative effects.

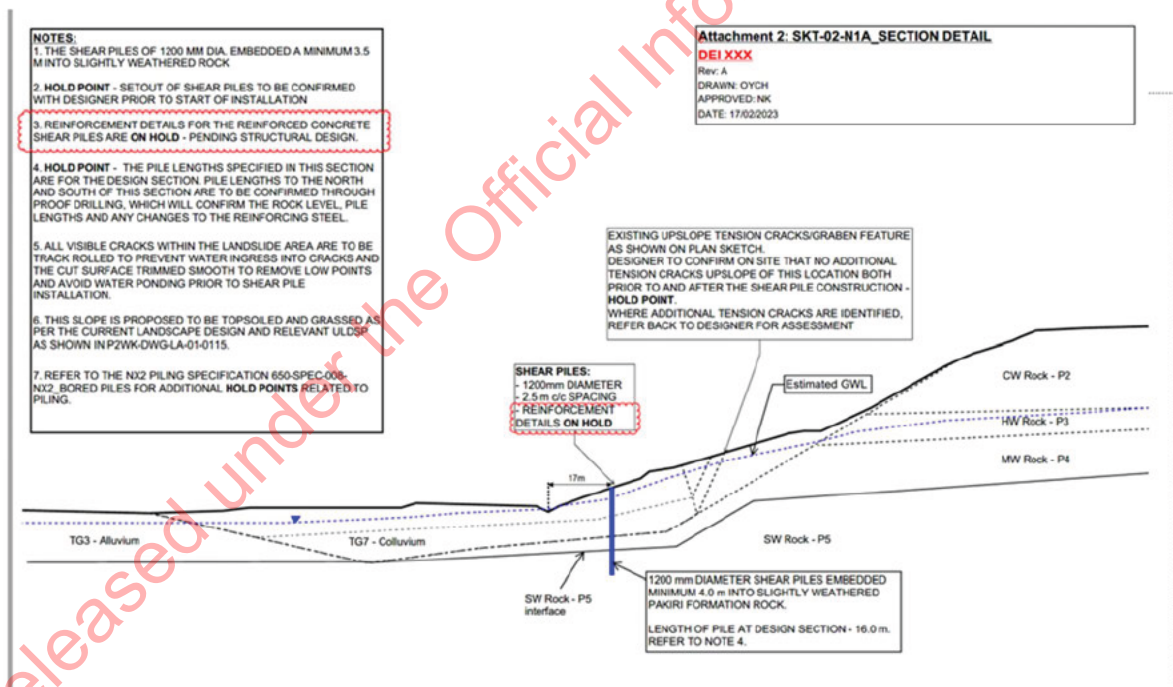
Figure 5 Options 2 and 3 section

- The piled solutions involve providing a restraining force to the upslope portion of the landslide, and effectively reduces the driving force on the lower portion of the landslide. The slip surfaces are positively intercepted and reinforced.

- The potential instability on gently inclined slip surfaces to the west of the piles and beneath the carriageway is likely decreased. Although the landslide body and slip surfaces here would remain unrestrained, and therefore the remaining instability of the downslope landslide mass should be investigated and confirmed during detailed design.

- It is essential that the piles are embedded into underlying stable rock well below the lower slip surface. This would require a knowledge of the geometry of the lowermost slip surface in the direction along the row of piles. We note that the NX2 presentation shows a proposed hold point to confirm the pile lengths through proof drilling. TAS agrees with this approach and would recommend that adequate proof drilling is carried out in advance of the construction in order to adjust or confirm the design based on the drilling results.

NX2’s Options 2 and 3 involve a structural solution, comprising installing a row of inground reinforced concrete piles in the slope on the eastern side of the carriageway. The piles penetrate the two identified slip surfaces and the toes of the piles are shown as being embedded into underlying rock. The piles would act in shear and provide a restraining force to the upslope portion of the landslide.

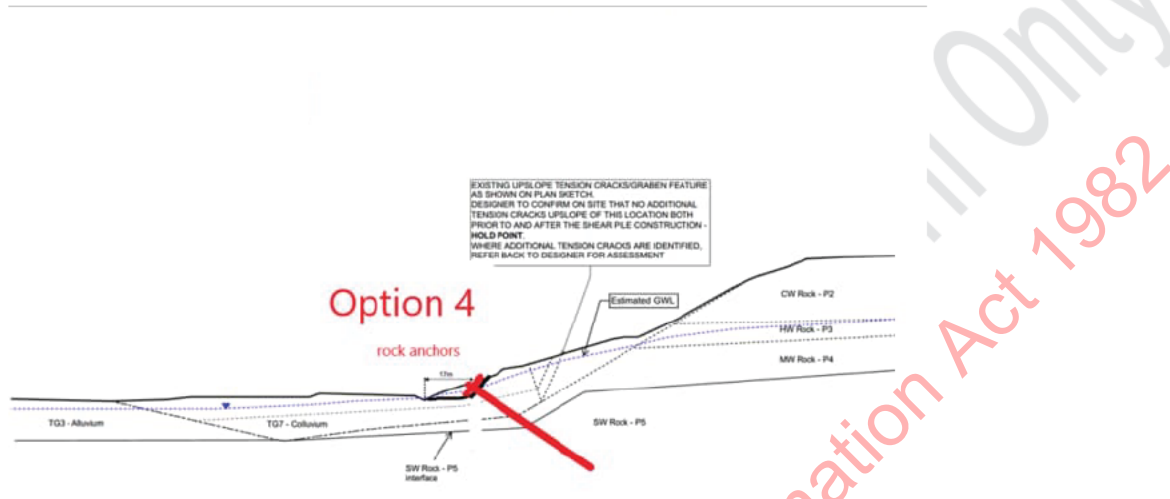
Figure 8 Modified NX2 sketch to show potential rock anchor option for consideration

A risk with Option 4 is that a better understanding of anchor founding conditions through further ground investigations would be required so that when installation of the anchors begin the risk of longer anchors being required is minimal. Trial anchors would need to be drilled and load tested to confirm anchor design prior to construction.

As an alternative deep rock anchors could be investigated as a possible solution requiring works to be performed along either one or two platforms on the slope face similar to Options 2 and 3. A second platform may be required if two rows of rock anchors are needed rather than a single row of rock anchors. The anchors would need large concrete pads to transfer anchor loads into the landslide mass. We expect that road closures for this option would be similar to that required for Option 3. Installation of rock anchors is likely to require smaller plant than that for Options 2 & 3.

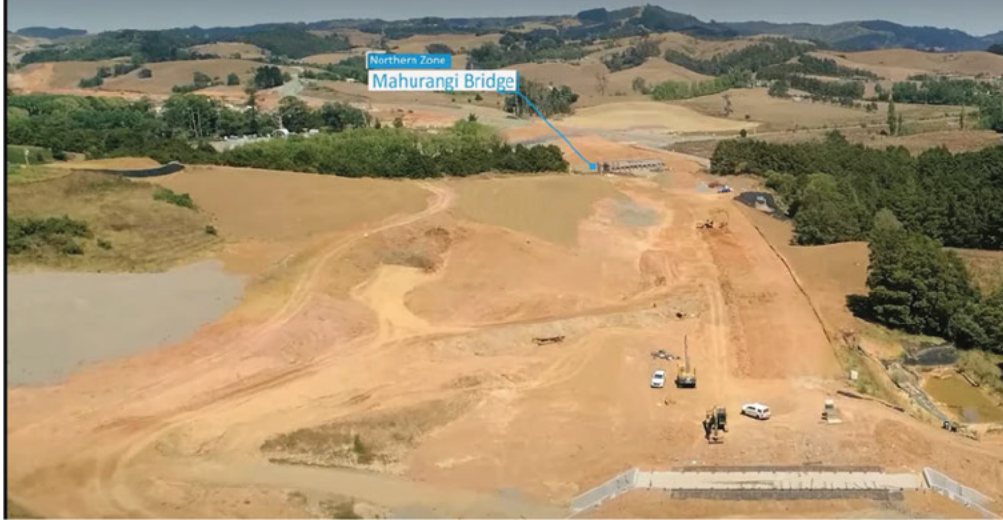
Figure 9 Screenshot of N1A cut (view southwards) from the February 2020 Drone Flyover

This measure may not be considered viable since the access road stability would have to be reviewed.

- reprofiling the slope below the farm access track to reduce the driving force on the upper portion of the slope. Originally fill was placed in this area prior to the 2020 landslides. See drone photo below.
