Pūhoi To Warkworth (P2Wk)– Landslide Risk Assessment

# Geotechnical Review of Cut Slopes and Landslide Risks

Revision E

Date: 11 April 2023

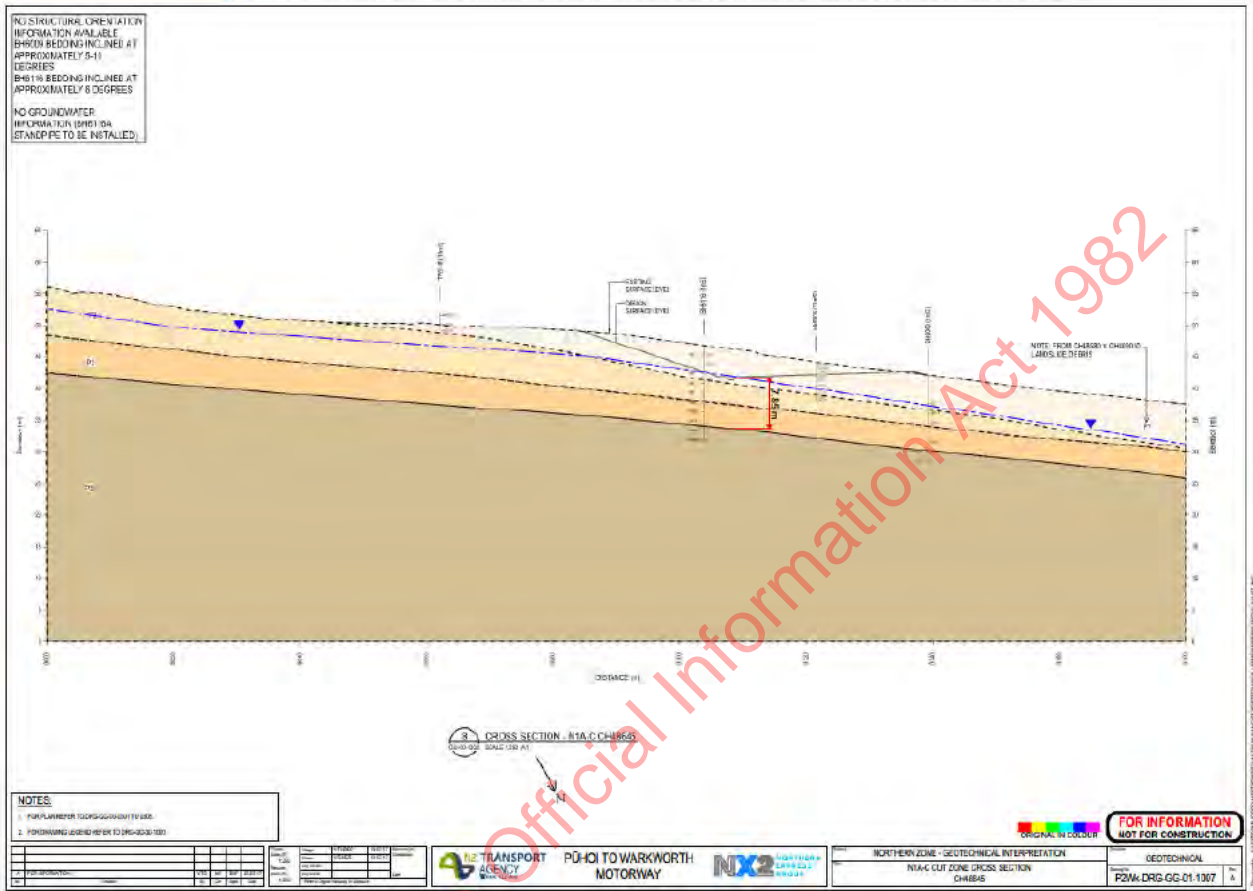
Soil Rock Transition Zone	5° to 10°
Rock Cut	Rock cut exposure at the eastern side of cut slope formed 4H:1V
Remedial Works Design	DEI 0440, DEI 0444 (Ch48700 – 48730, Soil Stabilisation)
Remedial Works Details	<p><b>First landslide:</b></p> <ul style="list-style-type: none"> <li>• 5x counterfort drains at slip location Ch48,710 – Ch48,780,</li> <li>• Buttress fill</li> <li>• Reshaped from 3H:1V to 4H:1V</li> </ul> <p><b>Second landslide (Ch48,700 – 48,800) October/November 2022</b>          To be confirmed. Final details were not available at the time of writing this report.</p>
Independent Peer Review	Refer to PSM Report PSM4203-029R Draft Rev 4 – Appendix A (only applies for the first landslide)
Rock Cut Slope	Rock outcrop at lower part of cut slope is cut at 4H:1V
Groundwater Seepage Monitoring	<p>Seepage monitoring undertaken on the 14/07/2021 and within 48hours of rainfall. Groundwater seepage observations are as follows:</p> <ul style="list-style-type: none"> <li>• Soil slope was topsoil/mulched at time of inspection</li> <li>• Seepages recorded at northern end of cut slope</li> <li>• Seepage and landslide recorded on eastern cut slope side</li> <li>• Seepages recorded at soil-rock transition</li> <li>• Minor seepage from rock face and typically increased seepage directly after rainfall</li> </ul>

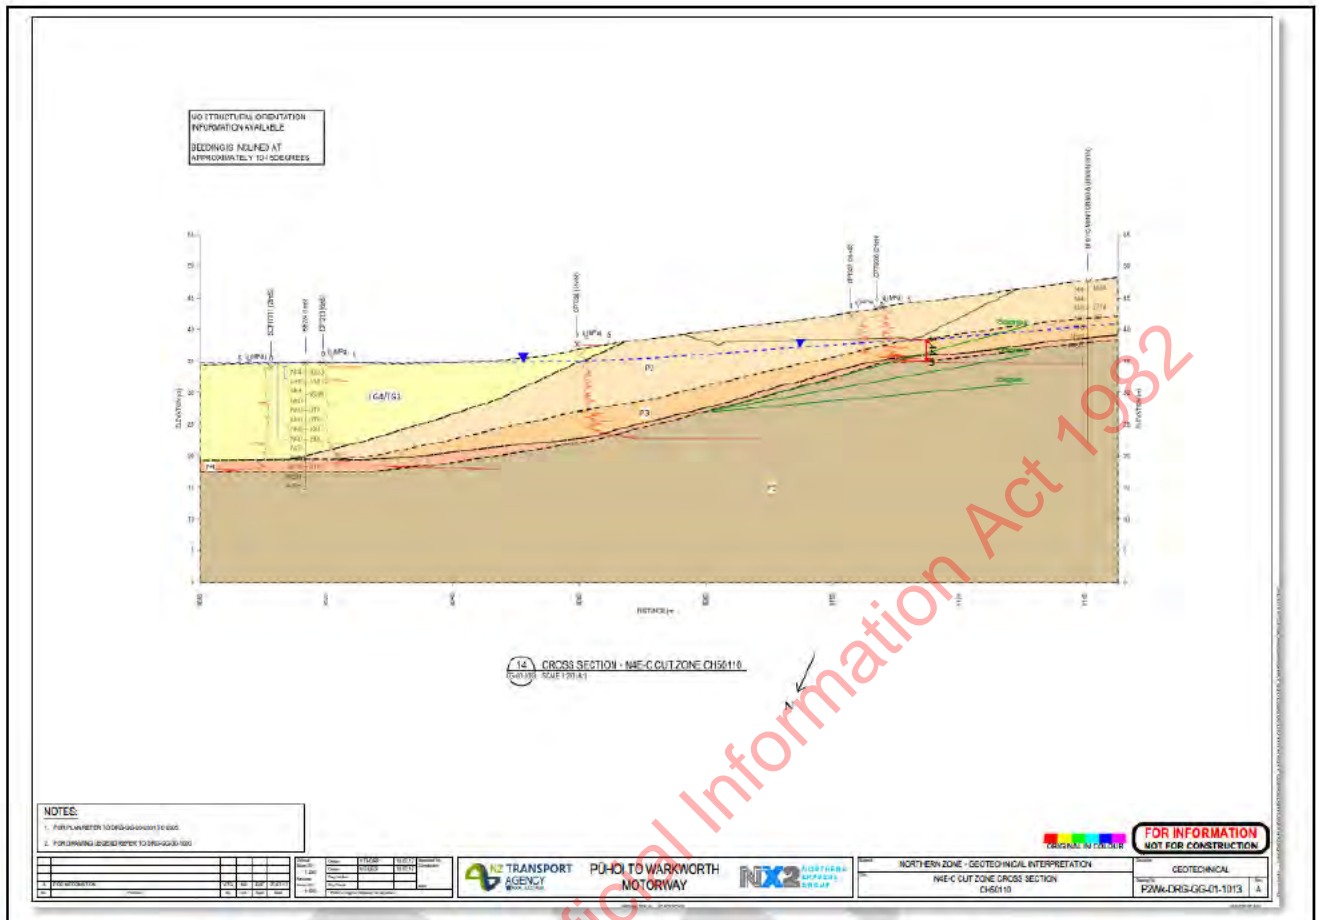
Soil Rock Transition Zone	Transition zone dips at 5-15deg from West to East approx. 3m below toe of slope
Rock Cut	No rock cut or rock exposures at cut slope.
Remedial Works Design	None required.
Remedial Works Details	Not applicable
Peer Reviewed in PSM Report Rev 4	Not reviewed
Groundwater Seepage Monitoring	No groundwater seepage monitoring carried out.
Risk of Future Slope Failure	<p><b>East (LHS):</b> The risk of future slope failure is considered <b>very low</b>. Low slope height. Topography dipping away at the back of the cut slope.</p> <p><b>West (RHS):</b> The risk of future slope failure is considered <b>very low</b>. Low slope height.</p> <p>The risk rating at both sides has been reduced from low risk to very low risk since the previous Revision D Report.</p>

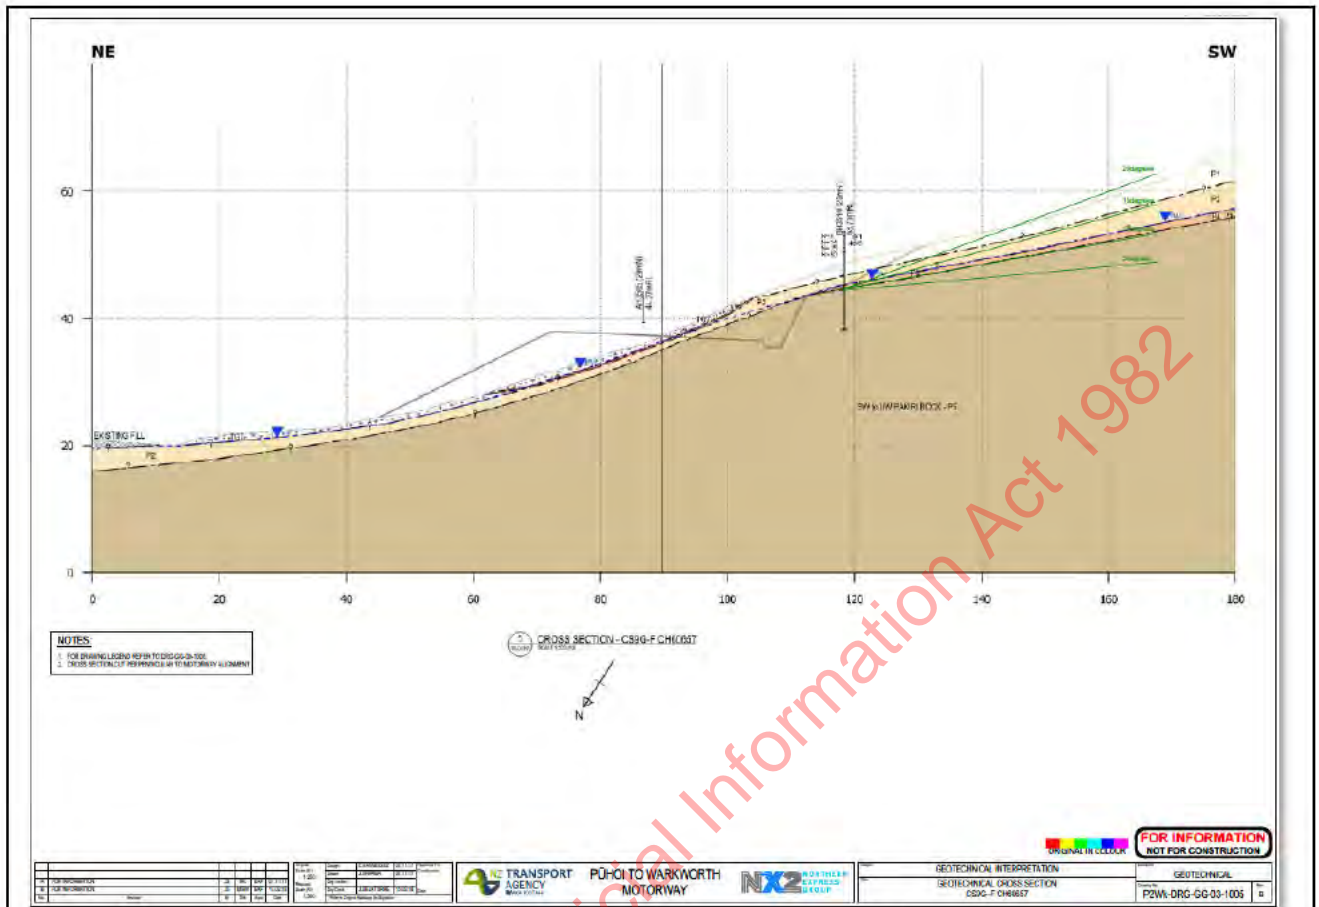
Soil Rock Transition Zone	Dipping in eastern direction at 10° unfavourable out of slope
Rock Cut	64° (1H:2V) up to 8m high at the western side
Remedial Works Design	None required
Remedial Works Details	Not applicable
Peer Reviewed in PSM Report Rev 4	Not reviewed
Groundwater Seepage Monitoring	<p>Seepage monitoring undertaken on the 30/06/2021 and 4/08/2021. Engineering geological site inspection were undertaken on the 2/06/2021 and 12/11/2021. Monitoring on the 30/06/2021 and 4/08/2021 was undertaken within 48 hours of rainfall. Observations are as follows:</p> <ul style="list-style-type: none"> <li>• 4x counterfort drains have been installed at Ch60600-east within the transition cut slope.</li> <li>• Seepages observed from counterfort drain trenches and subsoil drain outlets with water running down slope face and over bench.</li> <li>• <b>Multiple slips have occurred behind and above cut slope.</b></li> <li>• Seepages recorded at soil-rock transition</li> <li>• Seepages recorded from rock bedding structure</li> <li>• Seepages recorded from soil cut surface</li> <li>• Soil surface conditions soft and slippery with moss build-up</li> <li>• Transition cut slope Ch60,700-west appears over steepened of 2H:1V</li> </ul>

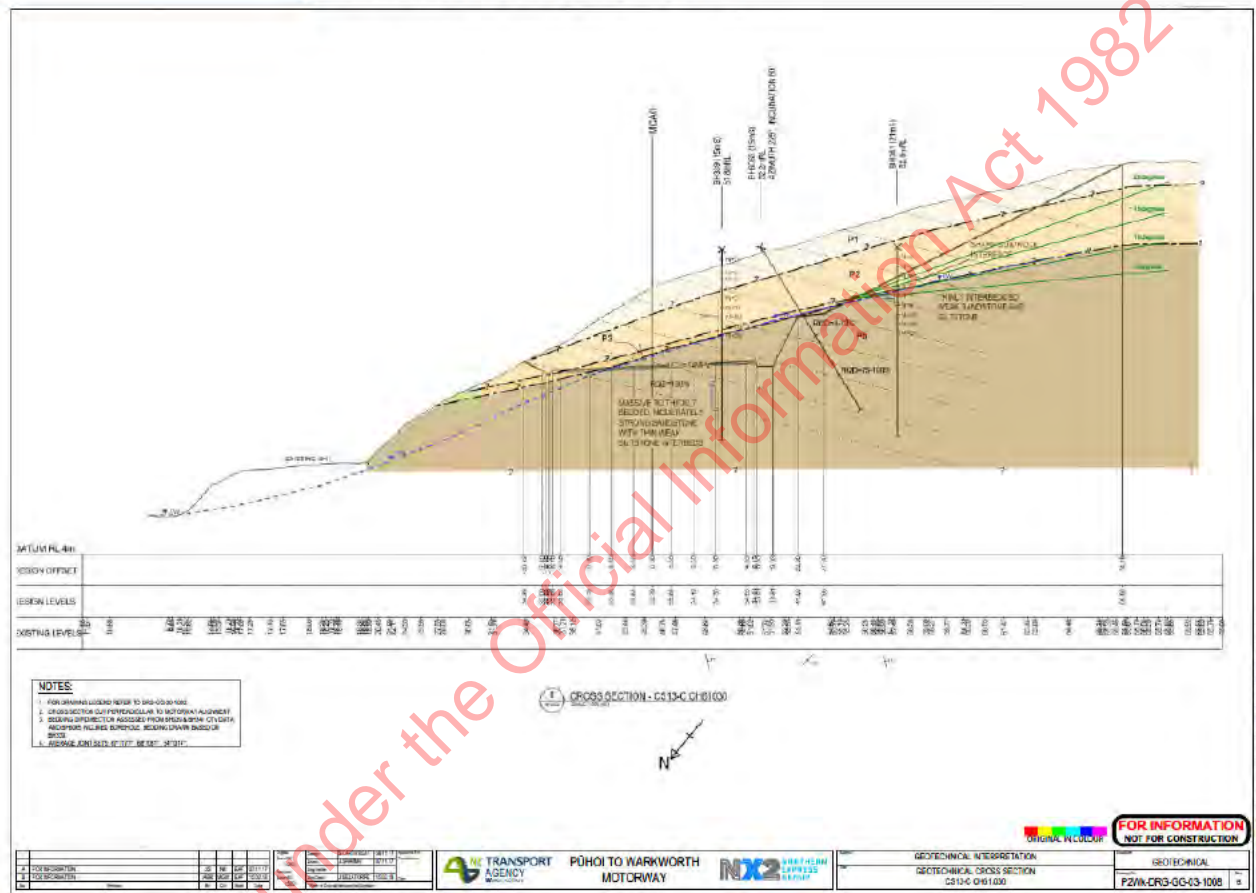
Soil Rock Transition Zone	Dipping in eastern direction at 10° unfavourable out of the slope
Rock Cut	64° (1H:2V) up to 10m high at the western side
Remedial Works Design	Remedial works are to be determined.
Remedial Works Details	Not available at time of writing this report Rev E.
Peer Reviewed in PSM Report Rev 4	Not applicable. The new slip occurred after this report was prepared.
Groundwater Seepage Monitoring	<p>Seepage monitoring undertaken on the 30/06/2021 and 4/08/2021. Engineering geological site inspections were undertaken on the 2/06/2021 and 12/11/2021. Monitoring on the 30/06/2021 and 4/08/2021 was undertaken within 48 hours of rainfall. Groundwater seepage monitoring was carried out after the cut slopes had been grassed/hydroseeded</p> <p>Groundwater seepage and engineering geological observations are as follows:</p> <ul style="list-style-type: none"> <li>• Seepage encountered at natural ground</li> <li>• Seepage encountered at soil-rock transition</li> <li>• Softened ground at soil-rock contact</li> <li>• Active surface erosion occurring</li> </ul>

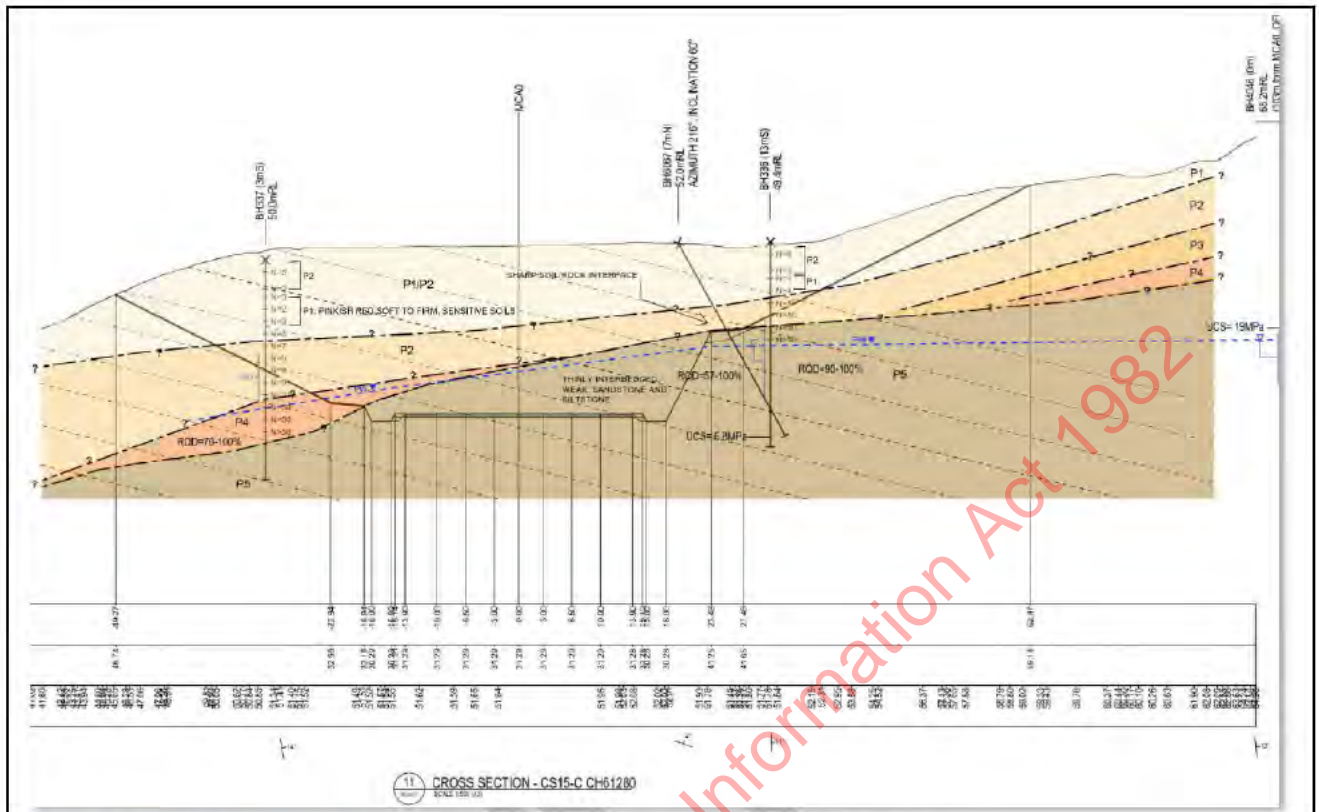
Soil Rock Transition Zone	Dipping in eastern direction at 5° unfavourable out of slope
Rock Cut	64° (1H:2V) up to 10m high at the western side
Remedial Works Design	Yes. No DEI issued.
Remedial Works Details	<p>Remediation will a toolbox solution already included in the IFC design.</p> <ul style="list-style-type: none"> <li>• Lay back to 3H:1V</li> <li>• Counterfort drains</li> <li>• Cut-off drain</li> </ul>
Peer Reviewed in PSM Report Rev 4	Not reviewed
Groundwater Seepage Monitoring	<p>Seepage monitoring undertaken on the 2/06/2021, 22/06/2021 and 4/08/2021. Monitoring on the 22/06/2021 and 4/08/2021 was undertaken within 48 hours of rainfall. Groundwater seepage monitoring was carried out after the cut slopes had been grassed.</p> <p>Groundwater seepage observations consisted of the following:</p> <ul style="list-style-type: none"> <li>• Soil slope face typically dry/hard with no seepage observed/able to be observed</li> <li>• Seepages were observed at soil-rock transition</li> <li>• Minor seepage recorded at rock cut slope with seepage present along rock bedding structure</li> <li>• Subsoil drains functioning with softened wet ground and surface erosion present at outlets</li> </ul>

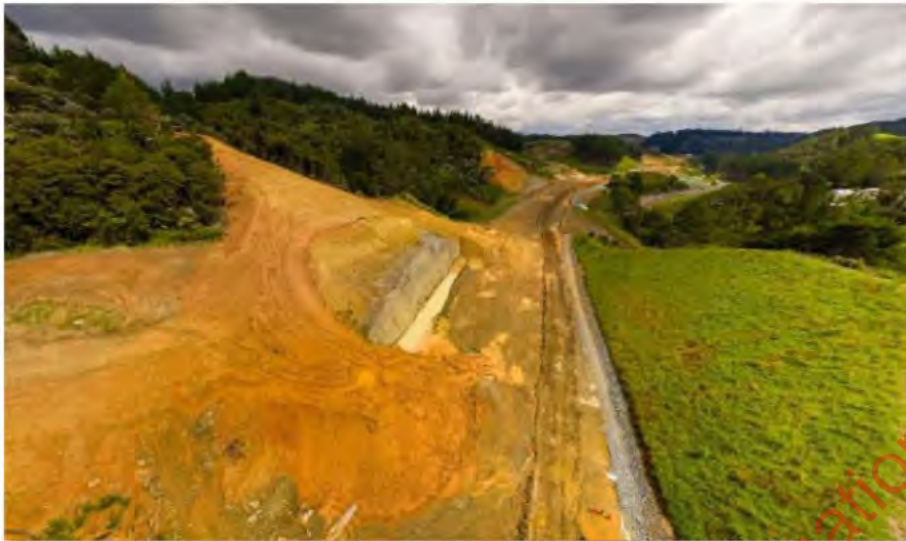
CS15A View in northern direction (Source: Landslide update 2020.45, Photo Date unknown)

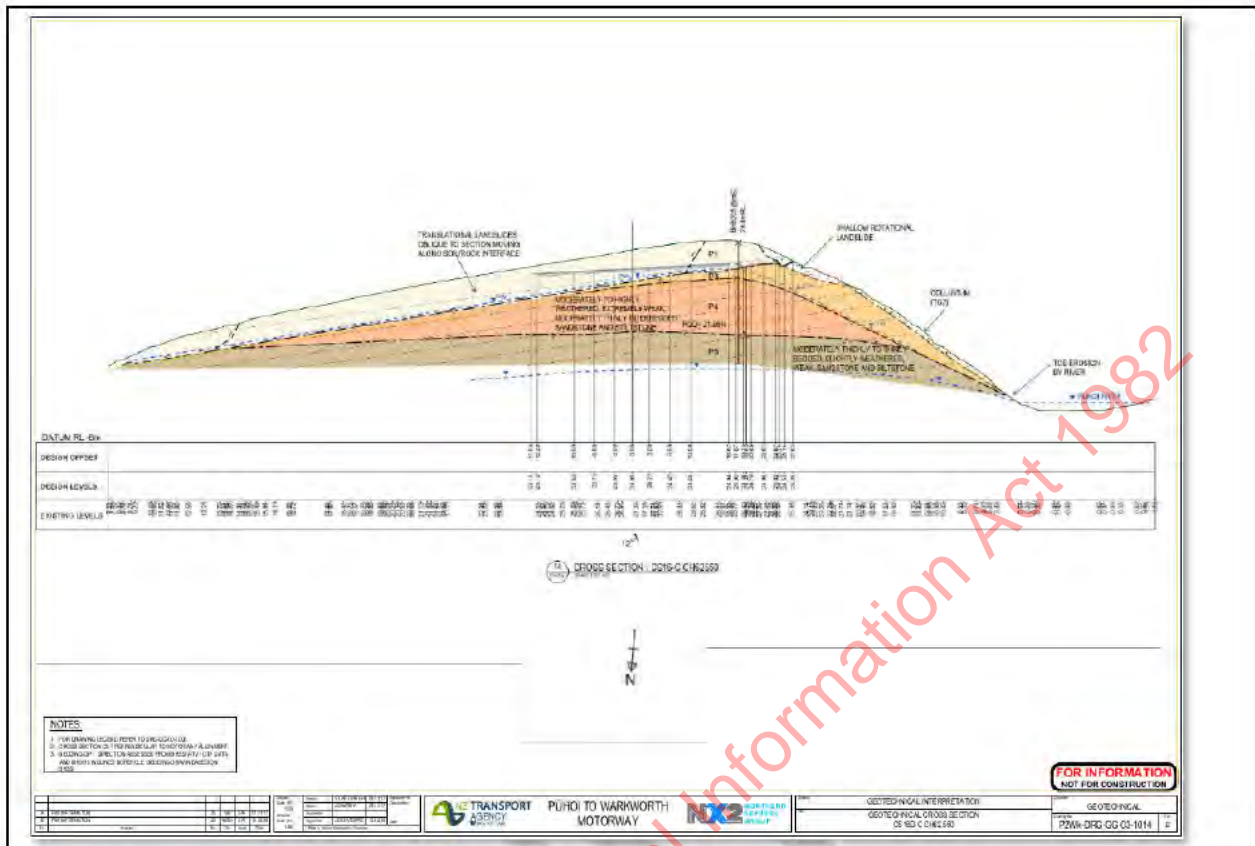
Soil Rock Transition Zone	Dipping in eastern direction at 5~10° unfavourable out of slope
Rock Cut	85° and 64° (1H:2V) up to 30m high at the western side
Remedial Works Design	DEI 503, DEI 511 (referenced in PSM's report PSM4203-029R Rev 4)
Remedial Works Details	Western soil batter laid back to 4H:1V above rock bench
Peer Reviewed in PSM Report Rev 4	Refer to PSM Report PSM4203-029R Draft Rev 4 – Appendix N
Groundwater Seepage Monitoring	Seepage monitoring and an engineering geological site inspection was undertaken on the 2/11/2021. Observations are as follows: <ul style="list-style-type: none"> <li>• Rock comprises highly interbedded sandstone and siltstone</li> <li>• Seepages observed at various RL from the rock mass structure</li> <li>• Seepages observed from soil-rock transition on to and over rock bench</li> <li>• Transition from rock to soil cut slope at northern end, Ch62000 relatively dry</li> <li>• Washout of mulch, topsoil and upper soil layers at Ch62500-west</li> </ul>

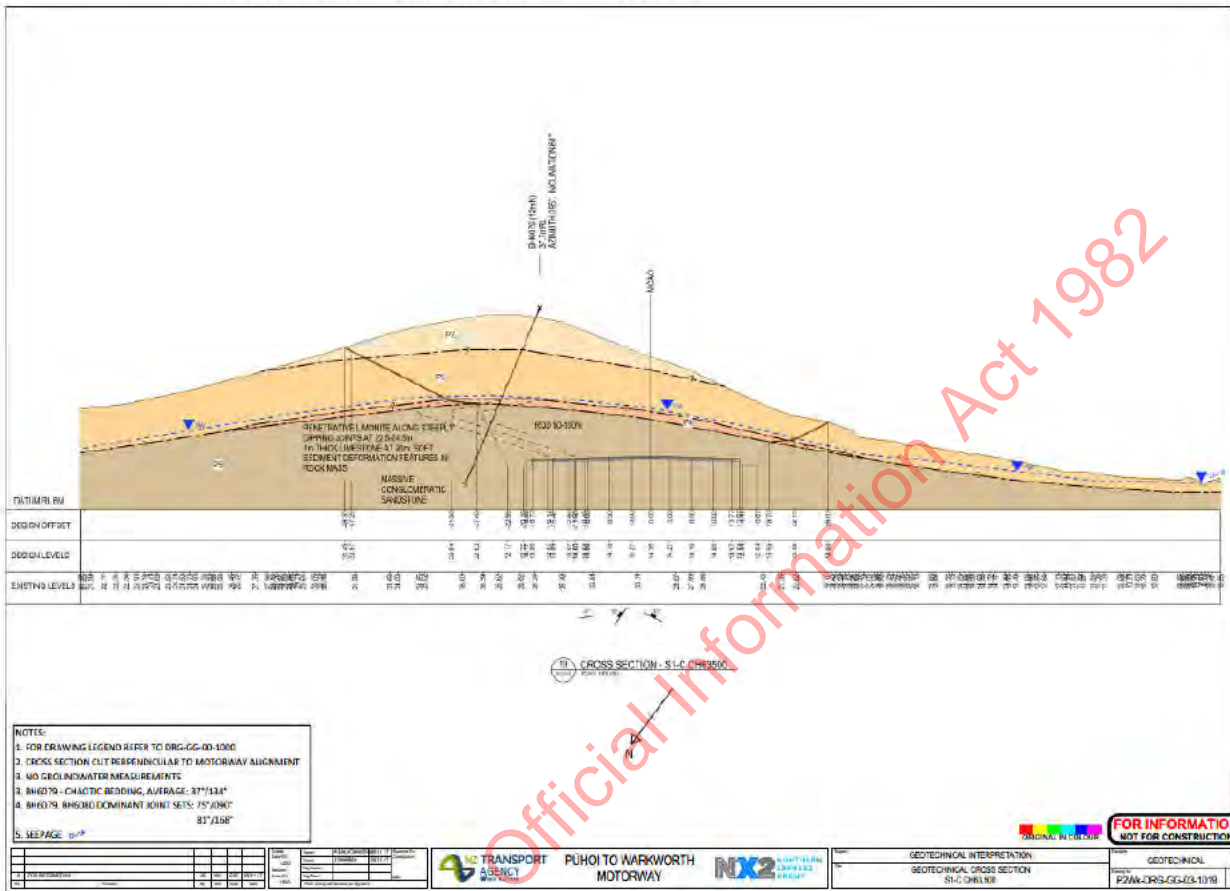
Soil Rock Transition Zone	Dipping in eastern direction at 5~10° unfavourable out of slope
Rock Cut	85° and 64° (1H:2V) up to 30m high at the western side
Remedial Works Design	DEI 0438 (Ch63260 – 63430, S1 Eastern Soil Stabilisation)
Remedial Works Details	<ul style="list-style-type: none"> <li>Remove all slipped material,</li> <li>Layback slope batter to 3H:1V,</li> <li>Counterfort drains,</li> <li>Wider rock bench</li> </ul>
Peer Reviewed in PSM Report Rev 4	Not included.
Groundwater Seepage Monitoring	<p>Seepage monitoring undertaken on the 23/06/2021 and 29/07/2021. Engineering geological site inspections were undertaken on the 2/06/2021 and 2/11/2021. Monitoring on the 23/06/2021 and 29/07/2021 was undertaken within 48hours of rainfall.</p> <p>Groundwater seepage and engineering geological observations are as follows:</p> <p><b>S1-East</b></p> <ul style="list-style-type: none"> <li>Subsoil drains functioning with minor trickles of water recorded from 2 of 9 subsoil drains and softened ground at outlets</li> <li>Seepage recorded at soil-rock transition</li> <li>Small seepage flows from natural ground slope with wet ground surfaces and surface water running downslope, softening of soil and staining on cut slope face</li> </ul>

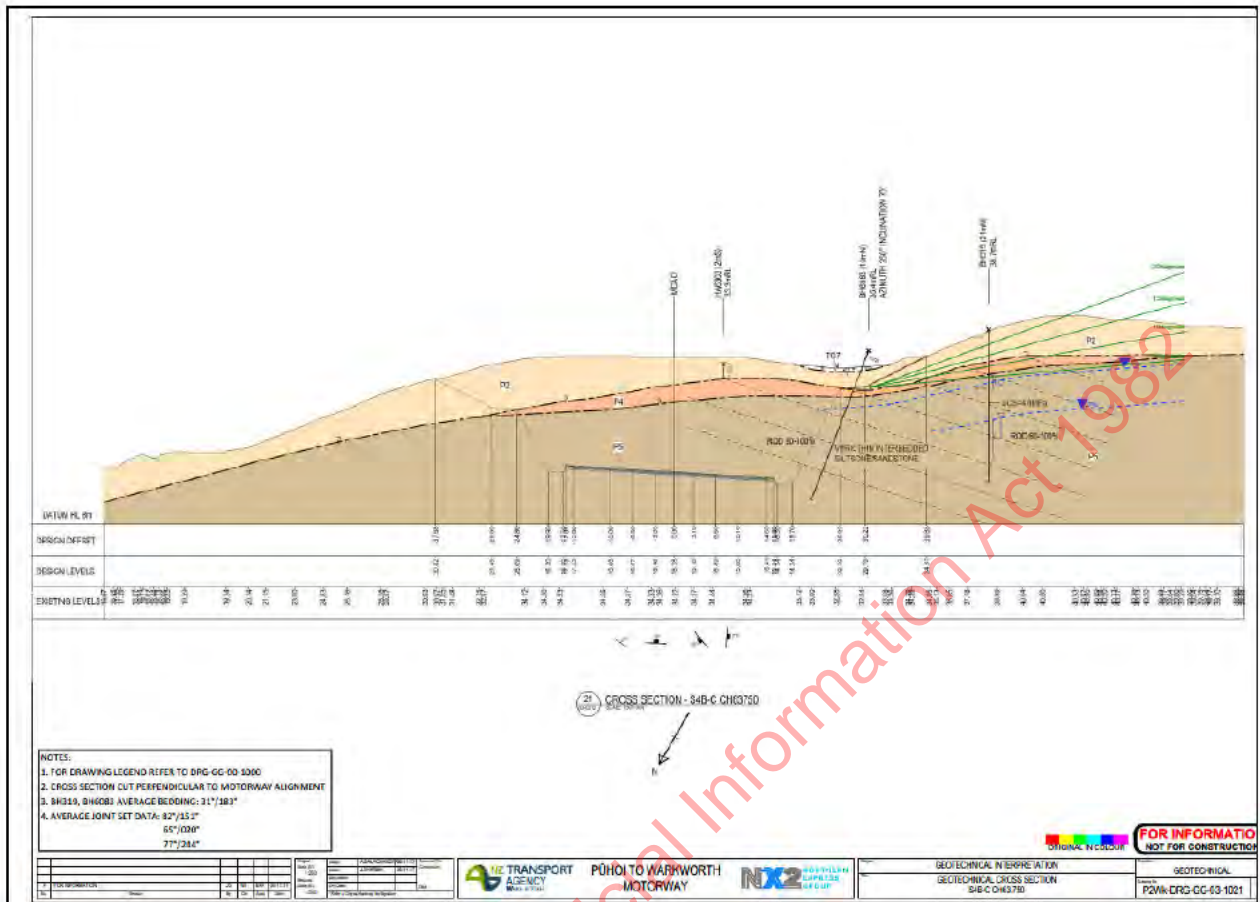
Soil Rock Transition Zone	Dipping in eastern direction at 5~10° unfavourable out of slope
Rock Cut	Rock cut at eastern side of wetland WP5 (not affecting SH1 alignment). Rock cut at western side at S4B.
Remedial Works Design	No DEI provided. Remedial design is a toolbox solution included in the IFC drawings.
Remedial Works Details	Toolbox solution as per IFC drawings
Peer Reviewed in PSM Report Rev 4	No
Groundwater Seepage Monitoring	<p>Seepage monitoring undertaken on the 23/06/2021, 29/07/2021. Engineering geological site inspection were undertaken on the 2/06/2021 and 12/11/2021</p> <p>Monitoring on the 23/06/2021 and 29/07/2021 was undertaken within 48hours of rainfall</p> <p>Groundwater seepage and engineering geological observations are as follows:</p> <ul style="list-style-type: none"> <li>• Minor seepages with softened, wet soil at the central and northern sections of cut slope</li> <li>• <b>Active</b> soil slumping/slip occurring towards northern end of cut with softened, wet ground at toe of slip. Slumping typically 0.5m high with a zone of influence up to 1-1.5m below surface</li> <li>• Cross slope cut off drains midway up slope may be serving to recharge surface water to lower soil slopes</li> <li>• Seepage at soil-rock contact with water flowing over bench face</li> <li>• <b>Active</b> minor surface erosion</li> </ul>

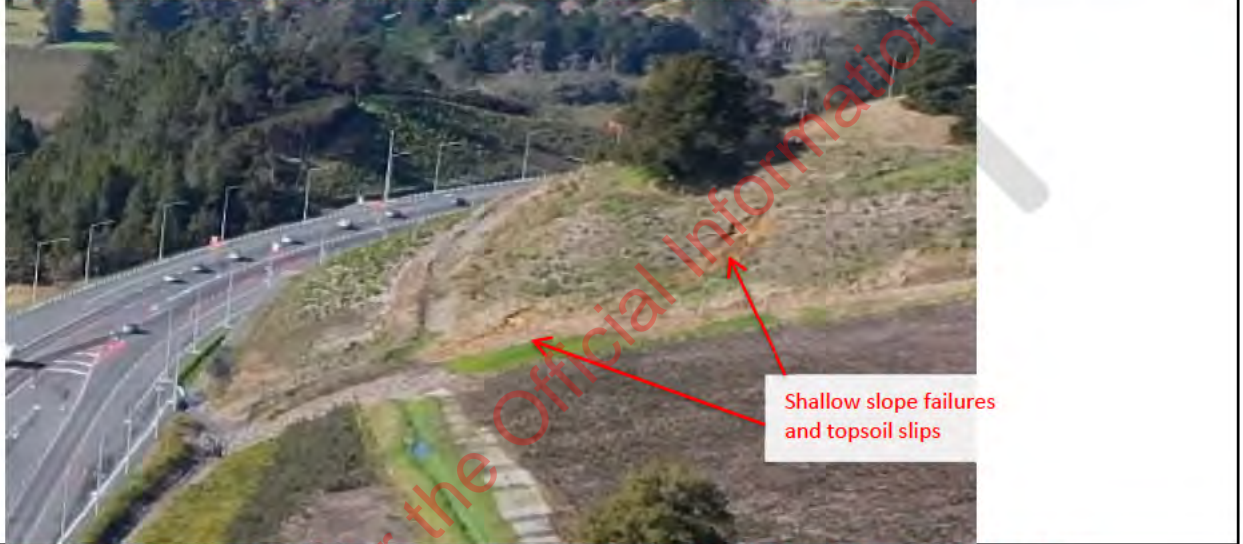
Shallow slope failures and topsoil slips

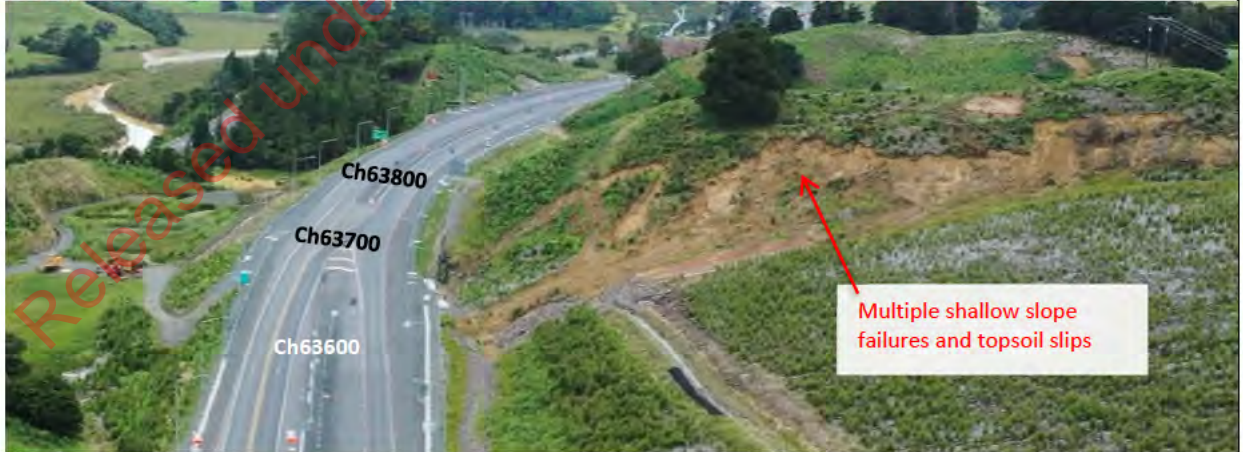
Multiple shallow slope failures and topsoil slips
