MEMO/SPECIAL INSPECTION

Subject: Diagonal 3L12-U13 west special structural inspection

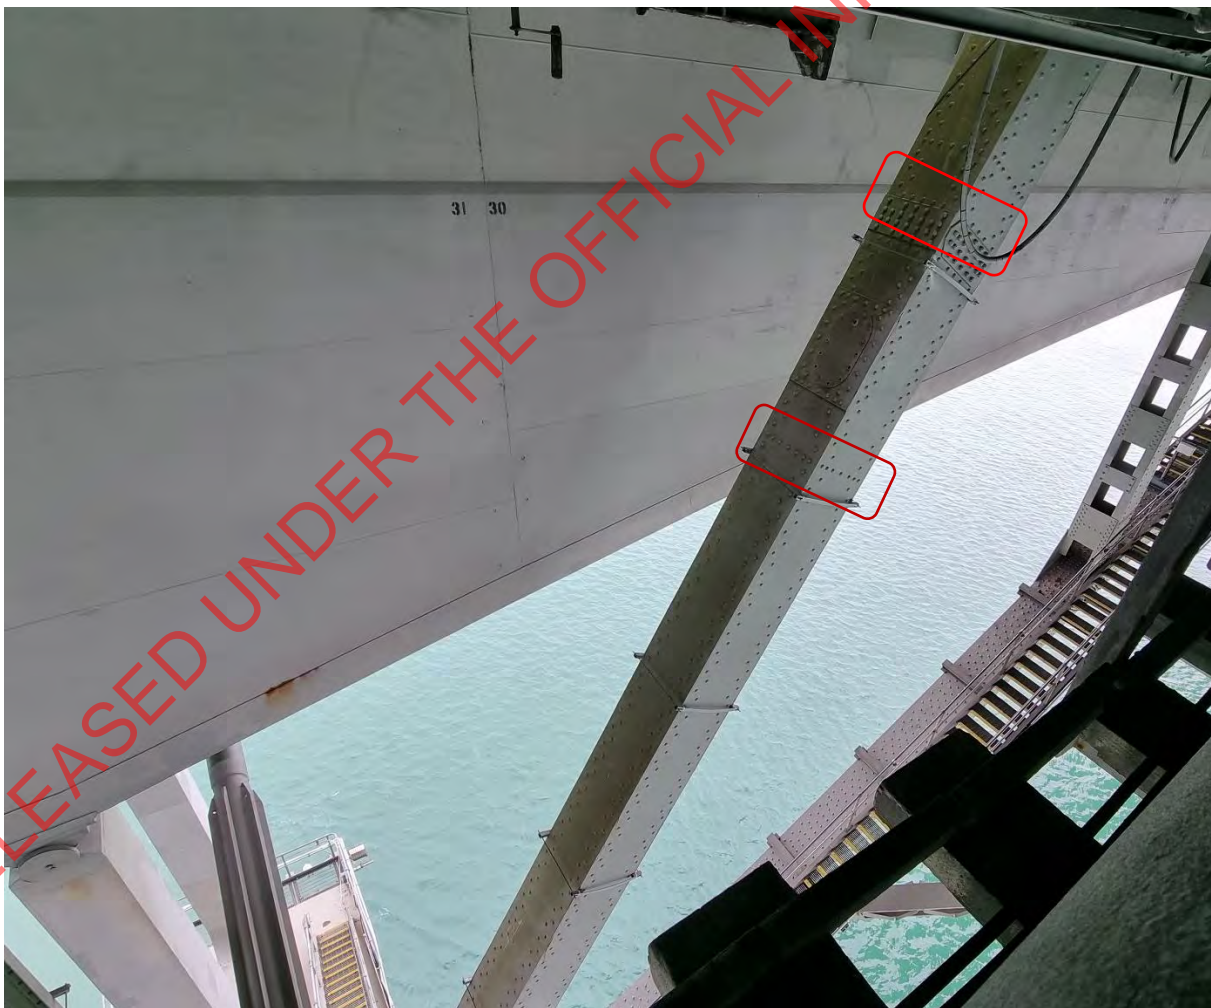
The diagonal did not have any of the four diaphragm plates installed, nor did it have any bird proofing installed. Subsequently, there was large amounts of bird droppings and used garnet located on the diaphragm connection flanges and bottom surface of the diagonal.

The inspection included the removal of dirt and clean-up of corrosion on diaphragms connections flange #2 and #3 (refer to Figure 1 and 2). Measurement of section loss was by use of the Elcometer MTG4 (serial No. XE24934). After the inspections the location was repaired via blast and paint.

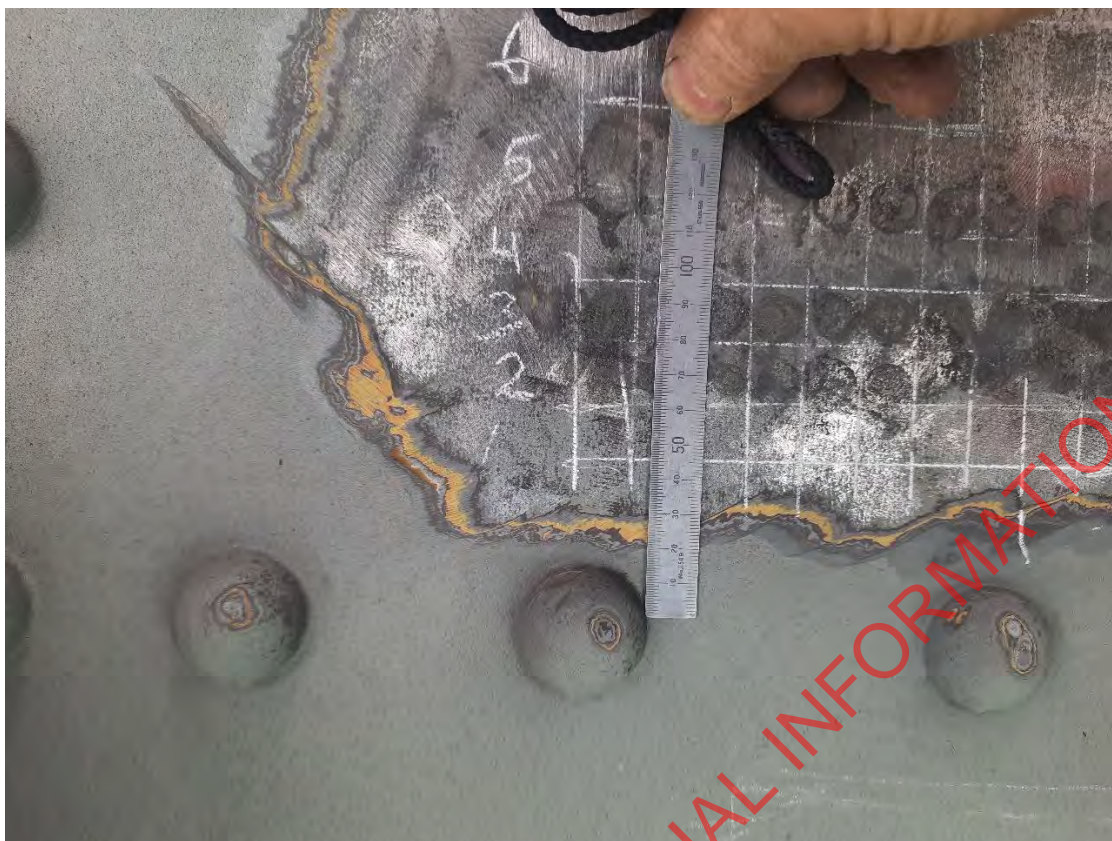
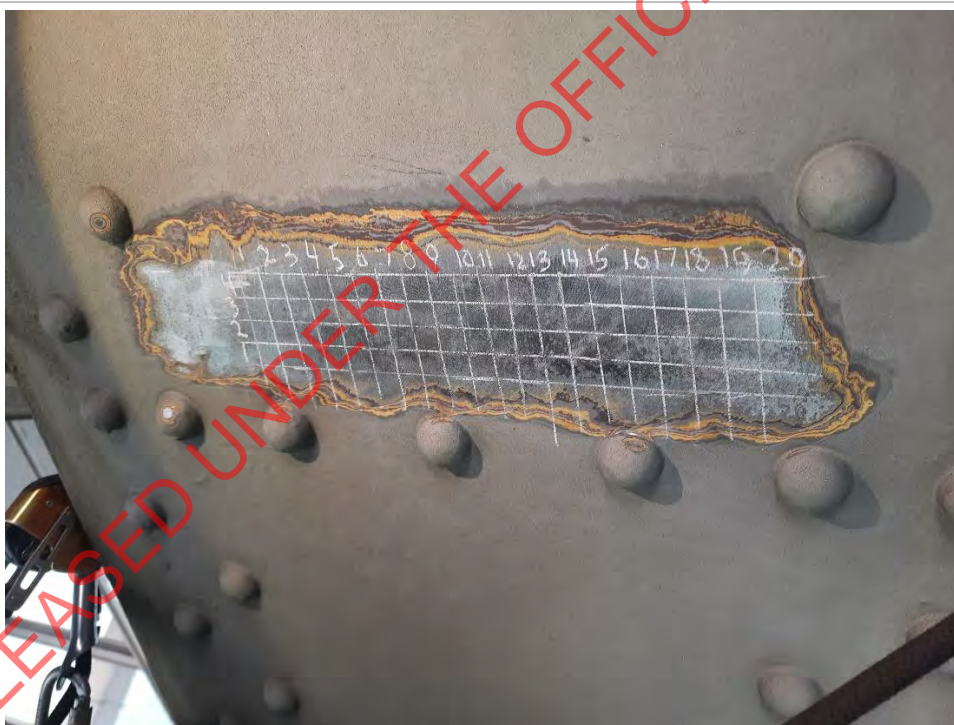
Structural Inspection- Measurement of section loss was by use of the Elcometer MTG4 (serial No. XE24934) from outside the Diagonal.

Moderate to major section loss was found to the north (bottom) plates, angles and diaphragm plates. The north (bottom) plates were measured using an Elcometer MTG4. Readings on the half inch plate came out at 12.8-13mm. Areas of section loss along are described on the **Appendix 1**. Reading at the worst location indicates approximately 50% section loss. Section loss on the angles and diaphragm was similar to the north (bottom) plate (however unable to be read by the UTG).

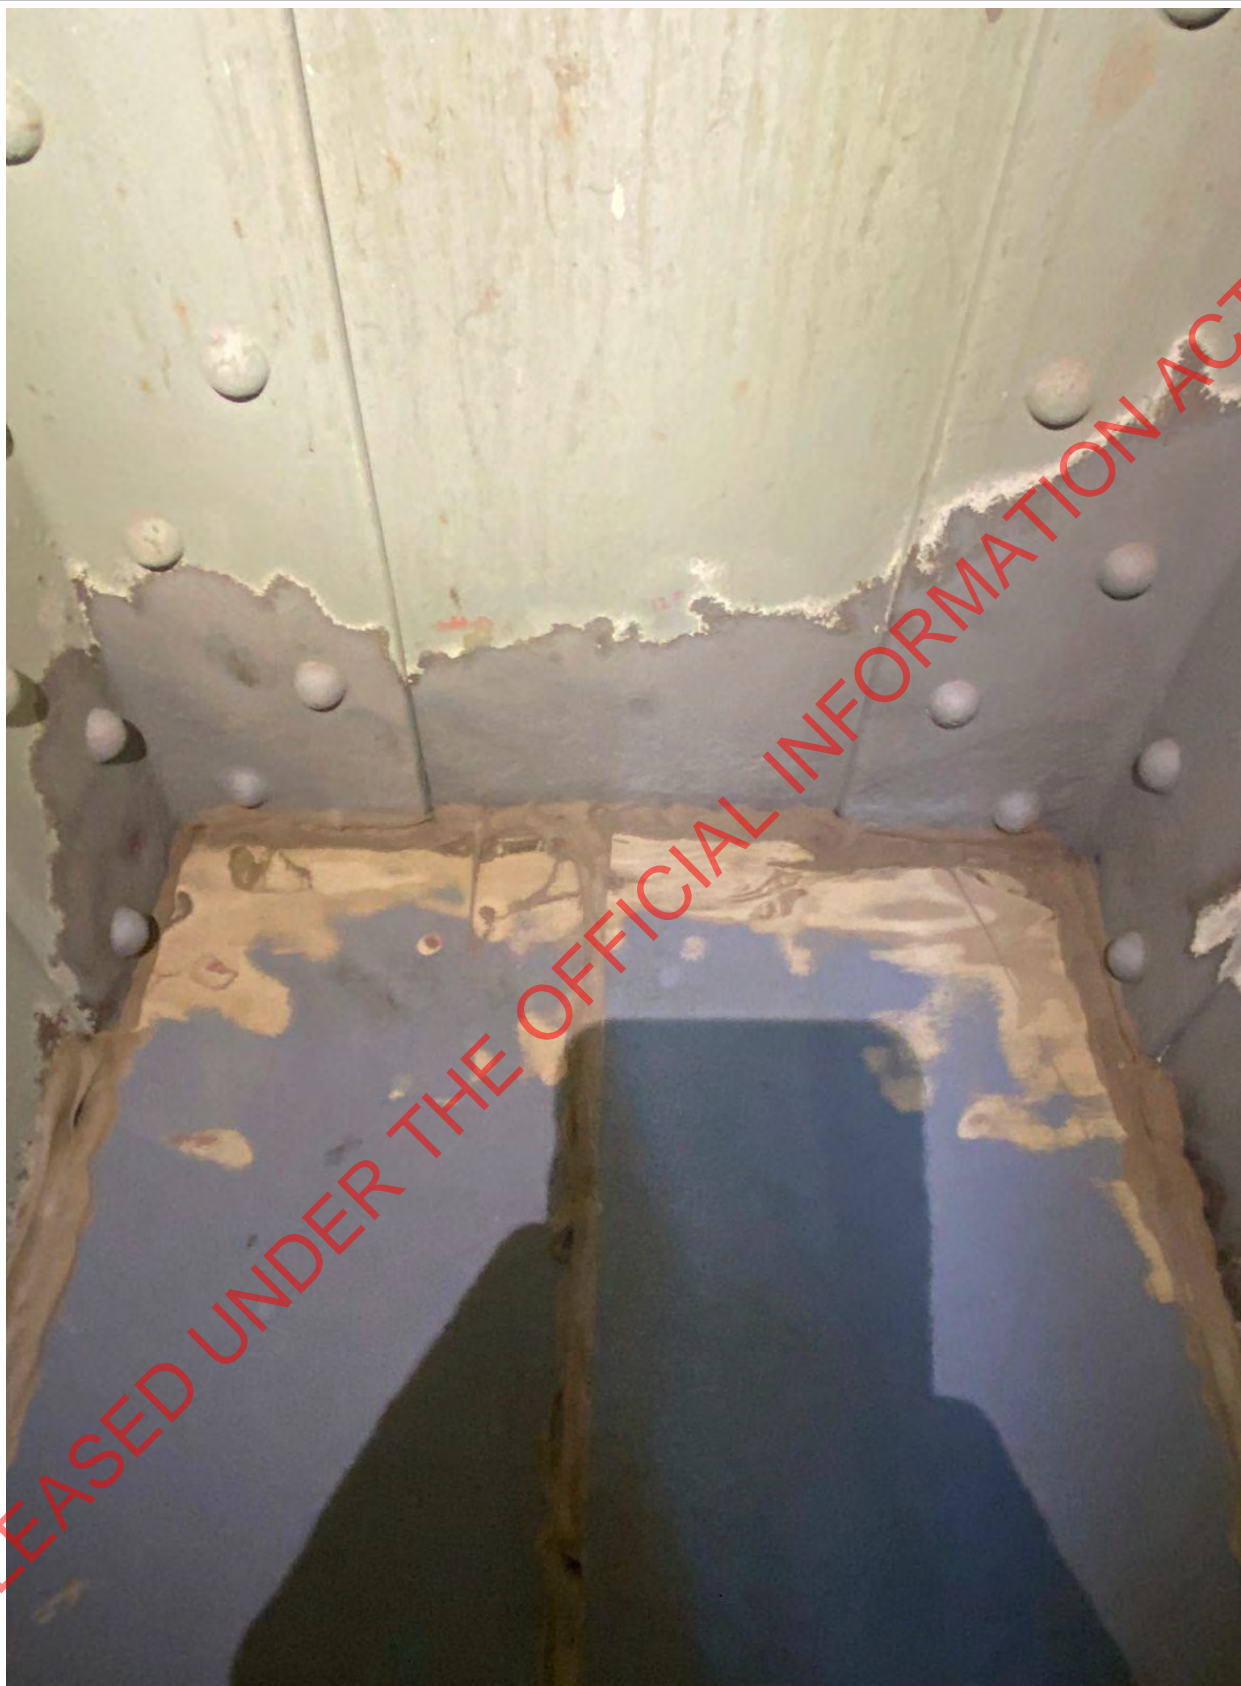
Remedial Action

Area of corrosion following abrasive blasting

Following the inspection of the diagonal, the Roving team have blasted and painted the area of section loss, however, further investigation and maintenance will be required to fully assess the current situation. A similar methodology will be utilised for the upcoming additional investigations within Span 1. The asset management team is currently reviewing previous inspection reports to identify the presence of diaphragm plates as the presence of water, bird detritus, and garnet increase the likelihood of corrosion and section loss.

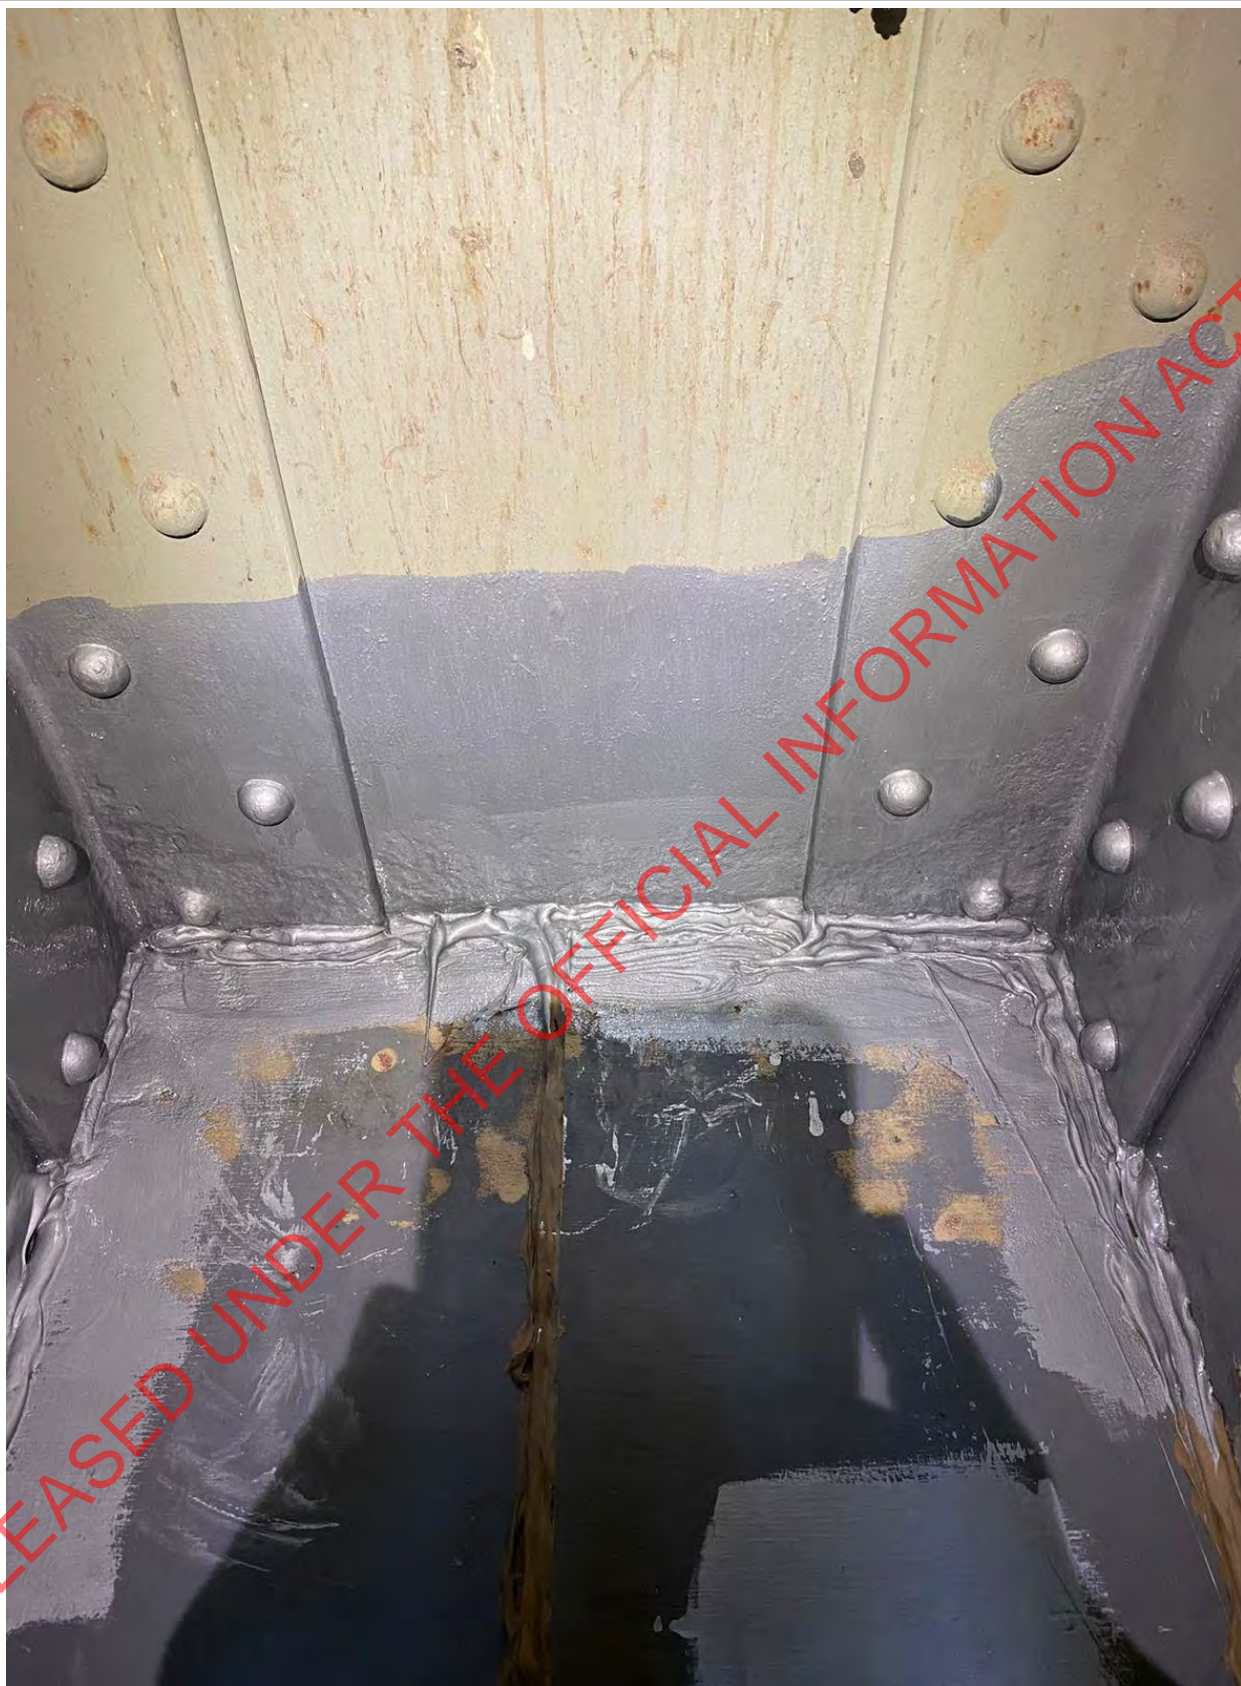
Remedial Action

Area painted
