Auckland Harbour Bridge Alliance

Principal Structural Inspection Box Girder Internal

2020/2021

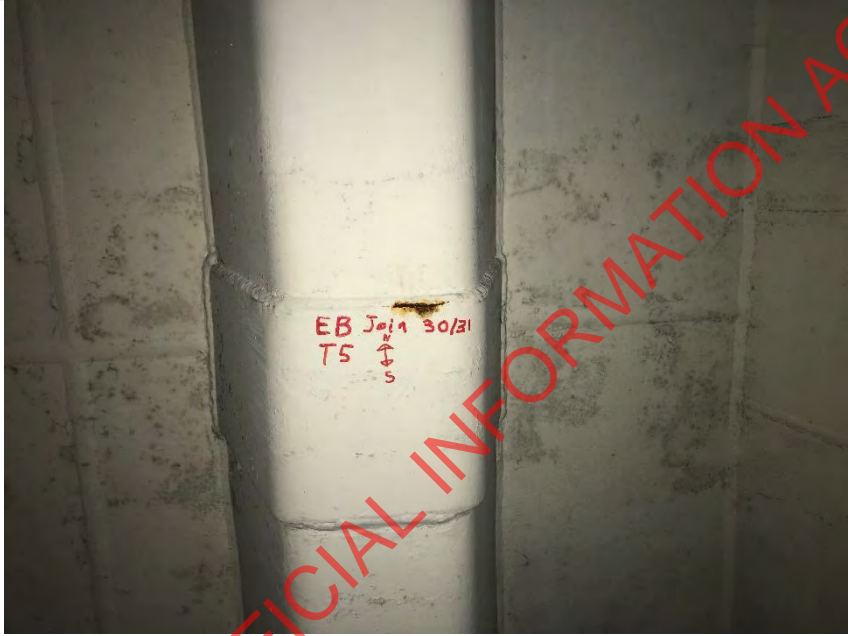
Photo ID	Marking Code	Description of Defects	Maintenance/ Repairs Recommendations	Maintenance/ Repairs Priority & Timeframe
BGI-1.	S

East box. Box join 30/31. Trough 5. Trough splice weld crack.	Weld crack repair.	H 1 Year
BGI-2.	S

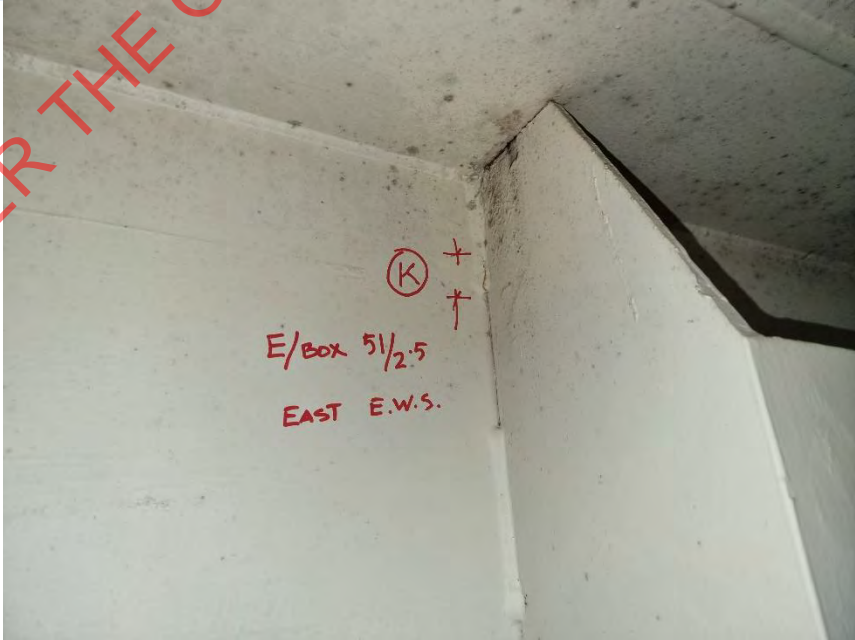
East box 51. Crossbeam 2-3. Outer web. Web stiffener weld crack.	Weld crack repair.	L 2+ Years

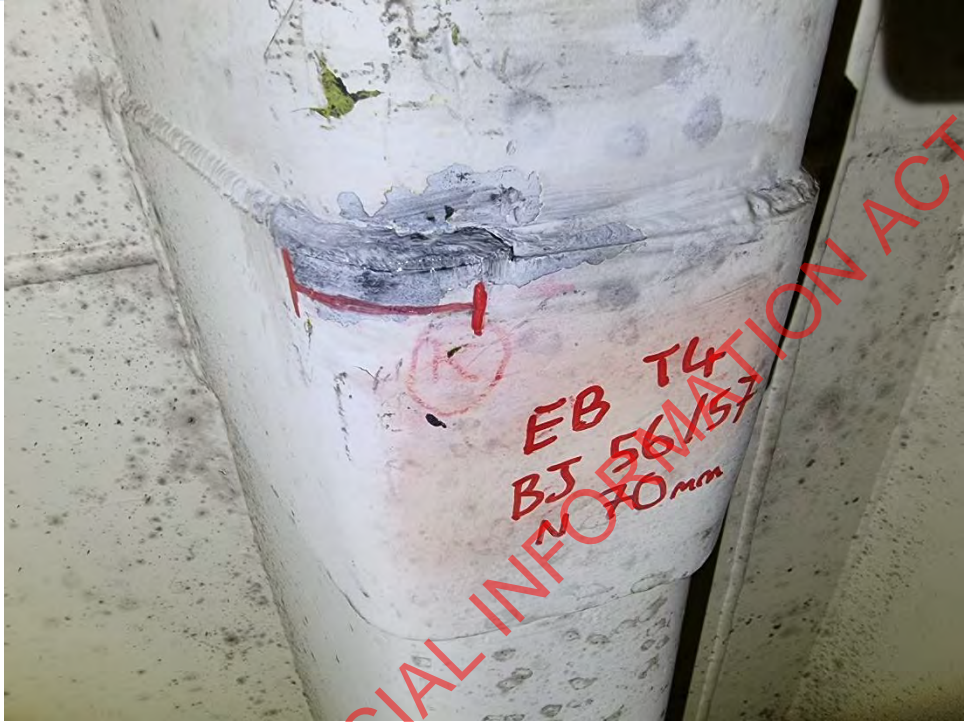
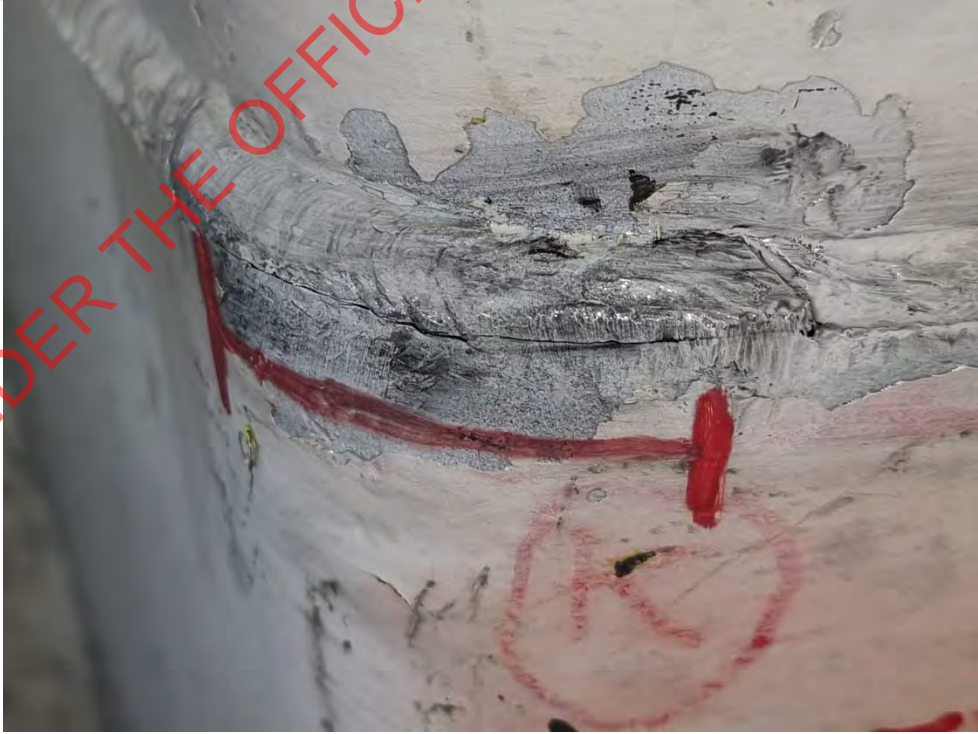
Photo ID	Marking Code	Description of Defects	Maintenance/ Repairs Recommendations	Maintenance/ Repairs Priority & Timeframe
BGI-5.	S

<p>East box. Box join 56/57. Trough splice north weld. Weld crack 70mm in length.</p>	Weld crack repair.	H 1 Year

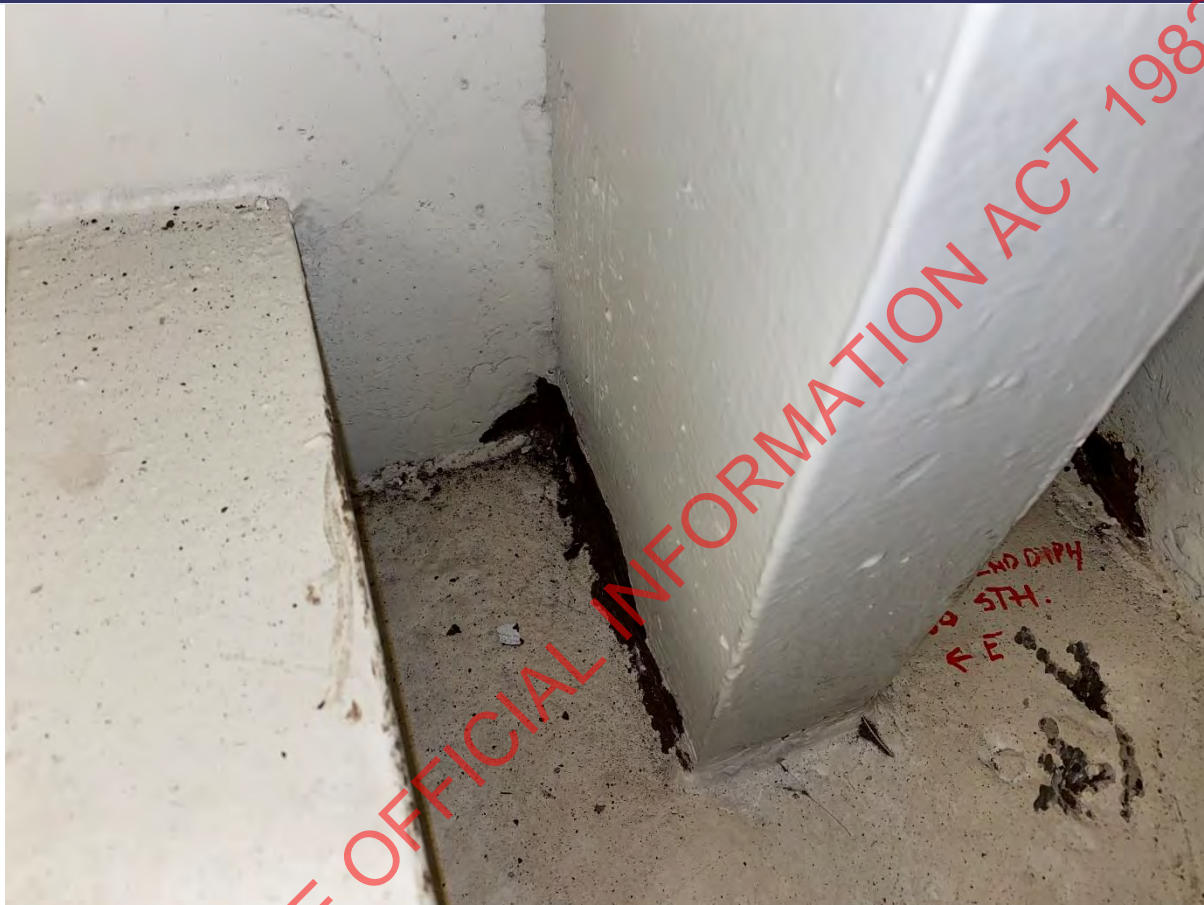
Photo ID	Marking Code	Description of Defects	Maintenance/ Repairs Recommendations	Maintenance/ Repairs Priority & Timeframe
BGI-13.	R

<p>East box 80. End diaphragm. East side of walkway. Major section loss (up to 3mm).</p>	Clean and paint	H 1 Year

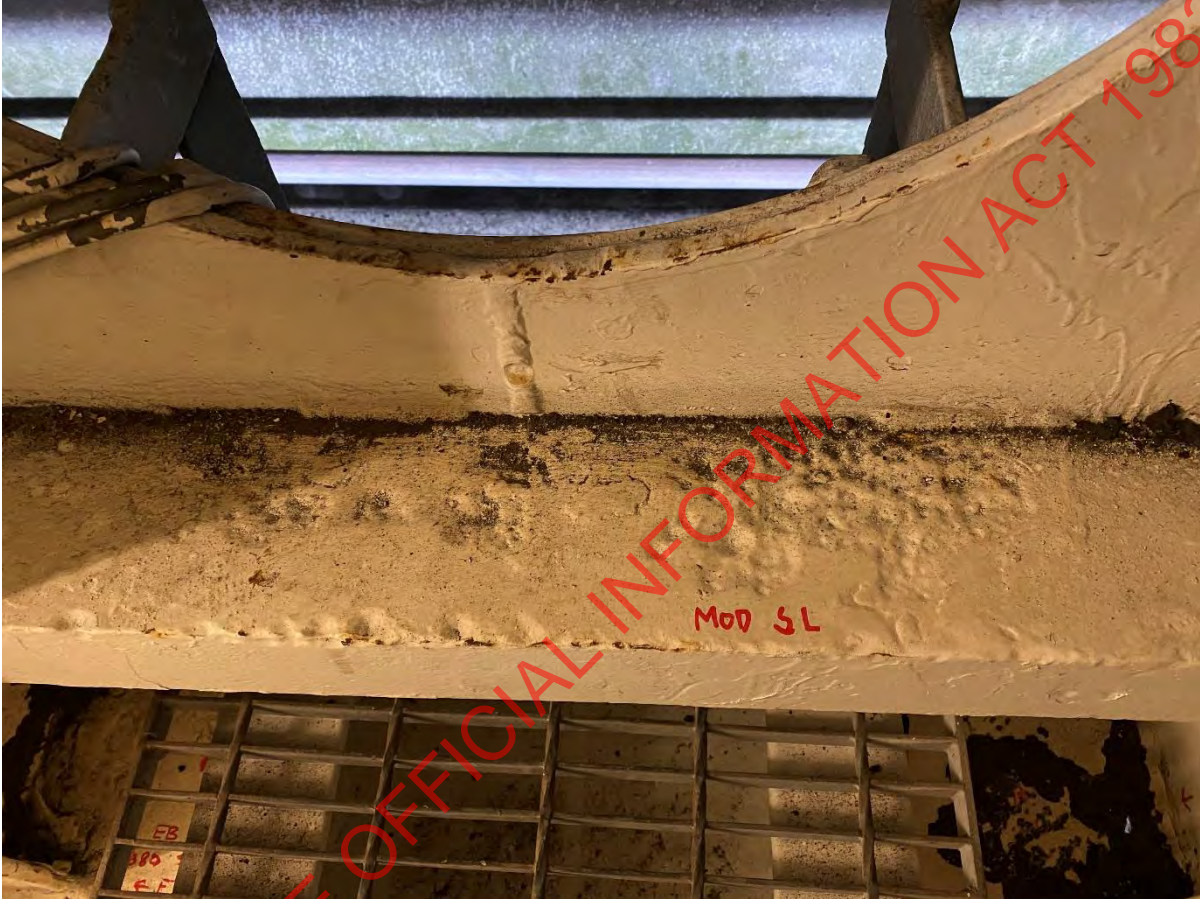
Photo ID	Marking Code	Description of Defects	Maintenance/ Repairs Recommendations	Maintenance/ Repairs Priority & Timeframe
BGI-15.	2

<p>East box 80. End diaphragm. Moderate section loss.</p>	Monitor at next inspection	At next inspection

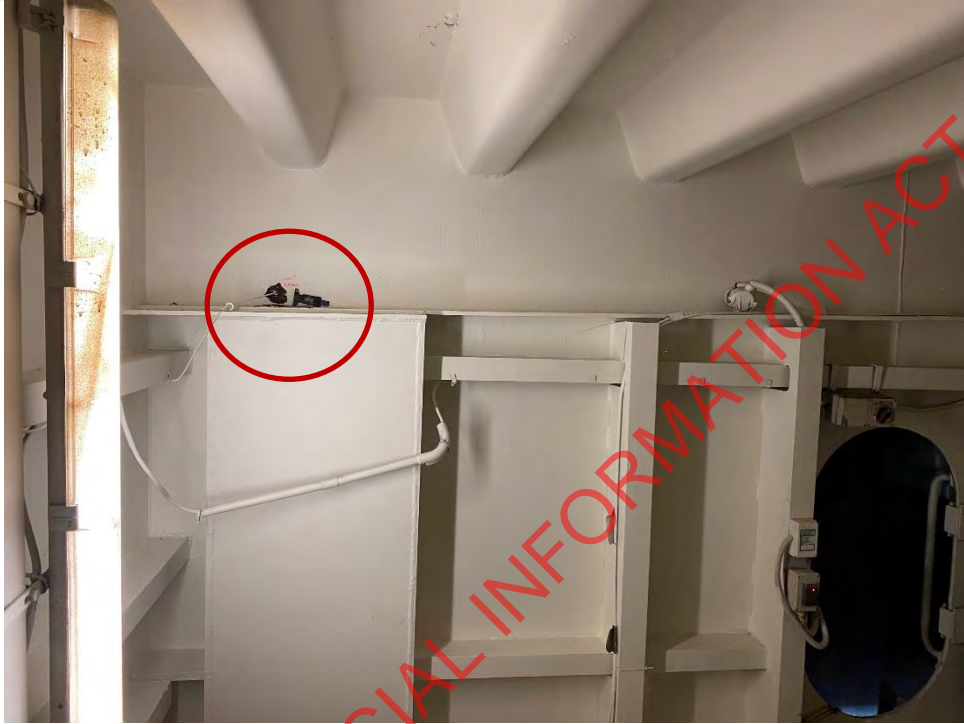
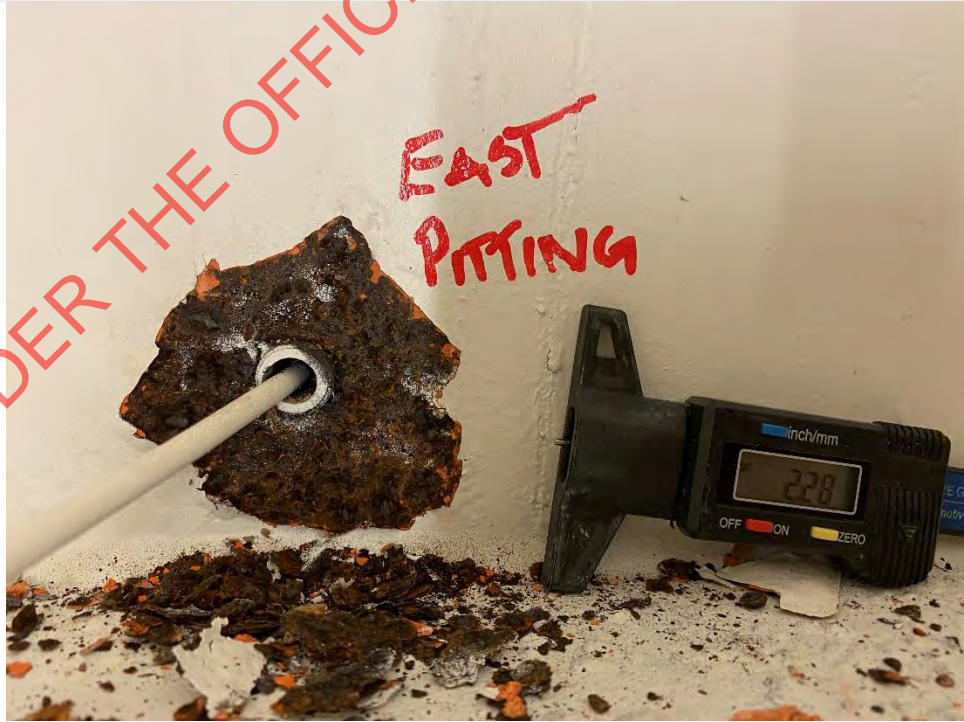
Photo ID	Marking Code	Description of Defects	Maintenance/ Repairs Recommendations	Maintenance/ Repairs Priority & Timeframe
BGI-16.	R

<p>East box 80. End diaphragm. Moderate section loss (2mm).</p>	Clean and paint	H 1 Year
