# Auckland Harbour Bridge Alliance

## Principal Structural Inspection Concrete Piers Above Water (Boat)

2020/2021

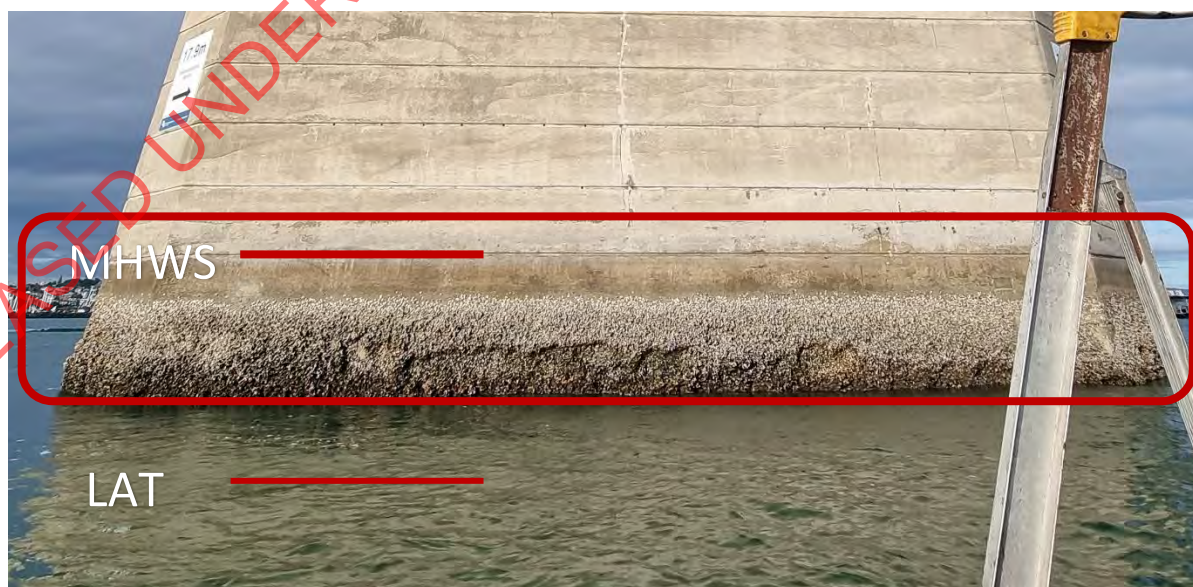
Figure 1 shows the areas where close up visual inspection and hammer tapping was conducted.

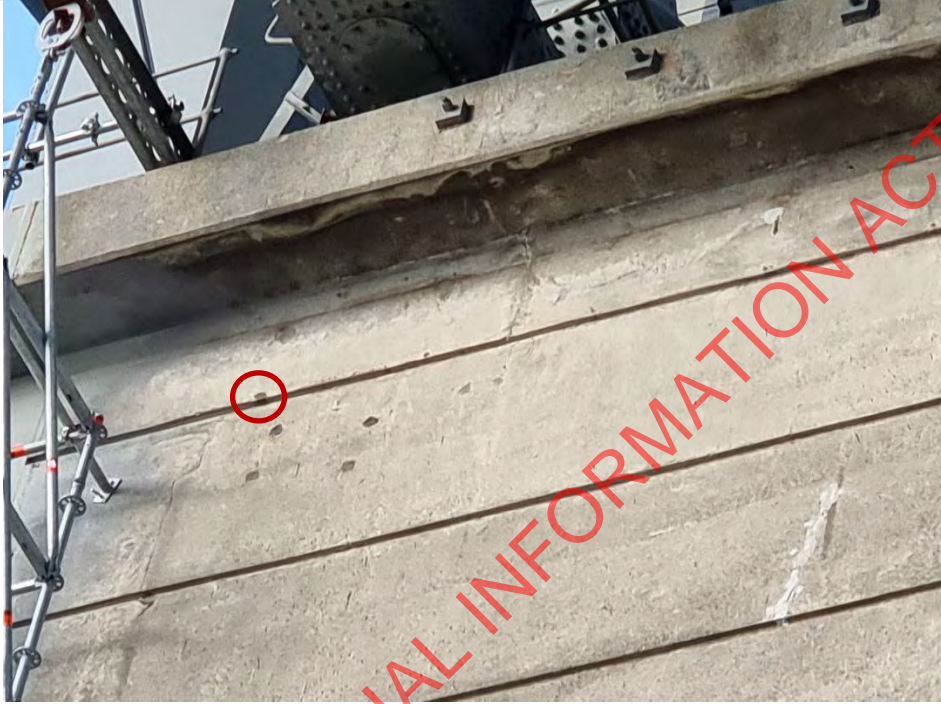
<p>Pier 1. North face. Section 1. Spalling approximately 100x100mm. Depth unknown.</p>	Concrete repair	L 2+ Years
P1-3.	S

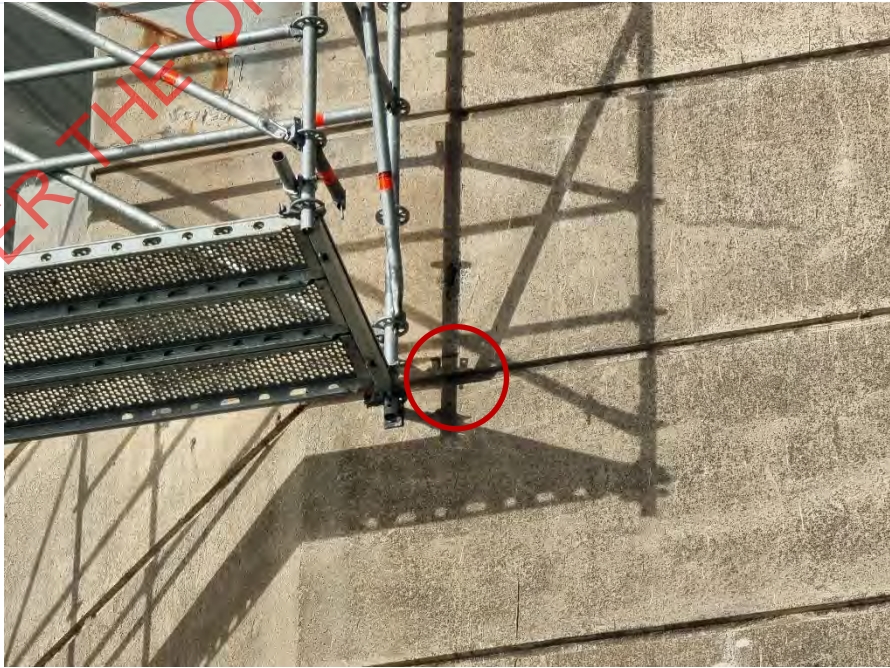
<p>Pier 1. North face. Section 8. Spalling with rebar exposed.</p>	Concrete repair.	M 1-2 Years

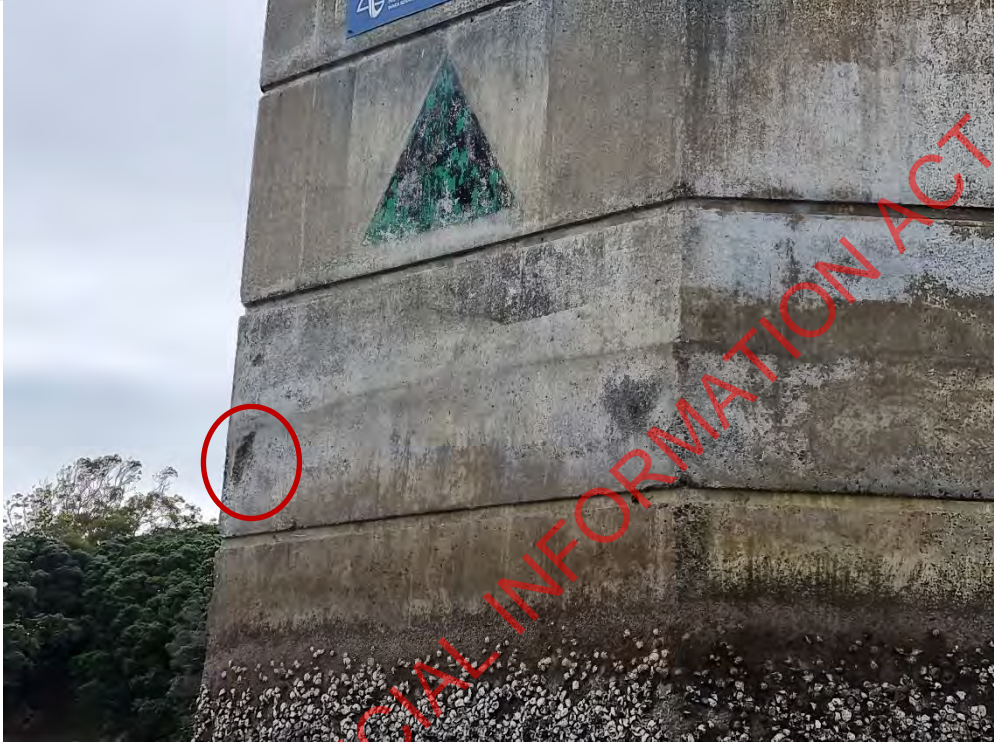
<p>Pier 1. South face. Section 18. Spalling/impact damage 40-50mm deep. No reinforcing exposed.</p>	Concrete repair.	L 2+ Years

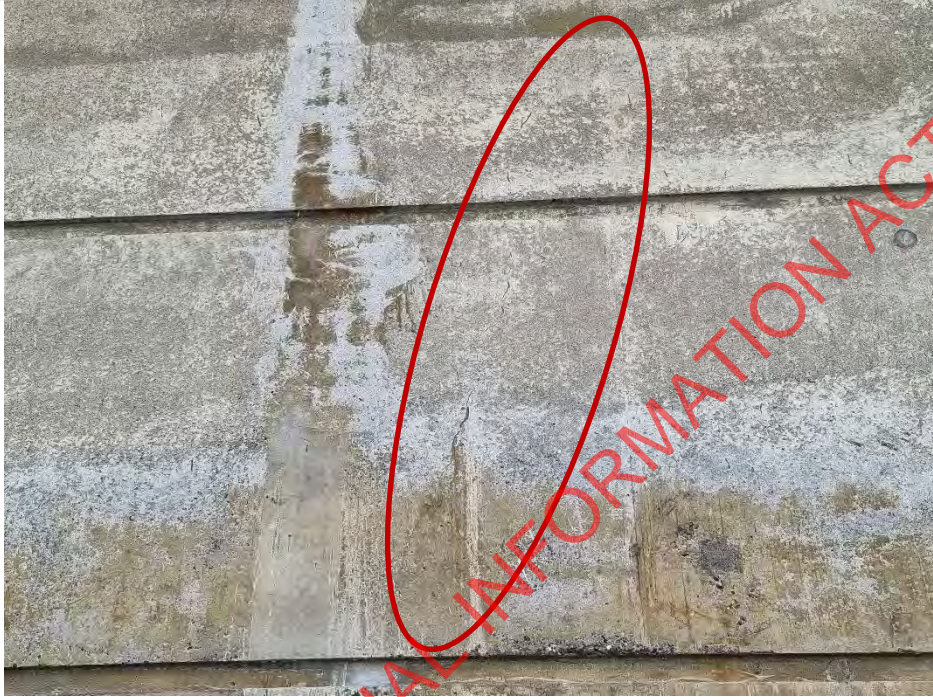
Pier 3. North face. Sections 12-14. Cracking (less than 0.25mm).	Monitor at next inspection.	At next inspection.
P3-6.	2	 		
		Pier 3. North face. Section 10. Cracking through old repair (less than 0.25mm).	Monitor at next inspection	At next inspection.

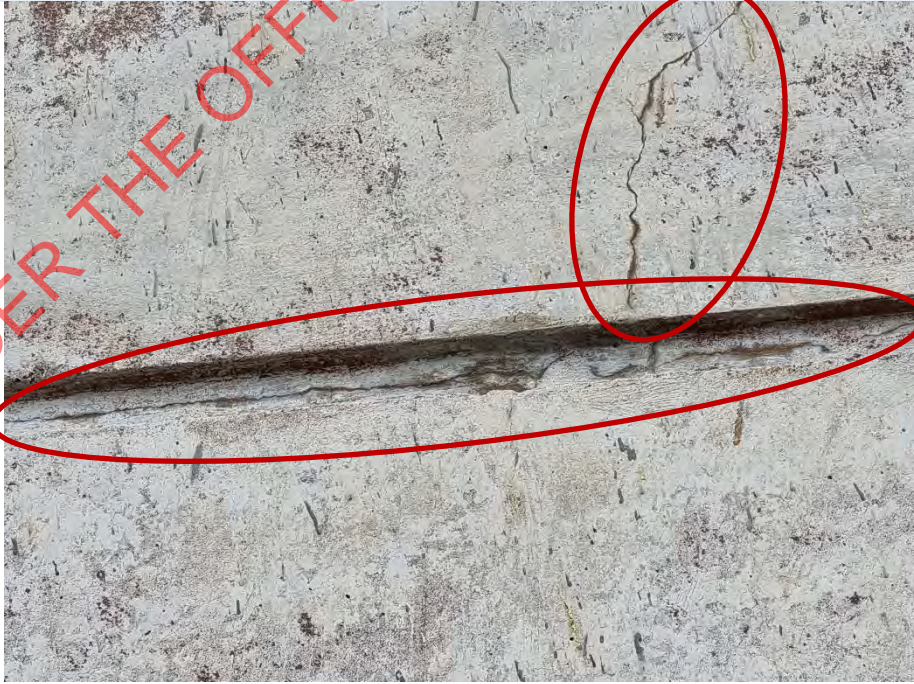
<p>Pier 3. South face. Section 12 recess. Cracking along recess (less than 0.25mm).</p>	Monitor at next inspection.	At next inspection.

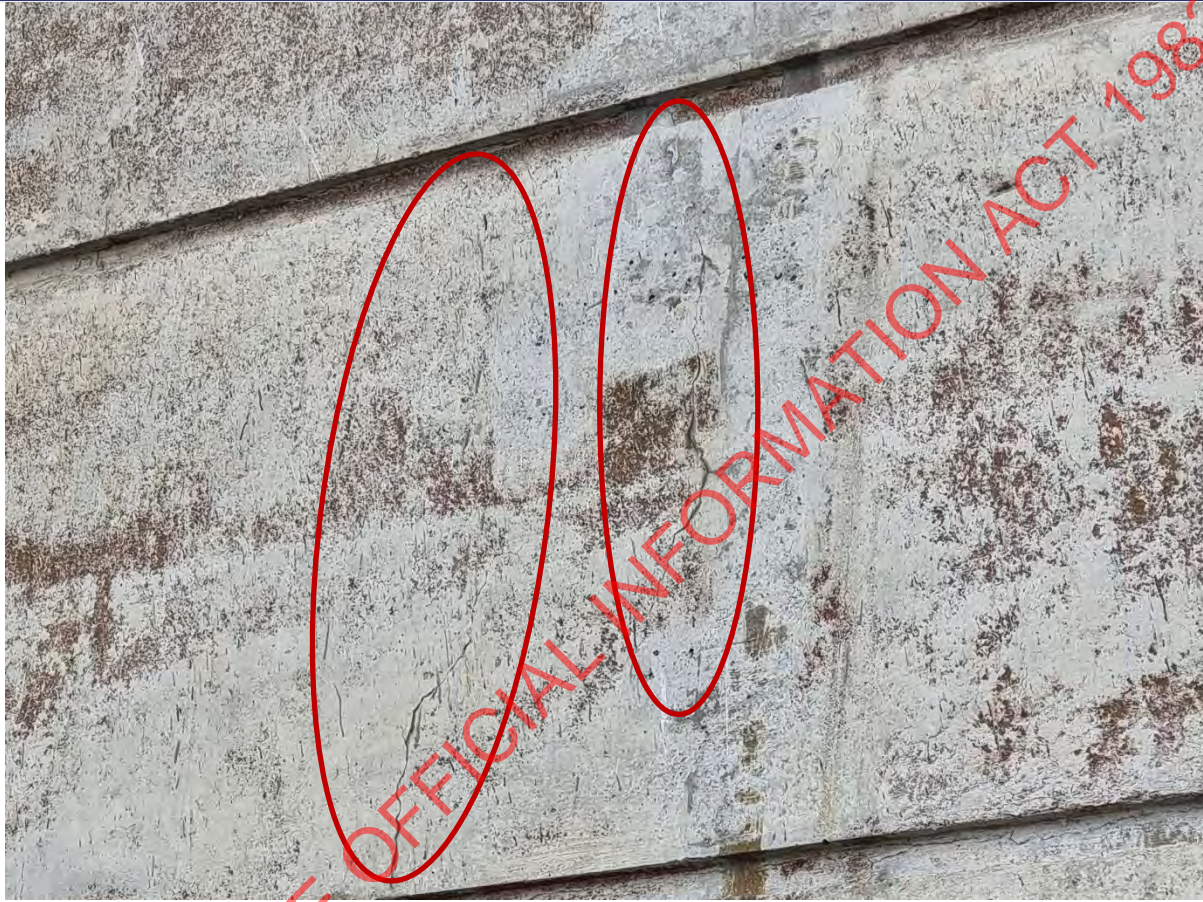
<p>Pier 3. South face. Section 11. Cracking (less than 0.25mm). Typical of the cracking on this side of the pier.</p>	Monitor at next inspection.	At next inspection.

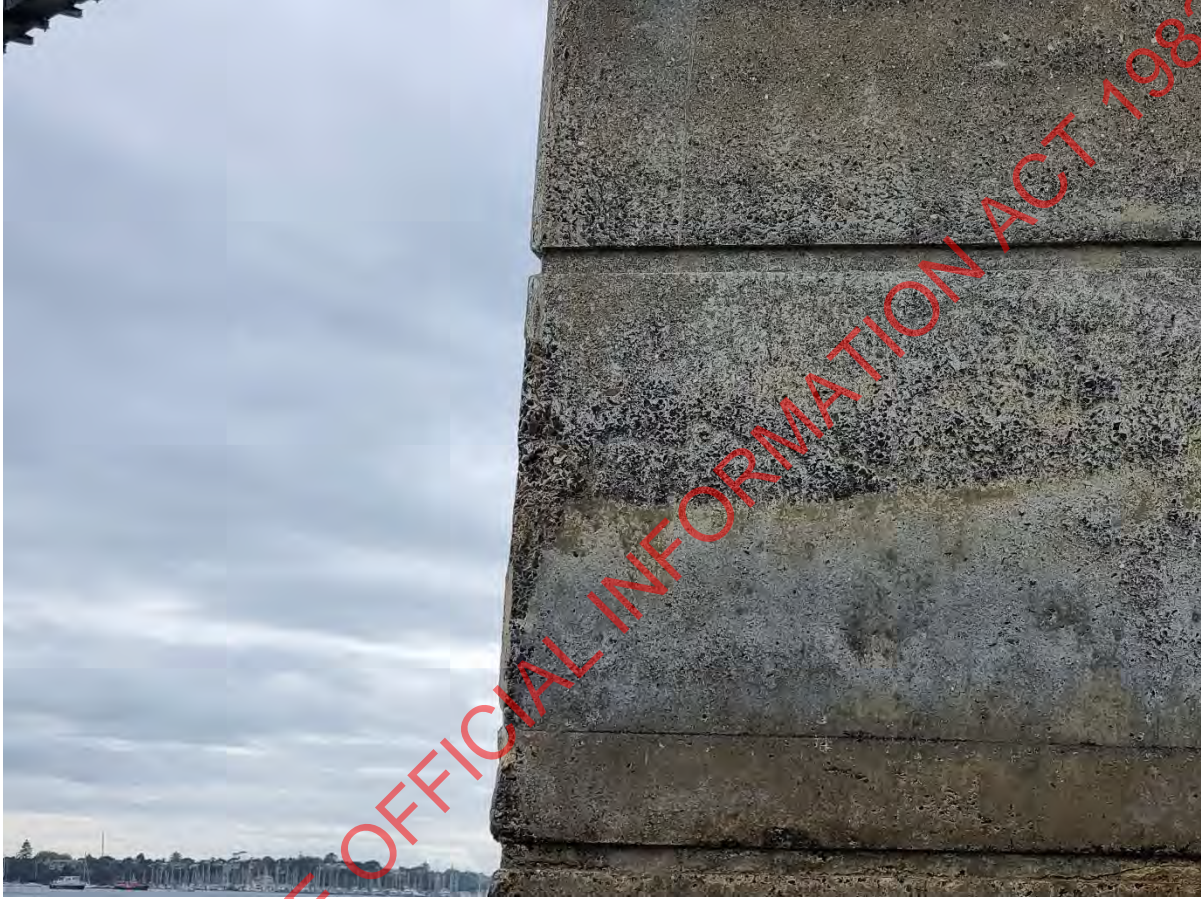
<p>Pier 4. West corner. Spalling/impact damage.</p>	Concrete repair.	M 1-2 Years

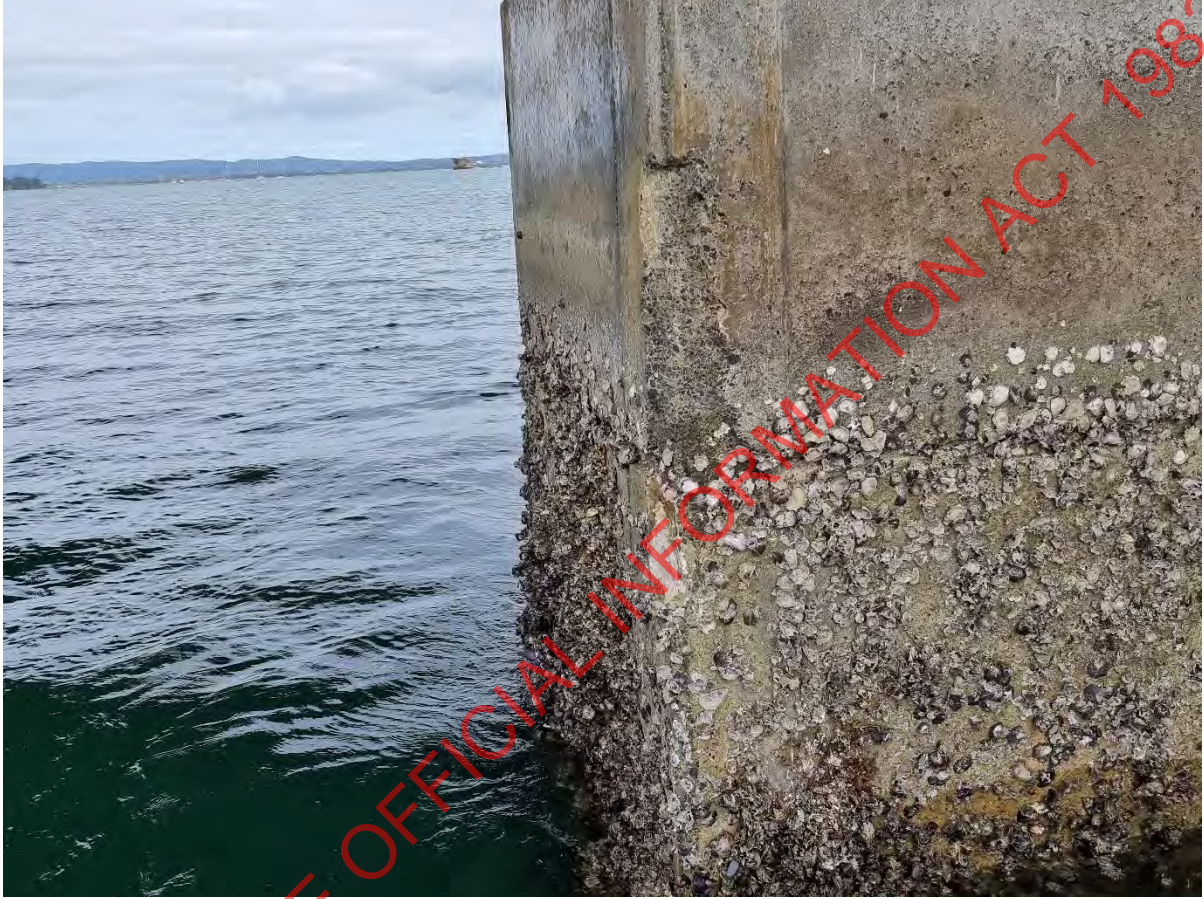
<p>Pier 5. East corner. Spalling/impact damage. Old repair failure.</p>	Concrete repair.	M 1-2 Years

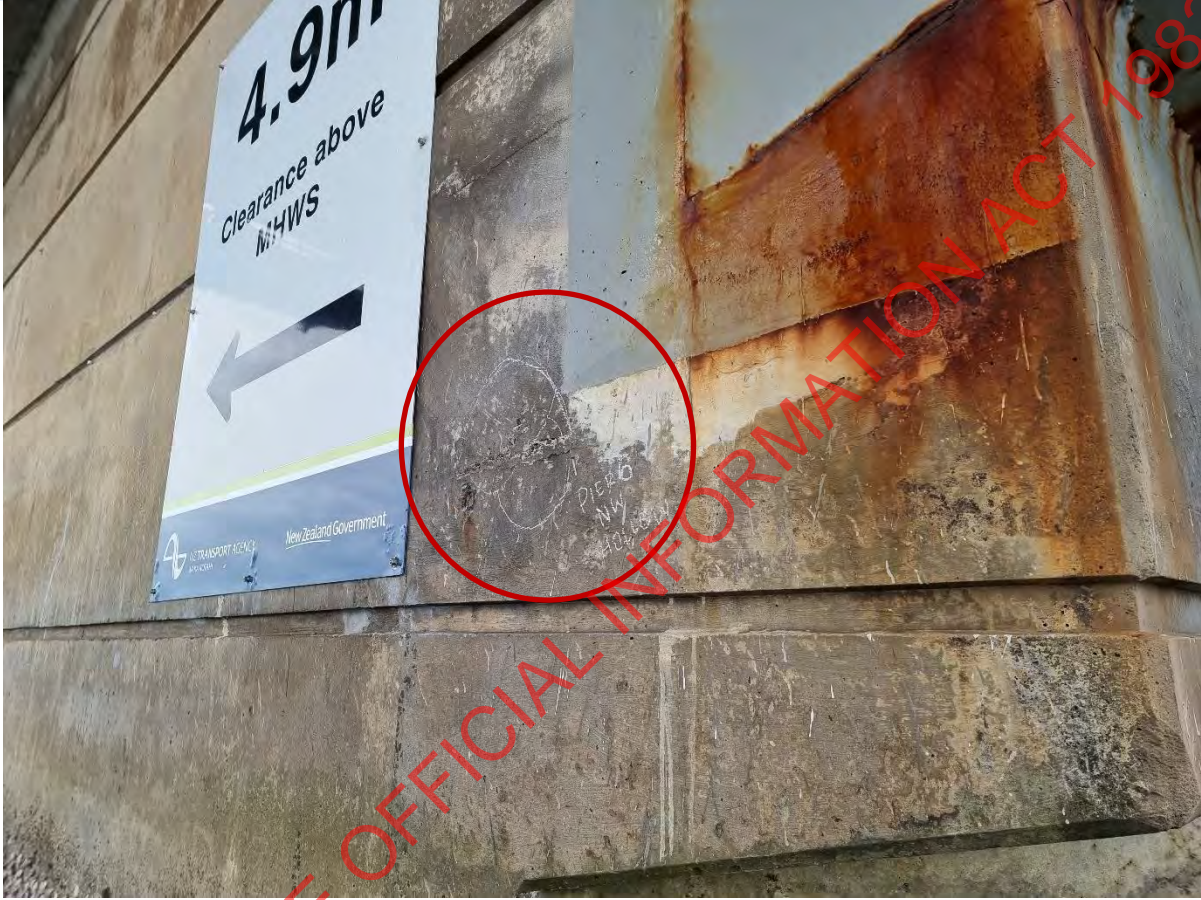
<p>Pier 6. North west corner. Hollow sounding delaminated concrete at circled area.</p>	Monitor at next inspection	At next inspection.

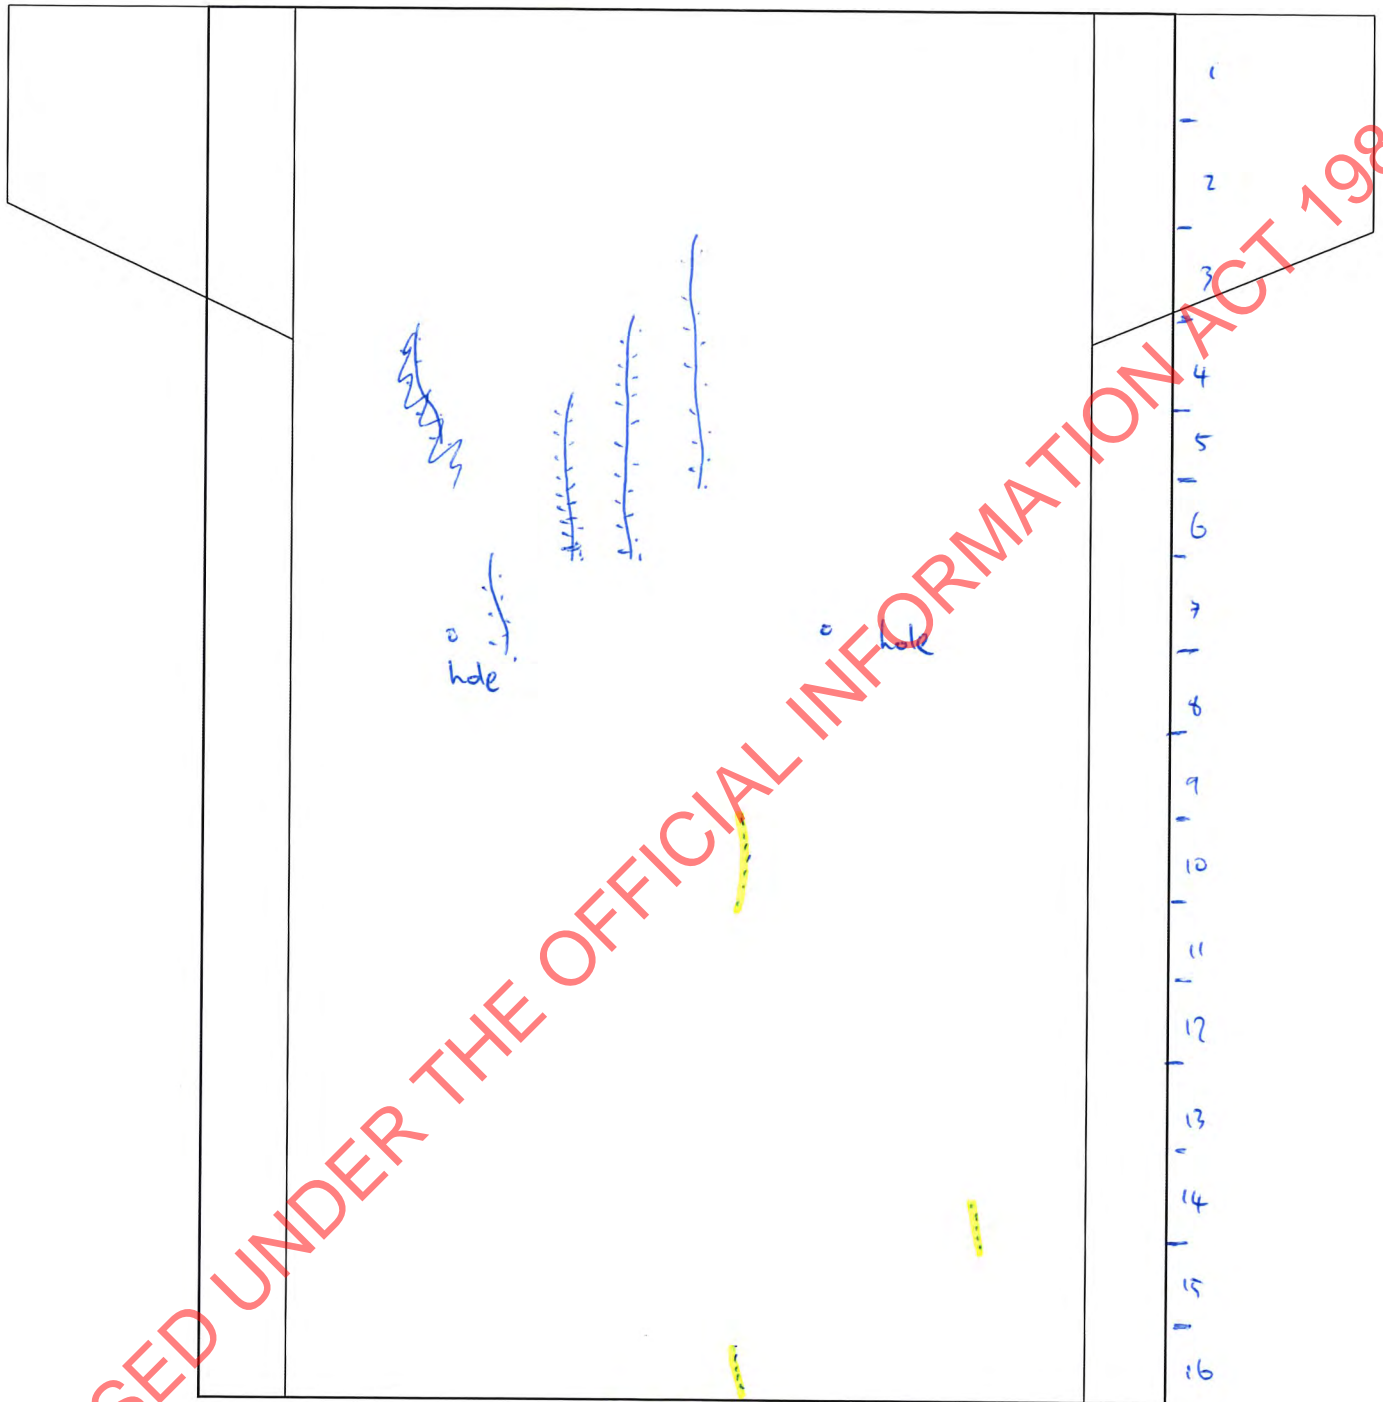
pier 2 south face

large cracks

rust

30-40mm 'spall'  
concrete  
recessed  
(see photo)
