ASM – AHB STRUCTURAL INSPECTION

Concrete Pier 1 Principal Inspection

s 9(2)(a)
9 NOVEMBER 2021

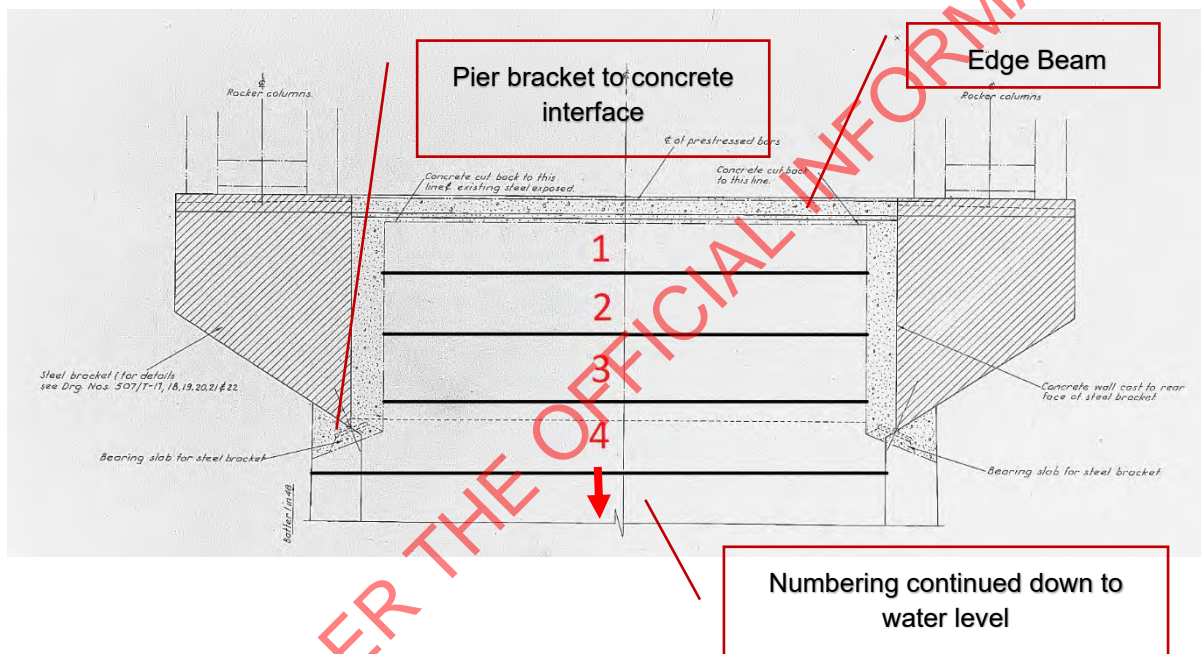
Figure 1 shows the numbering system used when inspecting the original concrete pier. Each numbered section notes where the formwork was at 1.2m (4'0") intervals.

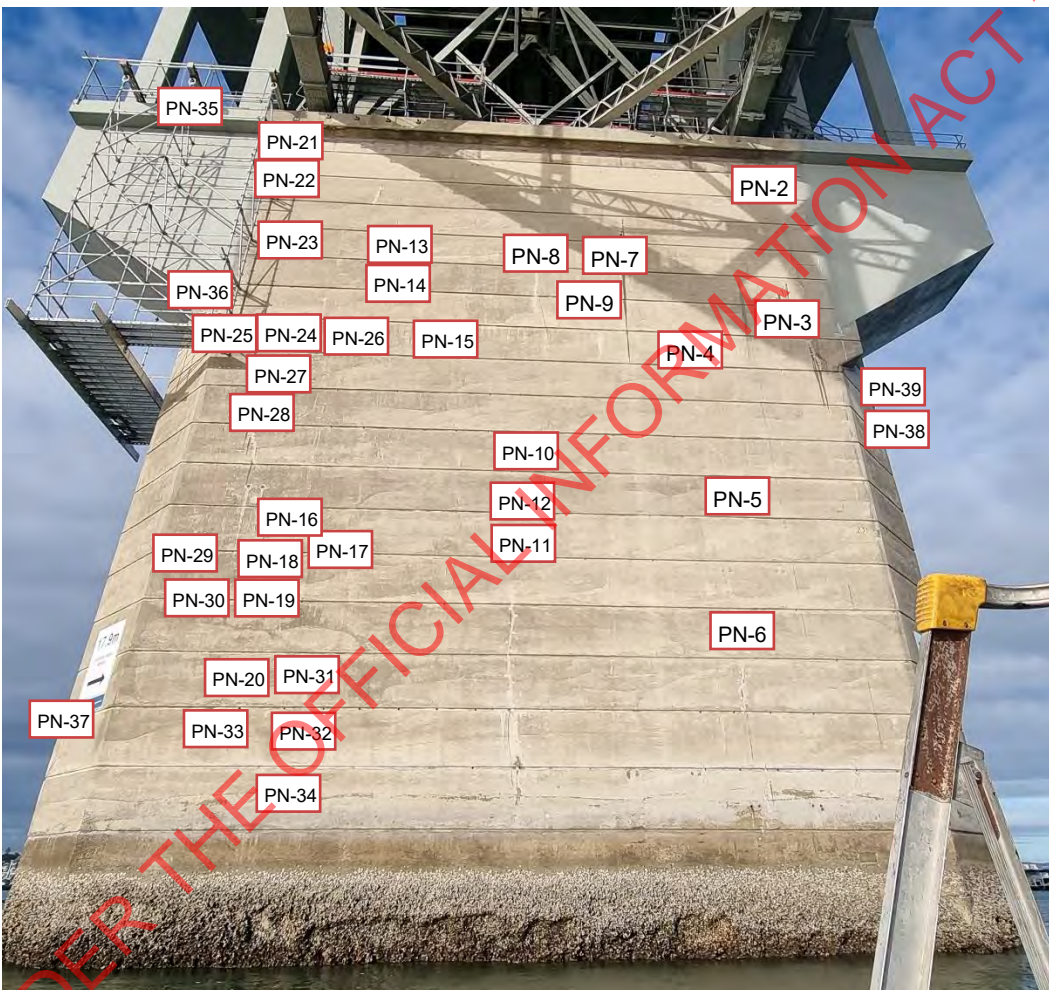
Photo ID	Marking Code	Description of Defects	Maintenance/ Repairs Recommendations	Maintenance/ Repairs Priority & Timeframe
PN-1	N

N/A	N/A
		General View Exterior North Face Wall, showing approximate defect locations	N/A	N/A

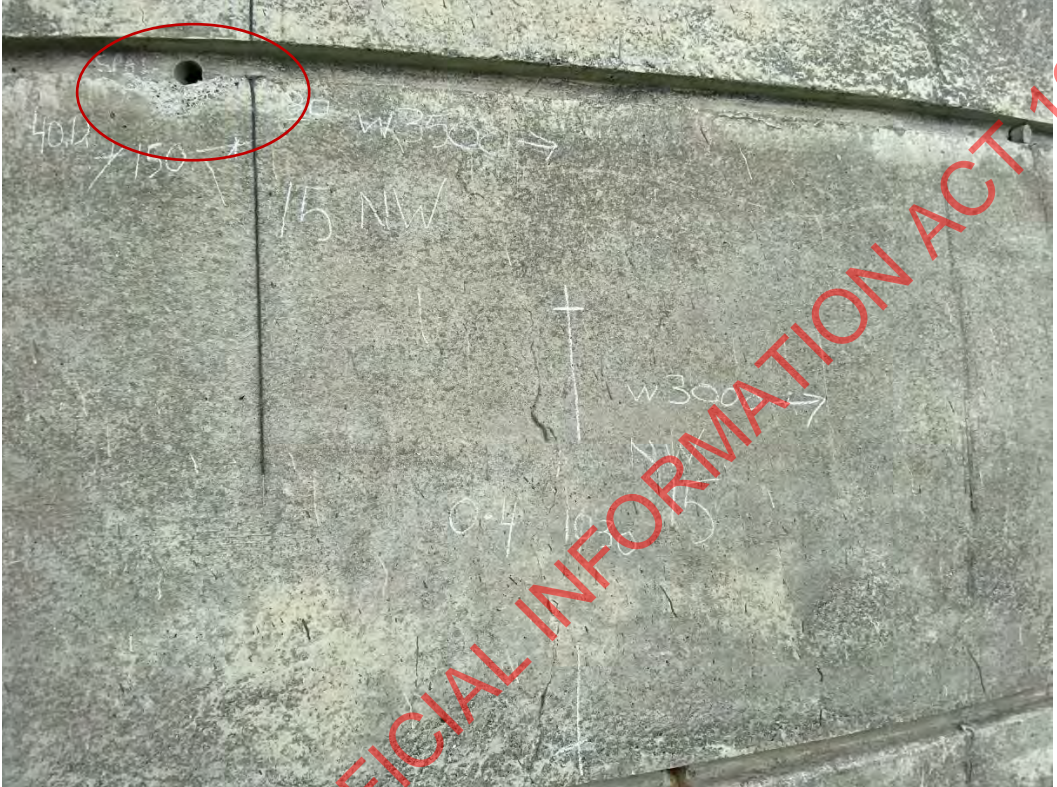
Photo ID	Marking Code	Description of Defects	Maintenance/ Repairs Recommendations	Maintenance/ Repairs Priority & Timeframe
PN-6	S S

Section 15. North-west 3m to Western Edge. Concrete Crack 0.4mm.	Crack injection	L 2+ years
		Section 15. North-west 3.5m to Western Edge. Concrete Spalling.	Concrete Repair	L 2+Years

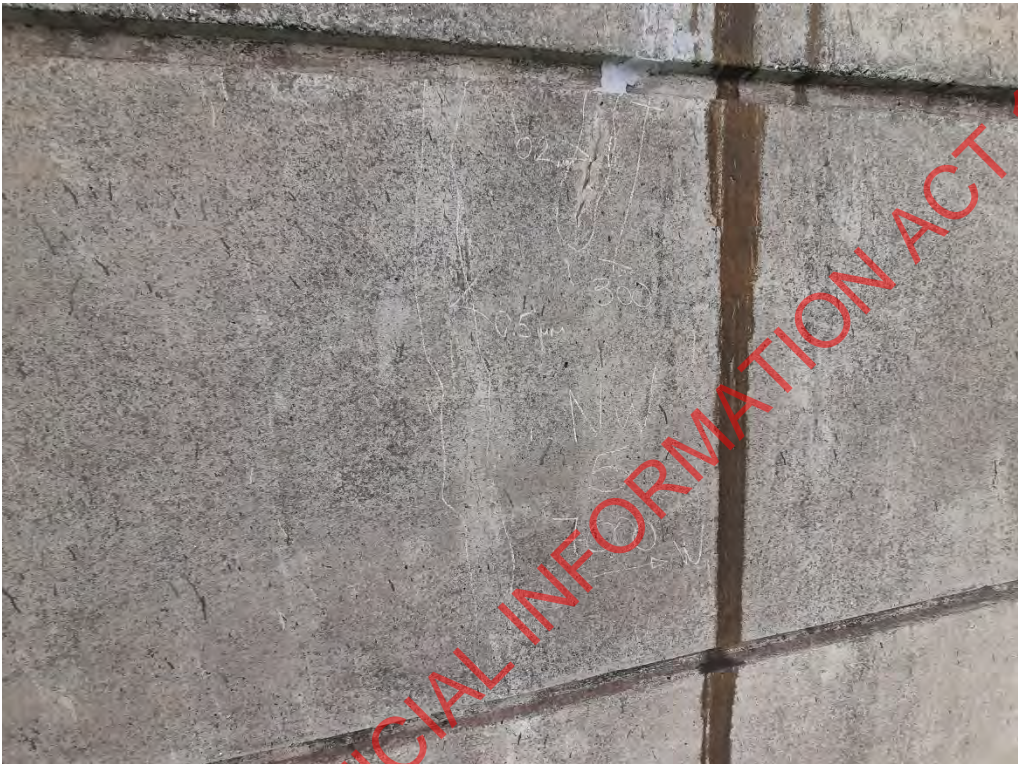
Photo ID	Marking Code	Description of Defects	Maintenance/ Repairs Recommendations	Maintenance/ Repairs Priority & Timeframe
PN-9	2 S

Section 5. North-west 7m to Western Edge. Concrete Crack 0.2mm.	Monitor	At next inspection
		Concrete Crack 0.5mm.	Crack injection	L 2+ years

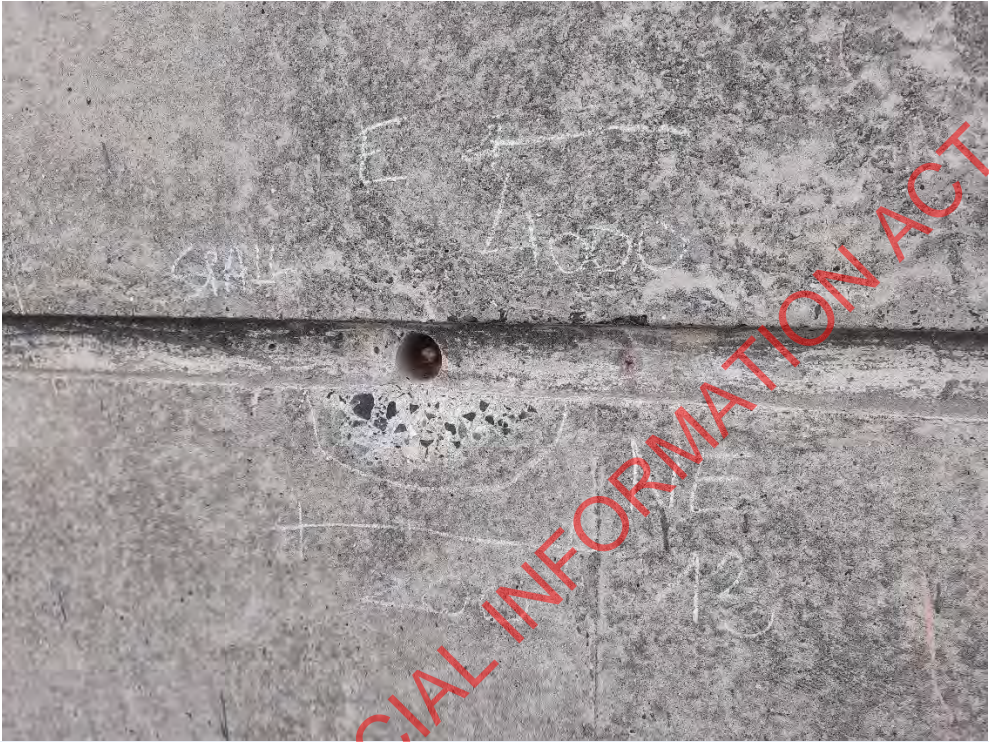
Photo ID	Marking Code	Description of Defects	Maintenance/ Repairs Recommendations	Maintenance/ Repairs Priority & Timeframe
PN-16	S

<p>Section 13. North-east 4m to Eastern Edge. Concrete Spalling.</p>	Concrete Repair	L 2+ Years
PN-17	2

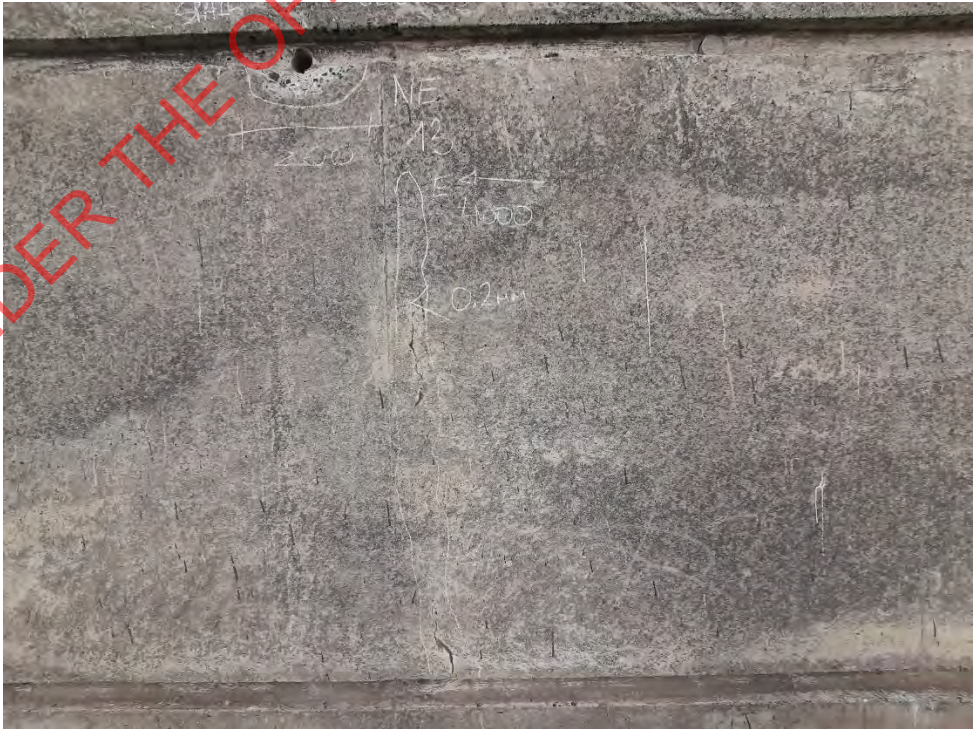
<p>Section 13. North-east 4m to Eastern Edge. Concrete Crack 0.2mm.</p>	Monitor at next inspection	At next inspection

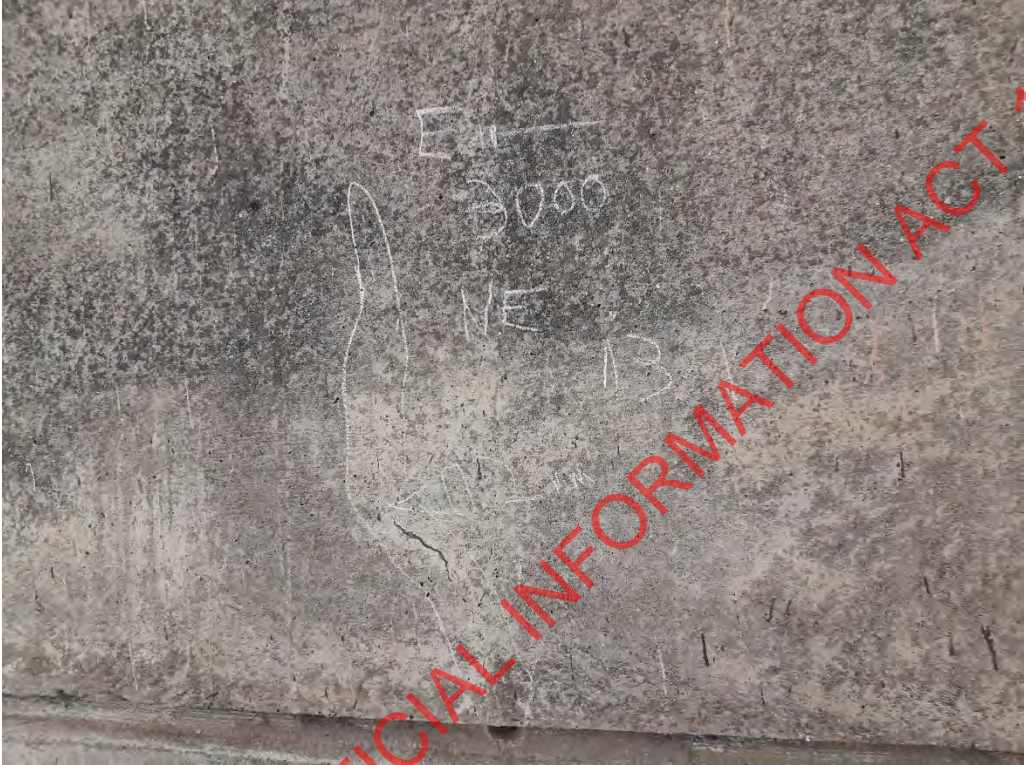
Photo ID	Marking Code	Description of Defects	Maintenance/ Repairs Recommendations	Maintenance/ Repairs Priority & Timeframe
PN-18	2

<p>Section 13. North-east 3m to Eastern Edge. Concrete Crack 0.2mm.</p>	Monitor at next inspection	At next inspection
PN-19	S

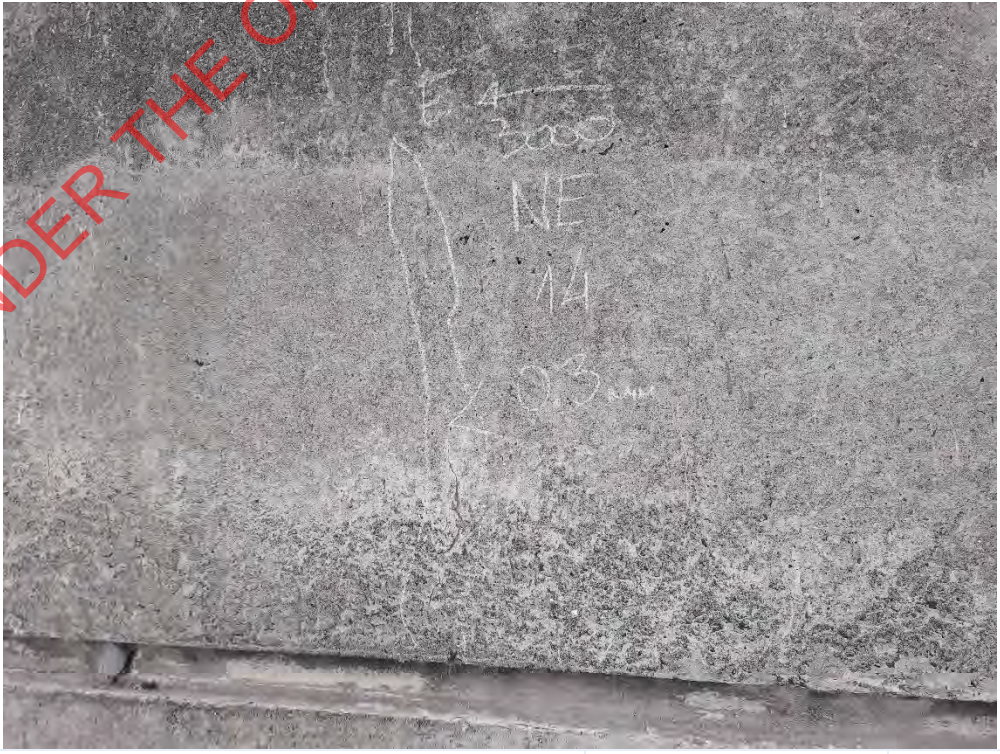
<p>Section 14. North-east 3m to Eastern Edge. Concrete Crack 0.3mm.</p>	Crack injection	L 2+ years

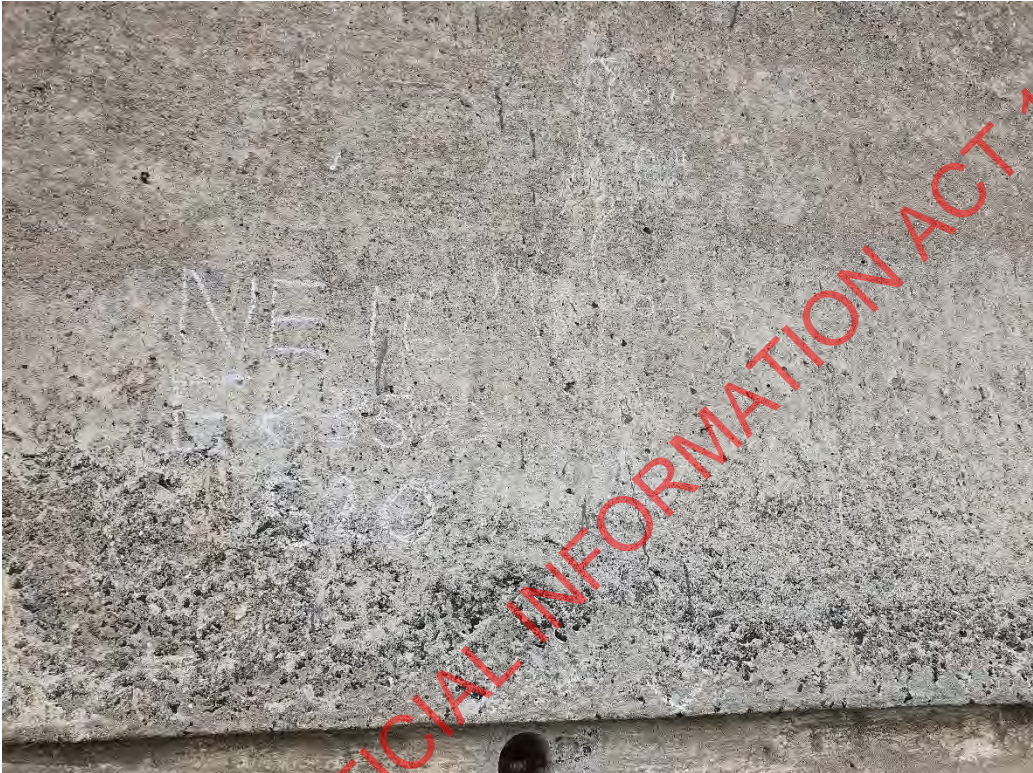
Photo ID	Marking Code	Description of Defects	Maintenance/ Repairs Recommendations	Maintenance/ Repairs Priority & Timeframe
PN-31	S

<p>Section 16. North-east 3.5m to Eastern Edge. Concrete Crack 0.1mm to 0.4mm.</p>	Crack injection	L 2+ years
PN-32	S

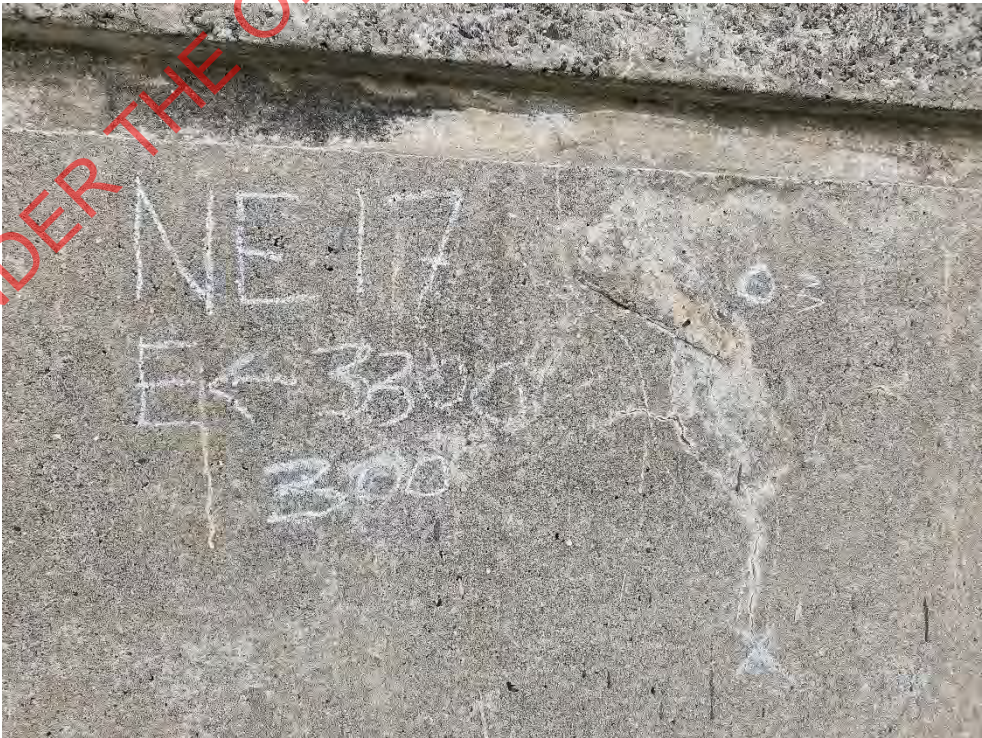
<p>Section 17. North-east 3.3m to Eastern Edge. Concrete Crack 0.3mm.</p>	Crack injection	L 2+ years

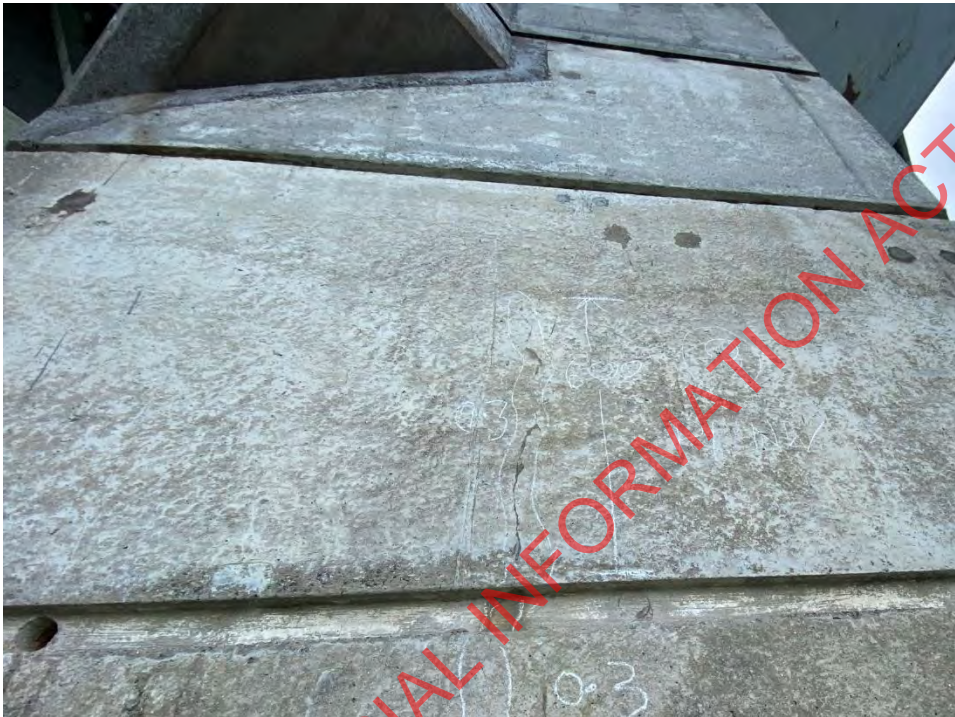
Photo ID	Marking Code	Description of Defects	Maintenance/ Repairs Recommendations	Maintenance/ Repairs Priority & Timeframe
PN-39	S

<p>Section 9. North-west 1.1m to Western Edge. Concrete Crack 0.3mm.</p>	Crack injection	L 2+ Years

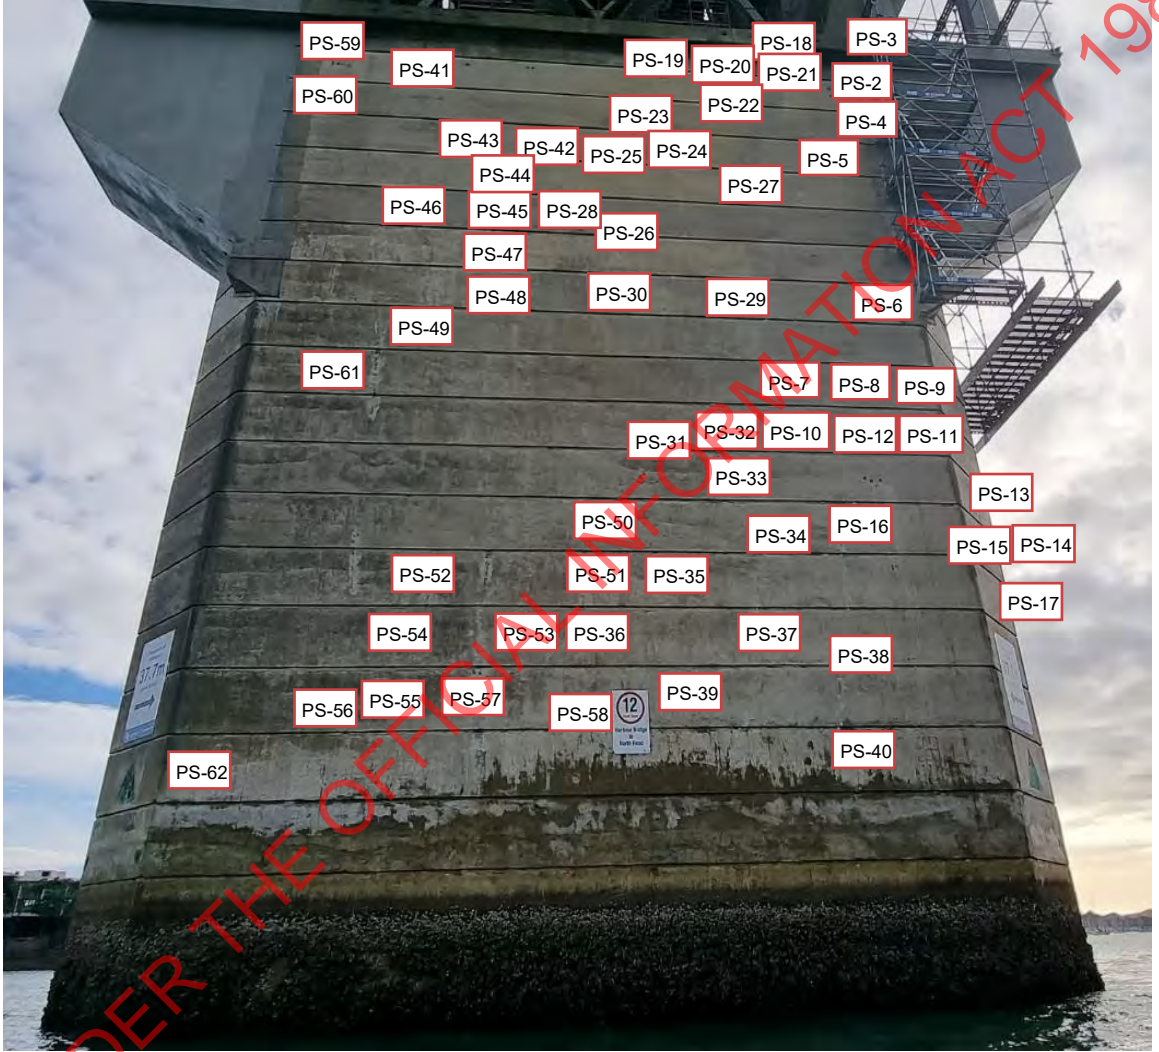
Photo ID	Marking Code	Description of Defects	Maintenance/ Repairs Recommendations	Maintenance/ Repairs Priority & Timeframe
PS-1	N

N/A	N/A
		General View Exterior South Face Wall, showing approximate defect locations	N/A	N/A

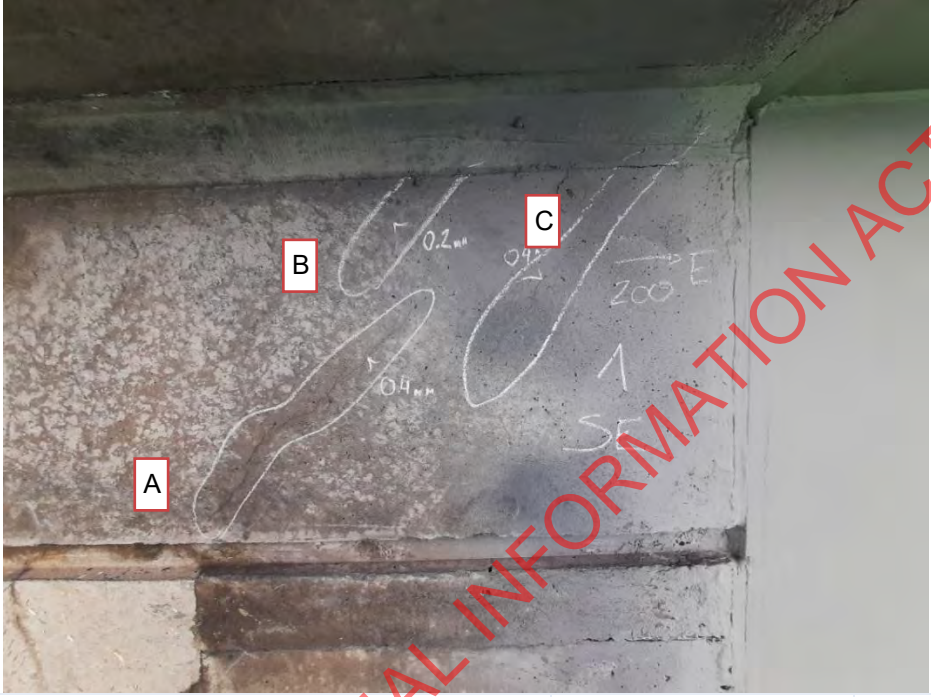
Photo ID	Marking Code	Description of Defects	Maintenance/ Repairs Recommendations	Maintenance/ Repairs Priority & Timeframe
PS-2	S 2 S

Section 1. South-east 0.2m to Eastern Edge. Concrete Crack A 0.4mm.	Crack injection L 2+ Years
			Concrete Crack B 0.2mm.	Monitor at next inspection At next inspection
			Concrete Crack C 0.4mm.	Crack injection L 2+ Years
PS-3	R

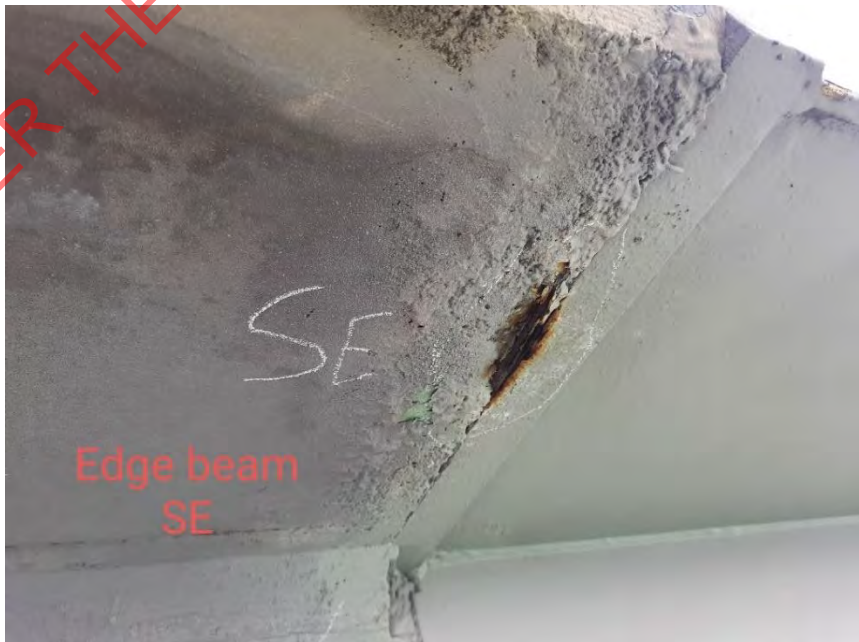
Pier Bracket South-east to Edge Beam interface. Severe Surface corrosion.	Blast extent of corrosion. Paint and Seal. L 2+ Years

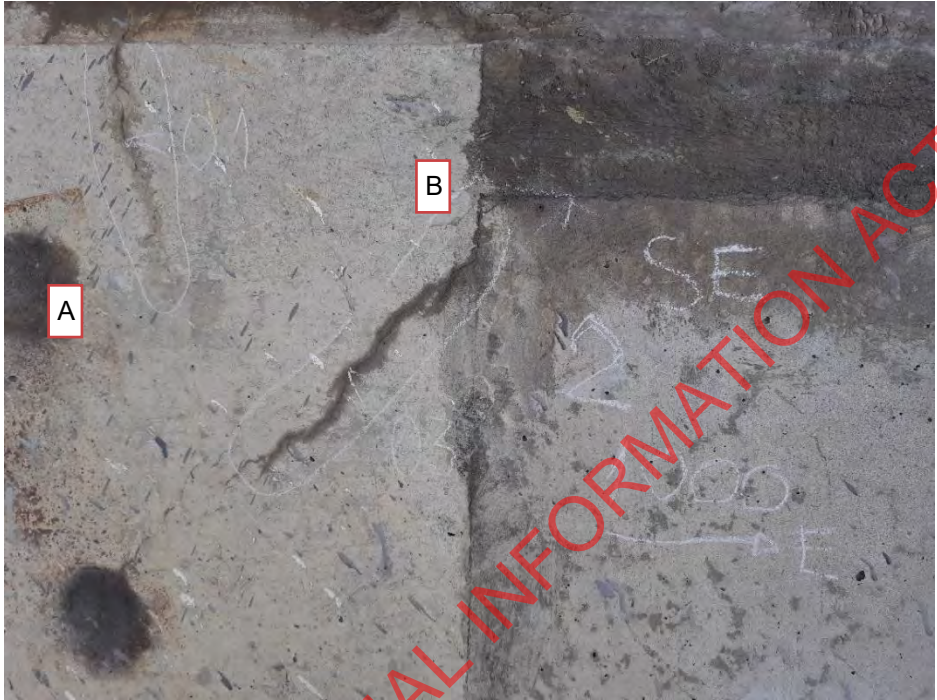
Photo ID	Marking Code	Description of Defects	Maintenance/ Repairs Recommendations	Maintenance/ Repairs Priority & Timeframe
PS-4	2 S

Section 2. South-east 1m to Eastern Edge. Concrete Crack A 0.1mm.	Monitor at next inspection At next inspection
			Concrete Crack B 0.3mm.	Crack injection L 2+Years
PS-5	S	 		
			Section 4 South-east 2m to Eastern Edge. Severe surface Corrosion to Old fixing.	Protective coating to steel and Concrete Repair. L 2+Years

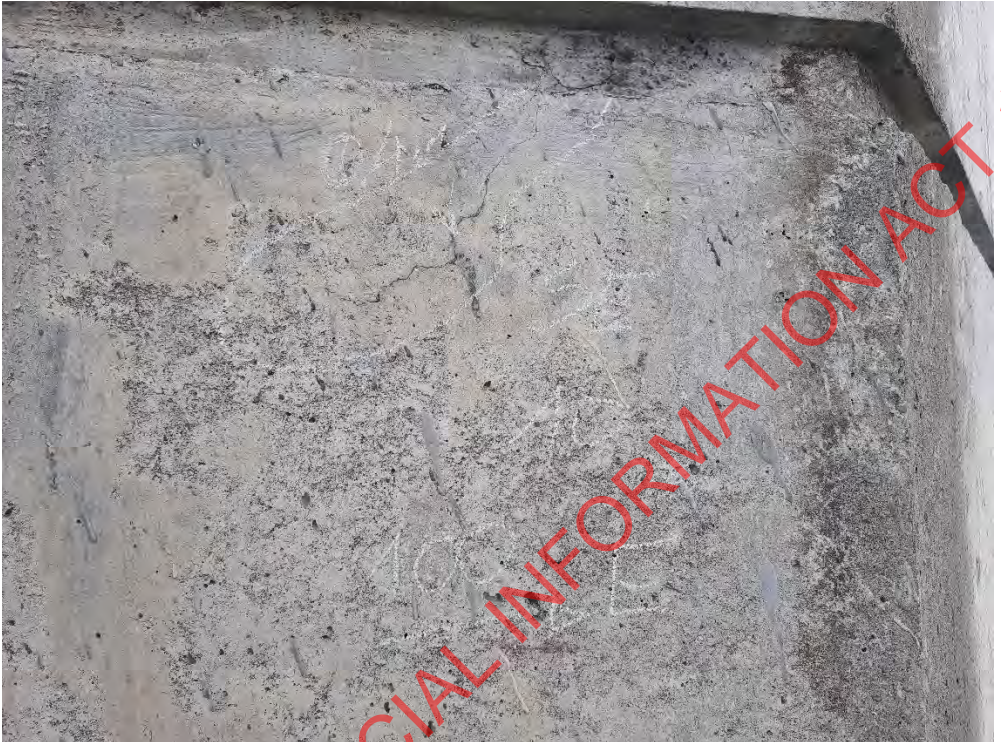
Photo ID	Marking Code	Description of Defects	Maintenance/ Repairs Recommendations	Maintenance/ Repairs Priority & Timeframe
PS-9	S

<p>Section 10. South-east 0.1m to Eastern Edge. Concrete Crack 0.4mm.</p>	Crack injection	L 2+Years
PS-10	S

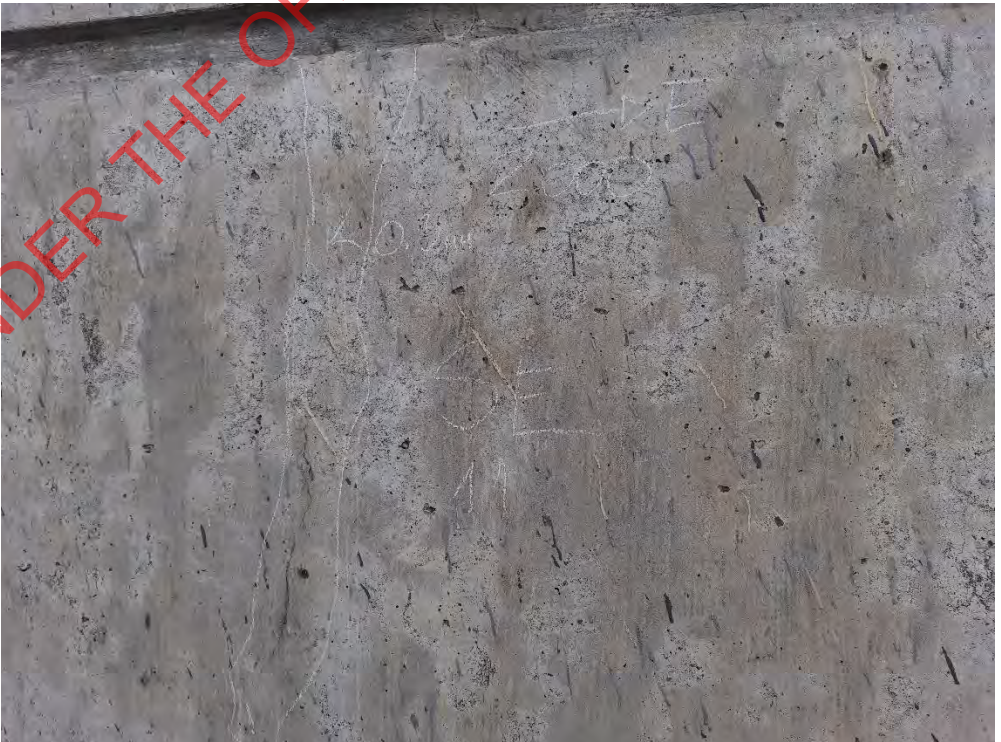
<p>Section 11. South-east 2m to Eastern Edge. Concrete Crack 0.3mm.</p>	Crack injection	L 2+Years

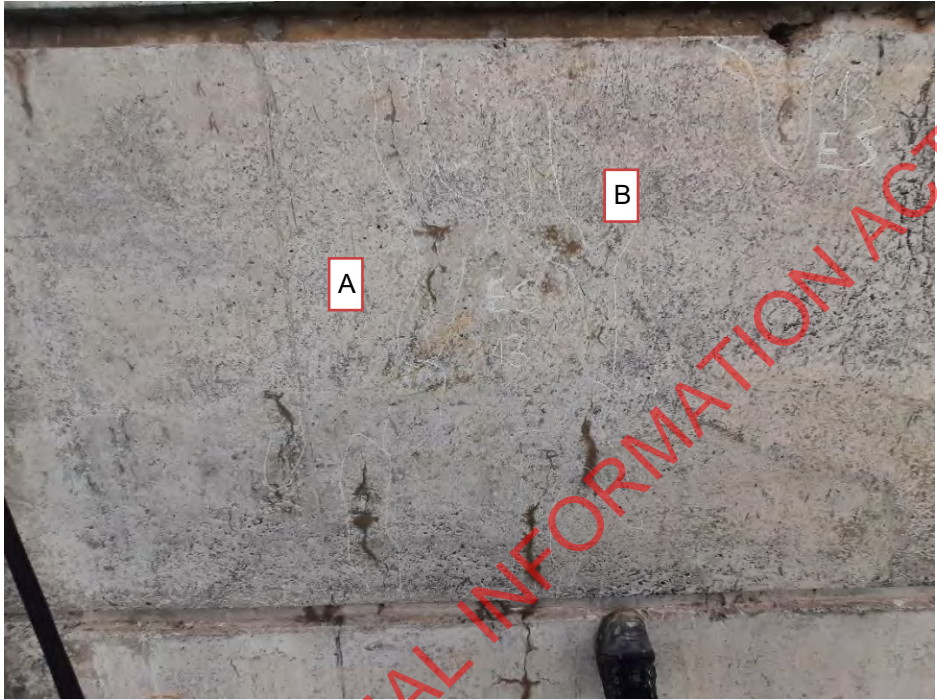
Photo ID	Marking Code	Description of Defects	Maintenance/ Repairs Recommendations	Maintenance/ Repairs Priority & Timeframe
PS-15	2 S

Section 13. East-south 0.5m to Southern Edge. Concrete Crack A 0.2mm.	Monitor at next inspection
			Concrete Crack B 0.3mm.	Crack injection
PS-16	S

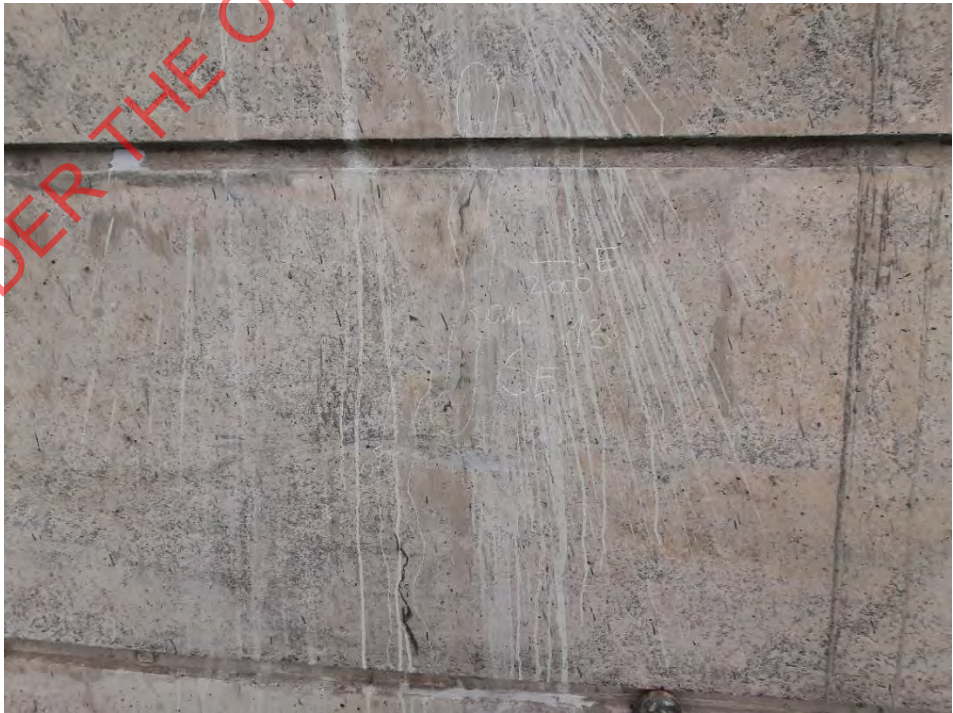
Section 13. South-east 2m to Eastern Edge. Concrete Crack 0.4mm.	Crack injection

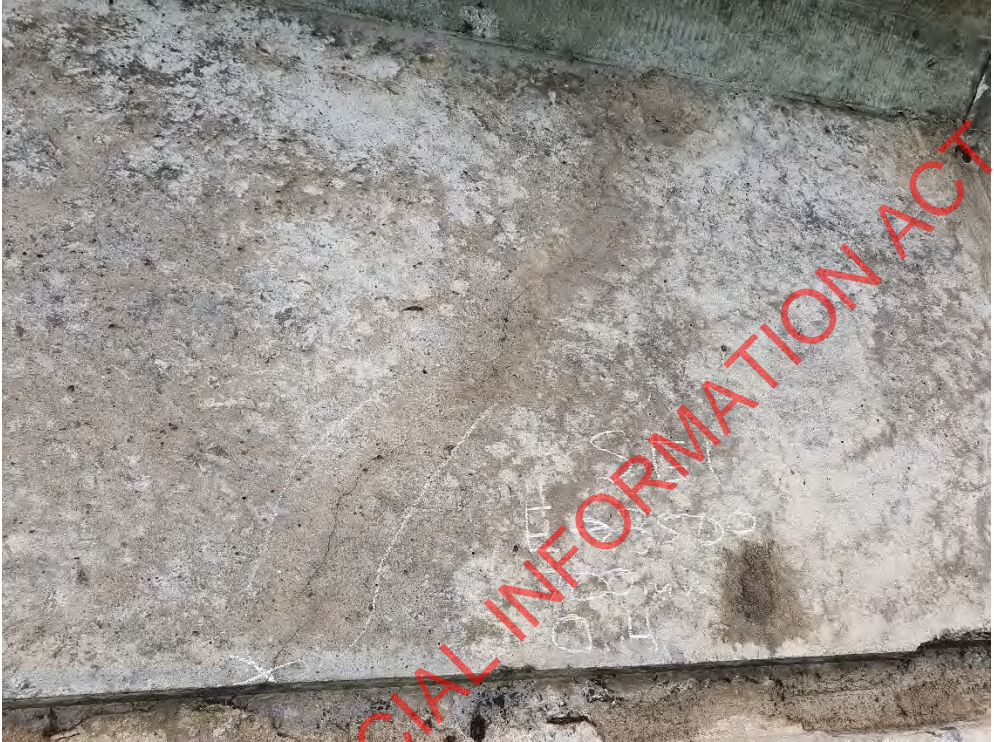
Photo ID	Marking Code	Description of Defects	Maintenance/ Repairs Recommendations	Maintenance/ Repairs Priority & Timeframe
PS-20	S

<p>Section 1. South-east 3.5m to Eastern Edge. Concrete Crack 0.4mm.</p>	Crack injection	L 2+ Years
PS-21	S	  <p>Section 1. South-east 3m to Eastern Edge. Concrete Crack 0.4mm.</p>	Crack injection	L 2+ Years

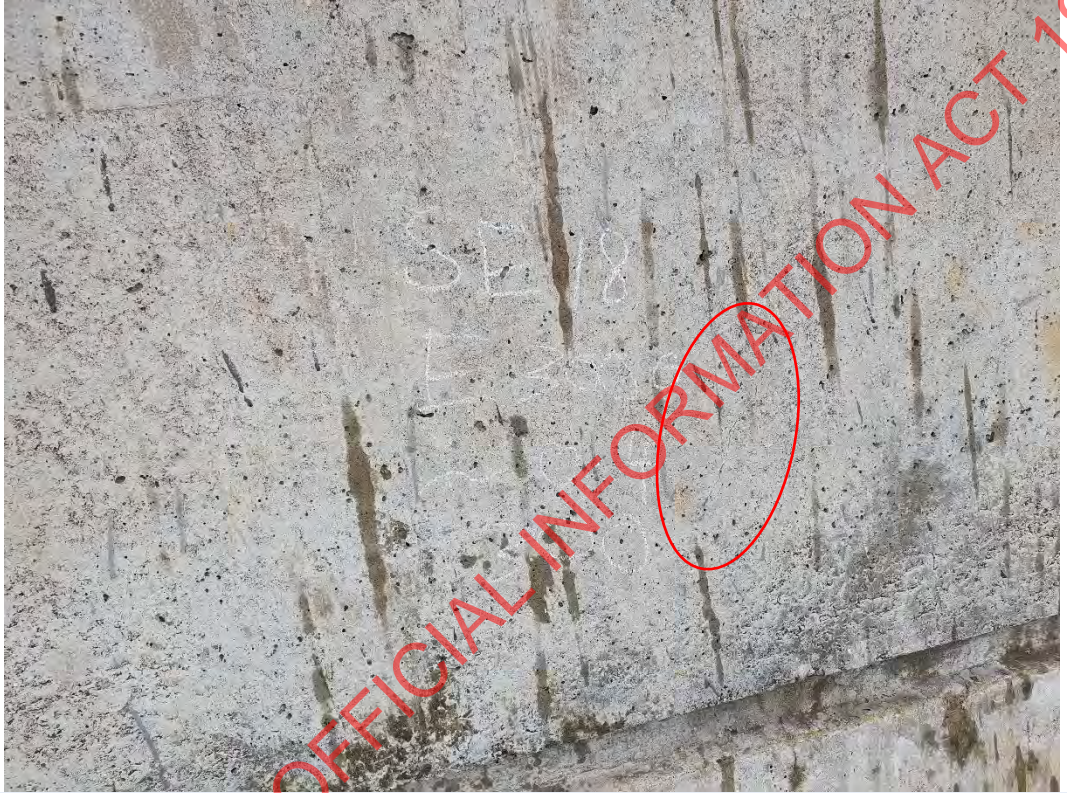
Section 18. South-east 3m to Eastern Edge. Concrete Crack 0.4mm.	Crack injection	L 2+ Years
PS-41	S

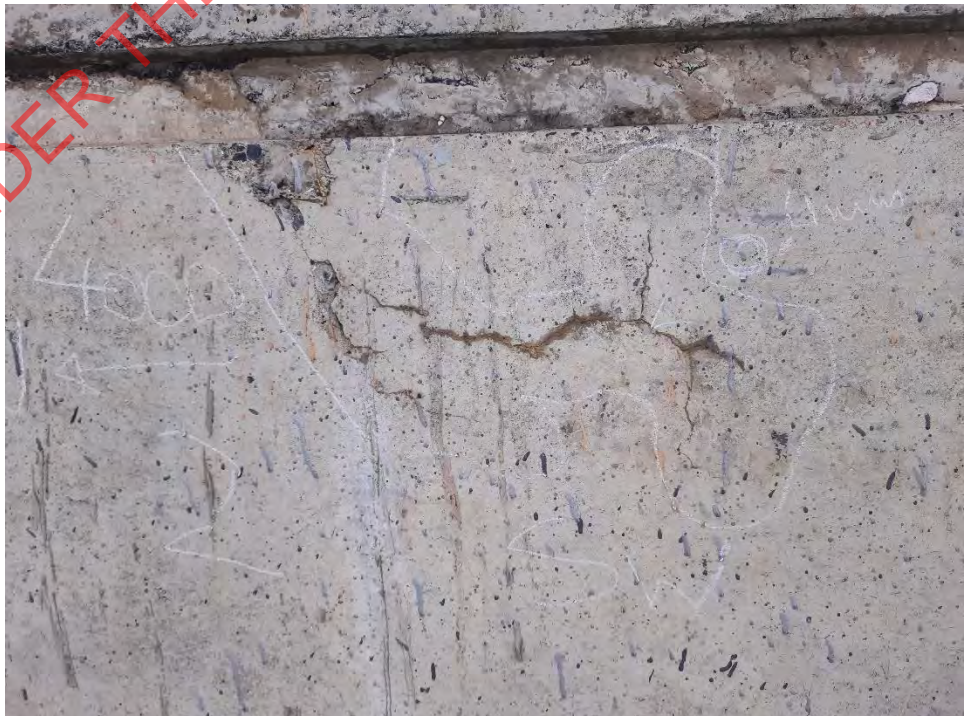
Photo ID	Marking Code	Description of Defects	Maintenance/ Repairs Recommendations	Maintenance/ Repairs Priority & Timeframe
		Section 2. South-west 4m to Western Edge. Concrete Crack 0.4mm.	Crack injection	L 2+ Years
PS-42	S S

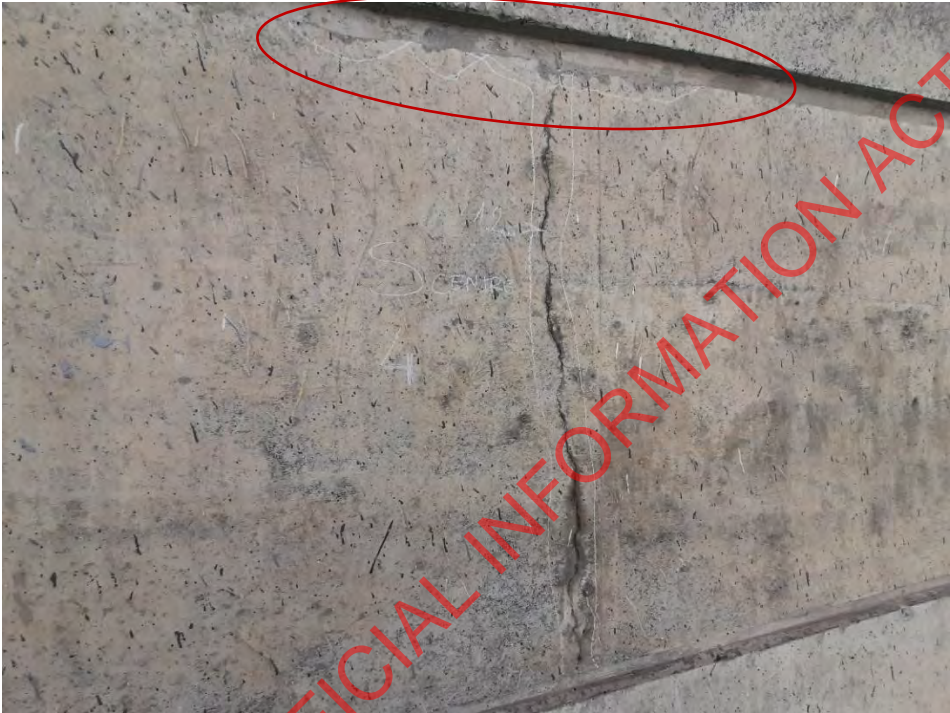
- . North Face Wall: - (PN-14) Section 6. 5m to Eastern edge. Concrete Crack (0.6mm to 1.0mm).
- . South Face Wall: - (PS-42) Section 4. South-centre. Concrete crack (1.2mm)
- (PS-45) Section 6. South-west 6m to Western edge. Concrete crack (1.0mm)
- (PS-46) Section 6. South-west 4m to Western edge. Concrete crack (1.2mm)

Section 4. South Centre. Concrete Crack 1.2mm.	Crack injection	L 2+ Years
		Concrete Spalling.	Concrete Repair	L 2+ Years
PS-43	2

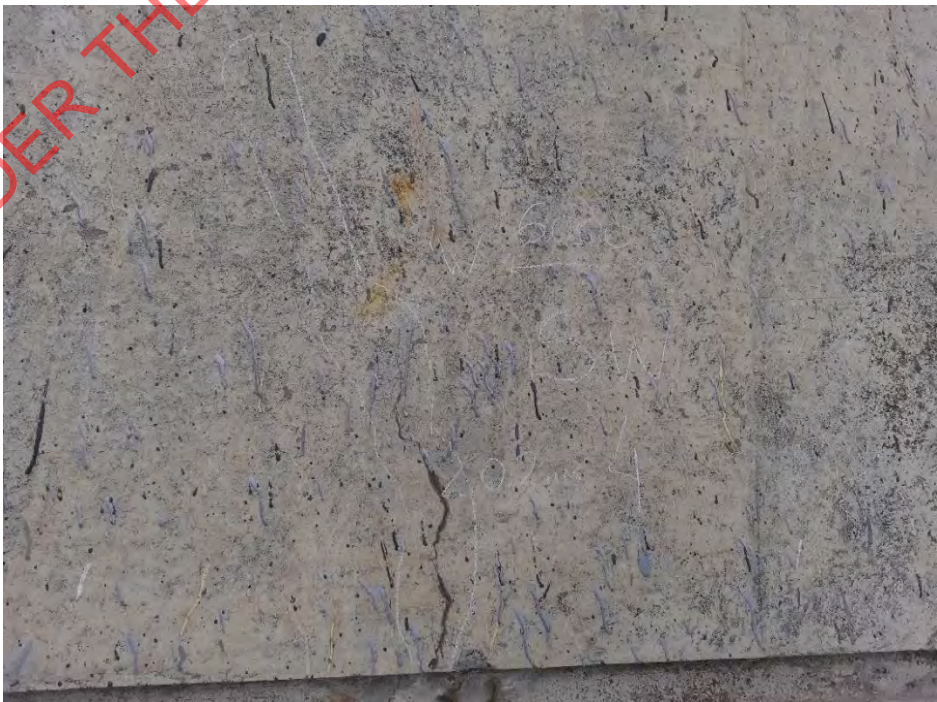
Photo ID	Marking Code	Description of Defects	Maintenance/ Repairs Recommendations	Maintenance/ Repairs Priority & Timeframe
		Section 2. South-west 6m to Western Edge. Concrete Crack 0.2mm.	Monitor at next inspection	At next inspection
PS-44	S	 		
		Section 5. South-west 6m to Western Edge. Concrete Crack 0.5mm at old Repair.	Crack injection	L 2+ Years
PS-45	S

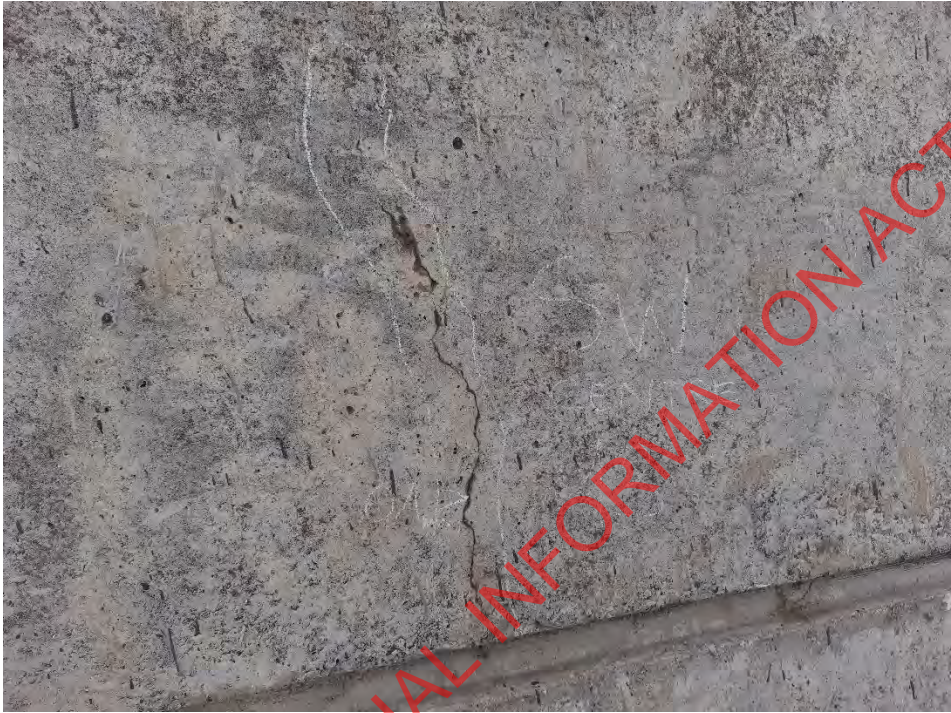
Photo ID	Marking Code	Description of Defects	Maintenance/ Repairs Recommendations	Maintenance/ Repairs Priority & Timeframe
PS-50	S

Section 13. South Centre. Concrete Crack 0.4mm.	Crack injection	L 2+ Years
PS-51	S

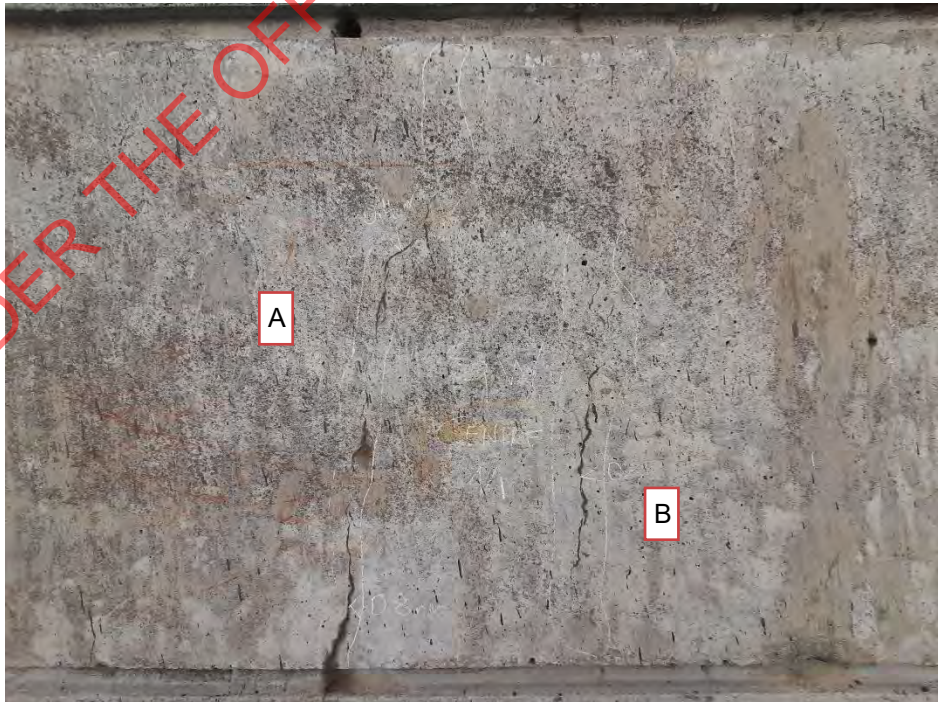
Section 13. South Centre. Concrete Crack A 0.4mm to 0.8mm.	Crack injection	L 2+ Years
		Concrete Crack B 0.3mm.	Crack injection	L 2+ Years

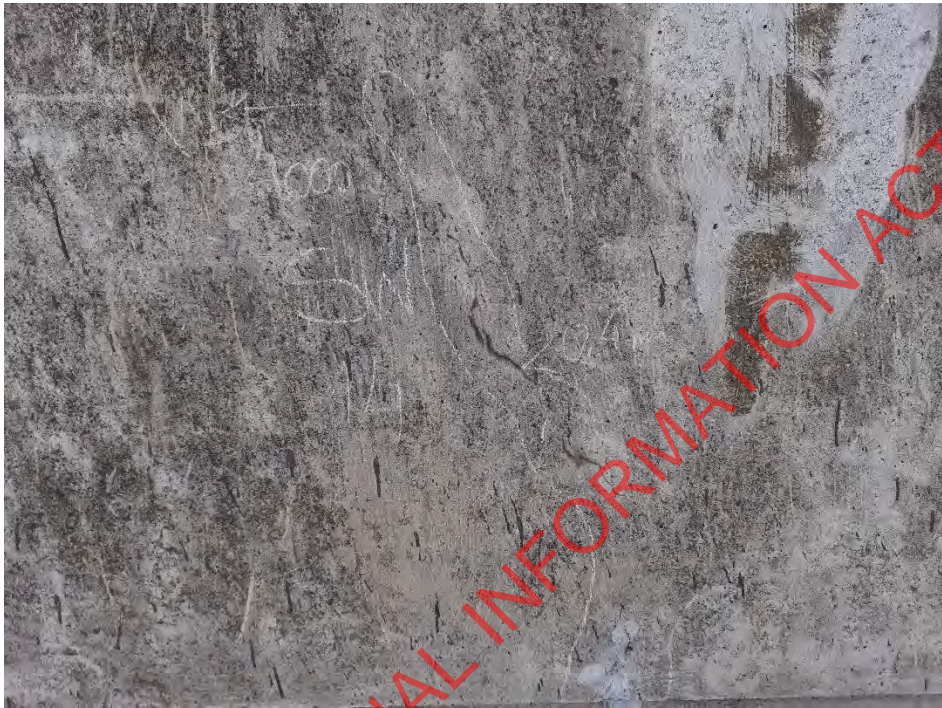
Photo ID	Marking Code	Description of Defects	Maintenance/ Repairs Recommendations	Maintenance/ Repairs Priority & Timeframe
PS-52	S

Section 14. South-west 4m to Western Edge. Concrete Crack 0.4mm.	Crack injection	L 2+ Years
PS-53	S

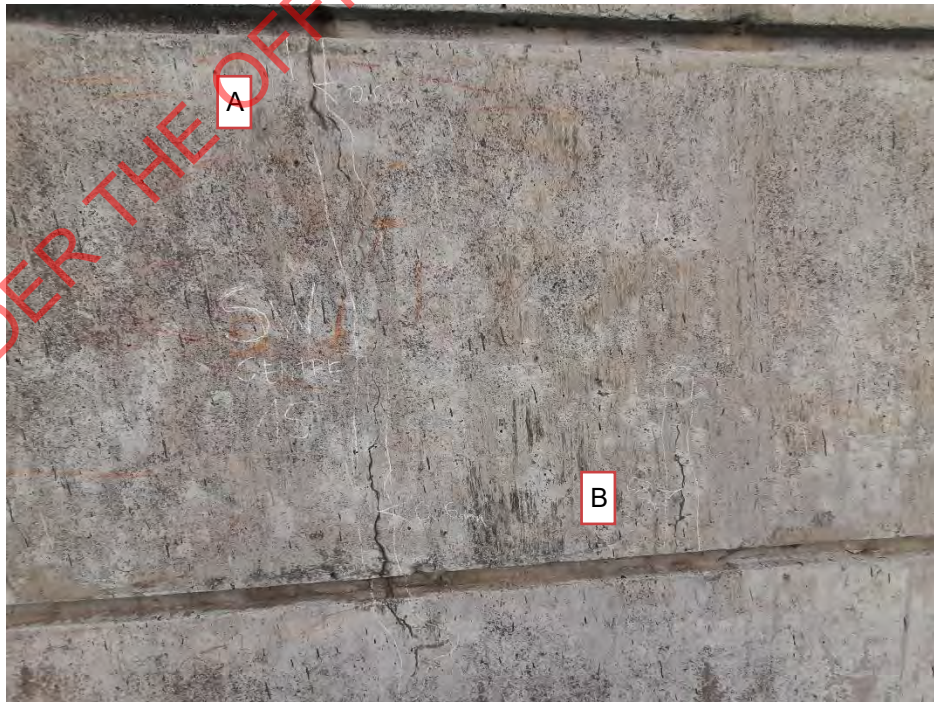
Section 15. South Centre. Concrete Crack A 0.6mm.	Crack injection	L 2+ Years
		Concrete Crack B 0.3mm.	Crack injection	L 2+ Years

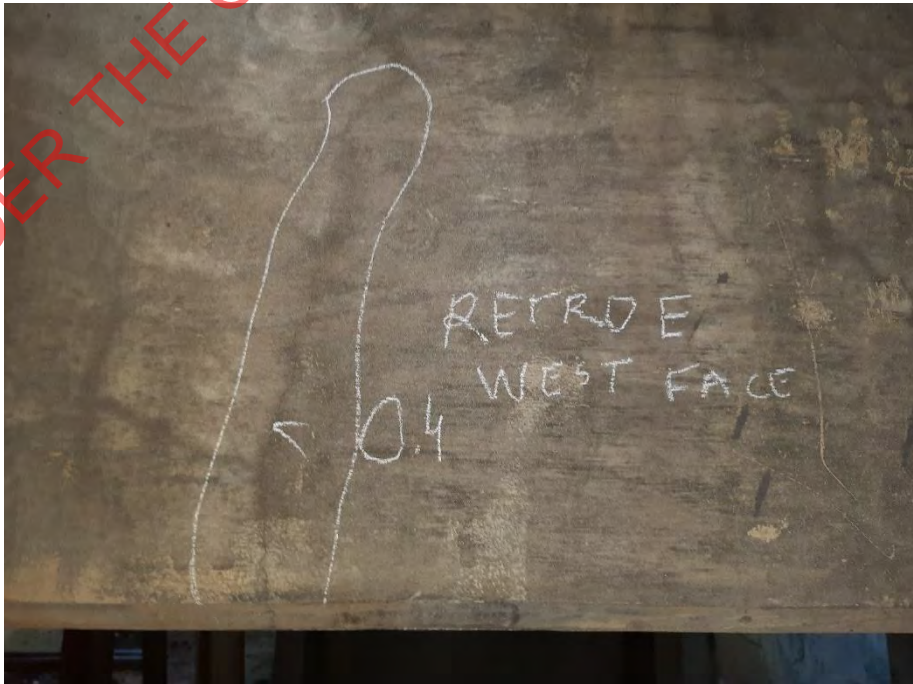
North-South Beam East. West Face. Typical. Shrinkage Cracking 0.4mm.	Crack injection	L 2+ Years
