ASM – AHB STRUCTURAL INSPECTION

Concrete Pier 1 Principal Inspection

s 9(2)(a)
9 NOVEMBER 2021

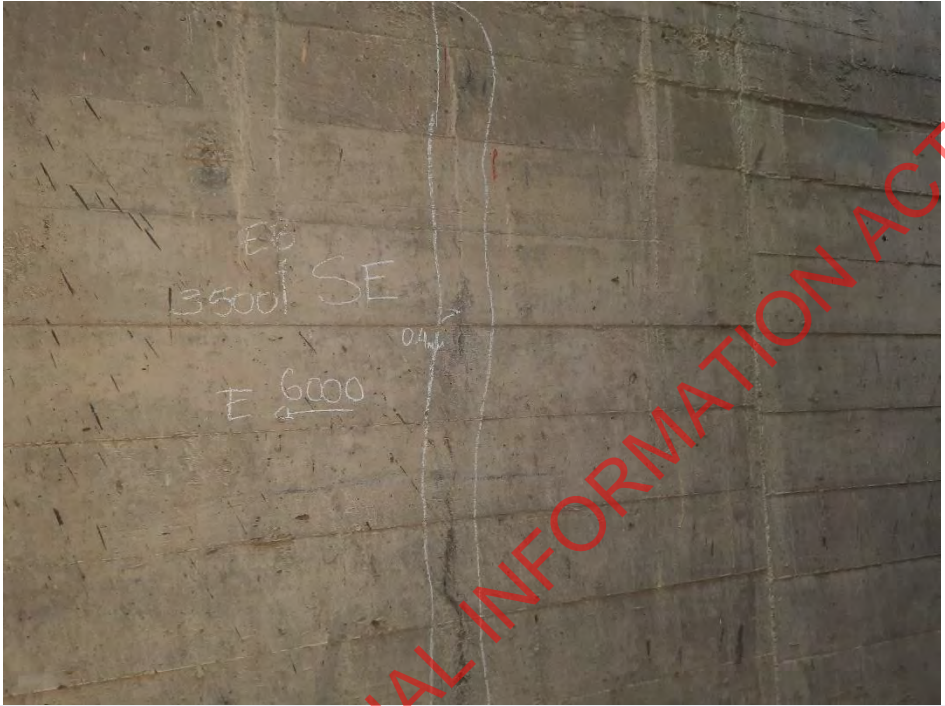
Photo ID	Marking Code	Description of Defects	Maintenance/ Repairs Recommendations	Maintenance/ Repairs Priority & Timeframe
IN-25	S

<p>South wall. 3.5m below edge beam. 6m to south-East pilaster. Concrete Crack 0.4mm.</p>	Crack injection	L 2+ Years
IN-26	S

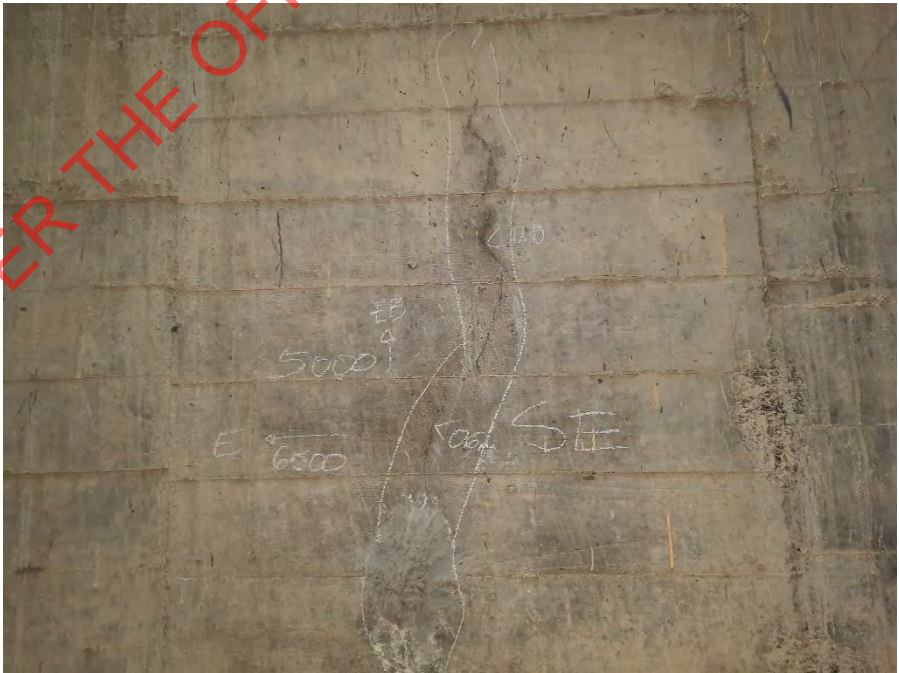
<p>South wall. 5m below edge beam. 6.5m to south-East pilaster. Concrete Crack 0.6mm to 0.8mm.</p>	Crack injection	L 2+ Years

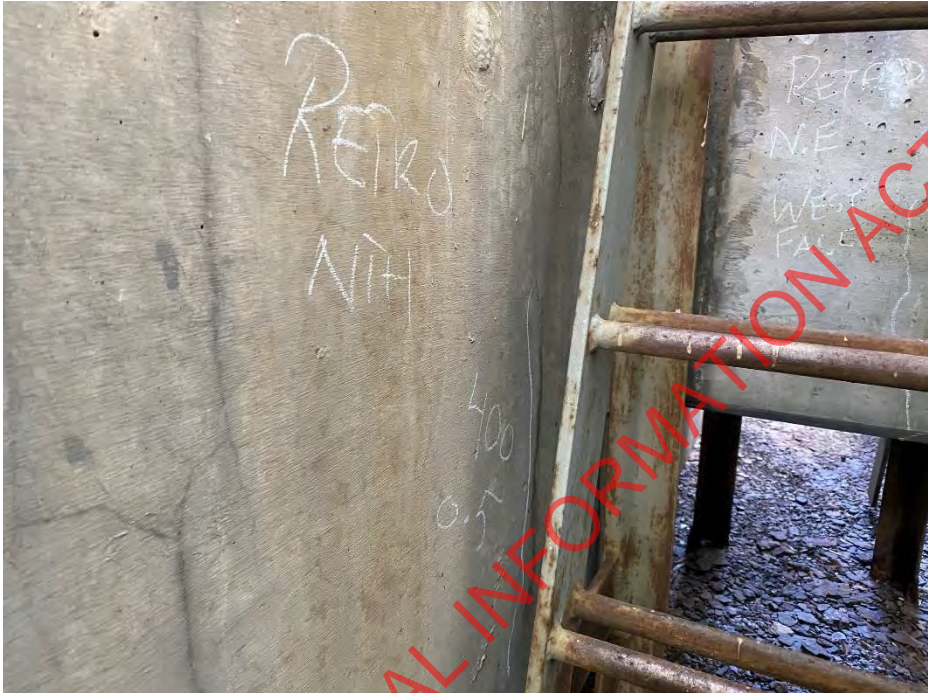
Photo ID	Marking Code	Description of Defects	Maintenance/ Repairs Recommendations	Maintenance/ Repairs Priority & Timeframe
IN-43	S

<p>North-west Retrofit Pilaster Concrete crack 0.5mm.</p>	Crack injection	L 2+ Years
IN-44	S

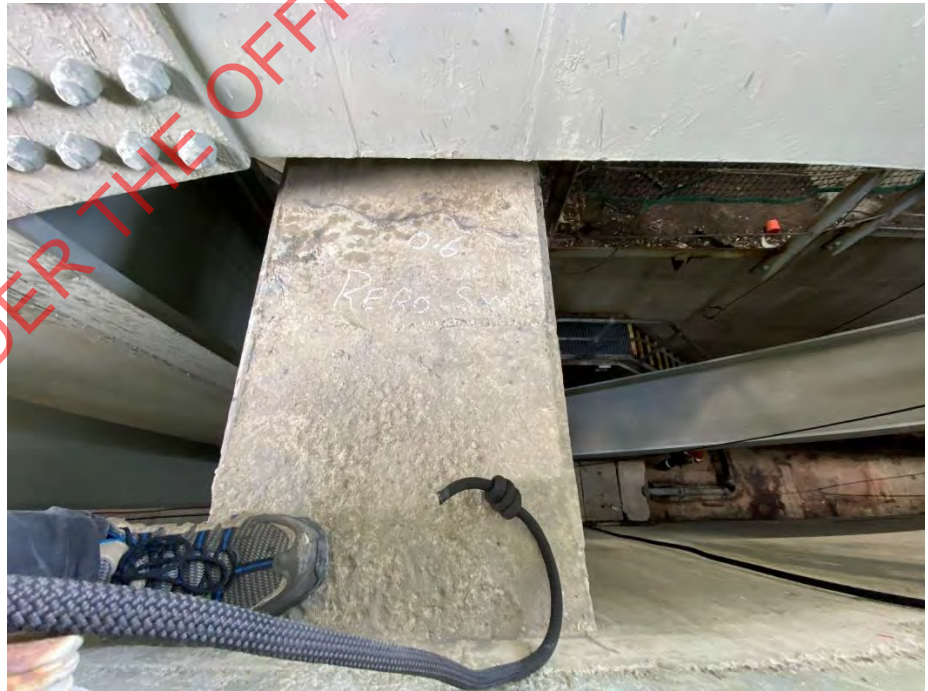
<p>North-South Beam West. Top Face. Concrete Crack 0.6mm.</p>	Crack injection	L 2+ Years

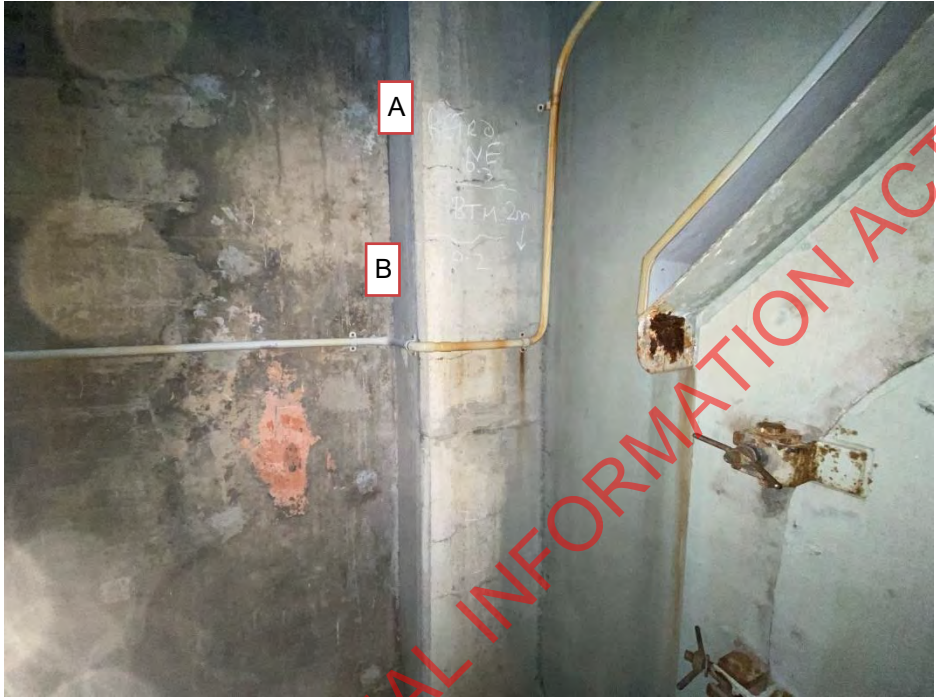
Photo ID	Marking Code	Description of Defects	Maintenance/ Repairs Recommendations	Maintenance/ Repairs Priority & Timeframe
IN-47	S 2

North-east Retrofit Pilaster 2m to Bottom Concrete Crack A 0.3mm.	Crack injection L 2+ Years
			Concrete Crack B 0.2mm.	Monitor at next inspection At next inspection

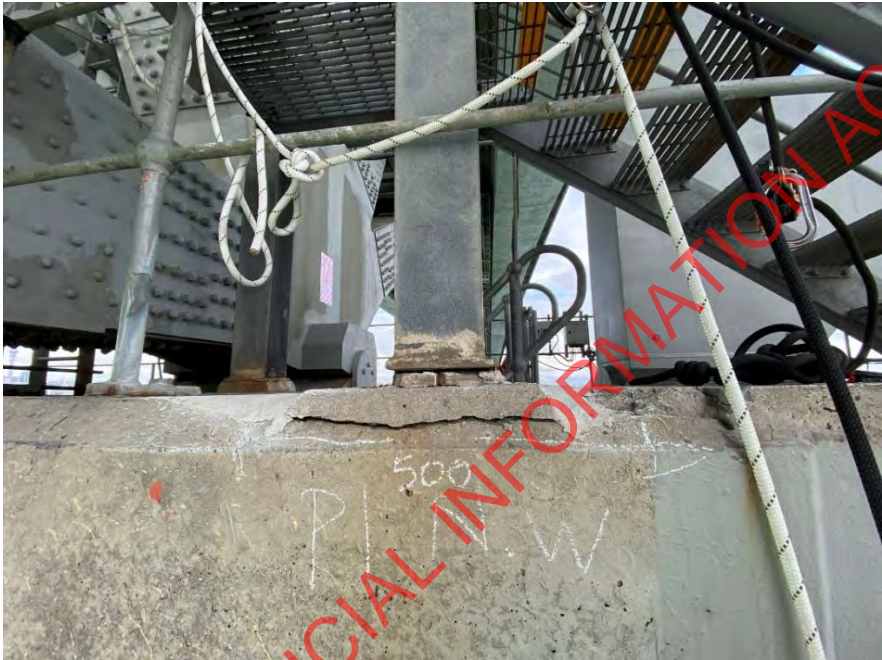
Photo ID	Marking Code	Description of Defects	Maintenance/ Repairs Recommendations	Maintenance/ Repairs Priority & Timeframe
EB-1	S

<p>Edge Beam North-west. Access Stairs Support mortar bedding Concrete Crack.</p>	Concrete Repair	L 2+ Year
EB-2	2

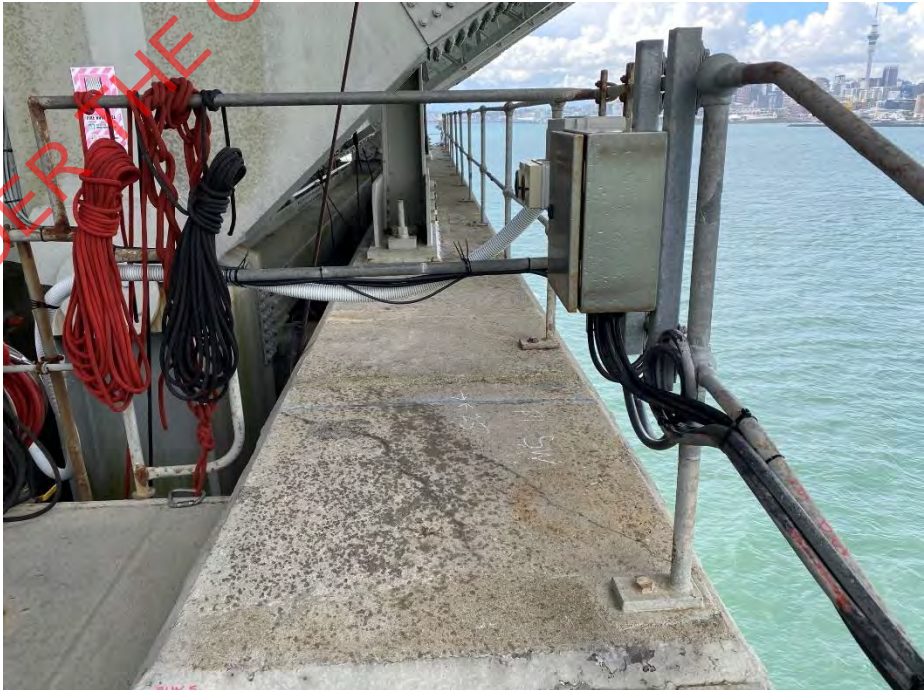
<p>Edge Beam South-west. Concrete injection.</p>	Monitor at next inspection	At next inspection
