State highway resilience

Lessons learnt from Kaikōura

July 2017

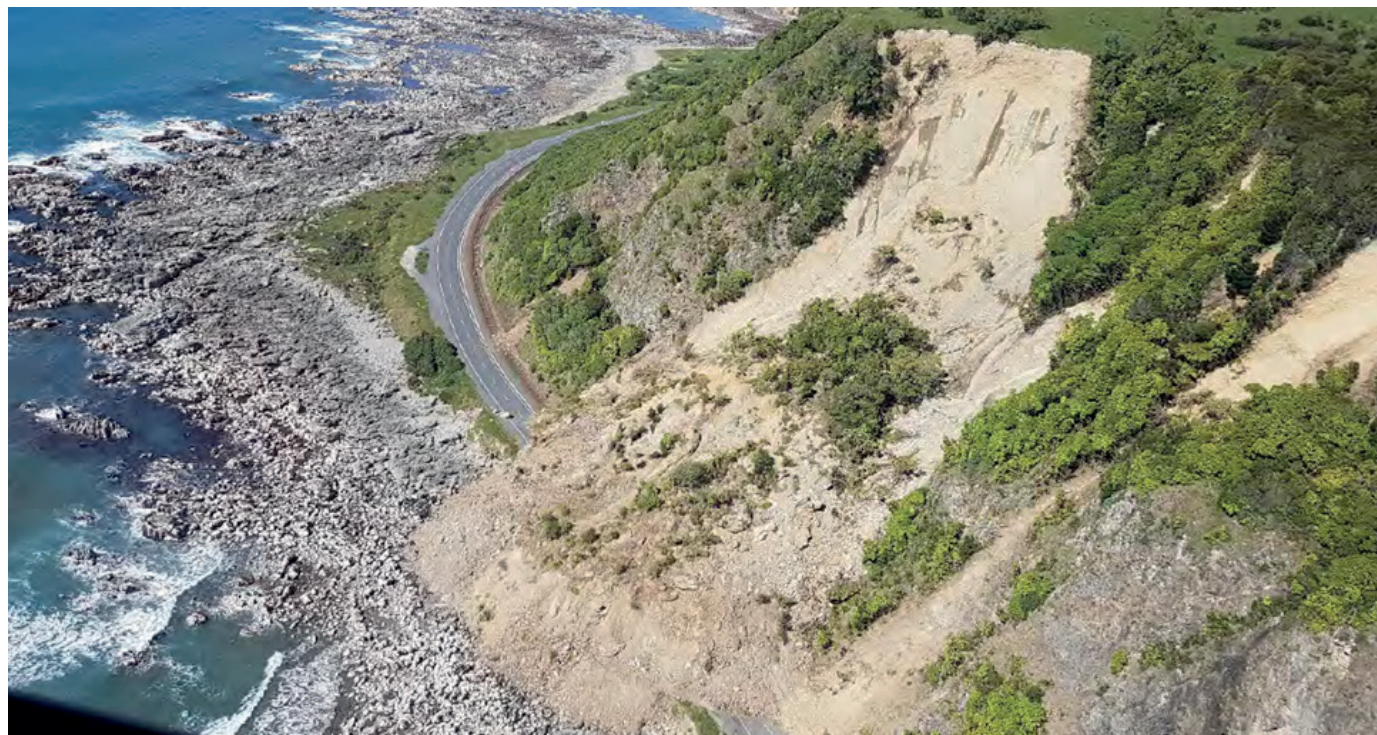
Major slip (#8) Okiwi Bay, north Kaikōura coast

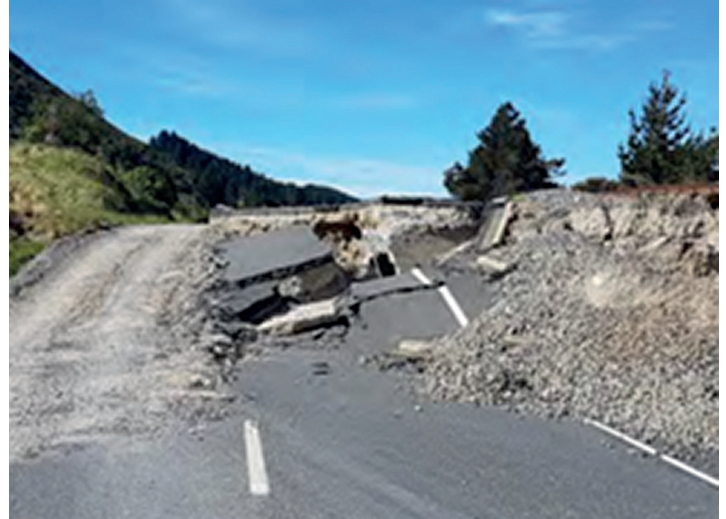
- **Fault rupture** and the resultant ground displacement of few to several metres cut off access along the route. Temporary access was able to be restored quickly within days. Full restoration will take much longer.

Fault rupture damage at Waipapa Bay, north Kaikōura coast

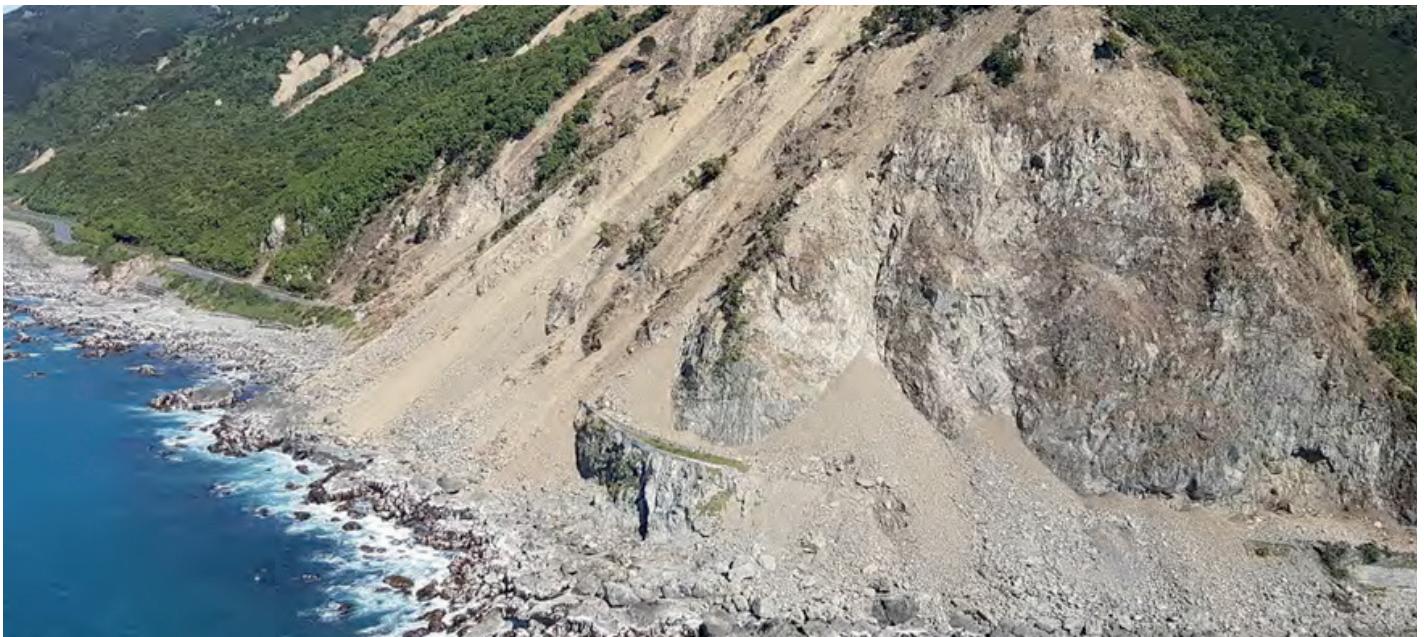
Slip at Ohau Point, north Kaikōura coast
