SAFETY ALERT

May 2019

NZ TRANSPORT AGENCY URGING FURTHER CHECKS OF NISSAN TRUCK PARK BRAKE CONTROL

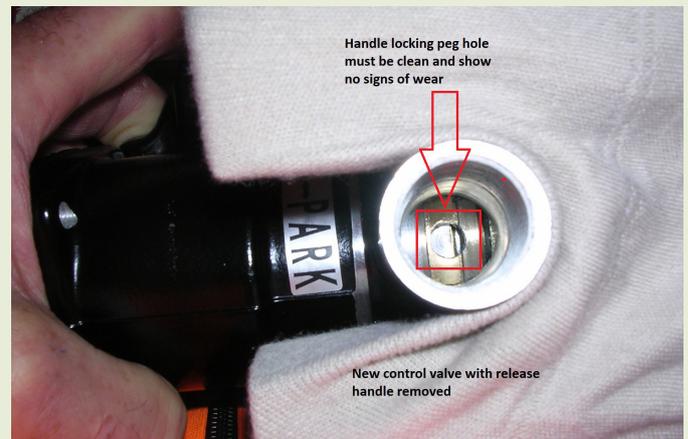
Locking peg hole

The areas that require a close inspection if you are looking to repair this valve are in the illustrations below (new valve shown).
