Attention: Greg Haldane, Programme & Standards, Manager Assurance
RE: External review panel – soil contamination, Te Onewa / Stokes Point
Our Reference: 2063

Summary

Site inspection

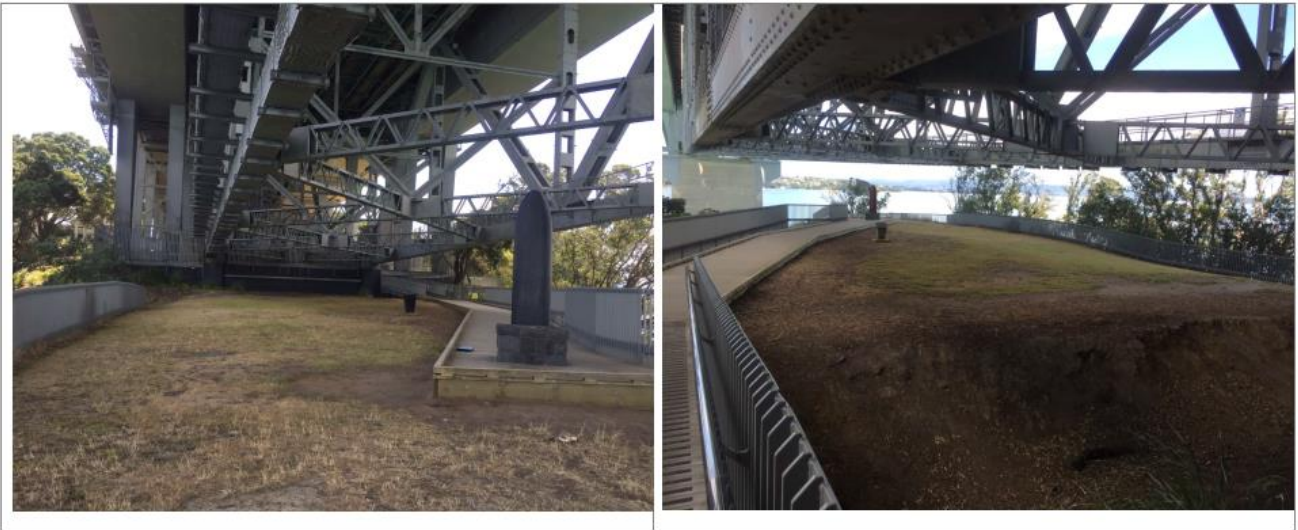
2 February 2021. Te Onewa Section; LHS – view to north towards North Anchorage; RHS – View to south from trench adjacent to North Anchorage showing Waitematā soils.

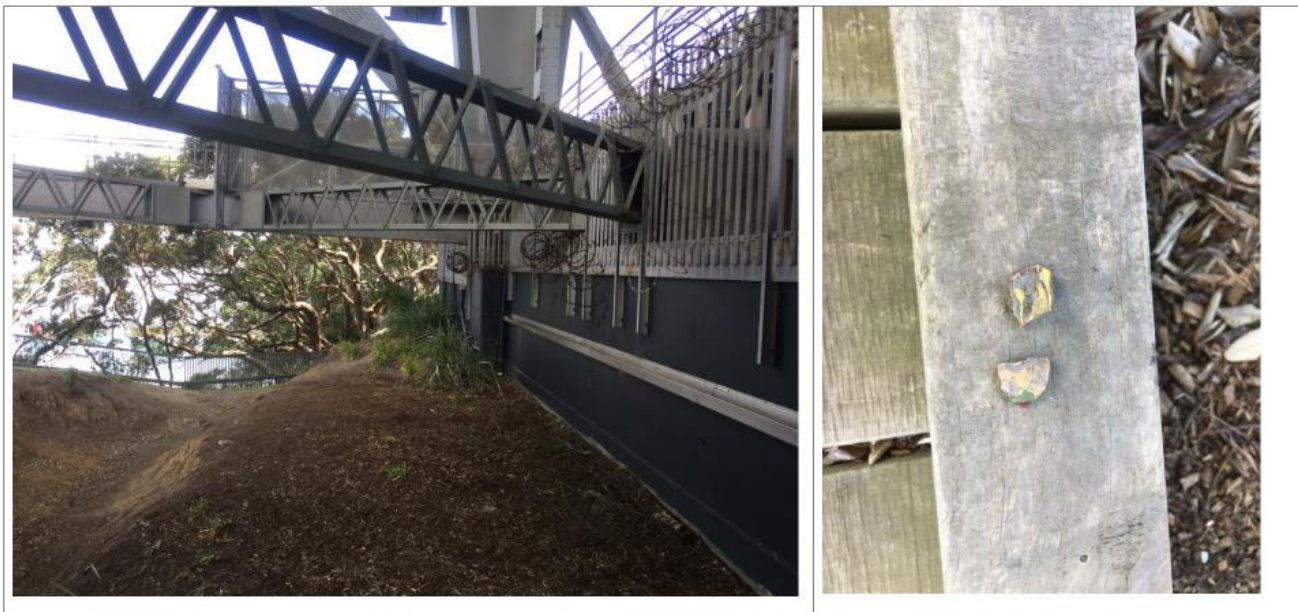
- The Te Onewa section comprises a relatively level area of land with sparse grass cover and occasional patches of bare earth. The area appears to have been graded or cut, presumably during bridge construction, to expose natural clay soils. A trench associated with the former pā is also present, exposing the top 1 m or so of the soil profile. Although we observed some shell debris, possibly midden, it was evident that imported fill soils are not present. The area is also almost entirely covered by the AHB and the soils were also very dry, inferred to be the result of the shelter afforded by the AHB. The over-arching bridge structure comprised predominantly painted steel. We also observed occasional large paint flakes on the ground (some > 1 cm diameter). North Anchorage is a painted steel structure.

2 February 2021. Te Onewa Section; LHS – view to west from Anchorage; RHS – Paint flakes

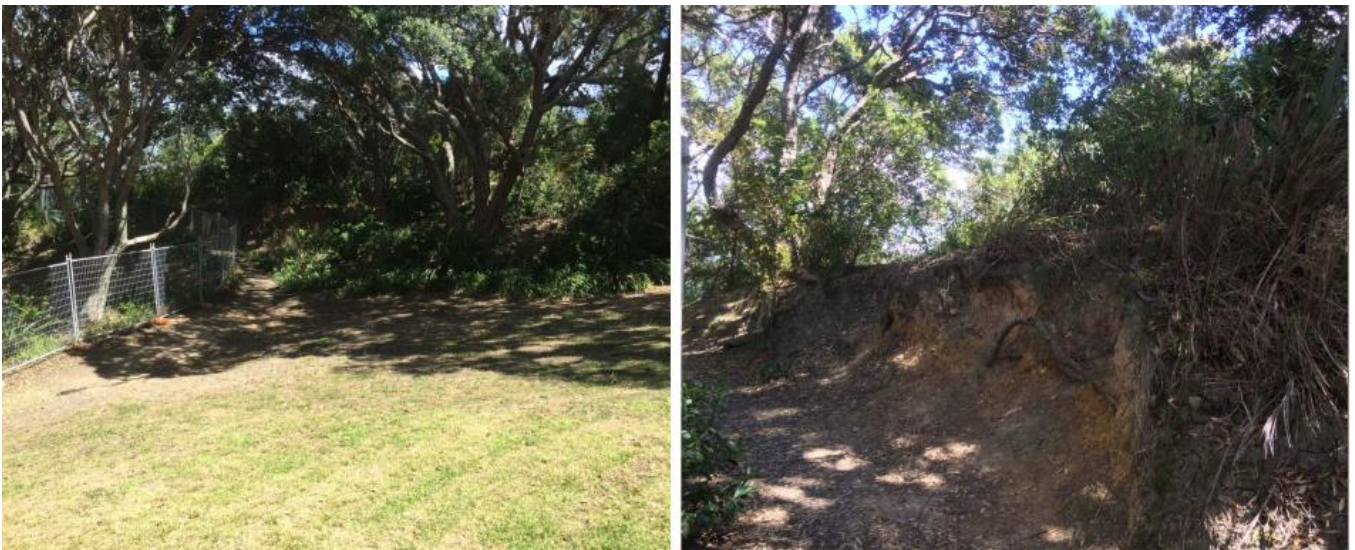
2 February 2021. Western Park; LHS – view to west; RHS – former path to ferry wharf showing Waitematā soils.
