*SH1 Otaihanga Roundabout*

# **Human Factors Review**

Date: 29 February, 2015  
Reference: 5-CJ112.50  
Status: Final

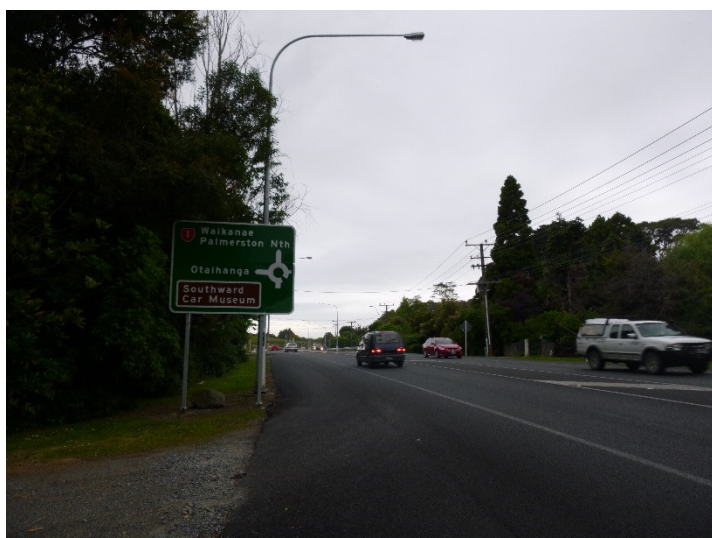
**Figure 4:** Northbound approach to the roundabout, showing the existing guide sign

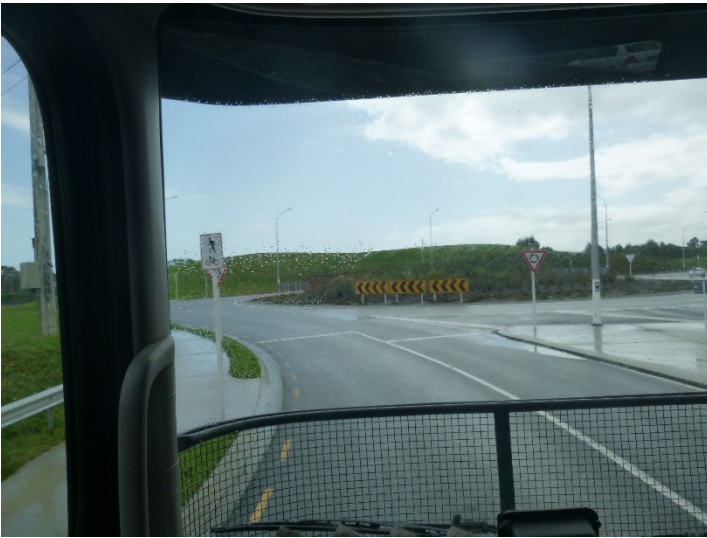
**Figure 7: Entering the roundabout, figure is from passenger side of truck**

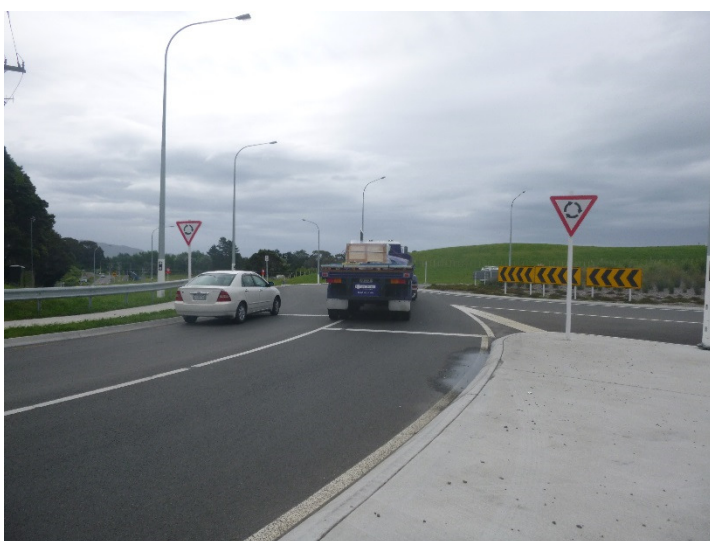
- No issues were observed with sun strike, low light or driving at night. No issues with lighting were reported by the drivers
- Drivers noted where the roundabout appears to tighten-up in the northbound direction as the main issue. The drivers whilst aware of the concerns within the industry felt that for their configuration of trucks the roundabout was generally ok, but for trucks with a higher centre of gravity, with moveable loads (such as Curtain sided B-trains) it would be more of a problem.
- The difficulty in seeing that the roundabout “tightens up” can be seen in the image below.

**Figure 14: Northbound approach sightline**

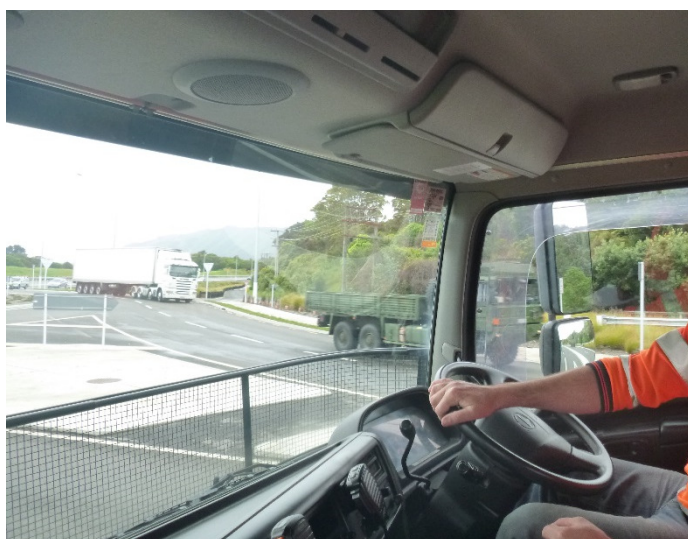
- There were comments regarding fatigue, speed and unfamiliarity carrying a particular load being a factor in previous incidents.
- The sightlines to the right is excessive

**Figure 15: Northbound approach sightlines to the right**

- Visual countermeasures could be considered to reduce high approach speeds. It is noted that a 2008 conference paper from report from Kennedy indicates that screening of the central reserve, until 15m of the limit line can reduce speeds. They note that the screening would need to be at least 2m and could be man-made or vegetation. They further note that care needs to be taken that drivers don't continue into the roundabout at their current speed if they are not accustomed encountering circulating traffic (which may be a problem at Otaihanga). Given the downhill approach to the roundabout this may be difficult to achieve.

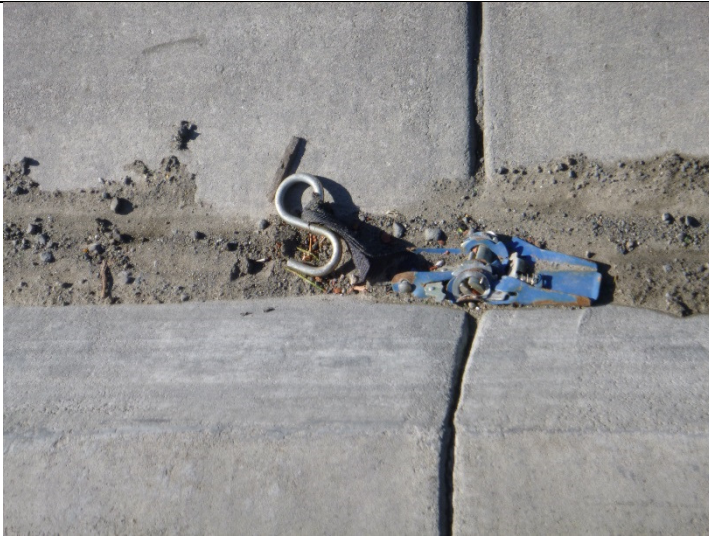
A broken tie-down strap was in the gutter between the exit for Otaihanga Rd and SH1 northbound direction.

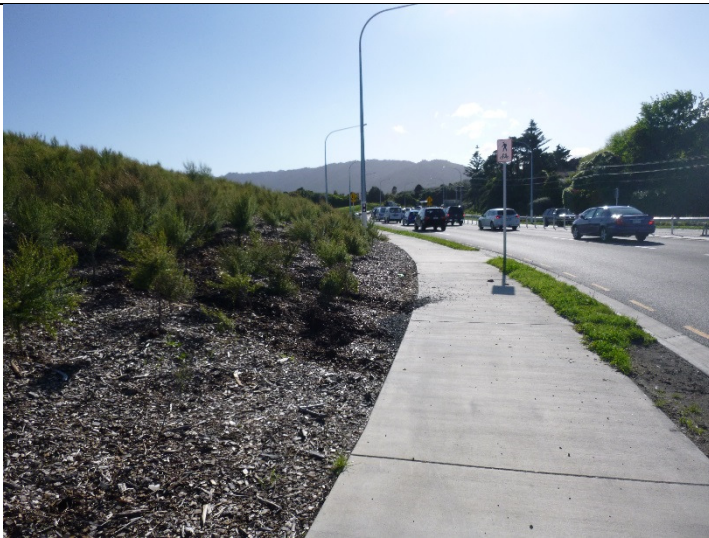
Evidence of a vehicle having run off the road at the exit of the roundabout travelling in a northbound direction.

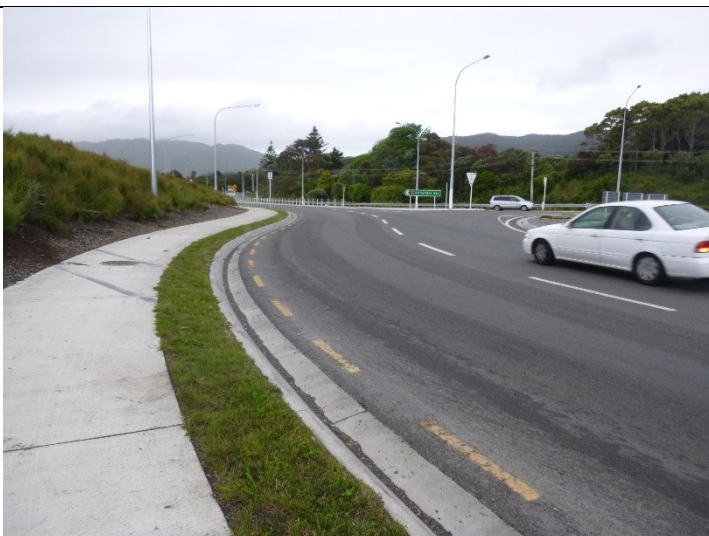
Evidence of a second vehicle having run off the road at the exit of the roundabout travelling in a northbound direction. The location of this run off suggests that excessive entry speed is a factor.
