OTAKI TO NORTH OF LEVIN RONS: INTERIM SAFETY IMPROVEMENTS

Prepared for the NZ Transport Agency

25 September 2017

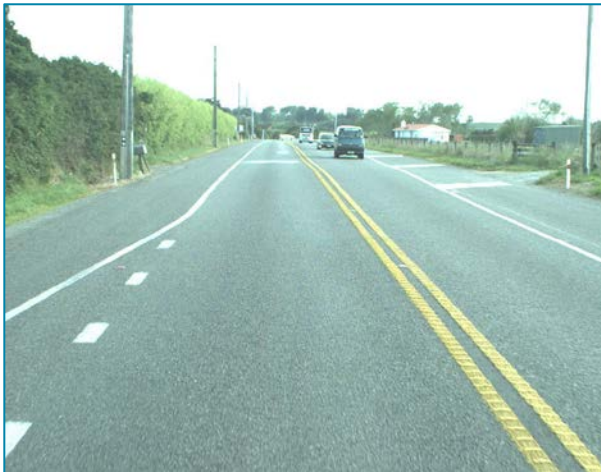
Figure 2-8: Power Poles north of Taylors Road

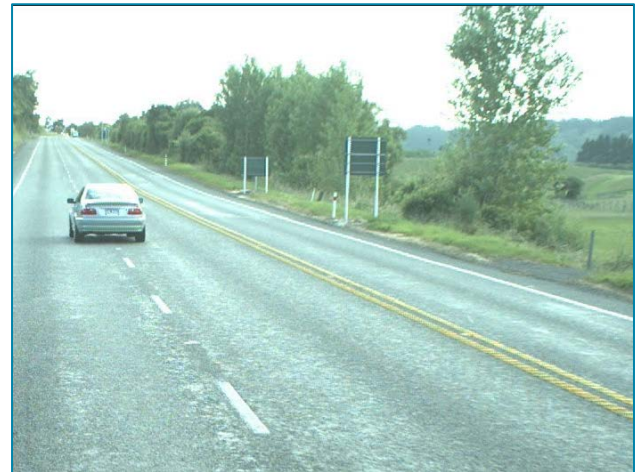
Figure 2-9: Trees and drop-off south of Forest Lakes Road

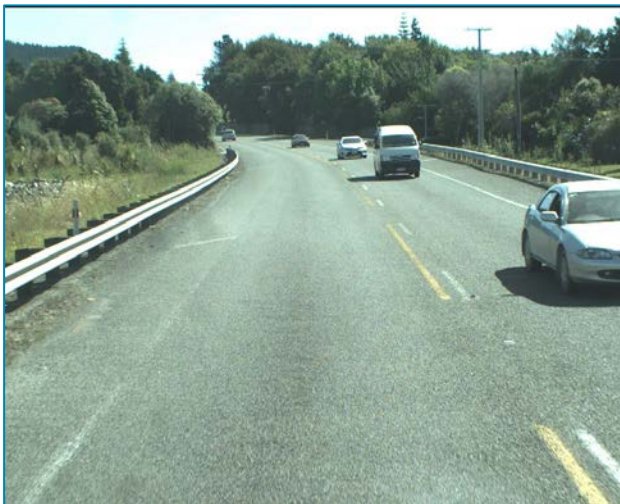
- Faded road markings (in some cases completely invisible - since been remarked).
- Missing street light pole luminare at Gleeson’s Rd (since been reinstated through maintenance).
- Overgrown vegetation limiting visibility out of Aitkins Rd.
- Chevron signs on the Pukehou Overbridge were dirty/faded and not level.

Figure 2-10: Faded line marking

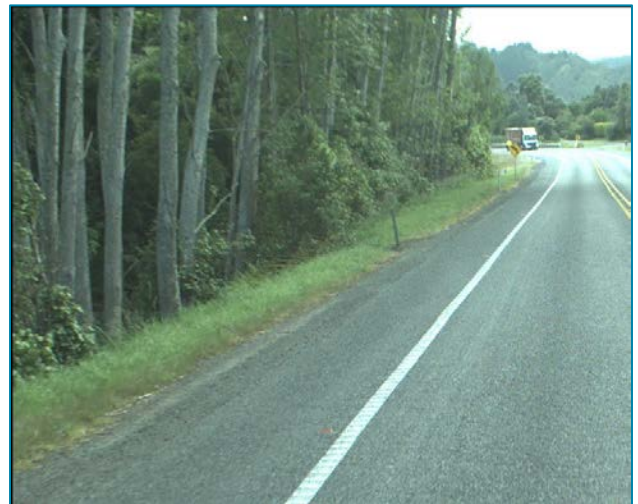
Figure 2-11: Trees and drop-offs south of Pukehou Overbridge

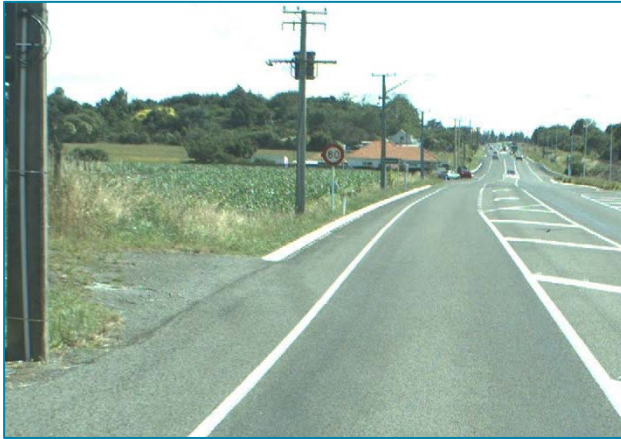
There were still five 100m sections where the KiwiRAP star rating fell below 3 stars (excluding intersections). This is likely to be a result of a number of unprotected power poles and hazards that were seen on the site visit.

Figure 2-12: Power poles through Manakau Township

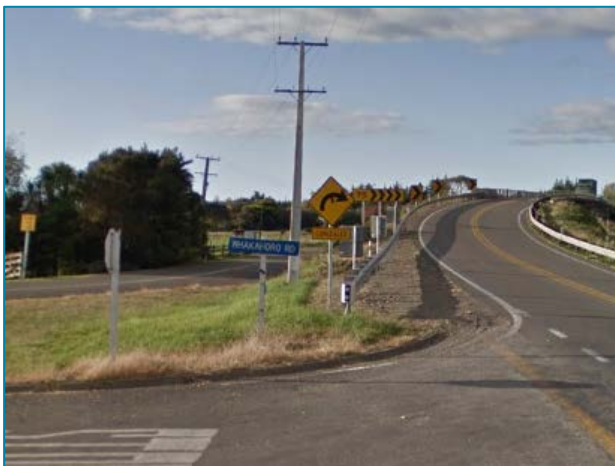
Figure 2-13: Poor sight distance from Whakahoro Rd

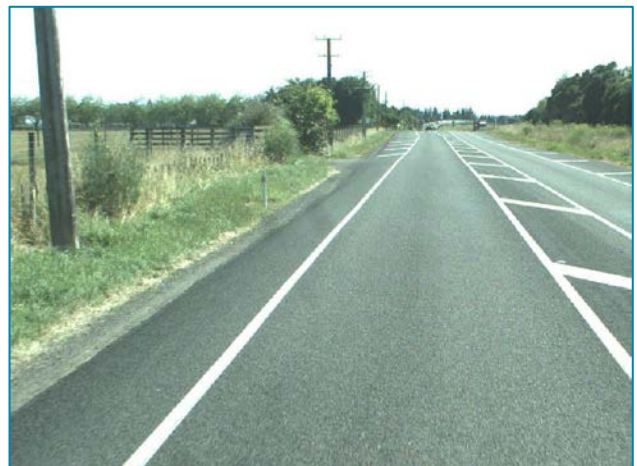
Figure 2-14: Unprotected power poles south of Manakau Rail Overbridge

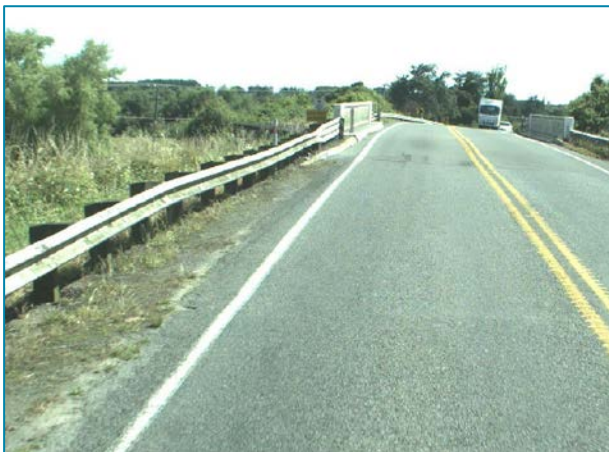
Figure 2-15: Narrow sealed shoulder and non-compliant bridge barrier, Ohau Rail Overbridge

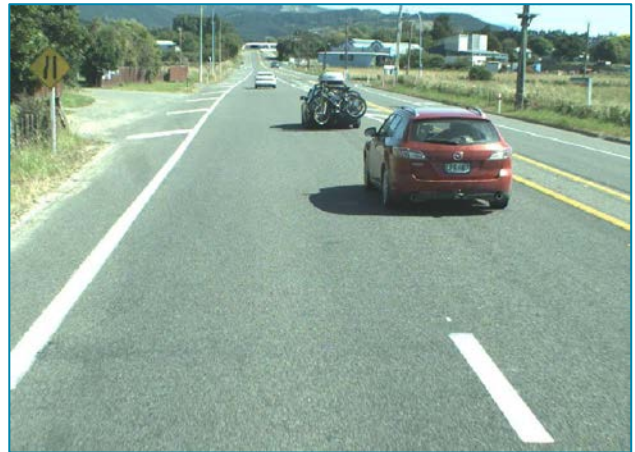
Figure 2-16: Passing lane termination at Te Iwi o Ngati Tukorehe Marae

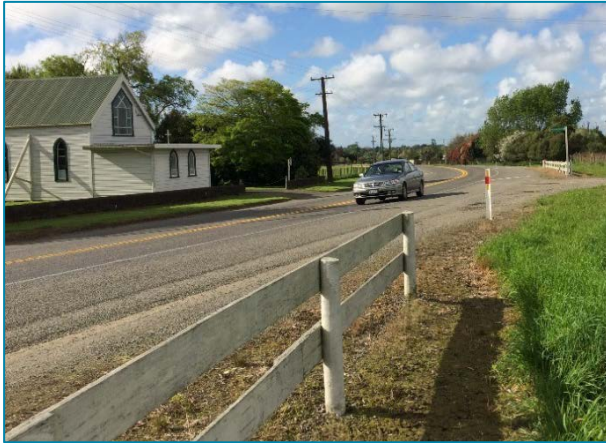
- The sight rails opposite St Stephen's Church are a hazard to errant vehicles. The unsealed turning area at this location does not provide good traction for turning vehicles and loose gravel has entered the carriageway.

Figure 2-17: Hazardous sight rail opposite St Stephens Church

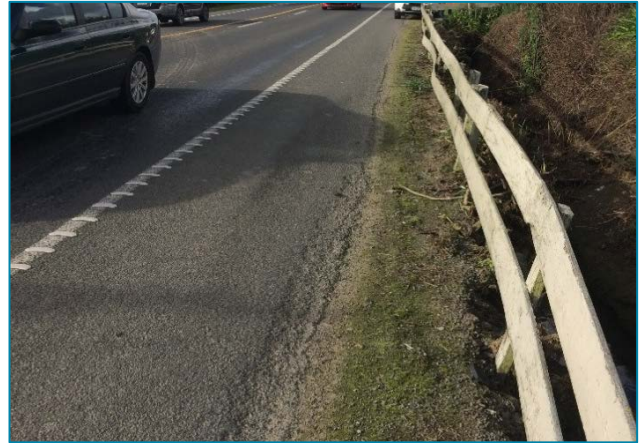
- The retaining for the deep stream/drain north of St Stephen's Church appears to be failing and the road shoulder is collapsing. In addition vehicles are only protected from the drain hazard by a sight rail.

Figure 2-18: Deep drain and failing retaining wall south of St Stephens Church

1. Address all basic maintenance items (identified within the Package Development Sheet) within a three month timeframe.
2. Further investigate the potential maintenance issue at the retaining wall opposite 'The Shekinah' and look to apply for maintenance funding to address this (if this is not deemed a maintenance issue then the culvert hazard should be addressed as part of the Block Funding / Safer Corridors package).
3. Increase the frequency of road marking renewal (unless long-life high reflective marking is installed) along with cleaning of signs and delineators, north of Pukehou Rail Overbridge.

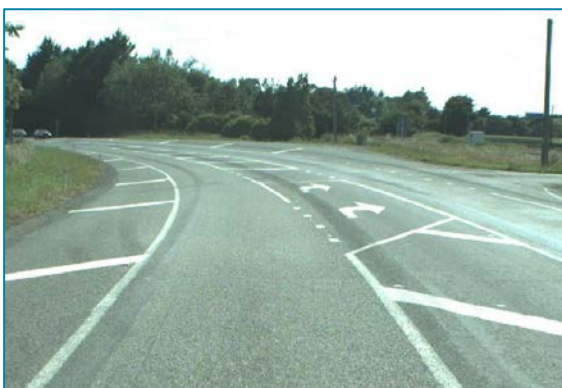
- The existing road marking is fading and old road markings are coming through the chipseal to the south of Ohau. This is extremely confusing and a poor look for the Agency.
- There are unprotected trees, power poles and drop-offs particularly at the curve north of Ohau, just before the curve south of Ohau and an area within Ohau.
- The speed limit change at the southern end of Ohau may not be obvious enough.
- The curve just south of Ohau is not well delineated.
- Poor visibility/difficulty for vehicles getting out of Marsden Terrace (raised by HDC)

Figure 2-19: Poorly delineated curve and roadside hazards south of Ohau. Old line marking visible

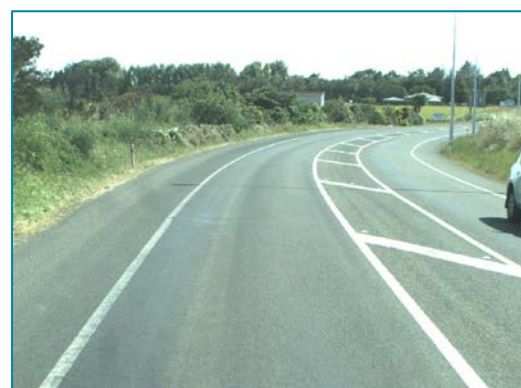
Figure 2-20: Poorly delineated curve and roadside hazards north of Ohau

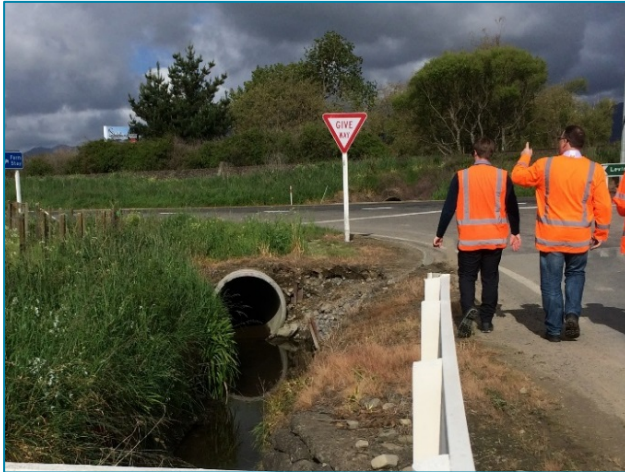
- Numerous roadside hazards including power pole and culverts between Vista Rd and the SH1/SH57 intersection.
- Buller Rd had hazards on both corners, was difficult to get out of and vehicles cut the corner when turning in.

Figure 2-21: Buller Rd Culvert (hazards on both sides of SH1 and Buller Road)

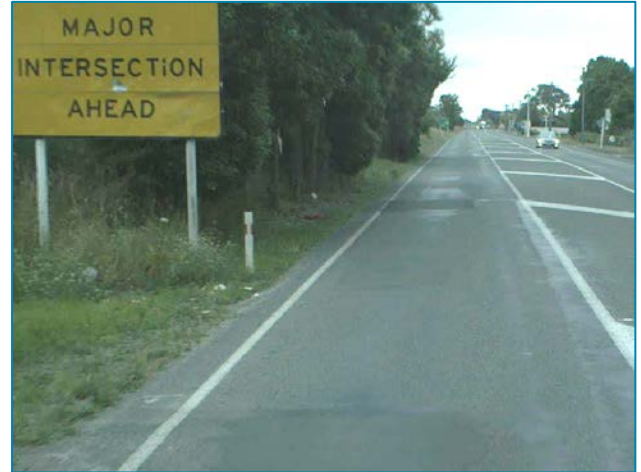
- Trees posed a hazard on the eastern side between Levin and SH1/SH57 (although it was noted that if they were taken away speed might increase along this length).

Figure 2-22: Narrow shoulder, trees & old sign north of SH57

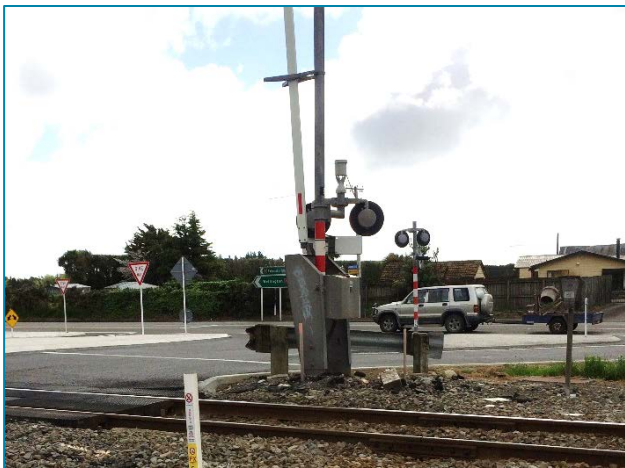
- The intersection lighting could be reviewed and potentially upgraded
 - There are non-compliant safety barriers around the railway barrier arms that create a spearing hazard.

Figure 2-23: Non-compliant safety barrier at SH57 intersection

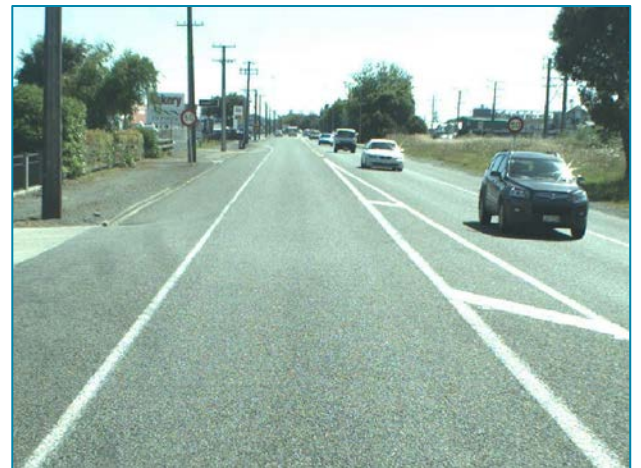
Figure 2-24: Inconspicuous speed limit signs

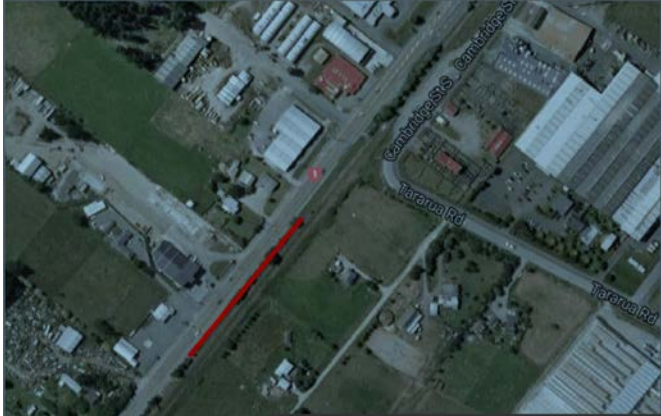
Horowhenua District Council Safety Issues – SH1 Adkins Rd to South of Levin	MWH/Stantec comments
<p>1. <u>Route Wide issues</u></p> <p>1.1. Roadside drainage is an issue throughout this site, with surface flooding occurring regularly.</p> <p>1.2. Power poles are in close proximity to the carriageway in many sections of the route.</p> <p>1.3. Lack of safe cycle facilities.</p>	<p>1.1 Unsure if this is due to a lack of maintenance or capacity, however this has been added as a maintenance item.</p> <p>1.2 These have already been identified within the sections in question, although added point 3.1</p> <p>1.3 Have added under route wide section, although addressing this is likely to be with a number of other safety measures, including wider shoulders. Pinch points could be addressed with better signage (including active signage).</p>
<p>2. <u>Section 7 – South of Cambridge Rd Intersection</u></p> <p>2.1. Flooding on east side shoulder.</p>

<p>2.1 Added as maintenance item.</p>

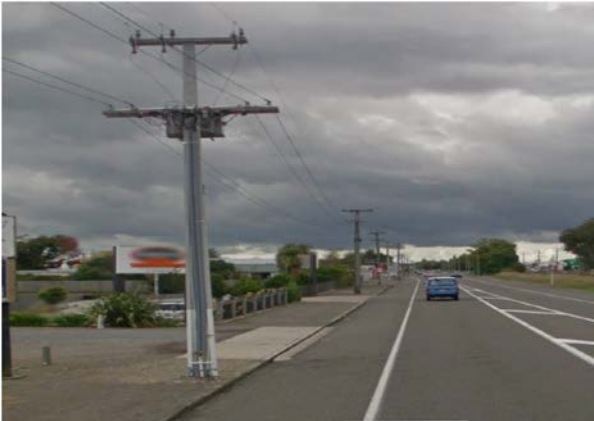
<p>3. <u>Section 7 Cambridge Road – Boulton Road</u></p> <p>3.1. Power poles too close to carriageway – consider underground lines.</p>

<p>3.1 Added to section and table of potential measures/options</p>

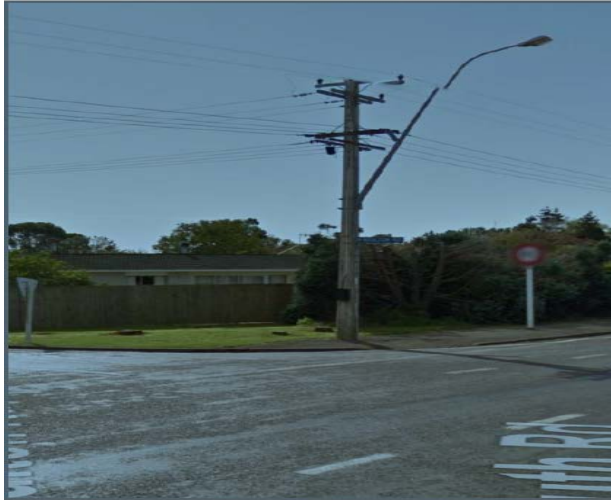
4.1. Power pole too close to intersection – consider underground lines.

4.1 Added to section and table of potential measures/options as per 3.1

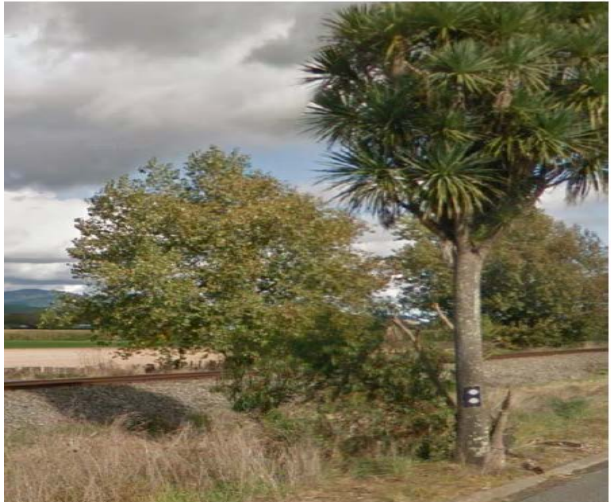
4.2. Cabbage tree opposite intersection – remove

4.2 Already covered in report although added note that these are on the eastern side.

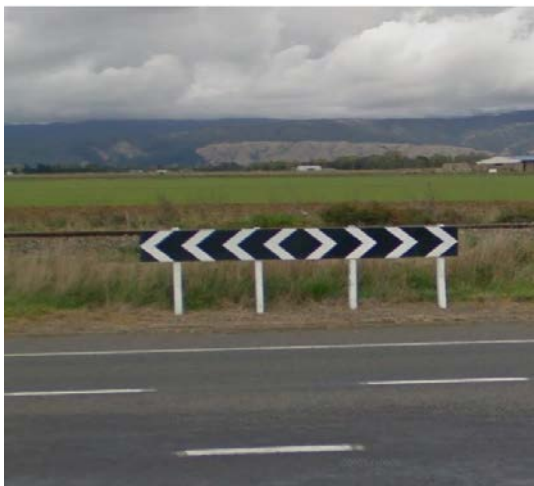
4.3. Chevron sign opposite intersection – replace to current standard

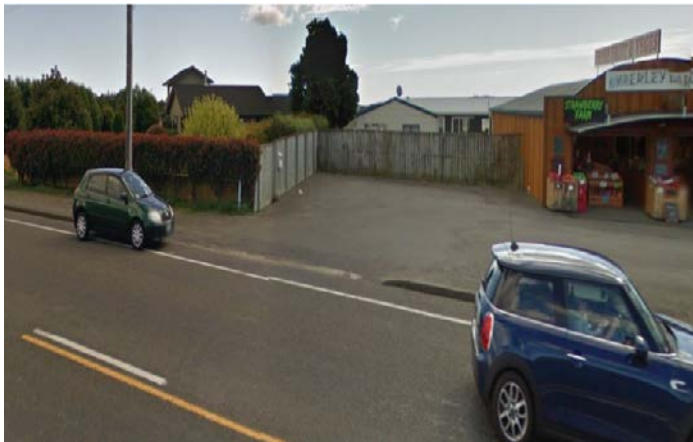
5.1. Vehicle entrances opposite intersection are unsafe – increase shoulder width.

5.1 Added although this would involve removing the footpath. One possible option is to convert the standard kerb and channel to a mountable type closer to the driveways enabling vehicles to get off the carriageway more easily.

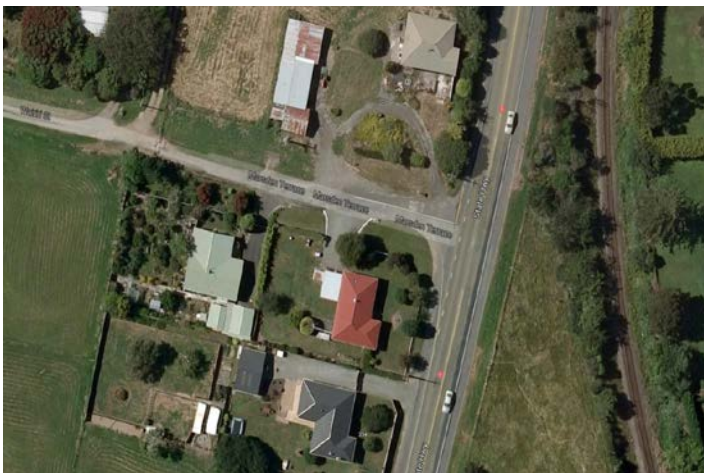
6. Marsden Terrace. Intersection

6.1. Intersection is unsafe, poor visibility – consider closing intersection and providing access via Wairiri St.

6.1 Added but would need quite a bit of consultation.

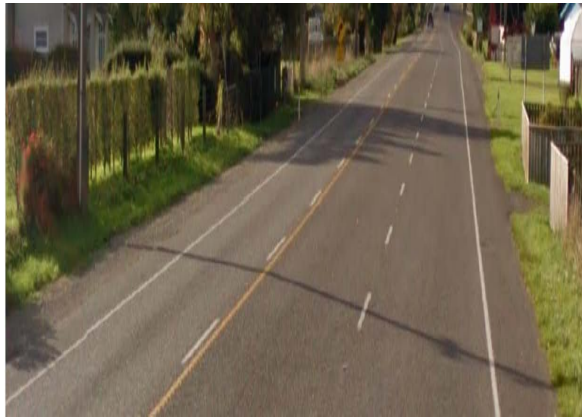
8. Section 5 – Ohau River Bridge – Kuku Beach Road
8.1. Shoulder too narrow or unsealed on both sides – consider sealing min 1.5m.

8.1. [Already covered in report](#)

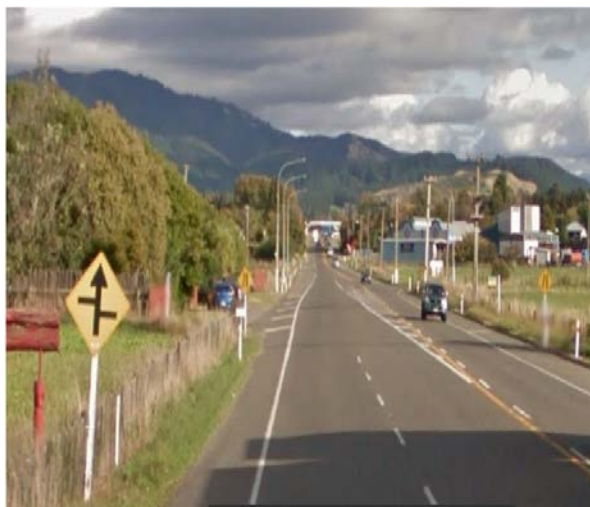
9. Section 5 – Kuku Beach Road Intersection
9.1. Right turn bay directly after passing lane, with high use vehicle entrance to Marae opposite – consider removing or reducing passing lane.

9.1. [Already covered in report](#)

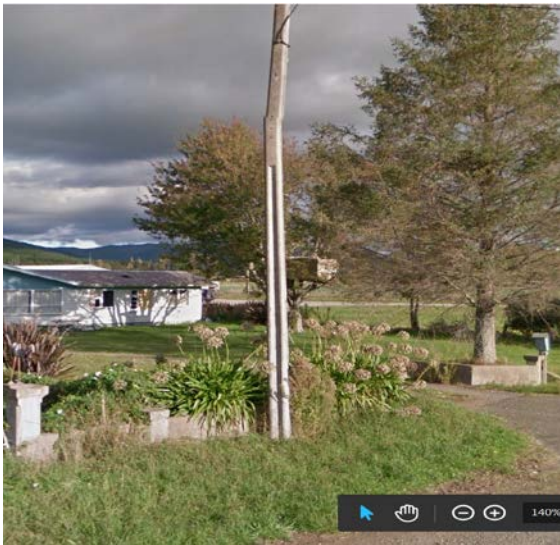
10. Section 4 – 694 State Highway (outside KY Gardens)

10.1. Pole in dangerous position – consider relocating or running line underground

10.1. Already covered in report as part of unprotected power poles and trees within this section.

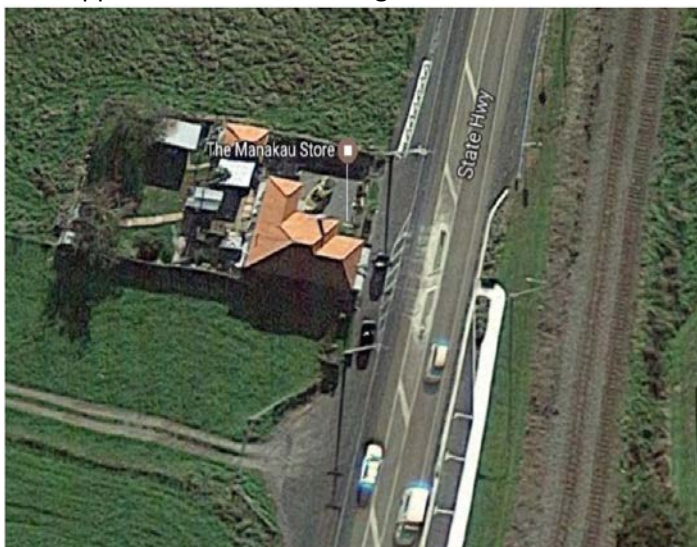
11.2. Pedestrian Refuge, no TGSIs refuge has been built below minimum width and slanted at an angle – consider redesign of pedestrian crossing point, consider further traffic calming treatments at both approaches to the crossing.

11.1. Acknowledged that this is not an ideal situation however the barrier cannot be extended due to the access directly adjacent to the driveway. Also it is unlikely the pole can be relocated. The reduction in vehicle speeds through this section will lower both the likelihood and severity of an incident.

11.2 Added although lower priority given recent works in area and the effective reduction in speed that has occurred.

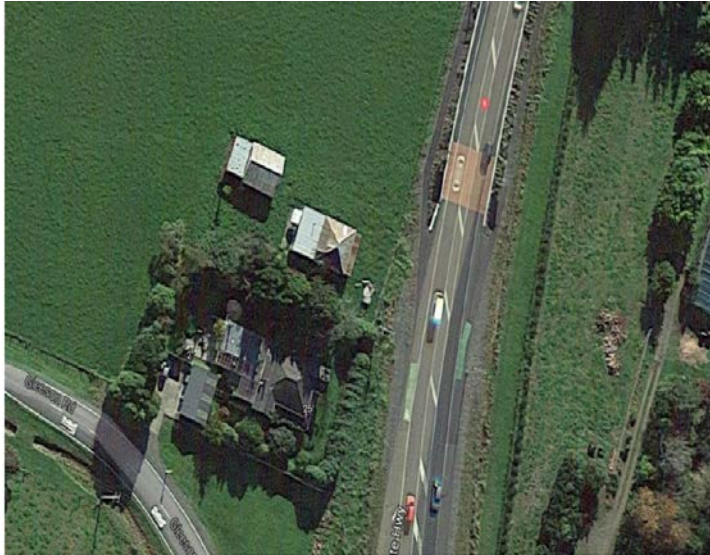
- 12.1. Cycle lane below minimum width, vegetation also encroaching – consider widening cycle land and remove or maintain vegetation.
- 12.2. Power poles in hazardous position North West of threshold – consider removal, relocation or protection.

- 12.1 Added comment about vegetation/maintenance
- 12.2 Already covered in report

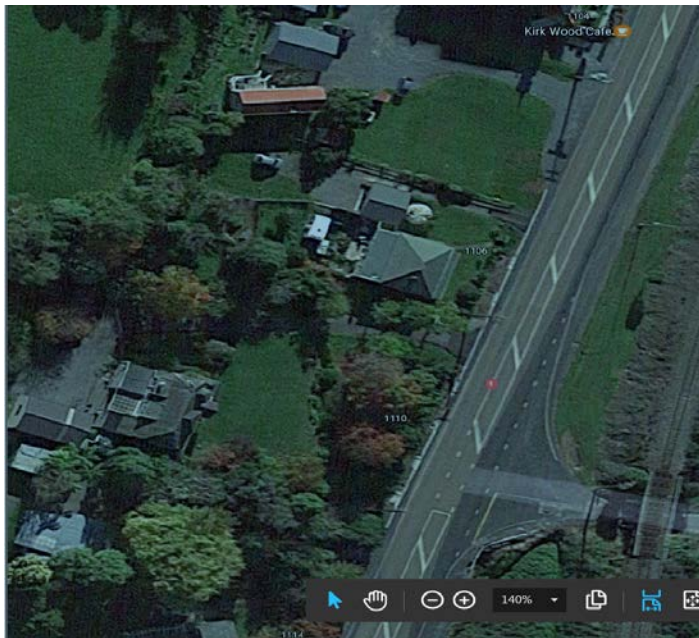
13. Section 3 – South of Kirkwood Café

- 13.1. Narrow shoulder on west side – consider removing kerb and channel, piping drain and filling shoulder.

- 13.1 Adjusted PP comment to include other hazards.
