Appendix E Bridge Lodge

29 March 2012

Phase 1 Environmental Assessment – 3 Otaki Gorge Road, Otaki

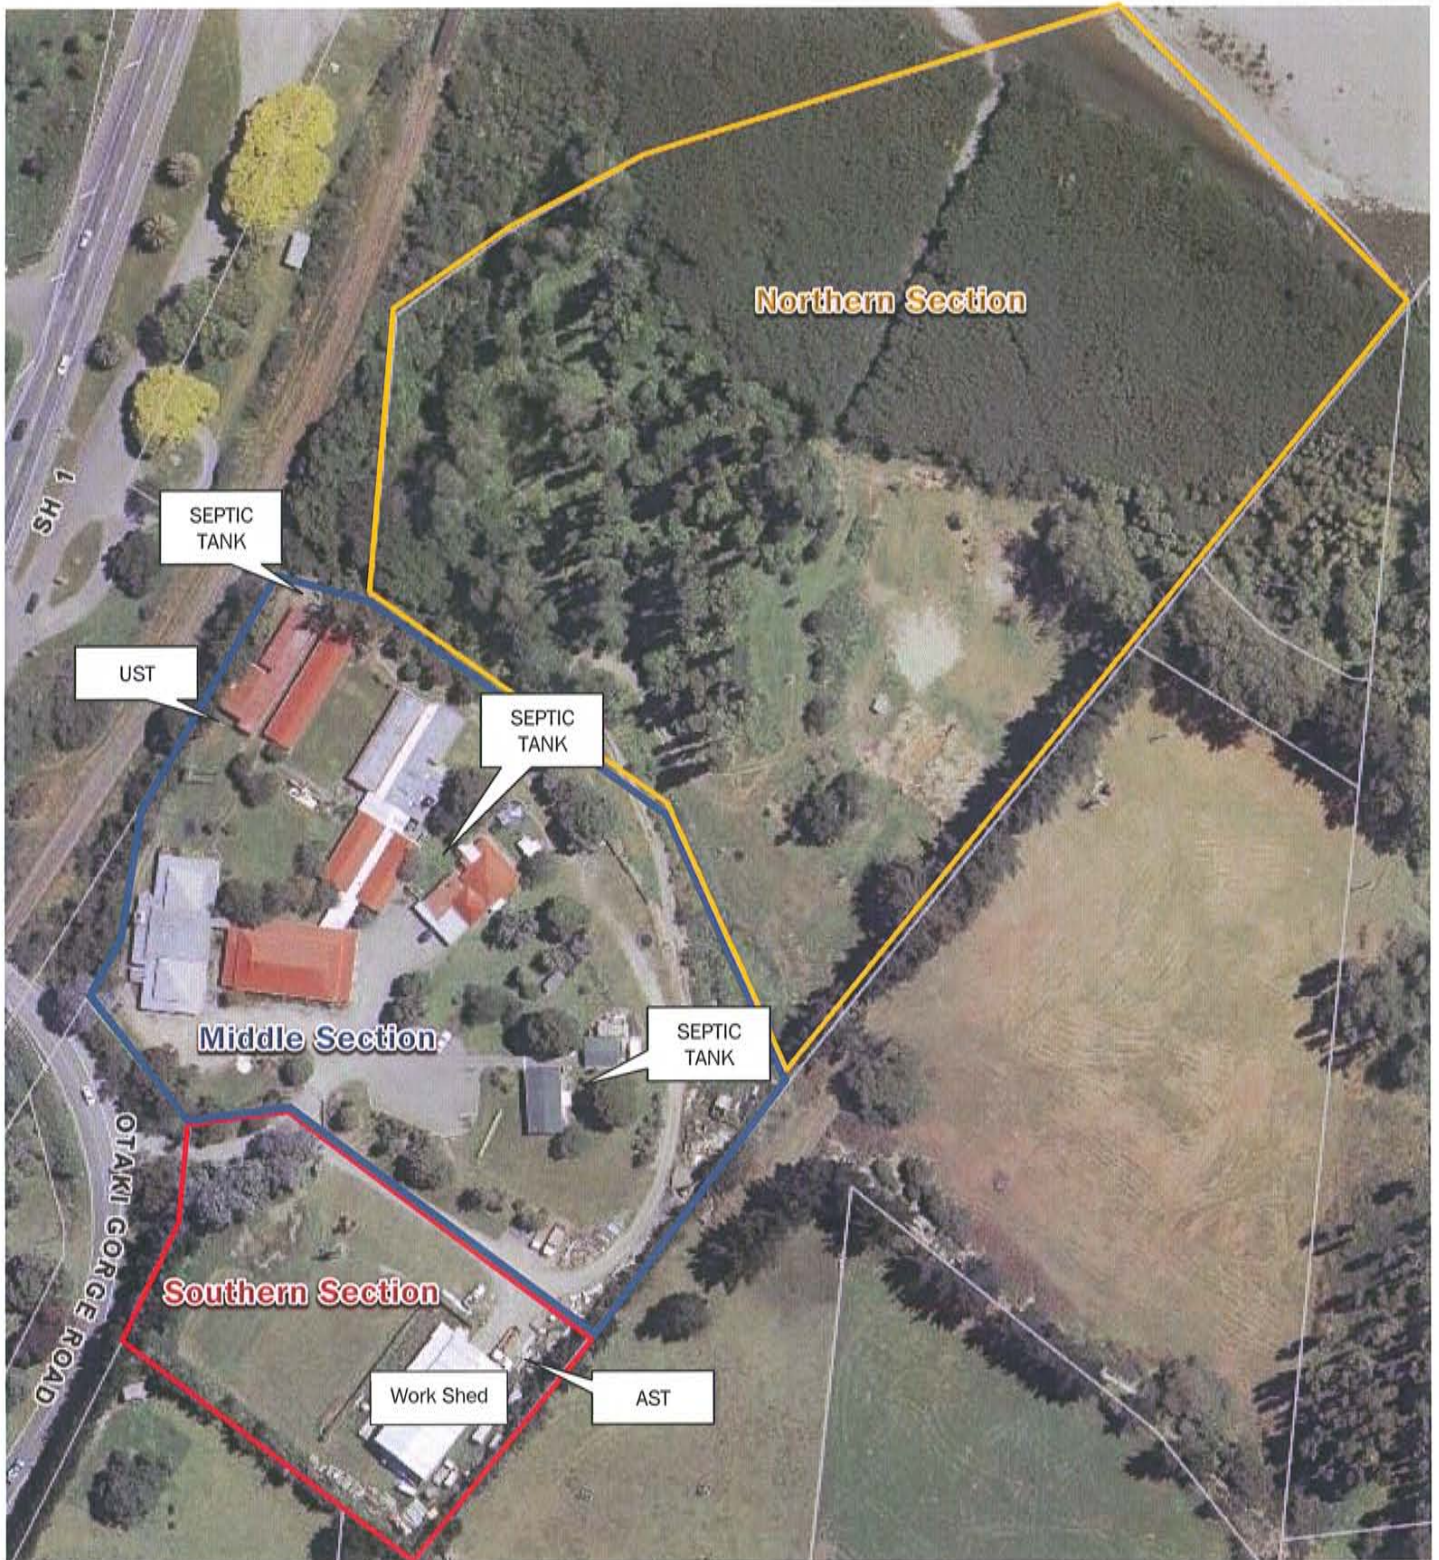
FIGURE 1 : 3 OTAKI GORGE ROAD SITE PLAN WITH PETROLEUM STORAGE TANK AND SEPTIC TANK LOCATIONS

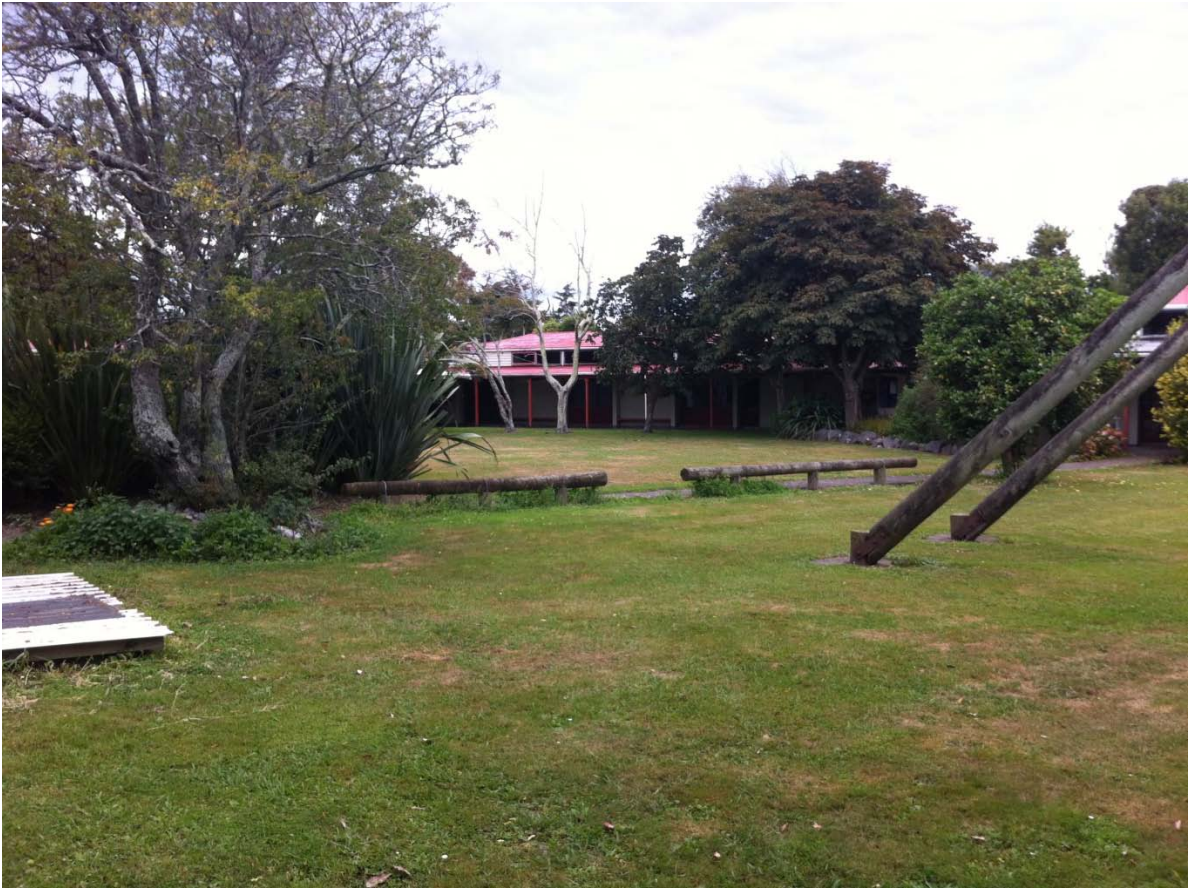
Photograph 1: Bridge Lodge grounds – Middle Section

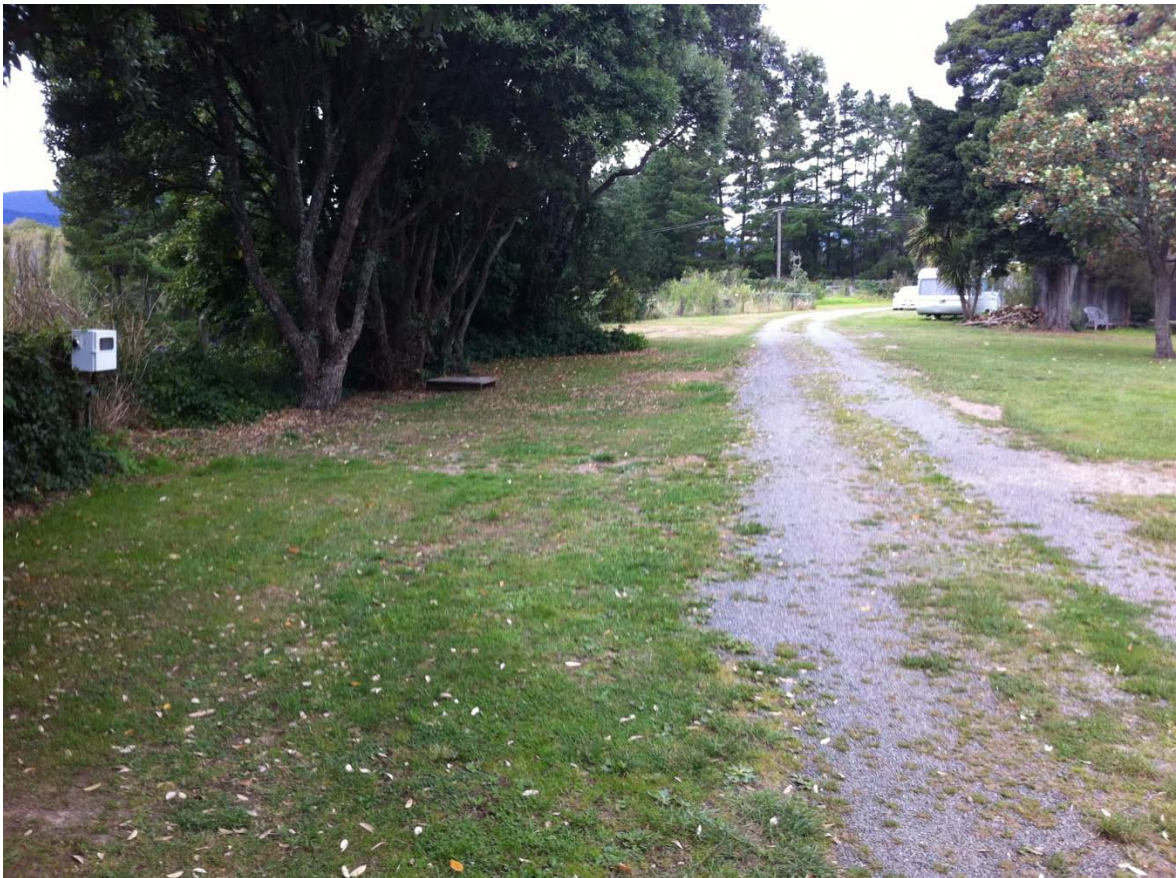
Photograph 2: Bridge Lodge grounds – Middle Section powered and non-powered sites

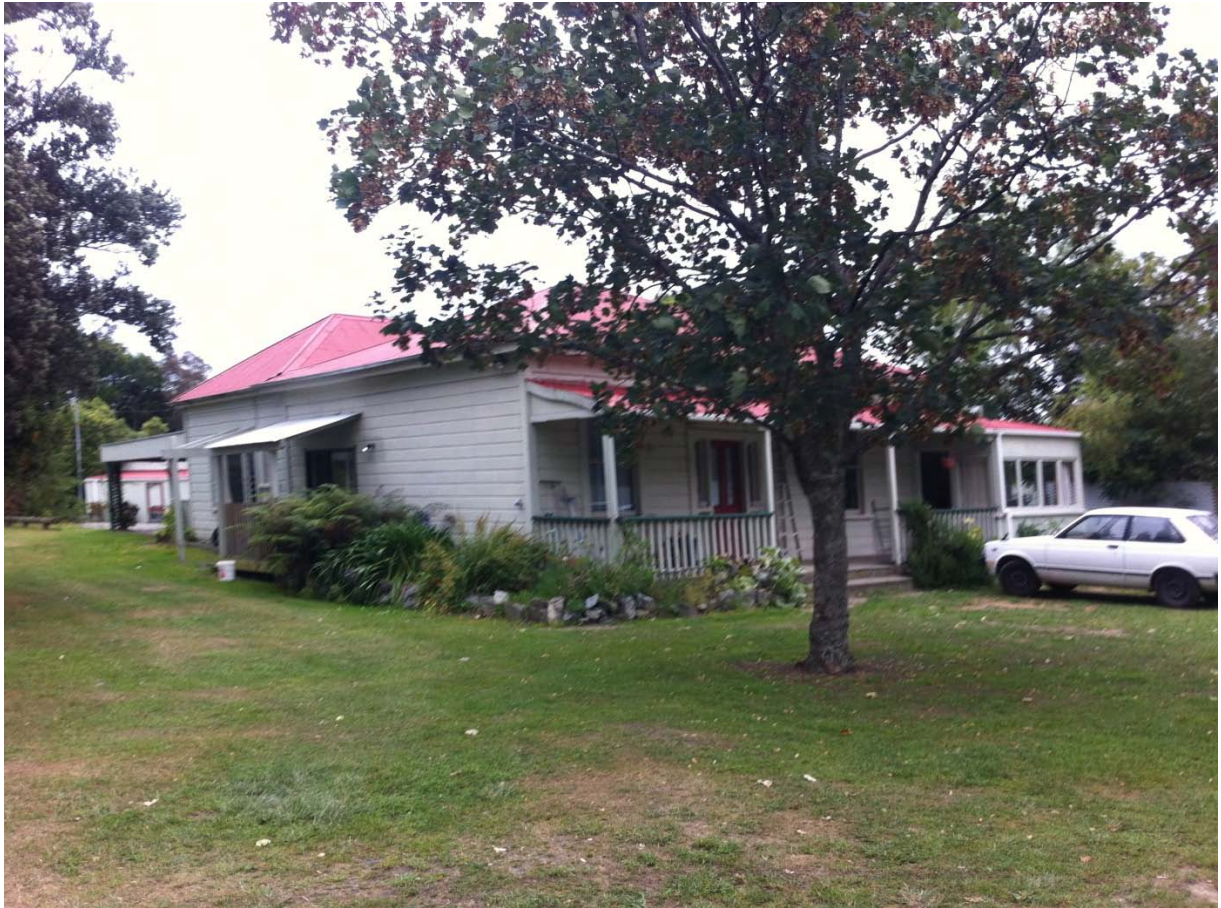
Photograph 3: Bridge Lodge grounds – Middle Section – Old Farm House

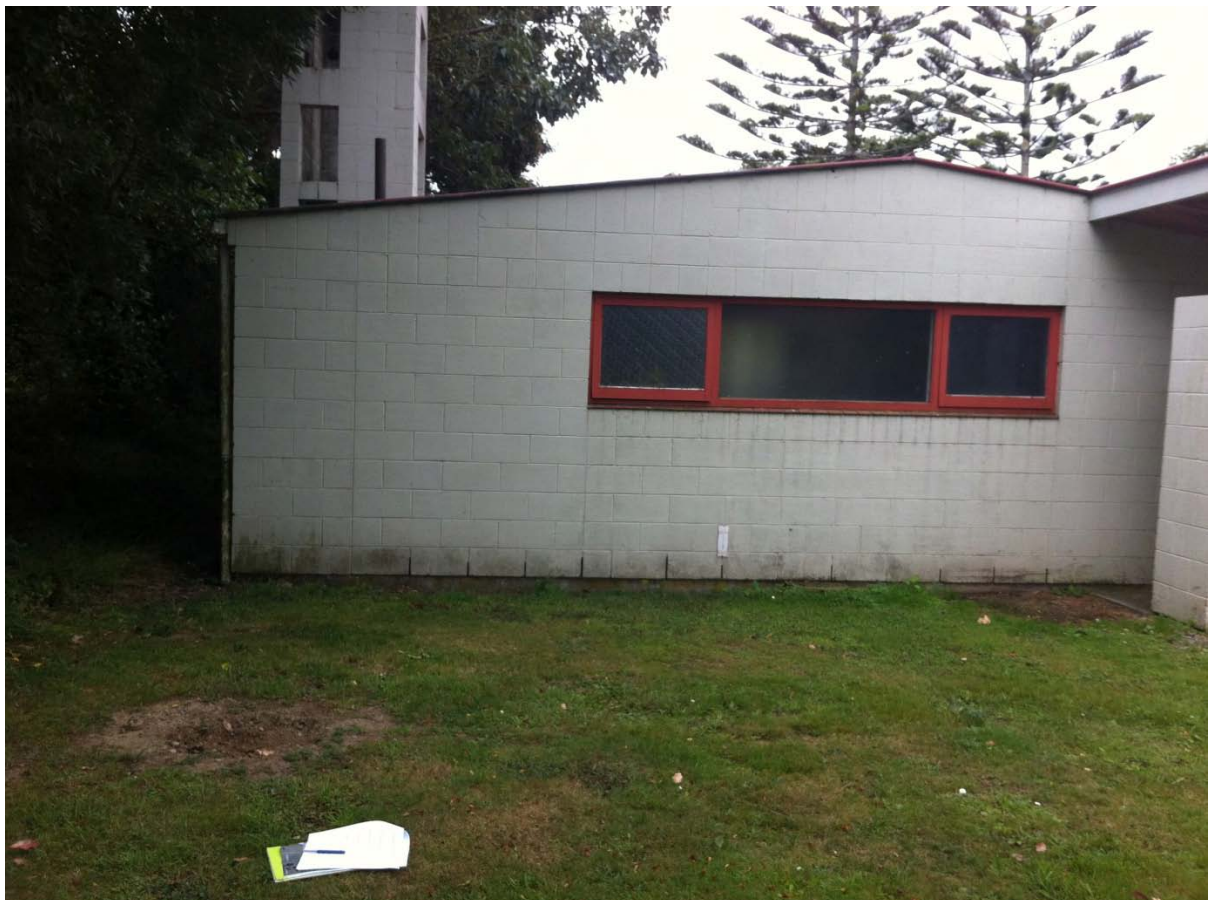
It is known that there is at least one old disused UST on site. The UST is up to 40 years old and is likely to be in poor condition. It is possible that spills, leaky pipes or holes in the tank have resulted in hydrocarbons residues in the soils around the tank pit. There is also potential for surface contamination in the vicinity of the diesel AST from spills, although the tank itself is bunded.

Photograph 4: Location of kerosene UST

In conclusion, with the exception of the two petroleum tanks and the three septic tanks, no other land use was identified that is likely to have resulted in residual contamination that would limit the proposed alignment or be detrimental to staff working on the alignment. It is therefore recommended that validation testing of the soils is conducted during removal of the UST and within the vicinity of the AST to assess whether any residual petroleum hydrocarbons exist and assess risk. Risk from the septic tanks is likely to be from a biological source so care needs to be taken during removal and excavation in these areas.

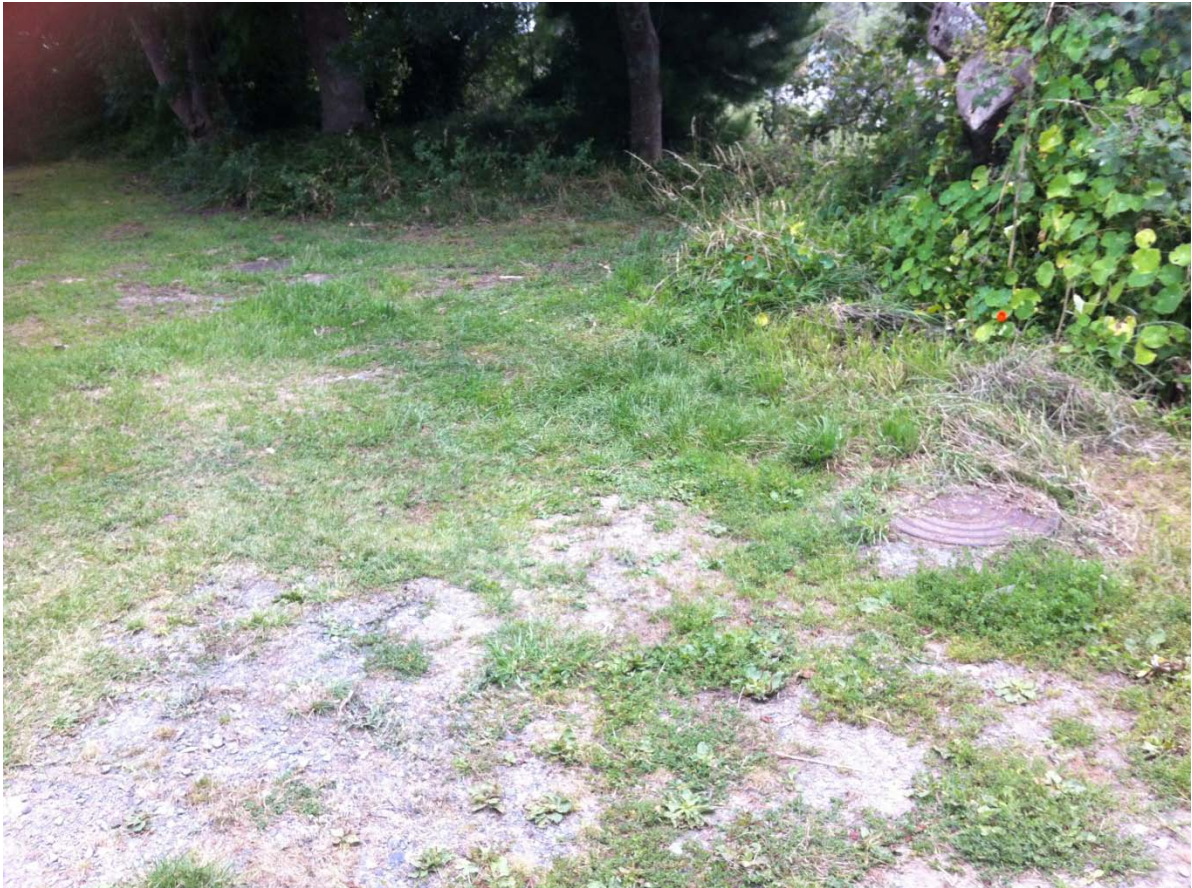
There are three septic tanks on site which are regularly emptied (M. Lange, pers. Comm., 29/02/12). However contamination of soil may result from the drain field or poor past operation practices leading to overflow of waste water/sludge. The locations of the drain fields are unknown.

Photograph 5: Western septic tank

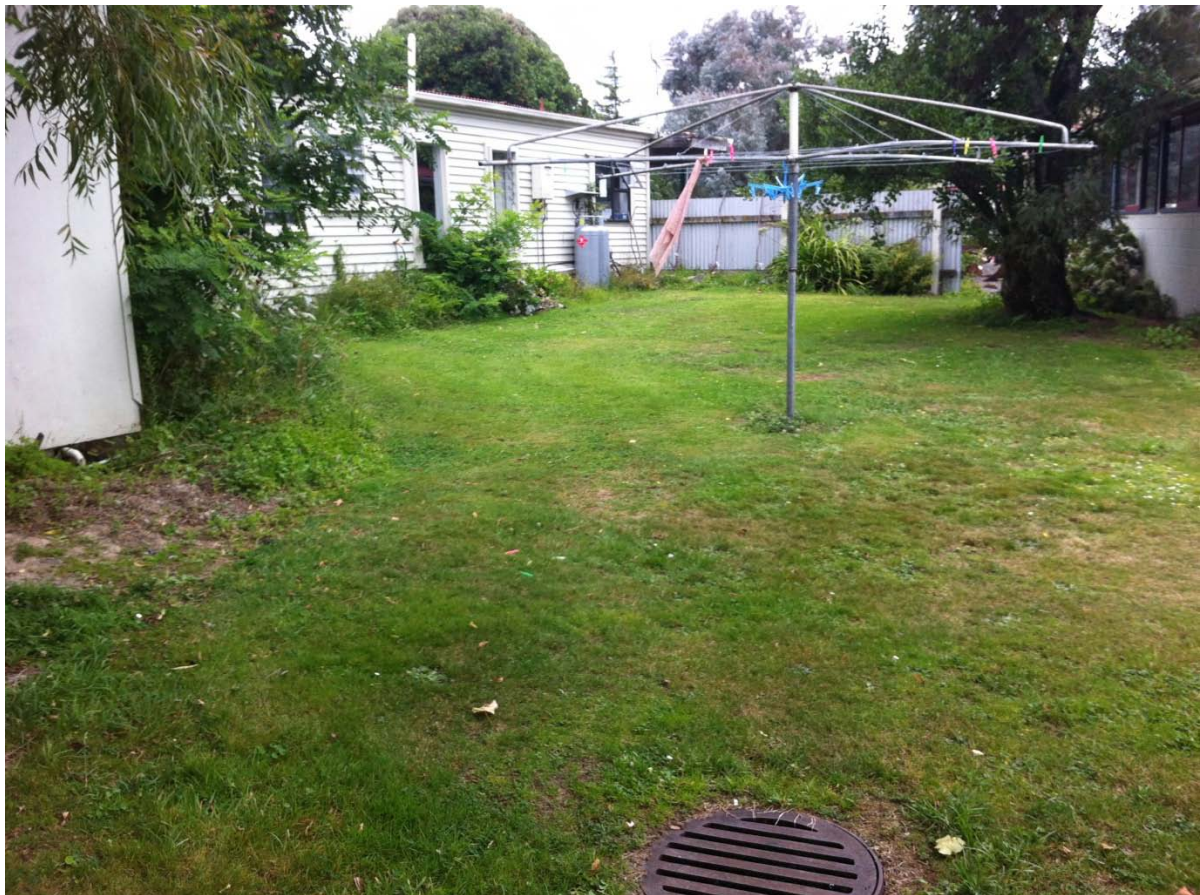
Photograph 6: Centre of site septic tank

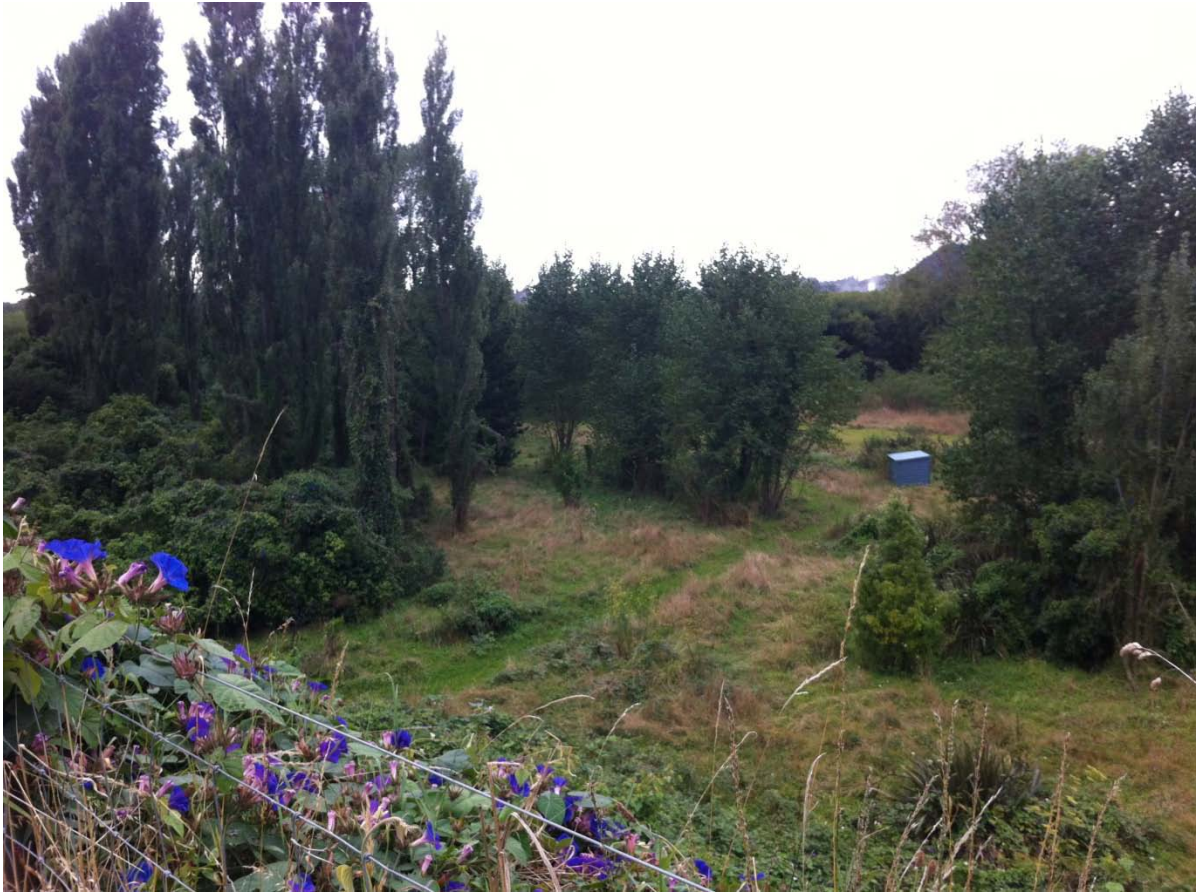
Photograph 7: Northern Section with pump shed - looking northwards.

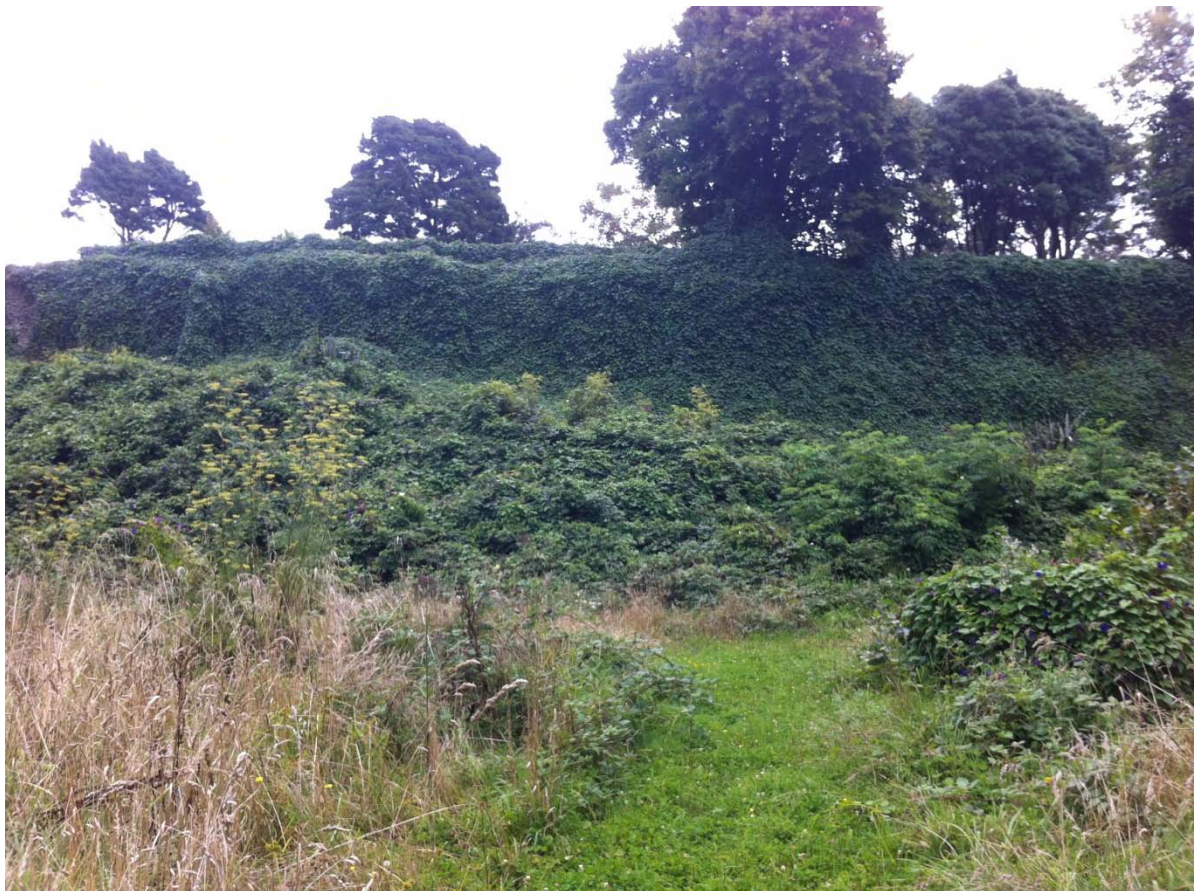
Photograph 8: Northern Section looking southwards at the terrace the middle and northern sections are on.
