15 May 2024  
Job No: 1094525

NZTA  
Private Bag 106602  
Auckland City  
Auckland 1143

## Brynderwyns Landslide Remedial Treatment Review Section F Landslip. Letter Report

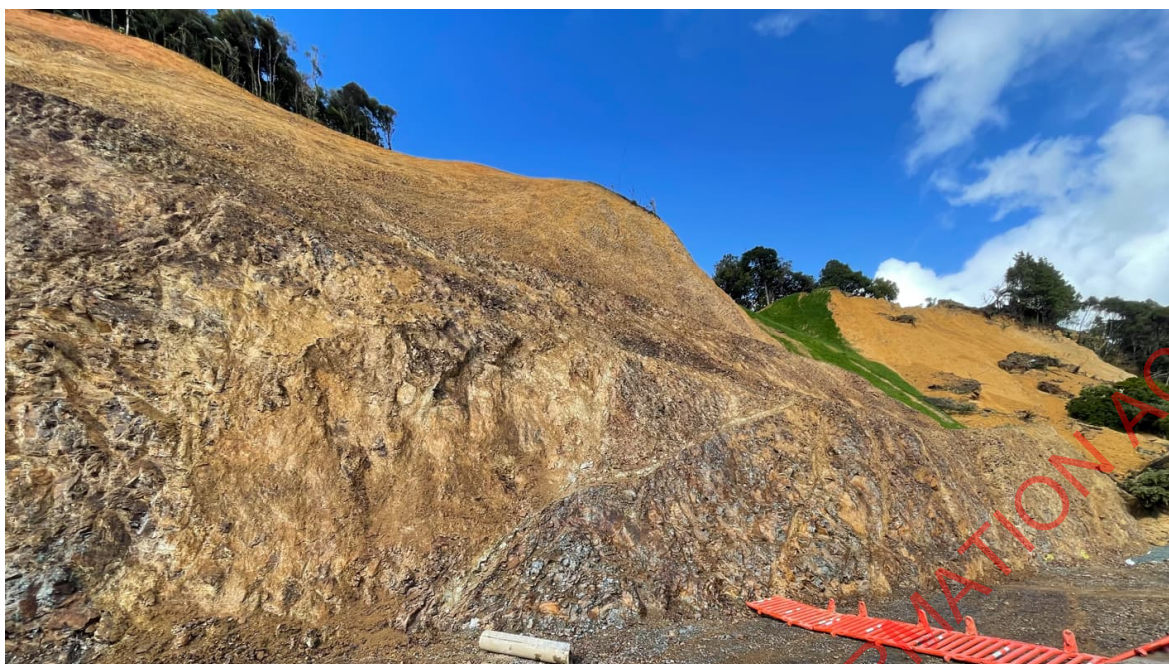
Figure 2: Section F in foreground and Section F beyond showing the recent failure in this section. Sections are on the west facing slope on north trending spur ridge with a series of steeply incised gully features (see Figure above, the recent slip is on the right of the photo).

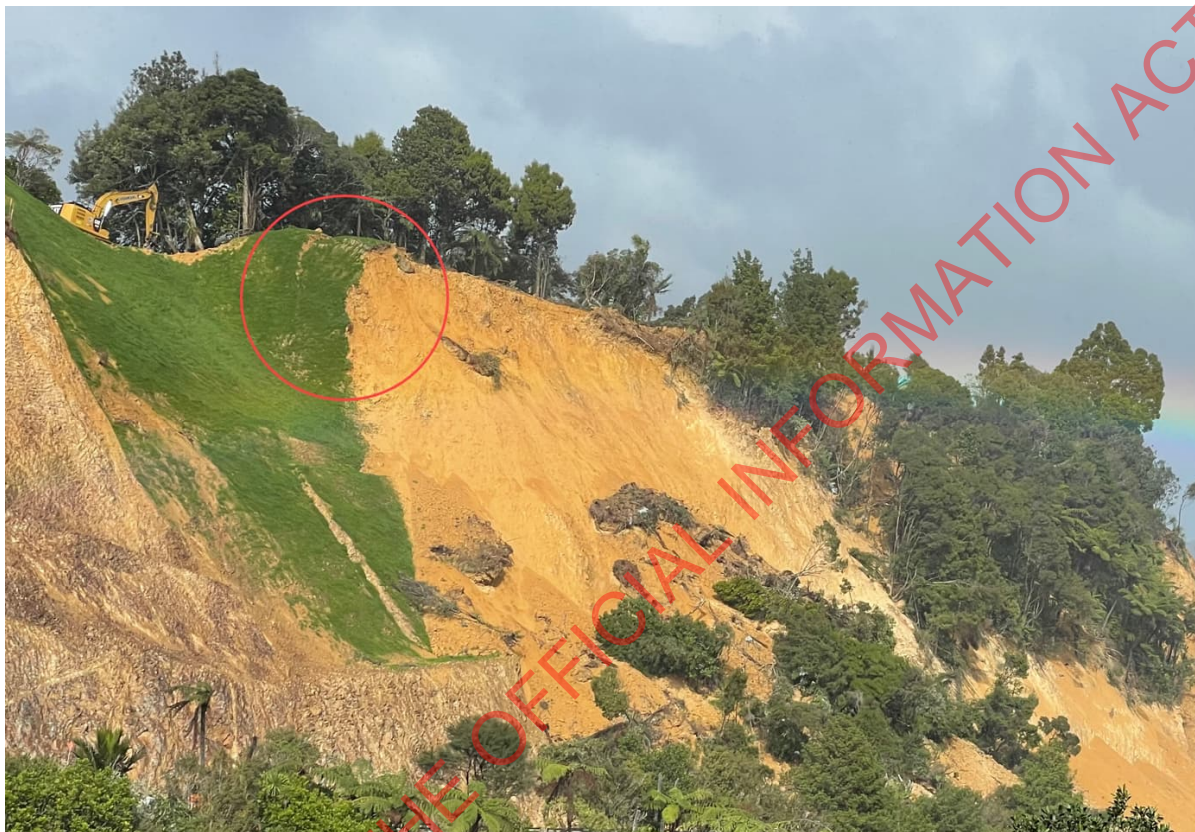
extended to the south to include a forested area of the face. The estimated 40,000m<sup>3</sup> of material is deposited on the road which both buttresses the slip debris and surcharging the road platform, see Figure 3 and 4. It is also clear from the video, and observing the material involved in the slip, that this area of the slope was in a critical state of stability, where any disturbance was highly likely to trigger movement. The team had already cut back the toe at the base of the slope to widen the road and were in the process of installing soil nails to stabilise the exposed highly weathered rock, but this was not able to provide sufficient buttressing to prevent mobilisation of the cohesionless soils above.

Figure 3: Failure scarp showing over-steepened rear scarp at crest and cracking circled behind the crest where it is exposed in the adjacent side face of the earlier landslide in Section E.

The material that has evacuated the upper face is reported to be dry cohesionless sandy silts derived by weathering (and leaching of minerals) of the greywacke rock to residual soils. The frictional strength of these materials is expected to be in the range of 32-35°, i.e., below the slope angle and stability would have been critical, FOS=1.0.

The landslide is likely to have been a translational event, primarily involving the completely weathered/ residual soils and shearing at the interface with the highly weathered rock beneath. The progressive movement would have loaded the highly weathered rock exposed at the base of the cut slope probably causing the breaking out that occurred in the early stages of the landslide.

Remedial works will require reshaping of the face to a stable batter of the upper slope and potential strengthening of disturbed rock at the toe. An over-steepened rear scarp remains at the crest of the slope, and this will need to be removed by access from the crest. The exposures highly weathered rock in the failure scarp indicate much of the completely weathered soils have evacuated the slope and this may provide the opportunity to limit the extent of further excavation to adequately stabilise the face. A trial excavation at the crest has also encountered highly/moderately weathered rock that provides a platform to work from. Further loading on the road platform by spoil during the remedial works should also be considered in staging the works.

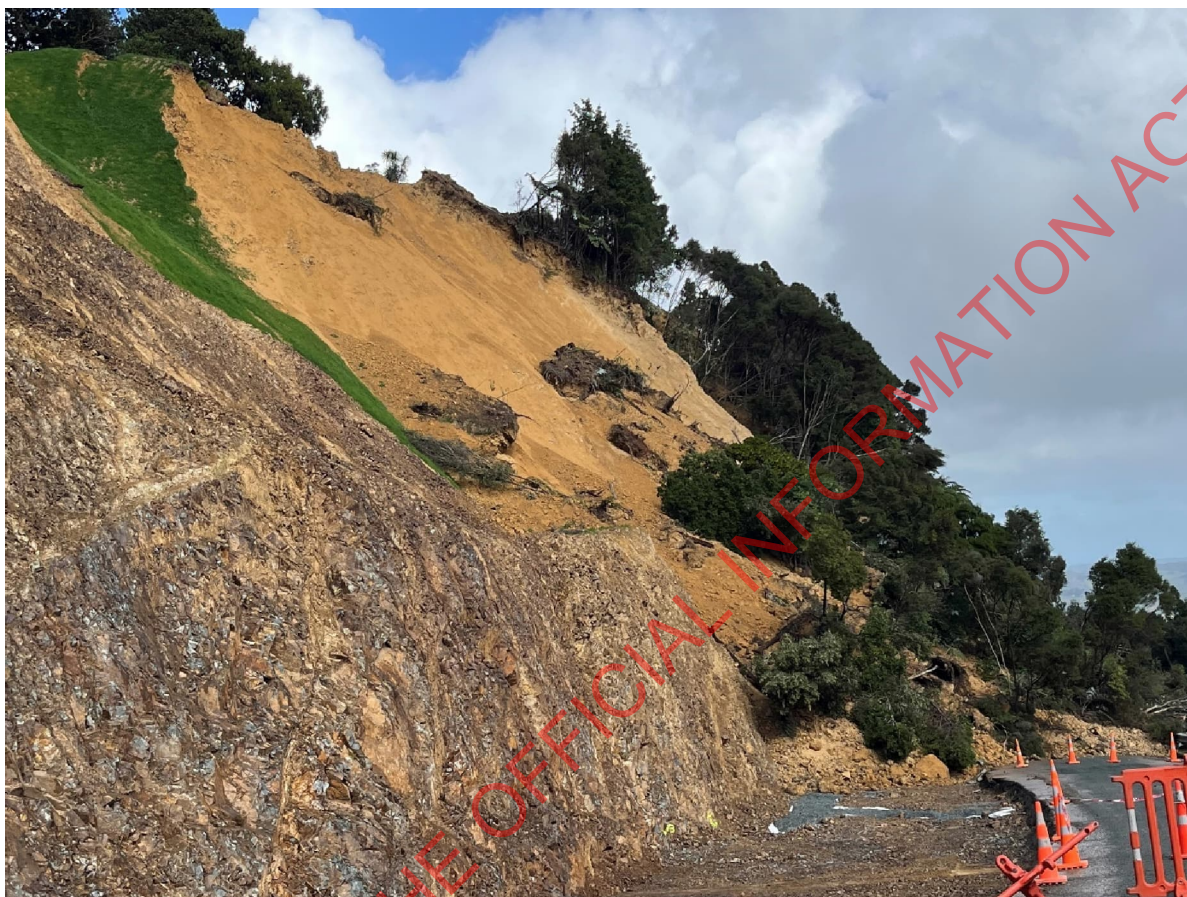
The spoil is covering the lower slope, see Figure 4, so it is not possible to assess the extent of damage to the rock, but it is important to note that early video showed rock being expelled over a section and some disturbance to the remainder of the face should be expected.

Figure 4: Landslip showing debris at road level and evacuated face above. HW rock exposed in foreground and hydroseeded face of earlier failure in Section D above with cracking evident at crest. HW rock is present at mid-height of the evacuated scarp.

We observed exposures of highly weathered rock in the evacuated upper face that indicates that much of the residual soils have now evacuated from the face. There remains an over steepened head scarp of residual soils at the crest of the ridge (see circled feature below). We understand Goodmans (Experienced earthworks sub-contractor) has excavated a trench at the crest and confirmed highly weathered rock at about 3m depth in the vicinity of the digger in the photo.

We note that HW rock is likely to be encountered at a relatively shallow depth on much of the exposed face, as evident in exposures of HW rock in the scarp, see Figure 4, and there may be options to limit the extent of further excavations, initially removing material at the crest to make safe and scaling the remaining loose soils on the middle section, sufficient to enable plant to operate on removal of the spoil at road level. The initial phase for both options is the same and it may be possible to target the latter while retaining the more extensive works if the lesser works cannot be safely achieved.

The site team are developing options for remediation, and we understand the current proposal is to cut down the ridge to HW rock to form a platform from which the remaining residual soils at the headscarp can be removed. The work will then progress down the slope maintaining a bench to operate safely from. We consider this would be a safe approach to securing that face but would delay access for the removal of spoil as it is buttressing the toe of the slipped materials.
