TC class dental clinic trailer – wheel loss failure

Investigation report

December 2022

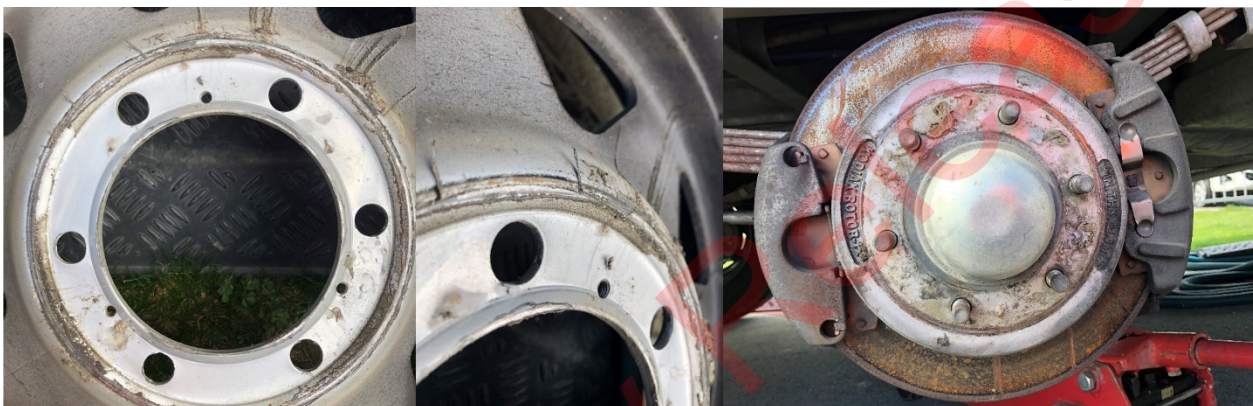
- The wheel mounting face of the brake disks have casting depressions to facilitate branding and wear limit markings. The brake disc casting depressions occupy sections of the wheel rim contact area and prevent the wheel rim's torque ring outer bead from making full contact with a flat mounting surface (as also mentioned in the supplied report by s 9(2)(a))
- Inconsistent wheel rim torque ring inner bead witness marks around the circumference of the wheel mounting surface contact area (on both the wheel rims and brake discs). This is most likely due to:
 - a damaged or poor-quality torque ring and or incorrect wheel nut torque; and
 - incorrect torque ring function due to areas of inadequate torque ring outer bead contact with the brake disc.

Wheel torque ring, interface (mounts towards brake disc)

Close up of wheel torque ring. Inconsistent witness marks evident.

Brake disc with wheel removed. Inconsistent witness marks and casting depressions evident

- replacing the wheel studs
- fitting a stepped spacer (to cover the hub recesses and provide an improved mating surface).
- fitting of a thicker higher rated rim option (still stud centric but with far less flexibility).

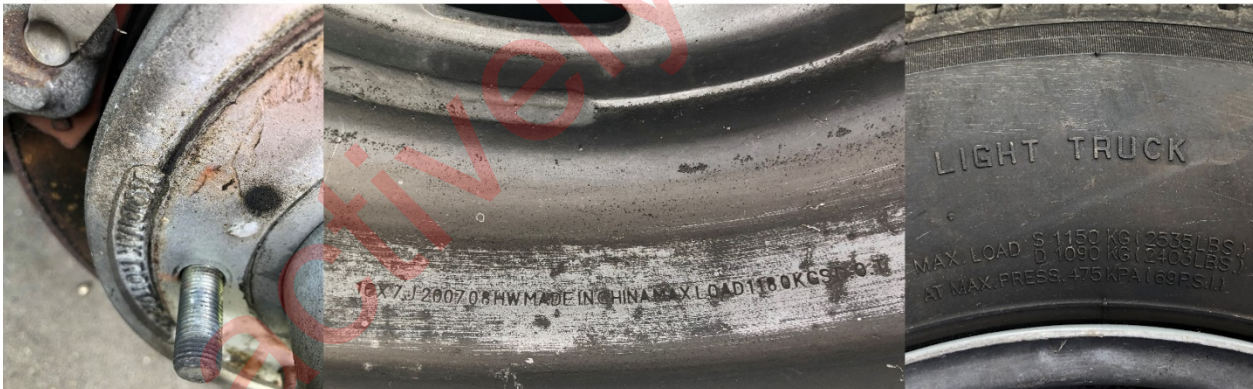
- Rating and size stamped on wheel rim does not match information supplied. 16x7 & max 1180 Kgs stamped on inspected wheel rims; Information supplied states 16x6 3200LBS (=1451Kg)

Close up of brake disc's wheel mounting surface. Witness mark from wheel rim and casting depression evident

Wheel rim stamped markings. max load rating evident (1180 KGS).

Fitted tyre marking. Max load rating of 1150 KG evident (single mounted)
