Factors influencing the decision to rehabilitate a pavement

June 2012

Patrick, JE and H Aramoorthy (2012) Factors influencing the decision to rehabilitate a pavement. NZ Transport Agency research report 491. 108pp.

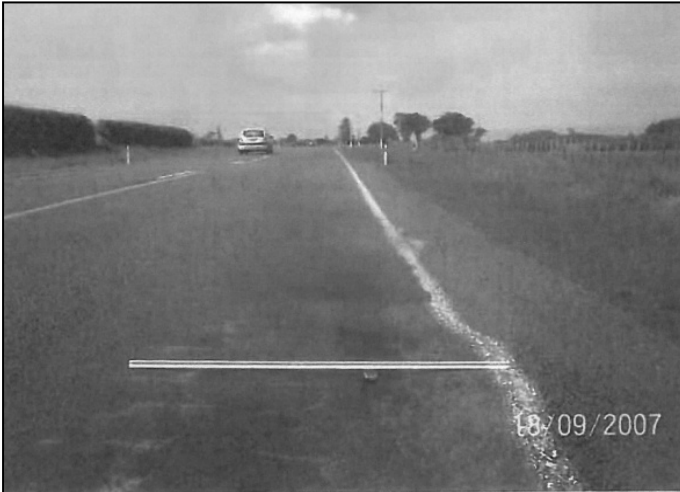
Figure 4.1 View of site 2, showing evidence of flushing and other areas of poor condition

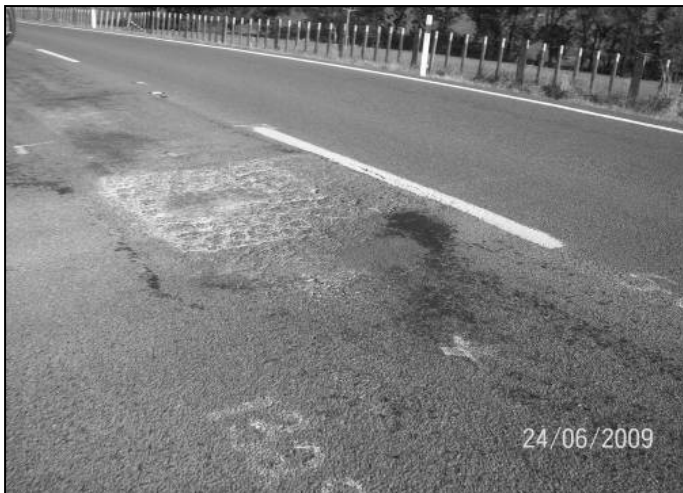
Figure 4.3 View of site B1, showing patchwork repairs and flushing

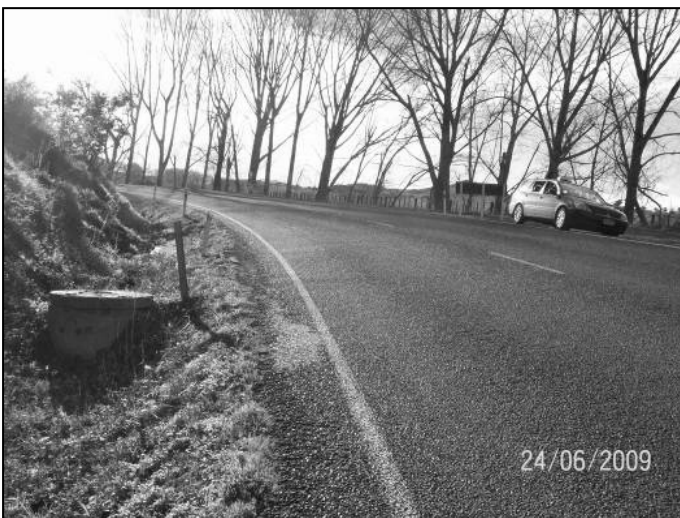
Figure 4.5 View of site B2, showing chip loss at the edge of the pavement

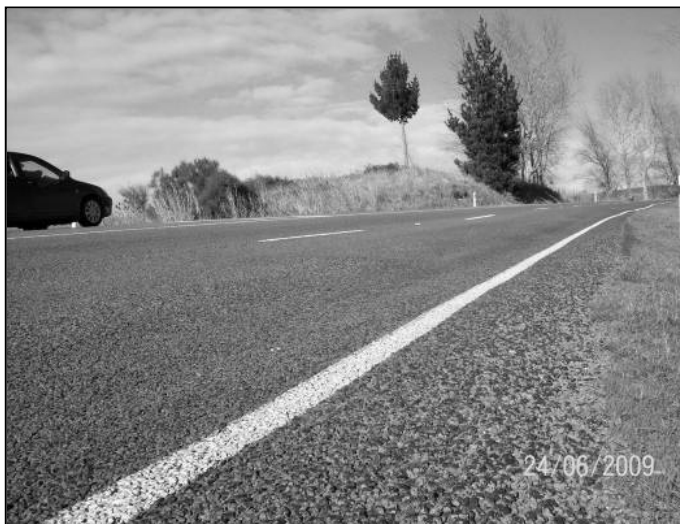
Figure 4.7 View of site B3, showing rutting

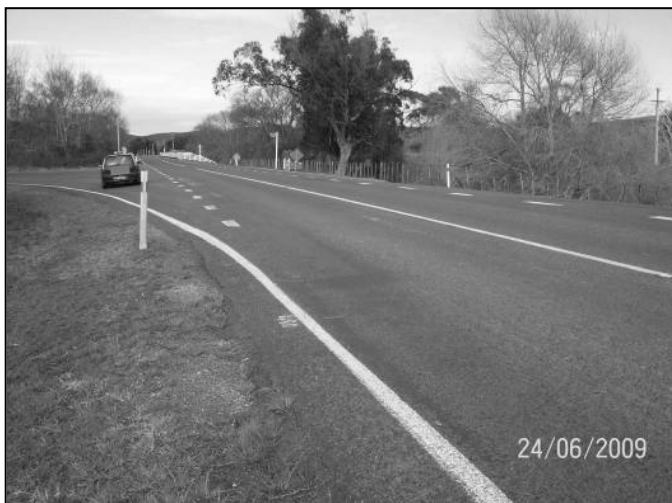
Site B4 appears to be an old piece of road which has drainage and subgrade issues. It was noticeable that the existing repairs were in poor condition. The main issues identified at this site were:

Figure 4.9 View of site B4, showing extensive flushing

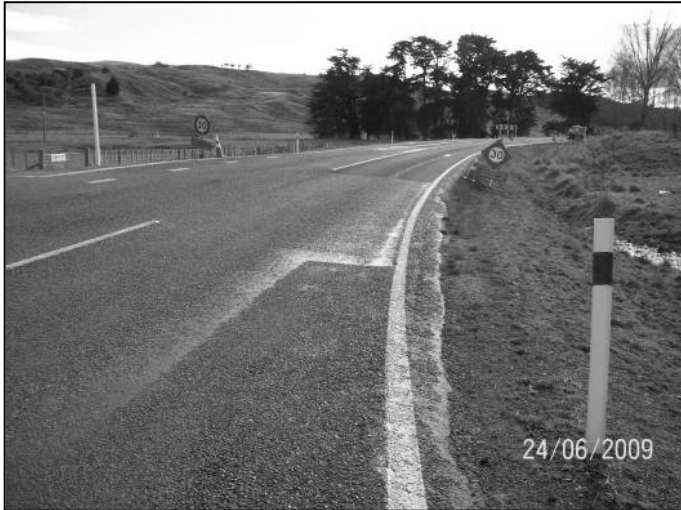
Figure 4.10 View of site B4, showing an example of patchwork repairs

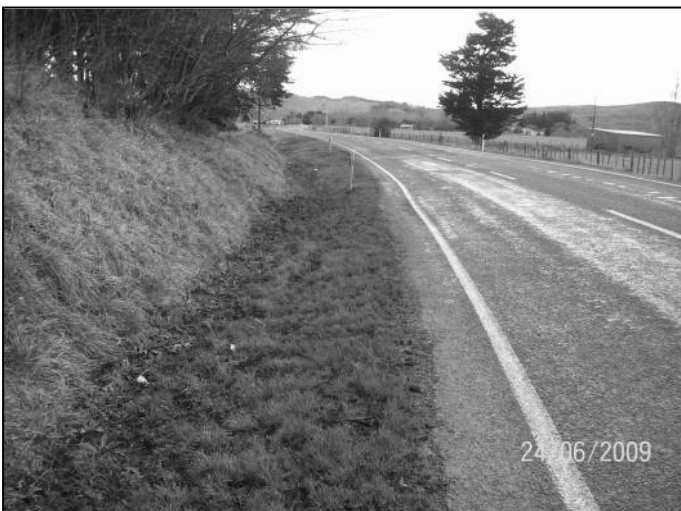
Site B5 also appears to be an old piece of road which has drainage (high shoulders) and subgrade issues, and the existing repairs were in poor condition. The main issues identified at this site were:

Figure 4.11 View of site B5, showing flushing and shape loss

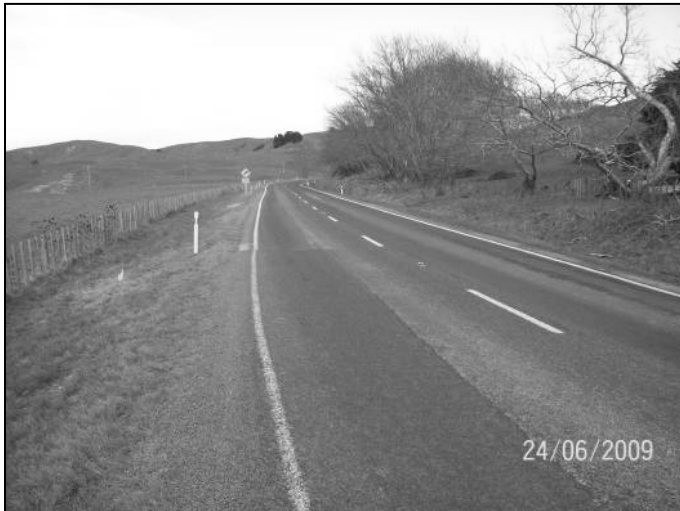
Figure 4.12 Alternate view of site B5, showing flushing and patchwork repairs

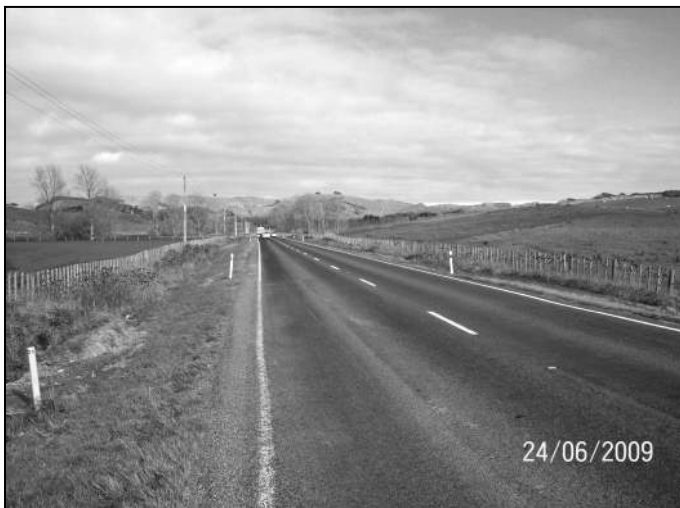
Figure 4.13 View of site B6, showing overall condition.

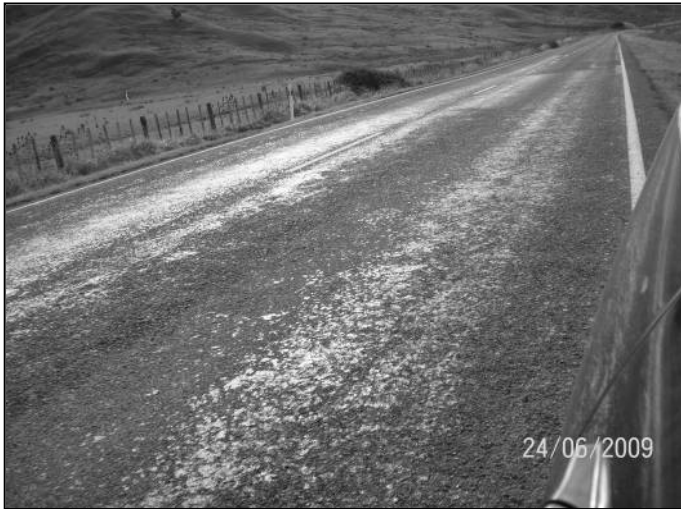
Figure 4.14 Alternative view of site B6, showing flushing

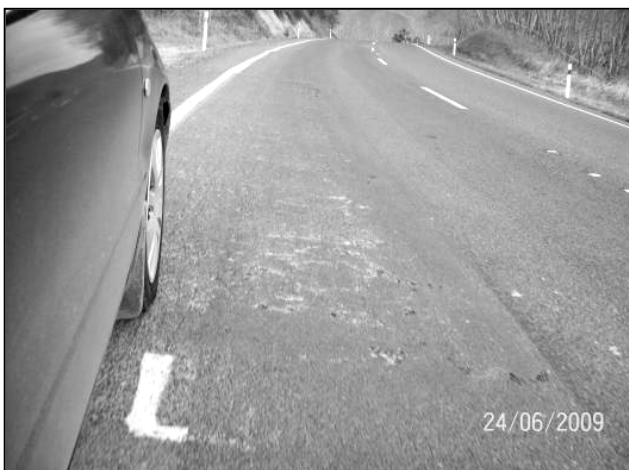
Quite a large amount of backlog repairs seemed to be required on this (and other) sites prior to undertaking an area-wide treatment. The site also seemed to have little or no roadside drainage (it had some longitudinal grade, but had high shoulders and was through a cutting with no table drains).

Figure 4.15 View of site B7, showing a failed patchwork repair

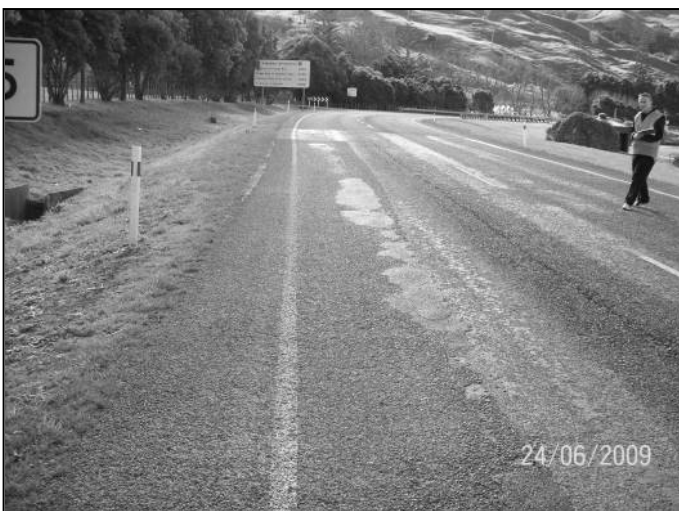
Figure 4.17 View of site B8, showing flushing and patchwork repairs

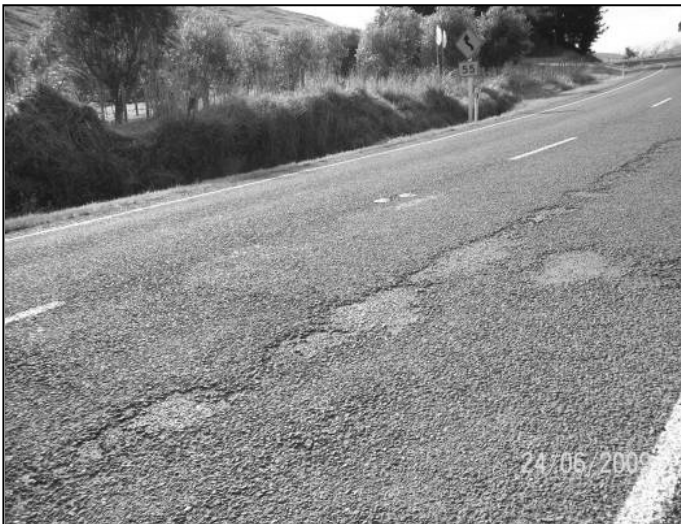
Figure 4.19 View of site B9, showing scabbing

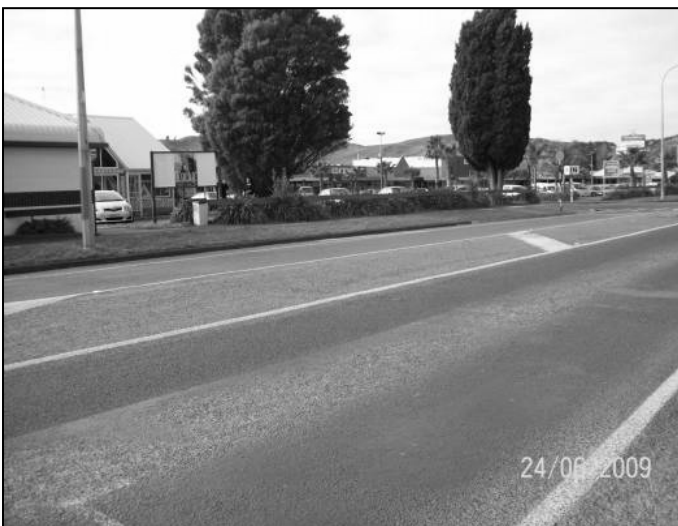
Figure 4.21 View of site B10, showing an area of flushing

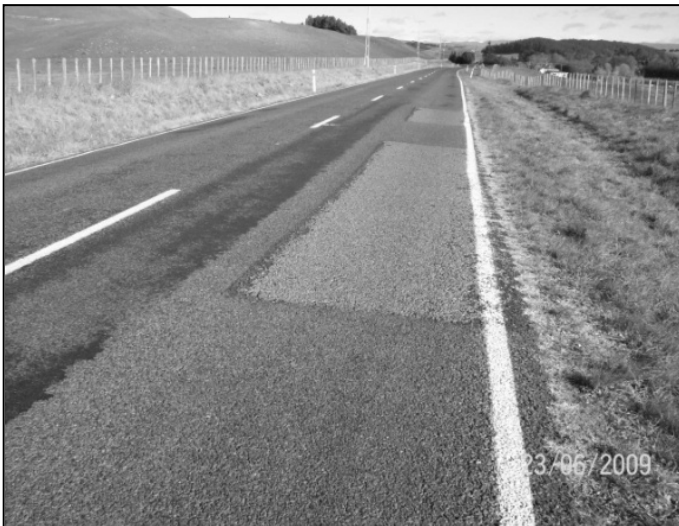
Figure 4.23 View of site C1, showing patchwork repairs and flushing

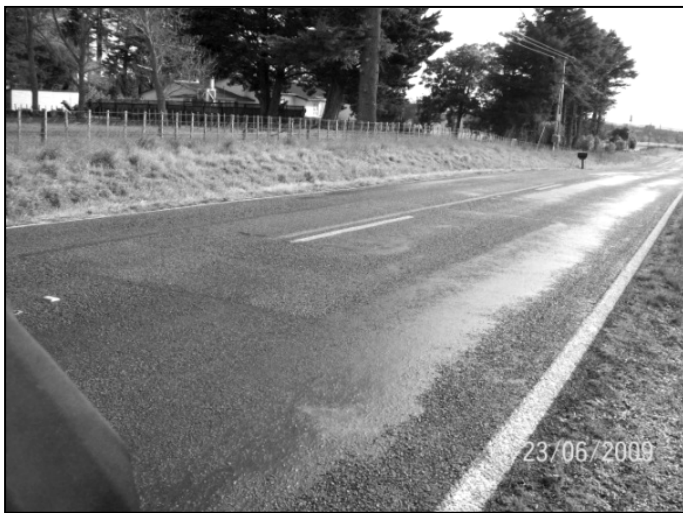
Figure 4.25 View of site C2, showing patchwork repairs and flushing

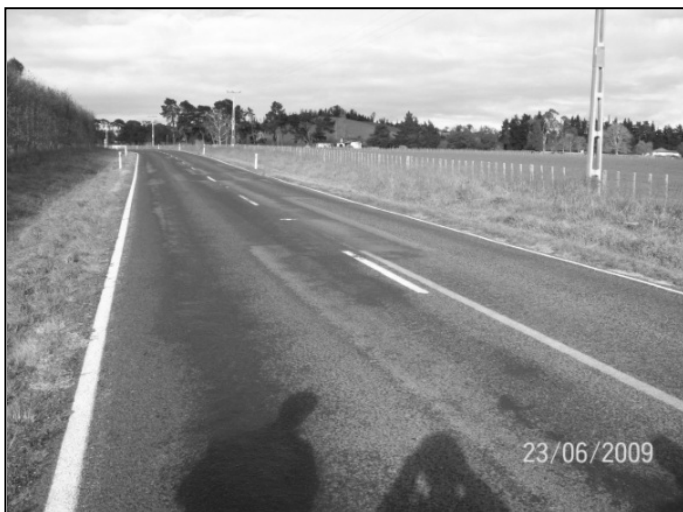
Figure 4.26 View of site C2, showing more patchwork repairs and extensive flushing

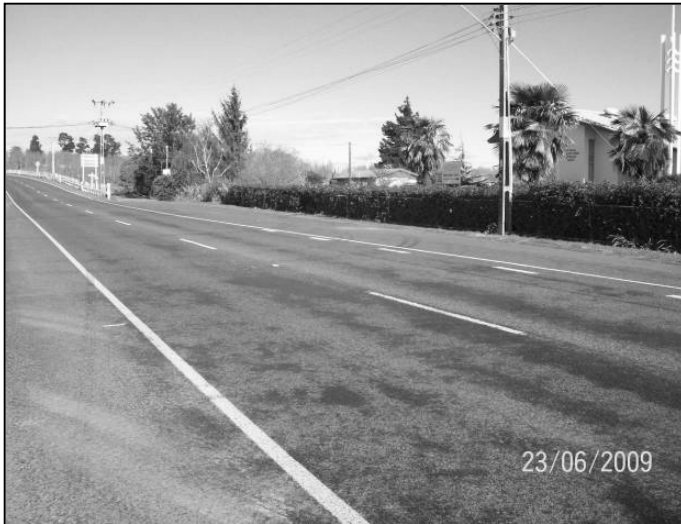
Figure 4.29 View of site C4, showing areas of flushing

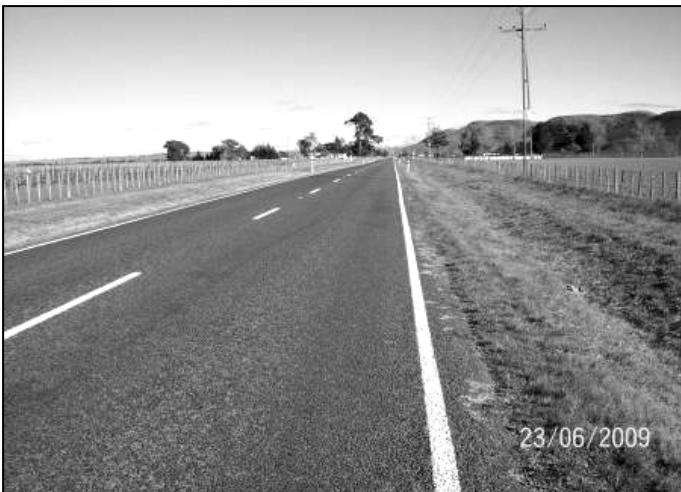
Figure 4.30 View of site C5, showing the reasonable condition of the pavement

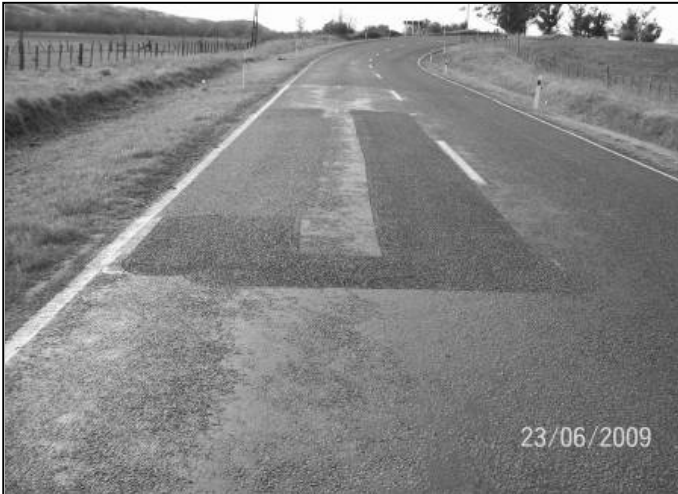
Figure 4.31 View of site C5, showing patchwork repairs and flushing

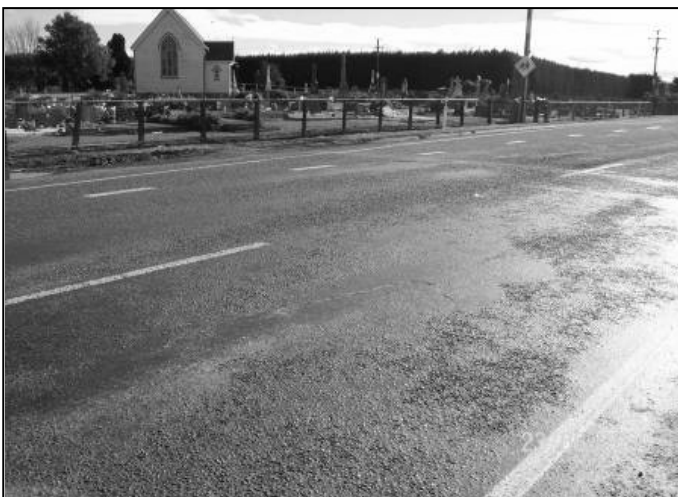
Figure 4.32 View of site C6, showing an area of considerable flushing

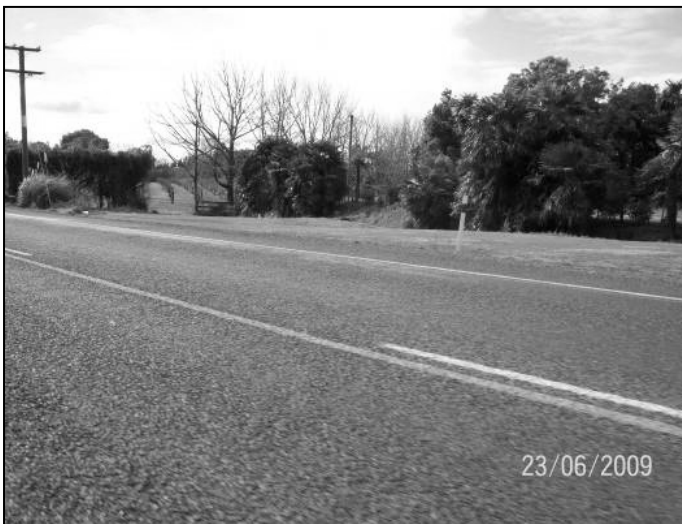
Figure 4.34 View of site C7, showing an area of good pavement condition

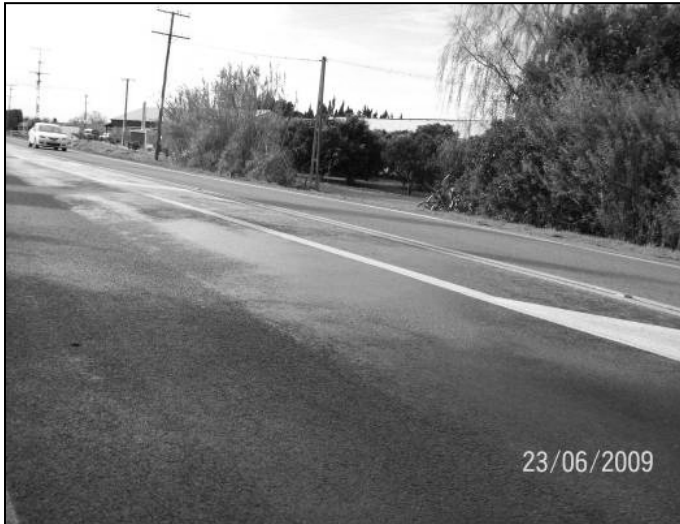
Figure 4.35 View of site C7, showing shape loss and flushing

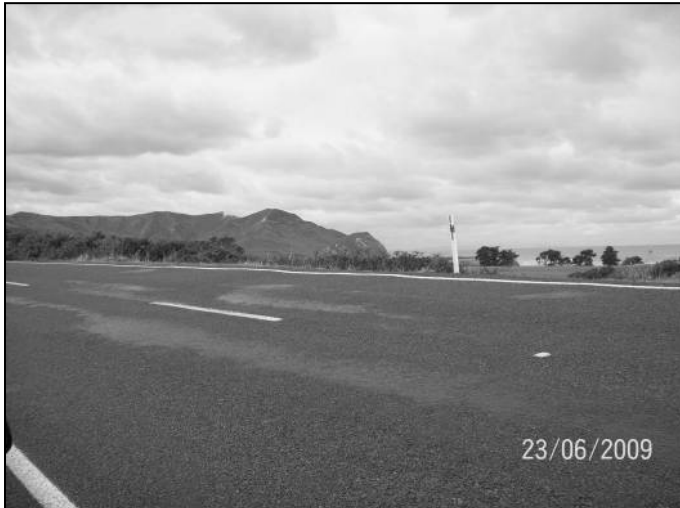
Figure 4.38 View of site C10, showing several areas of flushing

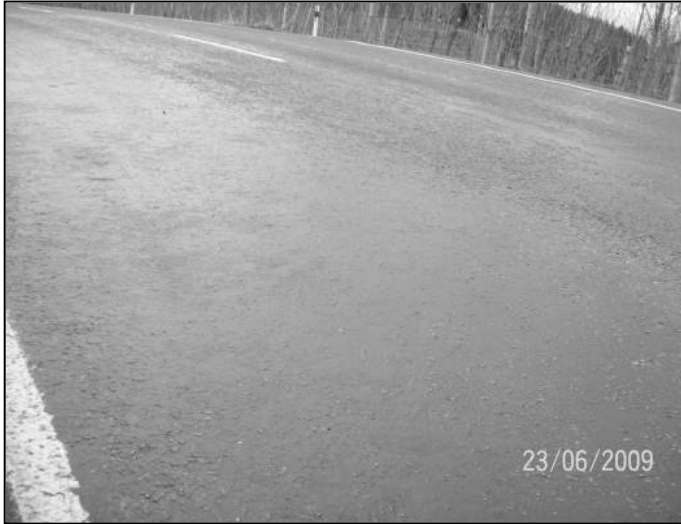
Figure 4.40 View of site C11, showing flushing on the full width of the road

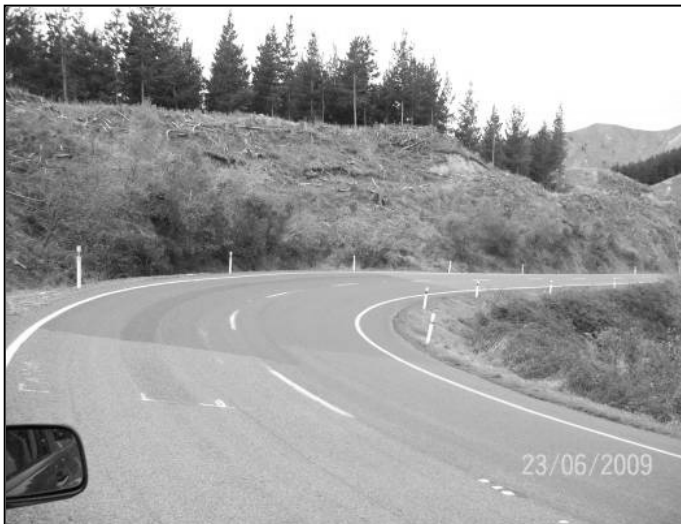
Figure 4.41 View of site C11, showing patchwork repairs and wide flushing on a curve

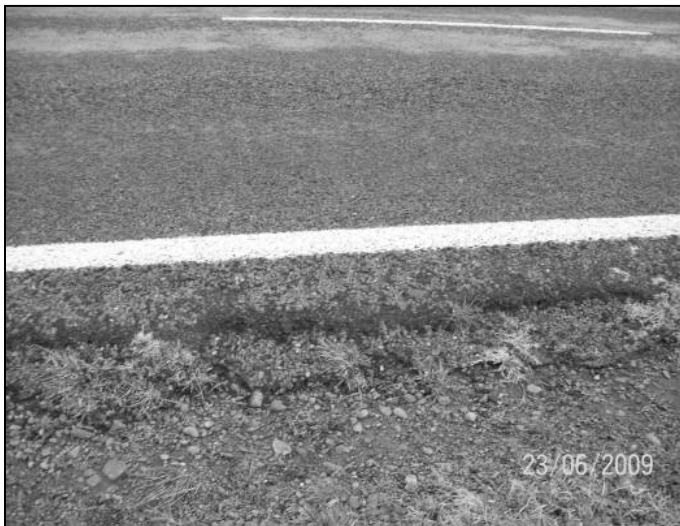
Figure 4.42 View of site C13, showing shape loss at the edge of the seal

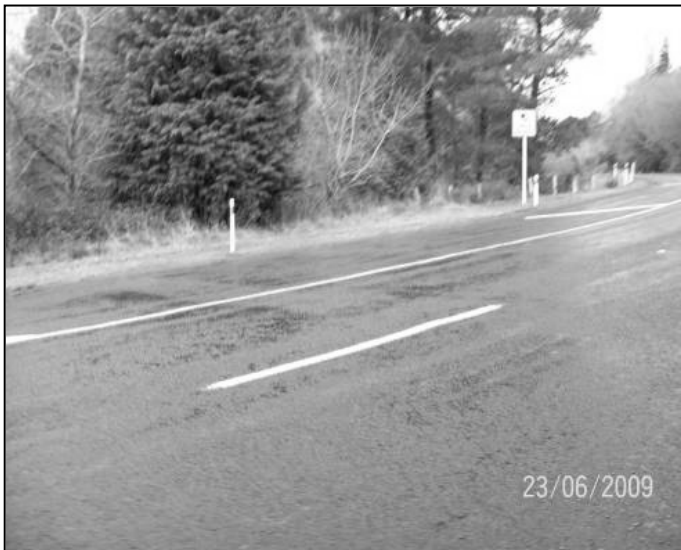
Figure 4.44 View of site C15, showing some of the flushing

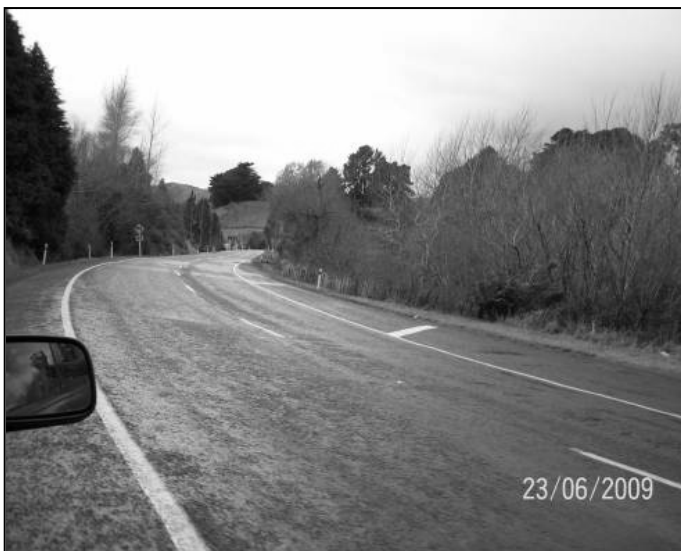
Figure 4.45 View of site C15, showing the general condition of the pavement

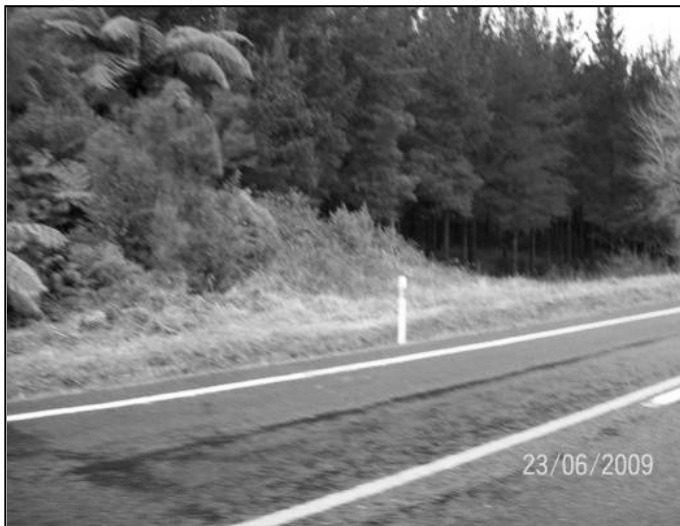
Figure 4.46 View of site C16, showing flushing

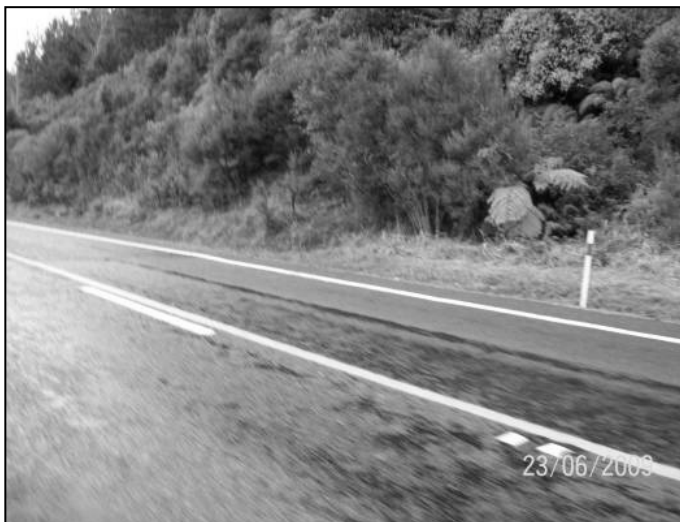
Figure 4.47 View of site C16, showing patchwork repairs and flushing

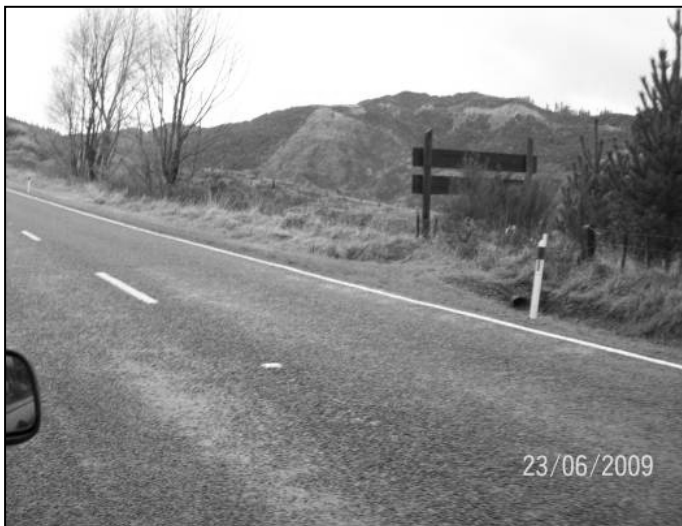
Figure 4.48 View of site C17, showing general condition

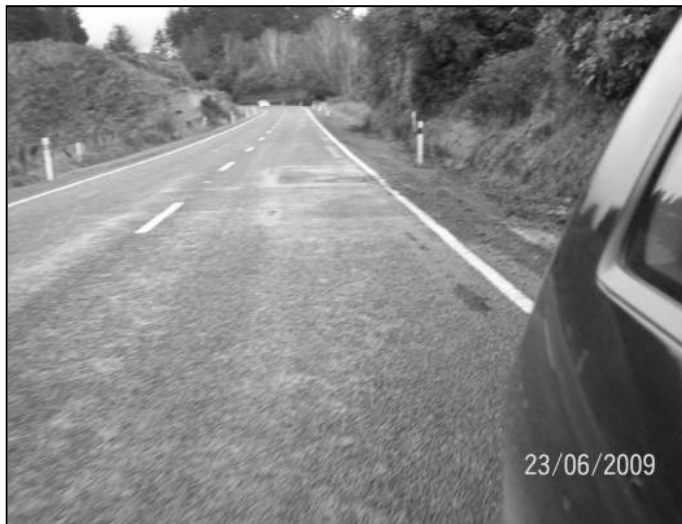
Figure 4.49 View of site C17, showing patchwork repairs

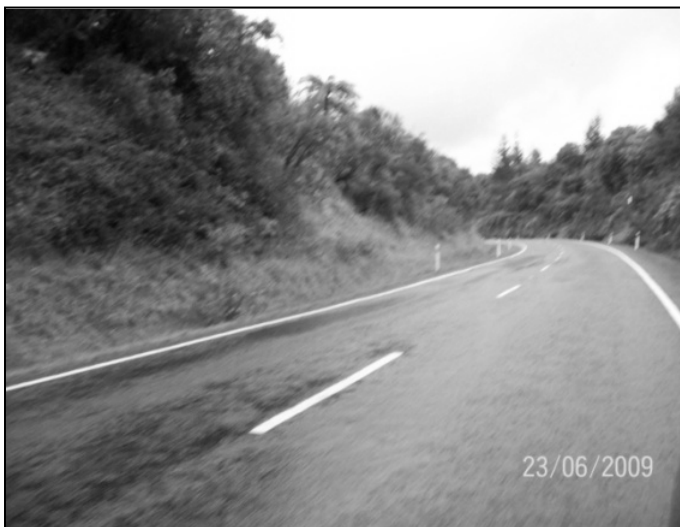
The main issue on this site seems to involve drainage. Water is possibly migrating into sublayers on the high side of curve as a result of:

Figure 4.50 View of site C18, showing the extensive flushing evident at this site

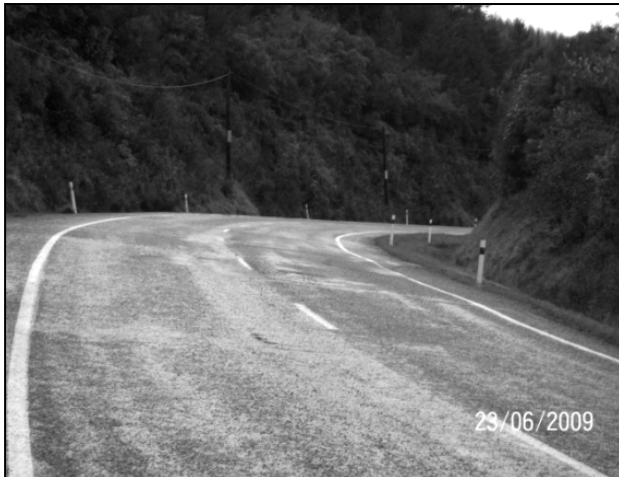
Figure 4.51 View of site C18, showing shape loss and patchwork repairs

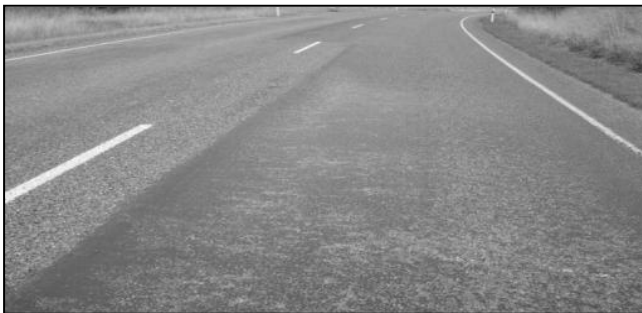
Figure 4.52 View of site D1, showing patchwork repairs and flushing

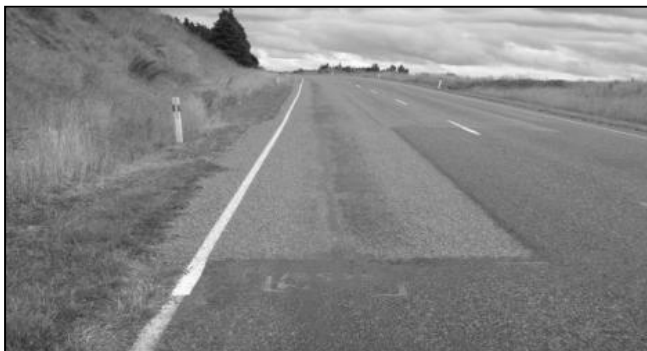
Figure 4.53 View of site D1, showing another area of patchwork repairs

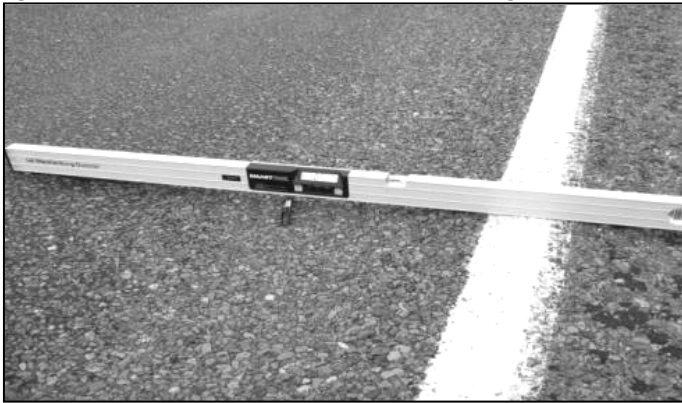
This site had a 47-year-old pavement. The last reseal was a 8.5m wide two-coat seal in 2001. This site has also been incurring increasing maintenance costs, and further maintenance is not likely to be economic. The main issues noticed at this site were:

Figure 4.54 Close-up view of site D2, showing the depth of the rutting

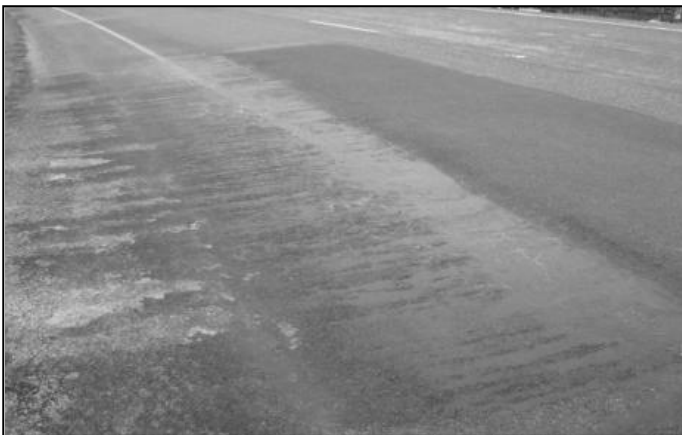
Figure 4.55 View of site D2, showing flushing and patchwork repairs

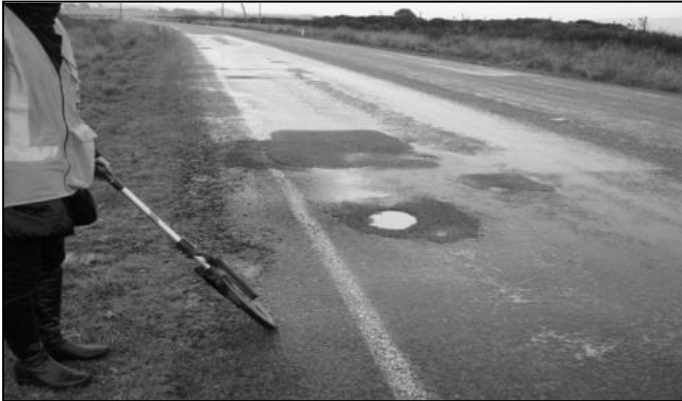
This site had a 47-year-old pavement. The last reseal was a 10m wide single-coat seal in 2006. Like sites D1 and D2, this site was incurring increasing maintenance costs and further maintenance is not considered economic. The main issues at this site were:

Figure 4.56 View of site D3, showing potholes

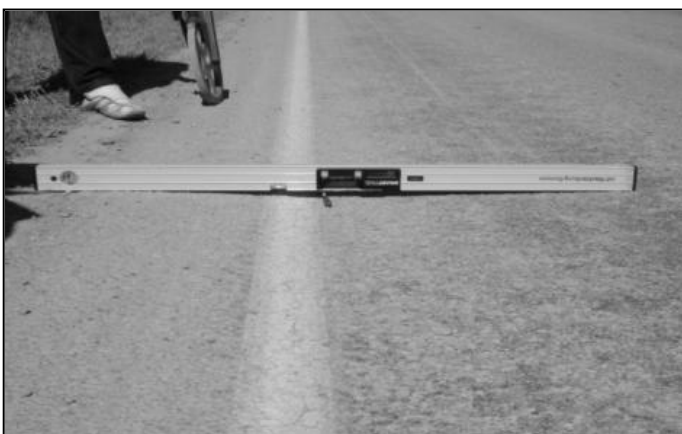
Figure 4.58 View of site D4, showing the depth of the rutting

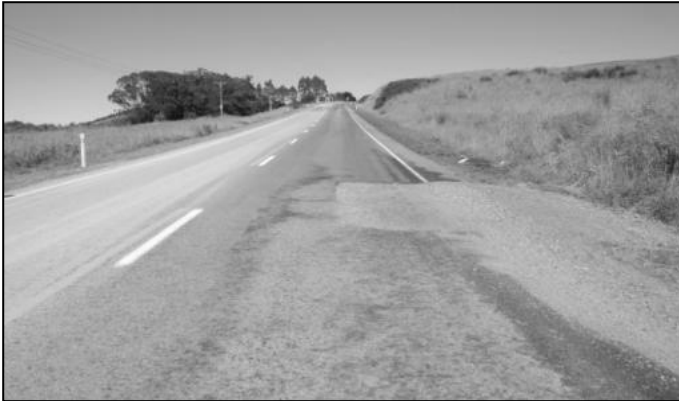
Figure 4.59 View of site D4, showing the overall poor condition of the pavement surface

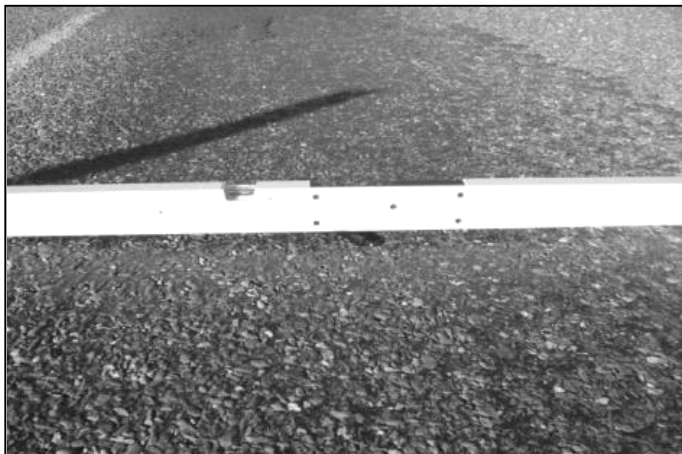
This site had a nine-year-old pavement. The last reseal was an 8.0m wide two-coat seal in 2002. Increasing maintenance costs mean that further maintenance is not economically justifiable. The main issues encountered at this site were:

Figure 4.60 Close-up view of site D5, showing the depth of the rutting

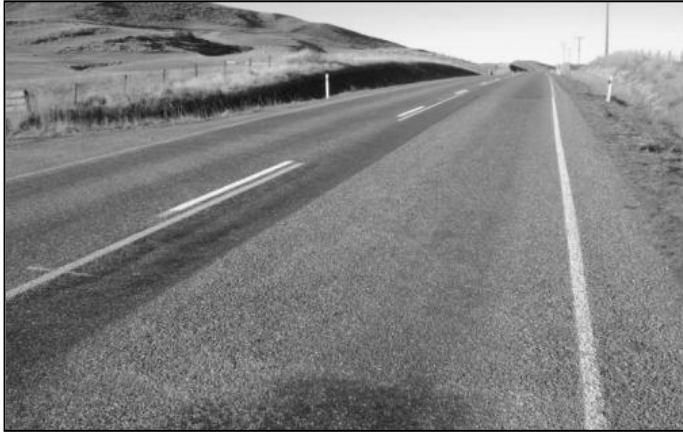
Figure 4.61 View of site D5, showing extensive flushing and rutting

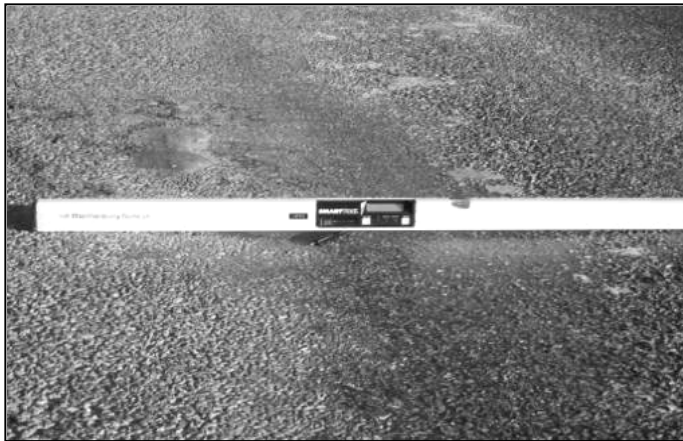
Figure 4.62 Close-up view of site D6, showing flushing and the depth of the rutting

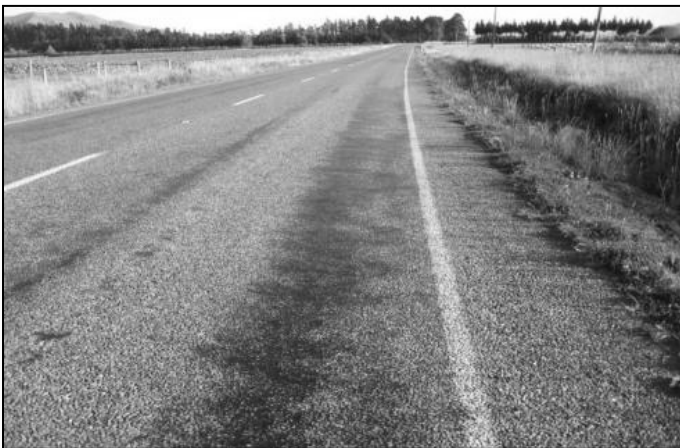
Figure 4.64 View of site D7, showing flushing in the wheelpaths

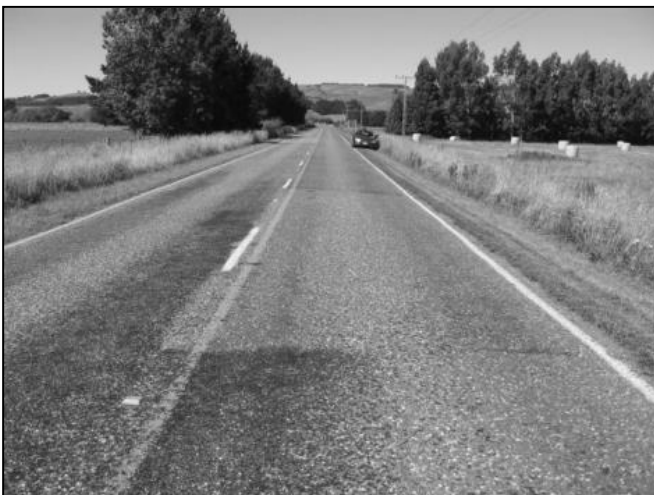
Figure 4.66 View of site D8, showing flushing and pavement repair

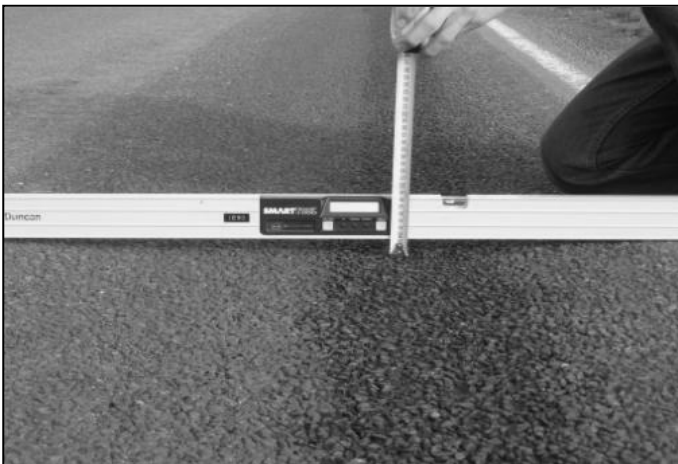
Figure 4.68 Close-up view of site D9, showing the depth of the rutting in the wheeltracks

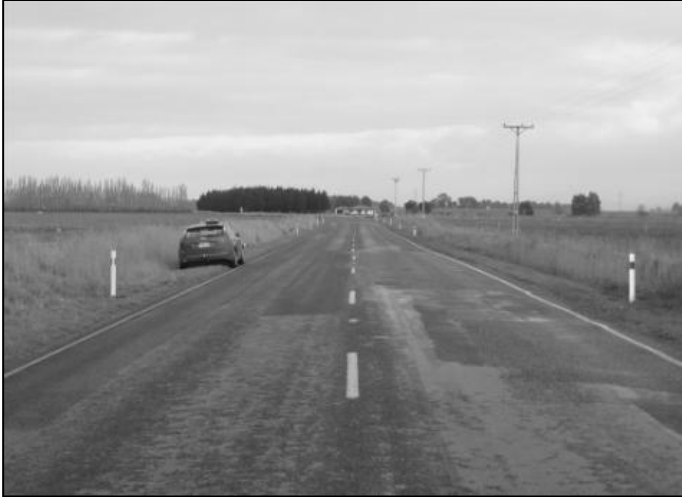
Figure 4.69 View of site D9, showing the overall poor condition of the pavement

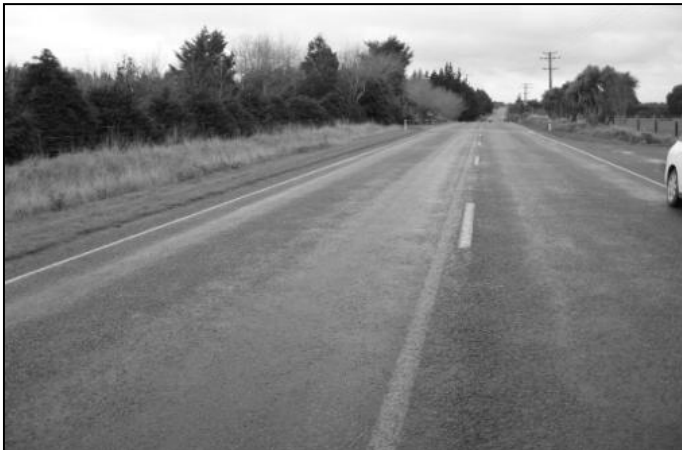
Figure 4.70 View of site D10, showing extensive flushing in the wheeltracks

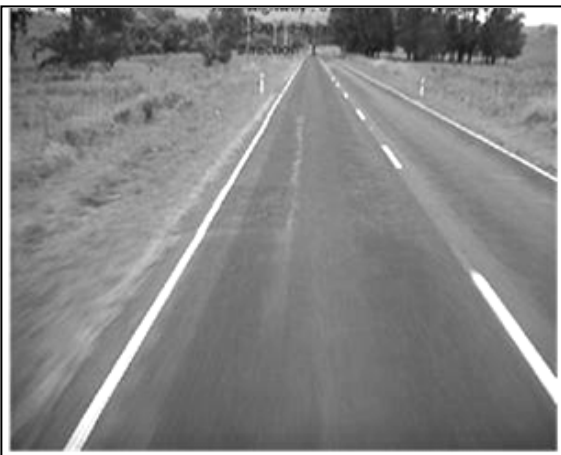
Figure 5.17 Another typical view of site B6 (RP 3763 increasing), showing evidence of pavement repairs

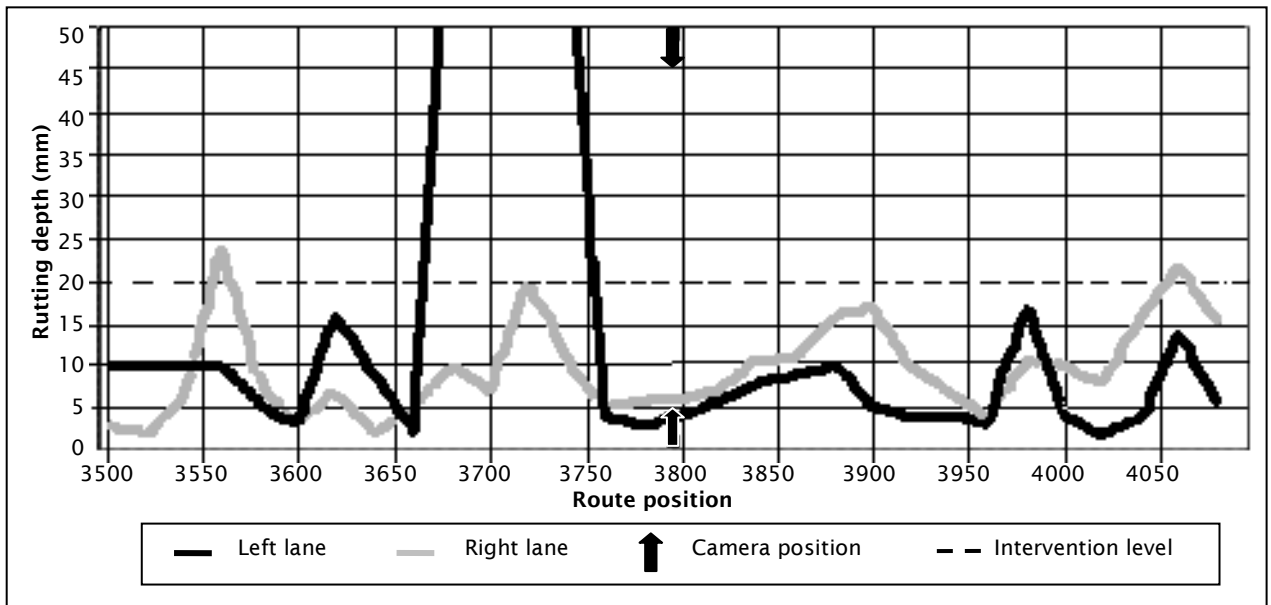
Figure 5.10 Site C1 maximum rutting: 20m data average = 3.6mm, 95% 14.9mm

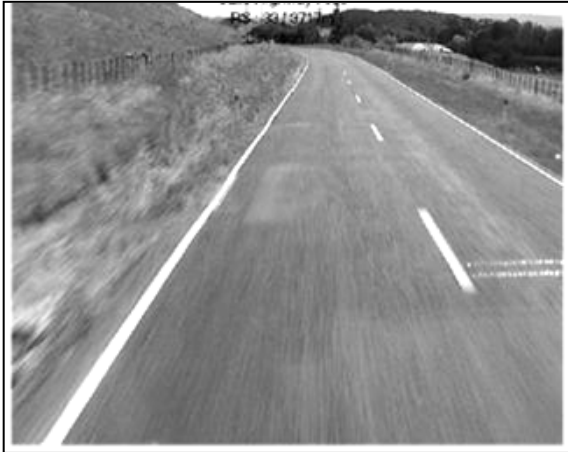
Figure 5.23 Typical view of site C1 (RP 3717 increasing) showing repairs

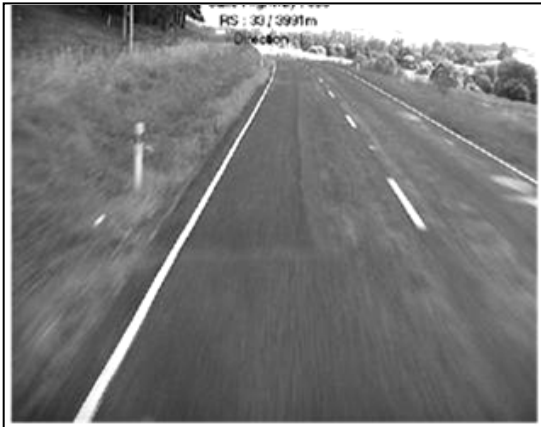
Figure 5.24 Typical view of site C1 (RP 3991 increasing), showing repairs and flushing

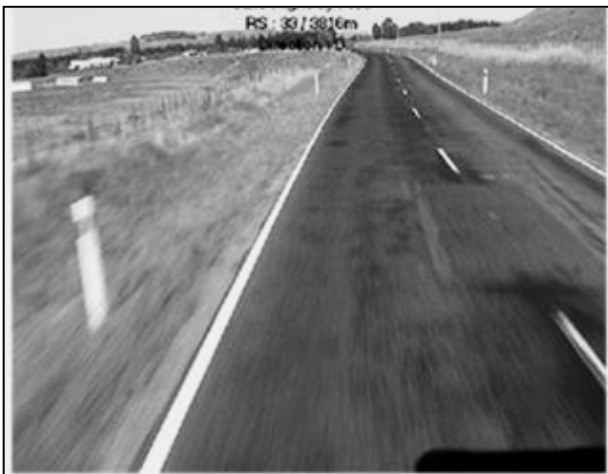
Figure 5.25 Typical view of site C1 (RP 33/3816 decreasing), showing repairs

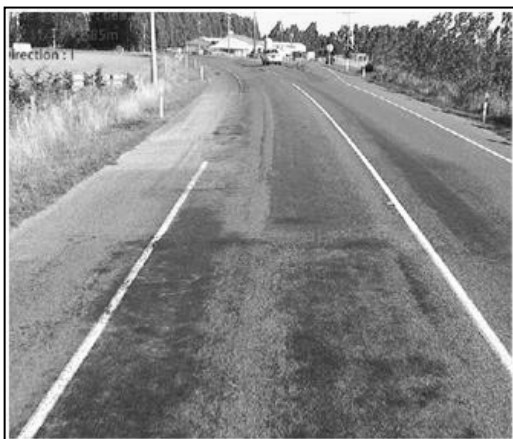
Figure 5.40 Inspection length in site D2 (RP 1145/6583), showing the poor condition of the pavement

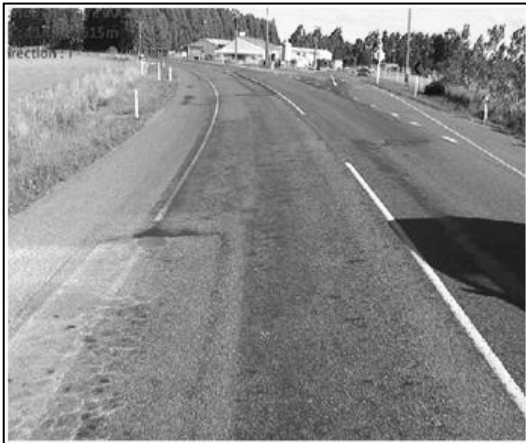
Figure 5.41 Another section of the inspection length in site D2 (RP 1145/6615), showing patchwork repairs, flushing and other evidence of poor pavement condition

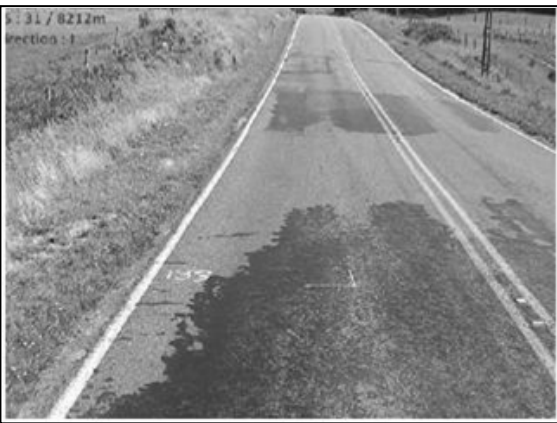
Figure 5.47 Another typical section of the first half of site D6: RP 8210 increasing, showing generally poor pavement surface condition

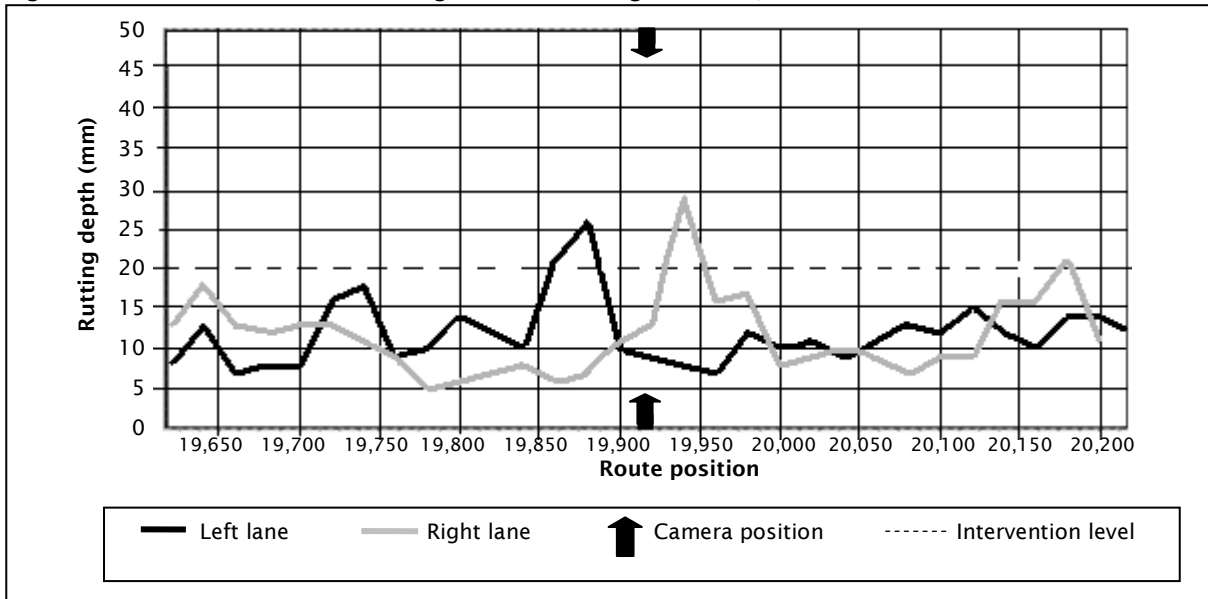
Figure 5.52 Site D10 maximum rutting: 20m data average = 6.4mm; 95% 12.3mm

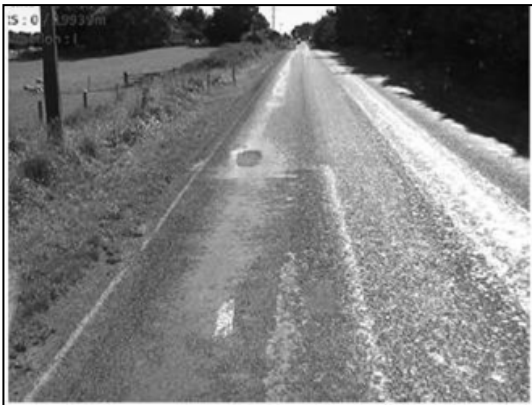
Figure 5.53 Typical view of site D10 (RP 0/19,939 increasing, showing evidence of potholing and flushing)
