Analysis and interpretation of New Zealand long-term pavement performance data December 2017

KL Neaylon, R Davies, L Harrow and R Henderson
Opus Research, Opus International Consultants

NZ Transport Agency research report 633
Contracted research organisation – Opus International Consultants

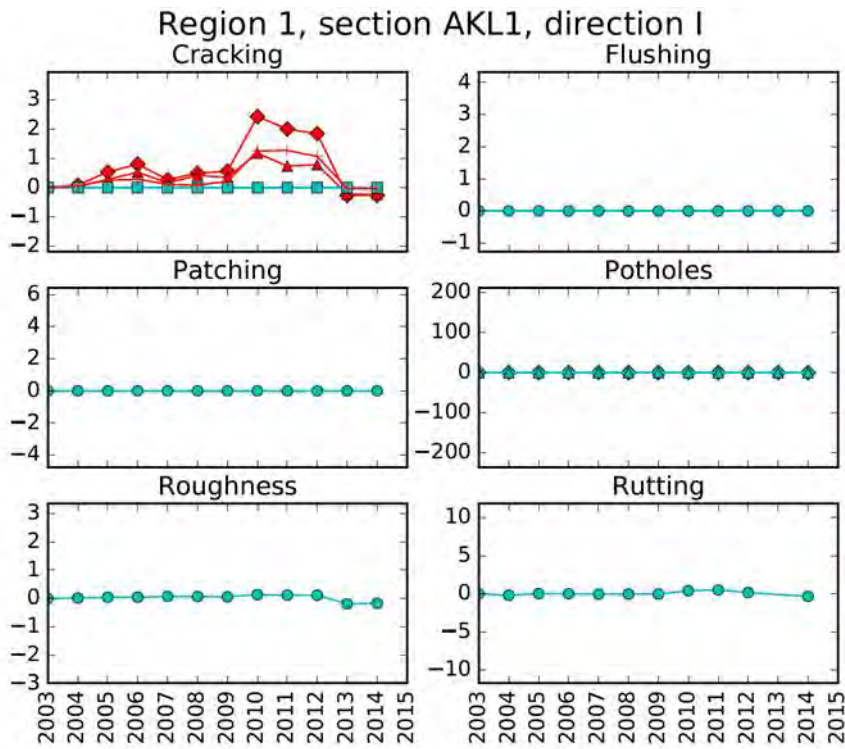
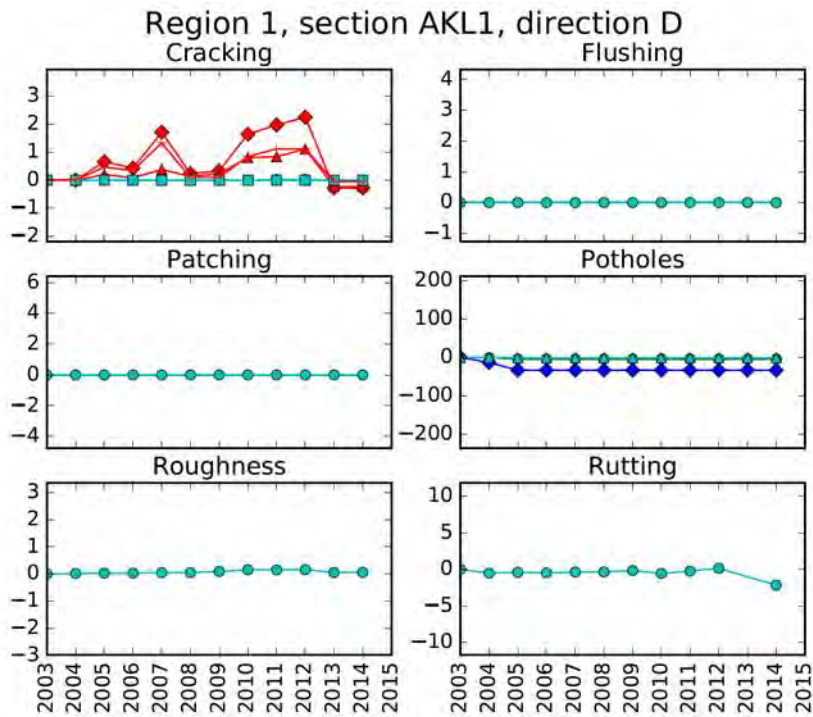
This site showed severe cracking, but no impact on pavement deterioration.

- Average daily traffic (ADT) 2015 is 32,681 with 3% heavy commercial vehicles (HCV).
- Only two surfaces are recorded in RAMM (G3 reseat 1983 and AC 2012) so some surfacing records are obviously missing.
- No pavement records recorded in RAMM for this site.
- No FWD recorded in RAMM for this site.
- No SNPs recorded in RAMM for this site.

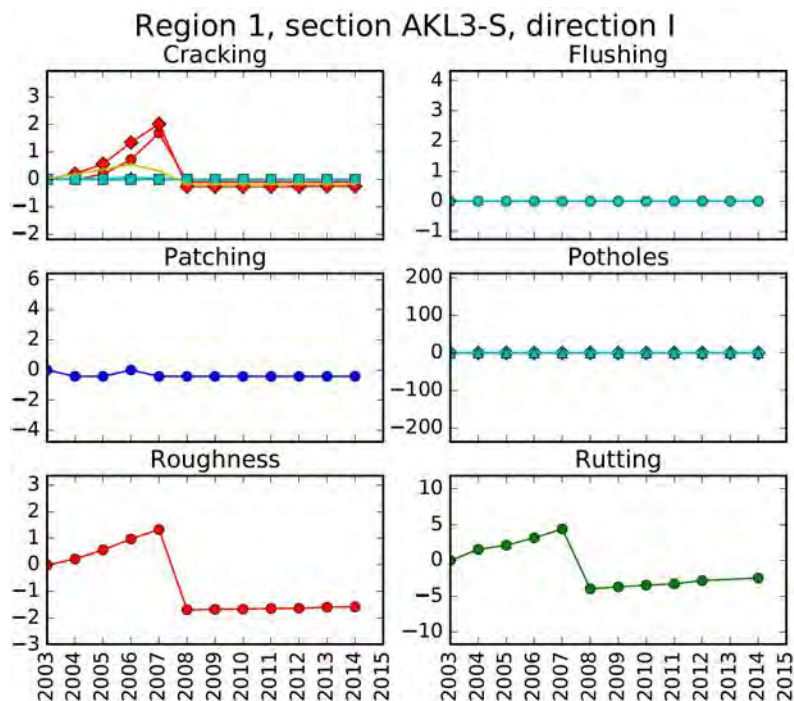
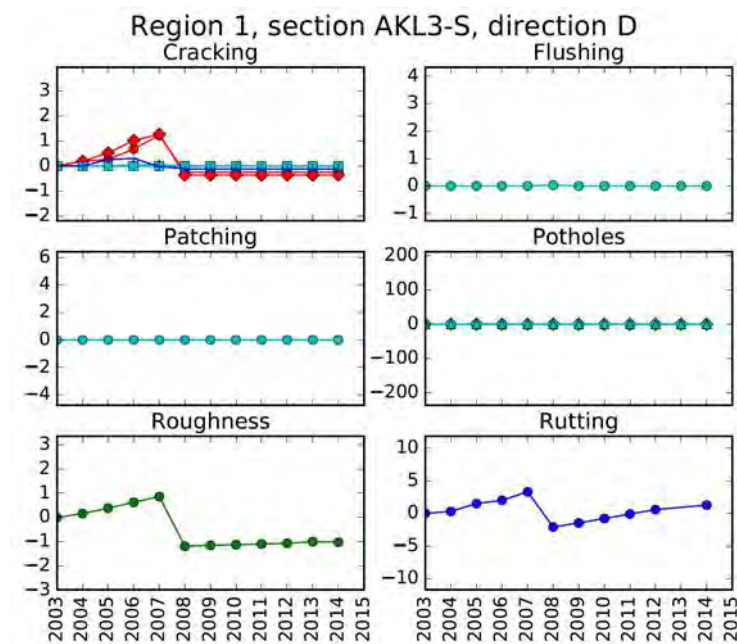
Cracking plus deteriorating roughness and rutting

- ADT 2012 is approximately 25,000 to 27,000 with 11 to 16% HCV.
- Three surfaces recorded in RAMM prior to the 2008 pavement renewal (G3 first coat 1971, G3/5 reseal 1989 and G3/5 reseal 2001 plus some sections of AC at various times in between). In 2008 a stone mastic asphalt (SMA) was applied as the wearing course for the pavement renewal.
- The original 1971 pavement is recorded in RAMM as approximately 200 mm of AP65. In 2008, 240 mm of pavement and surfacing were removed and replaced with 50 mm of mix20 asphalt followed by 190 mm of mix40 asphalt.
- No FWD recorded in RAMM for this site.
- No SNPs recorded in RAMM for this site.

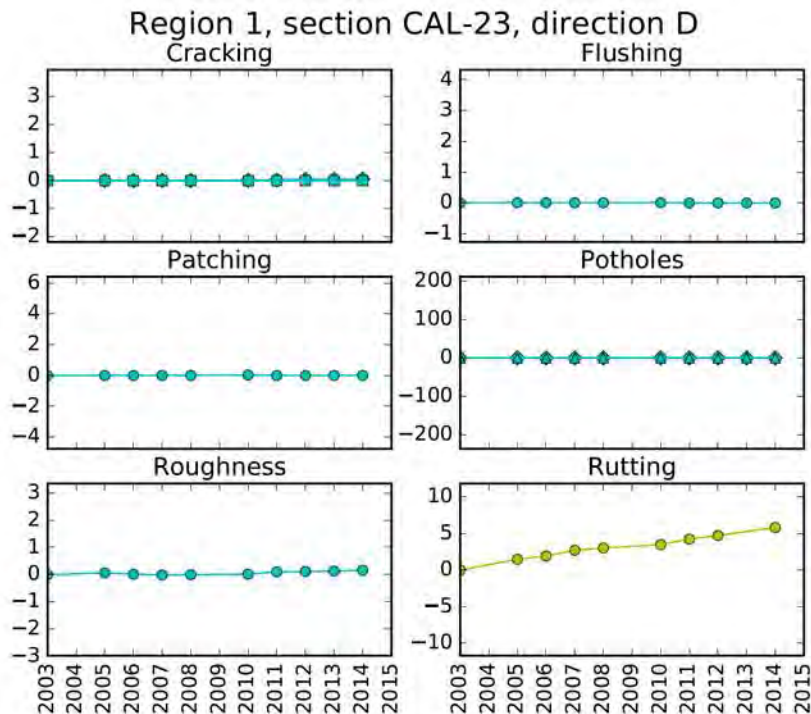
Rutting deterioration only

- ADT is 1,235 with 21% HCV.
- At least five chipseals (four recorded in RAMM: G2 second coat 1986, G5 1992, G2 1996 and G2/4 2006).
- Original pavement unknown but estimated at an approximate depth of 220 mm with the top 150 mm reconstructed in 1985.
- 2012 FWD reading shows a central deflection of 767 μm with a long bowl.
- Has a SNP of 3.6.

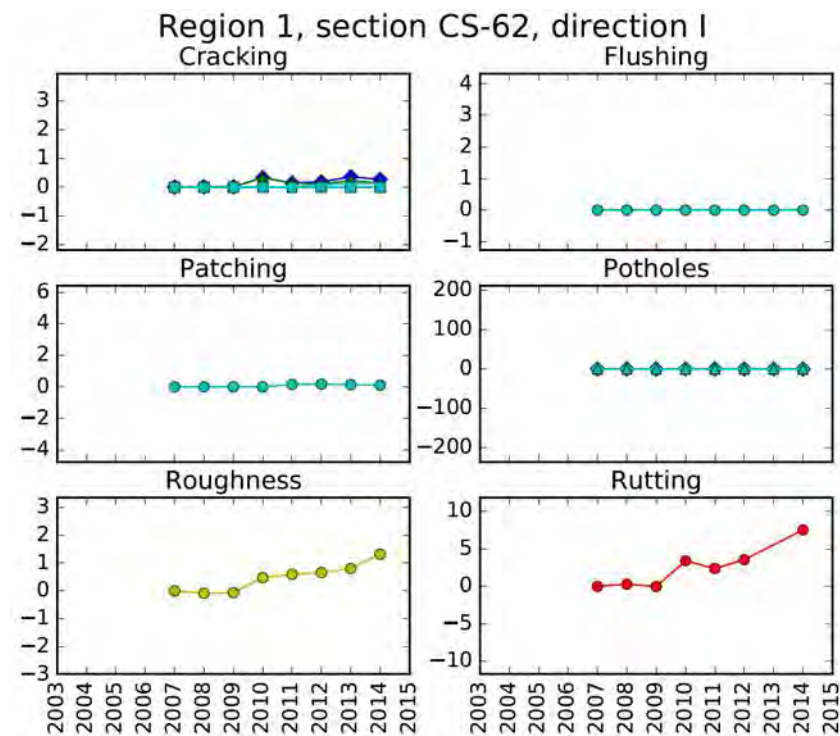
Roughness and rutting deterioration in increasing direction only

- ADT (2015 estimate) is 3,705 with 21% HCV.
- Three chipseals recorded (G3/5 first coat 2001?, G3/5 first coat 2005 and G3/6 2nd coat 2010).
- Original pavement unknown but estimated (1980?) AP40 at an approximate depth of 200 mm 6.0 m wide with the top 200 mm, 9.0 m wide, reconstructed in 2001.
- 2009 FWD reading shows a central deflection of 429 μm at an offset of 2.5 m with a long shallow bowl.
- Has a SNP of 4.49.

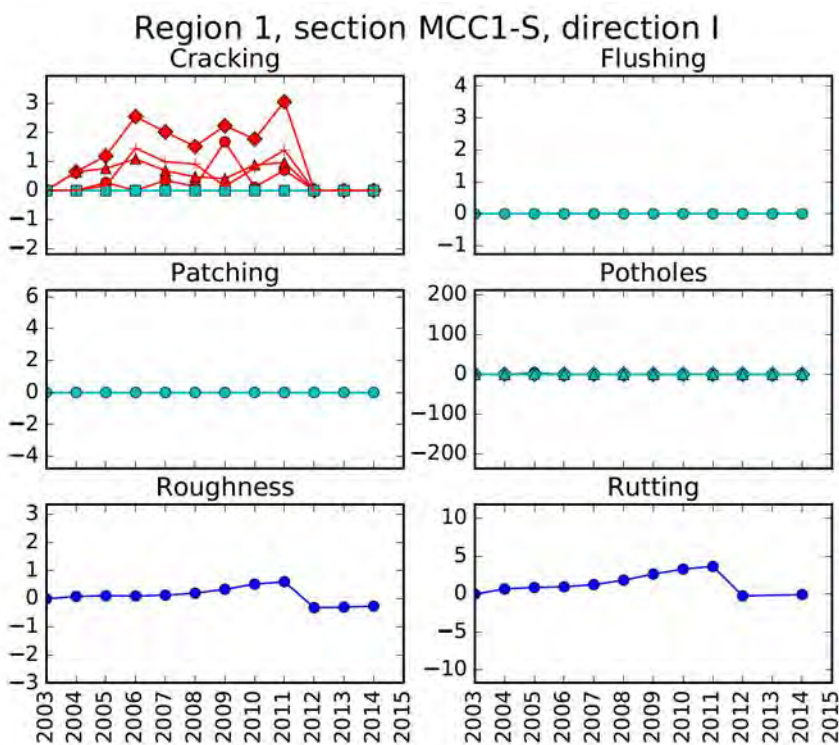
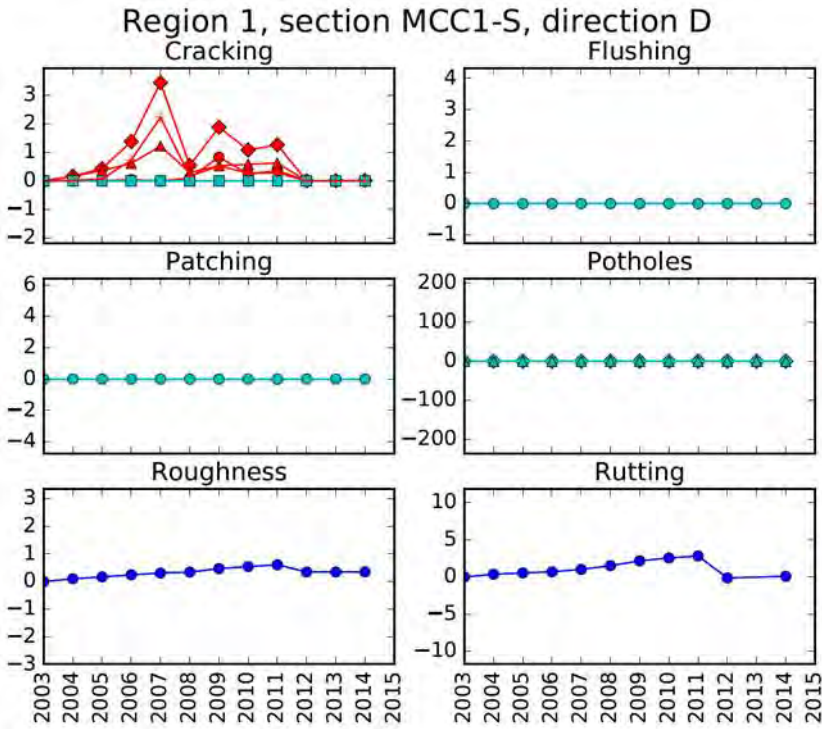
4.2.5 MCC1-S, both directions

Severe cracking but no impact on pavement deterioration

This is possibly a structural asphalt pavement with an asphalt wearing course.

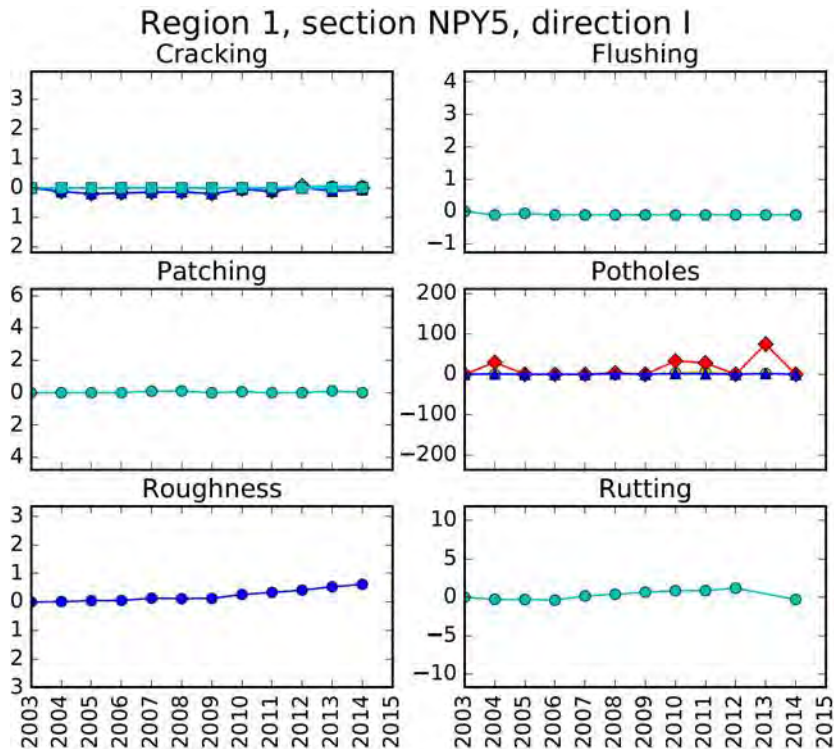
Very bad state. Is this because of poor reinstatement of trenching for underground services, rather than pavement failure?

This site appears to include sections of both chipseal and asphalt surfaces.

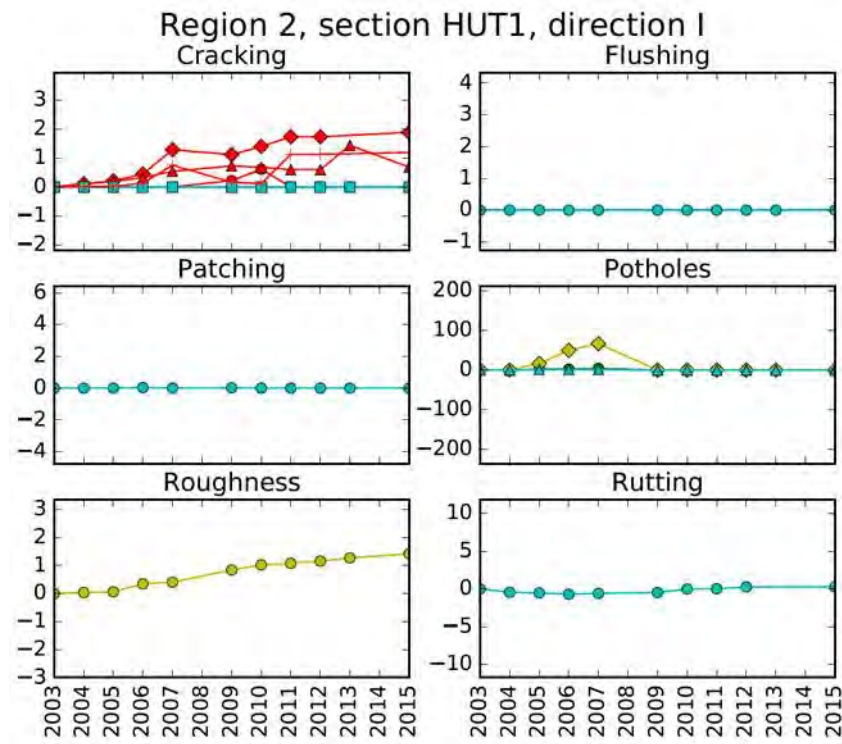
Cracking, potholing and roughness progression.

This is probably an asphalt surface over a granular pavement.

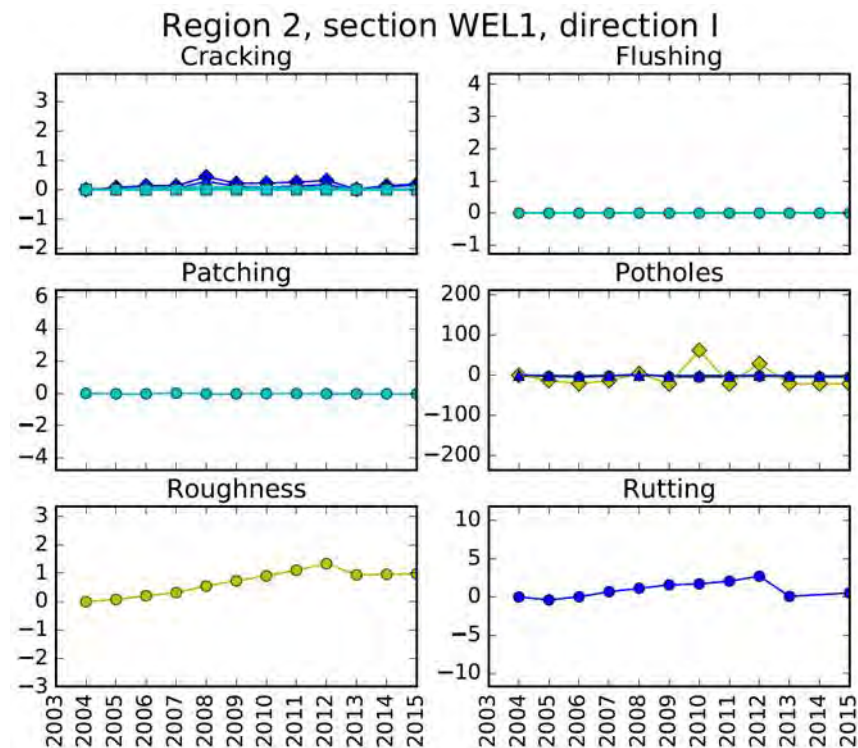
Roughness and potholing increasing, some cracking.

This is a granular pavement with an asphalt surface.

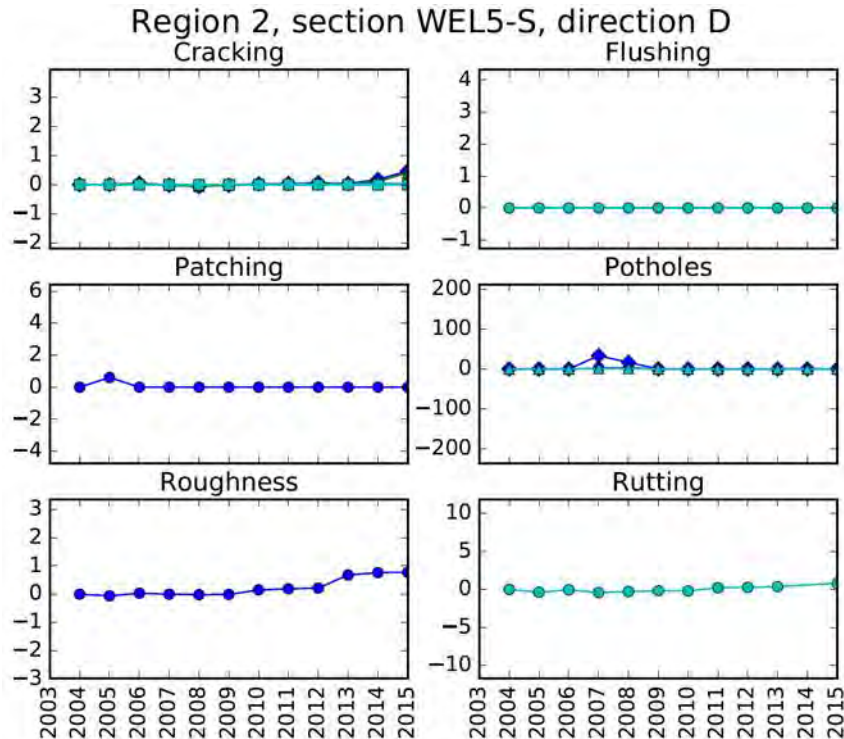
Increasing roughness leading to cracking in one direction only.

This appears to be a polymer modified binder reseal over a variety of surfaces including chip seal and asphalt on a granular pavement.

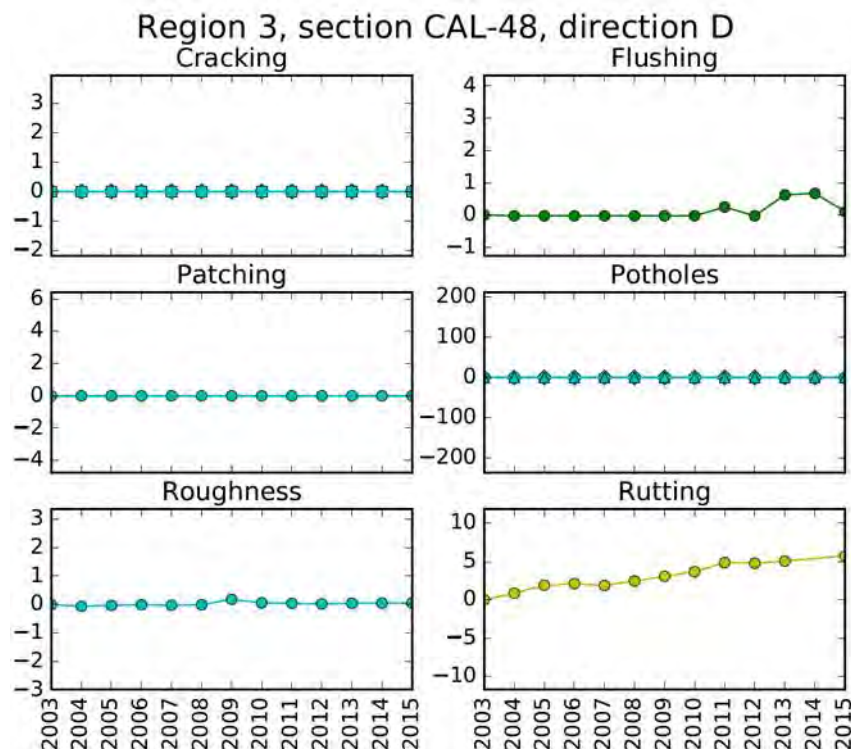
Deterioration in rutting only.

- ADT is 4,162 with 13% HCV.
- Unknown number of chipseals (four recorded in RAMM: G3 reseal 1982, G5 texturing seal 1991, G3 reseal 1997 (recorded in RAMM as G5 but clearly identifiable as a G3 in photographs) and a G4/6 reseal 2009 supposedly applied to treat cracking).
- Original pavement unknown (1980?). M4 AP40 estimated at an approximate depth of 140 mm.
- 2014 FWD reading shows a range of central deflection of 705 μm with a long bowl.
- Has a SNP of 3.27.

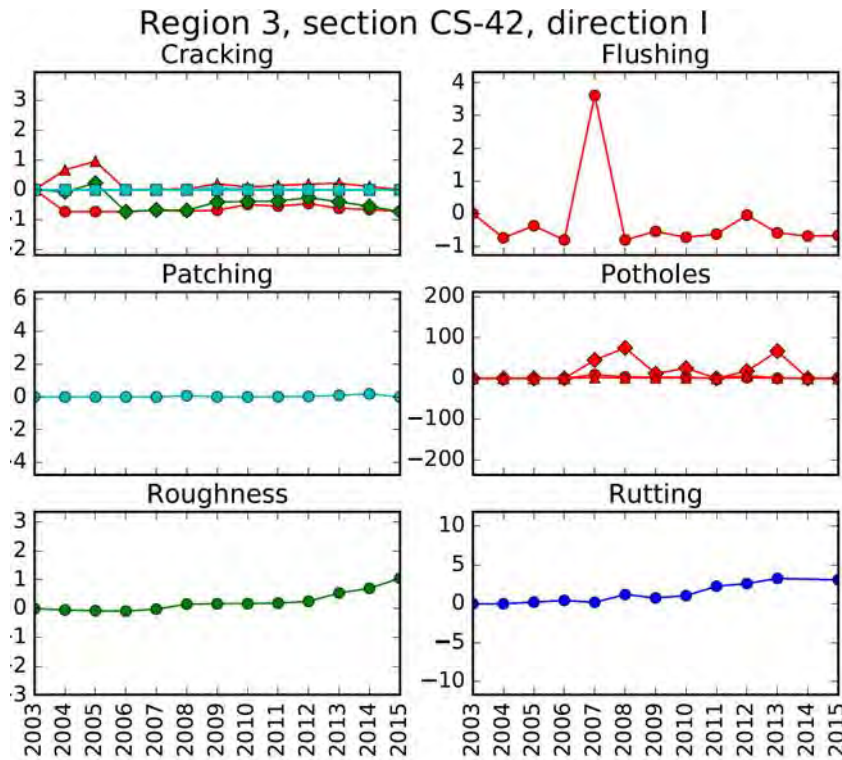
Deterioration in everything except patching.

- ADT is 1,549 with 15% HCV.
- Unknown number of chipseals (five recorded in RAMM: G6 texturing 1989, G3 single coat reseal 1993, G5 texturing 1997, G3/5 two coat 2001 and G3/5 two coat 2014).
- Original pavement unknown (~1964?). No pavement type or depth recorded.
- 2013 FWD reading range between 1309 μm and 1614 μm . Other years' deflections as high as 2469 μm .
- 2013 SNP range between 2.27 and 2.71. Other years' readings as low as 0.26.

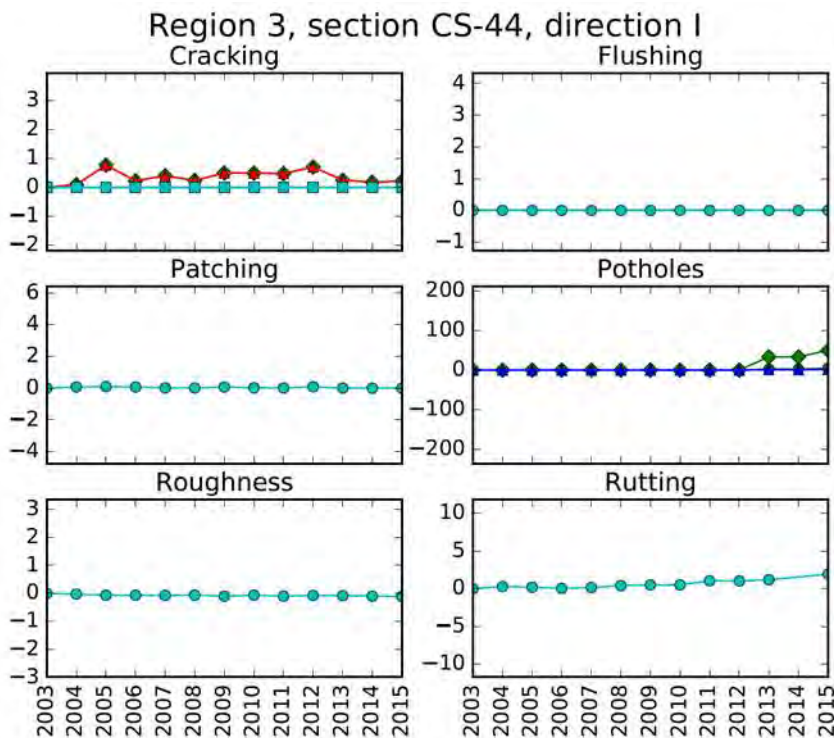
(Note: This statement 'Transverse cracking only' is a good illustration of the potential errors within the LTPP data and supports the recommendation in section 8.2.16 'Crack assessment' (see chapter 8). The statistical analysis used cracking codes in the data to make this statement when a review of the site photographs clearly shows the predominant crack type on this site is longitudinal cracks and particular to the probable cause of the failure at this site.)

- ADT is 3,726 with 10% HCV.
- Unknown number of chipseals although the distress evident in photographs would suggest a relatively thin layer of chipseals (two recorded in RAMM: G5 void fill 1985 (could be second coat), G3 single coat seal 1990).
- Original pavement unknown (RAMM has 50 mm of AP20 ~1961?).

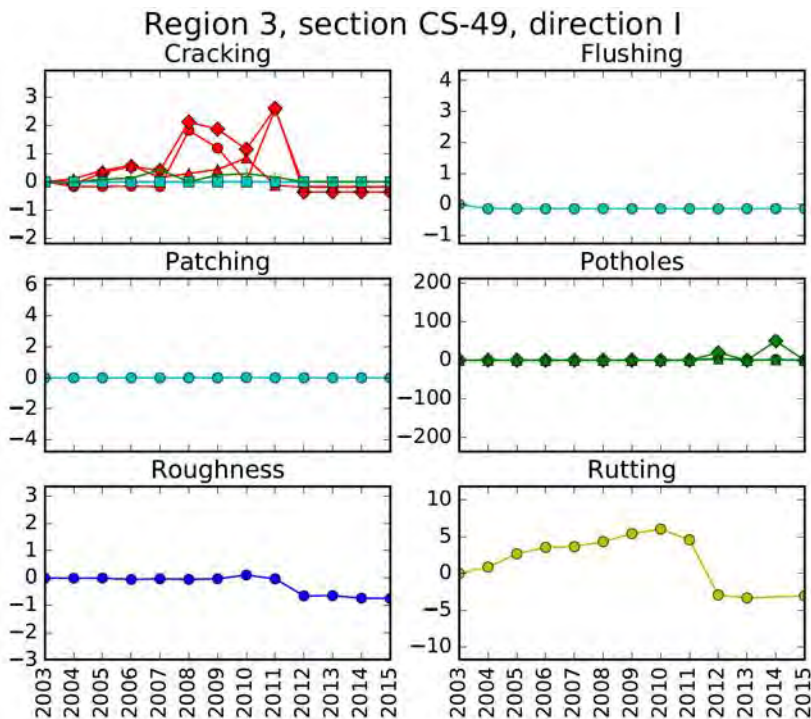
Cracking and rutting getting worse over time.

- ADT is 6,547 with 12% HCV.
- One chip seal (G3/5 two coat first coat 2011).

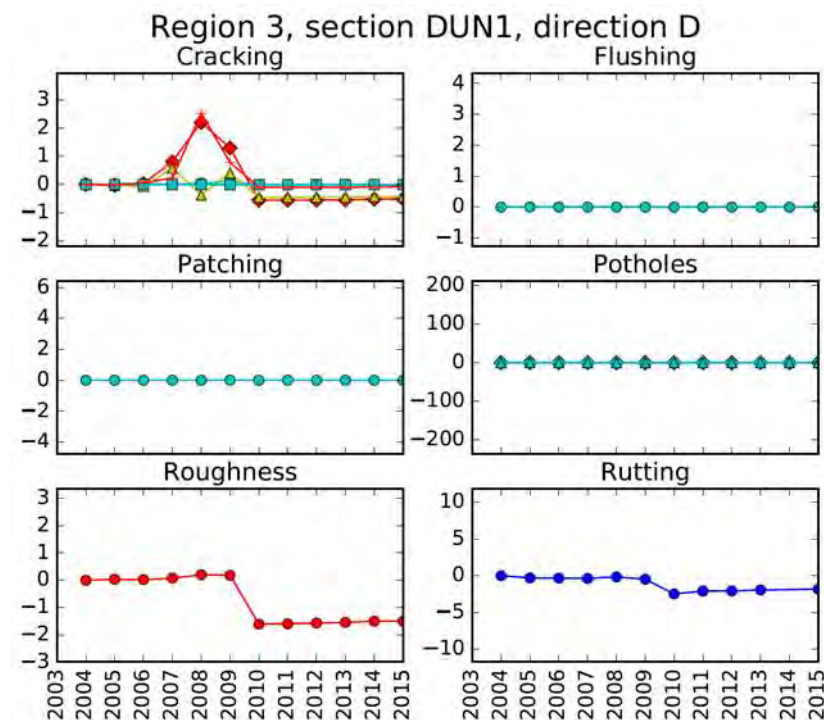
Cracking, but no other deterioration.

Appears to be a structural asphalt pavement with an asphalt wearing course.

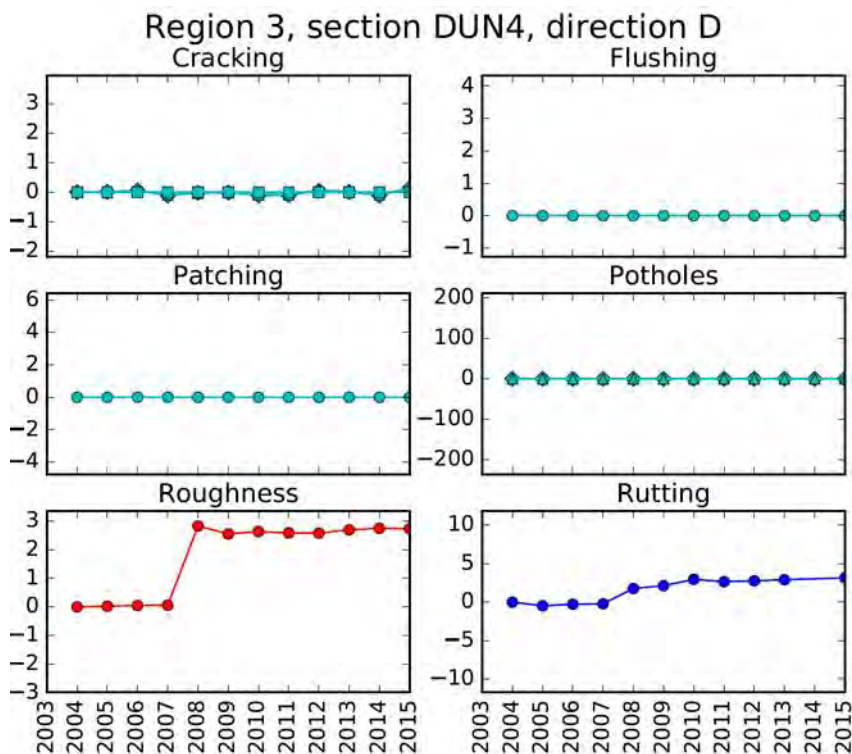
Big jump in roughness in 2008.

This is possibly a granular pavement with asphalt wearing course. It may be a structural asphalt pavement but there are significant areas of cracked thin AC pumping fines.

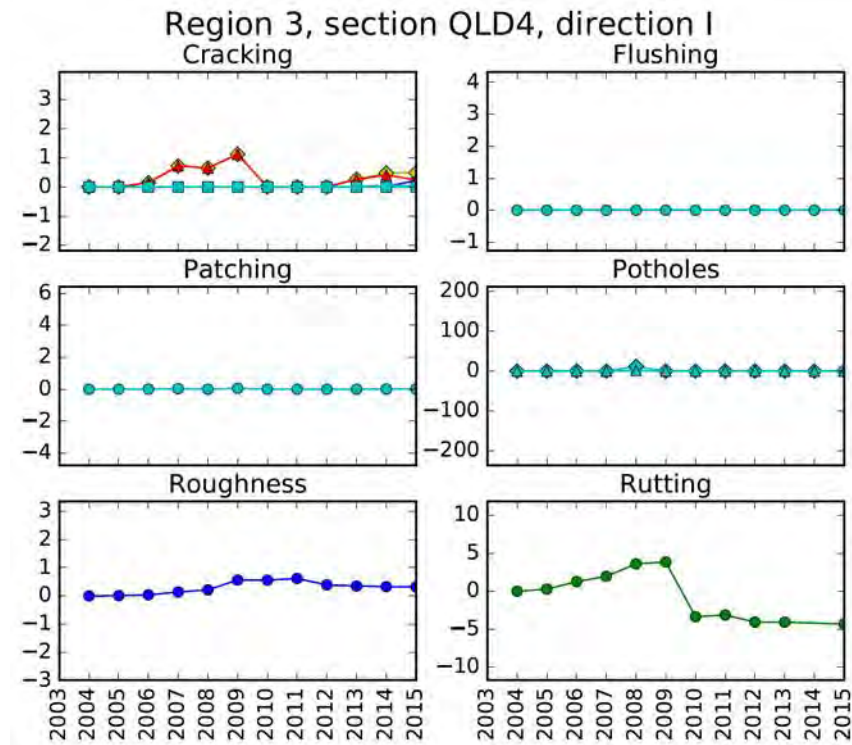
Cracking and rutting appear related.

This is a granular pavement with a chipseal surface

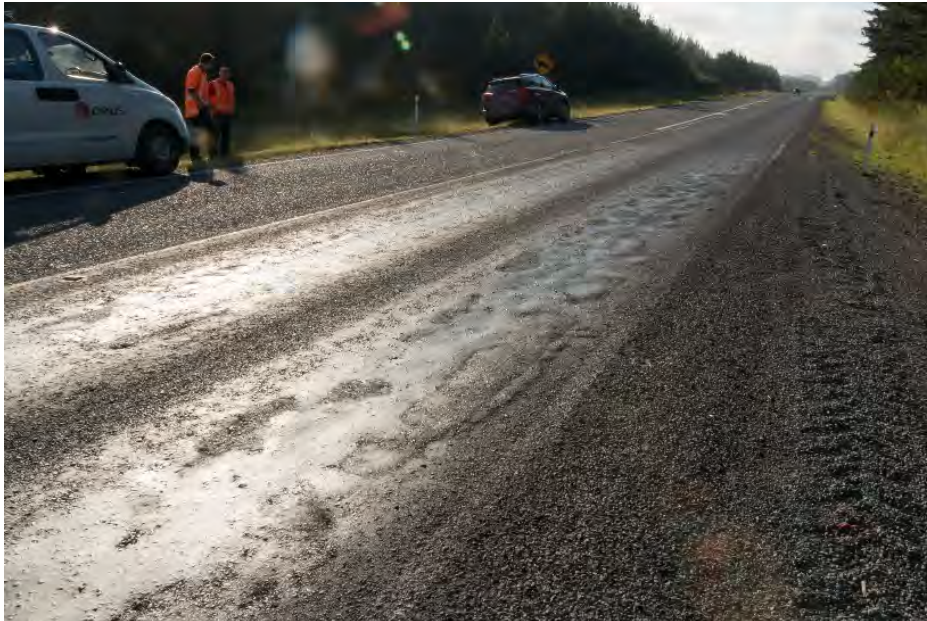
Figure 5.2 CAL- 58 SH38 RP 0/16.83 – 17.13 Decreasing direction

This site (figure 5.2) is a very good example of where poor maintenance repairs for whatever reason have dramatically affected the site data showing a dramatic reduction in pavement performance after spending a large amount of money on maintenance repairs. A total of \$42,838.85 has been spent on pavement and surfacing repairs in the decreasing direction since 2011/12.

Poor designs have also contributed to the failure of chipseals on maintenance patches and also of some chipseal renewals. Incorrect seal selection to accommodate the existing texture or incorrect binder and chip application rates contribute to either flushing or chip loss. Poor repair reconstruction has led to failed rough repairs which are all too common in both calibration and sterilised sites.

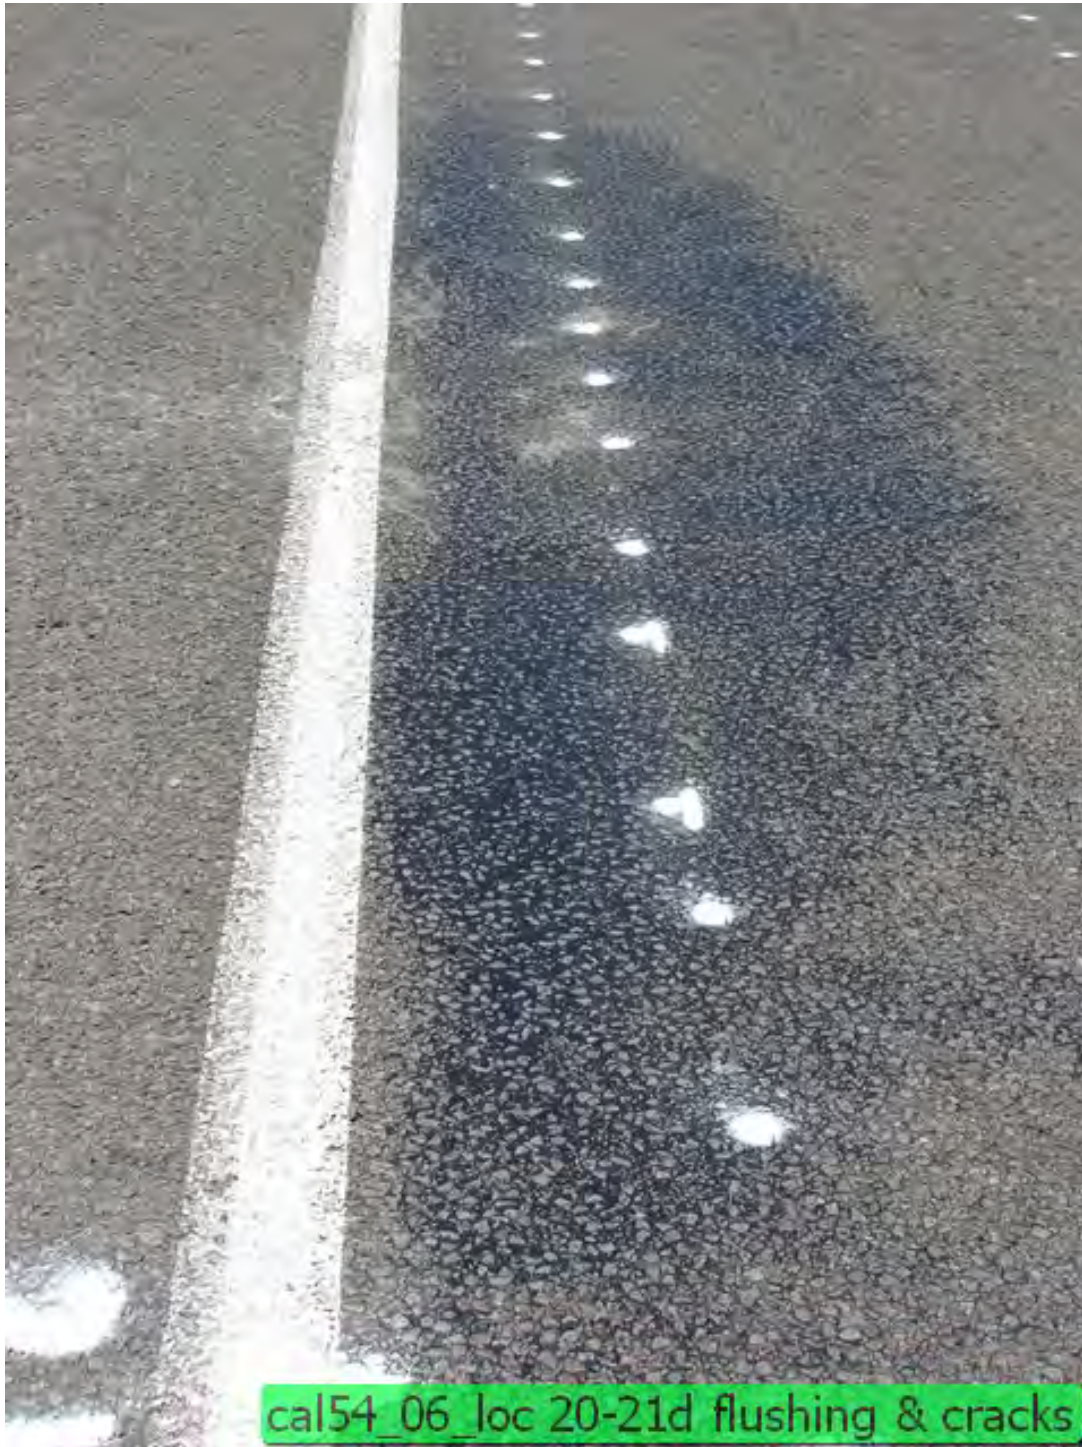
Figure A.1 Photograph 1, CAL- 54, 19 January 2007, loc 20- 21d flushing and cracking

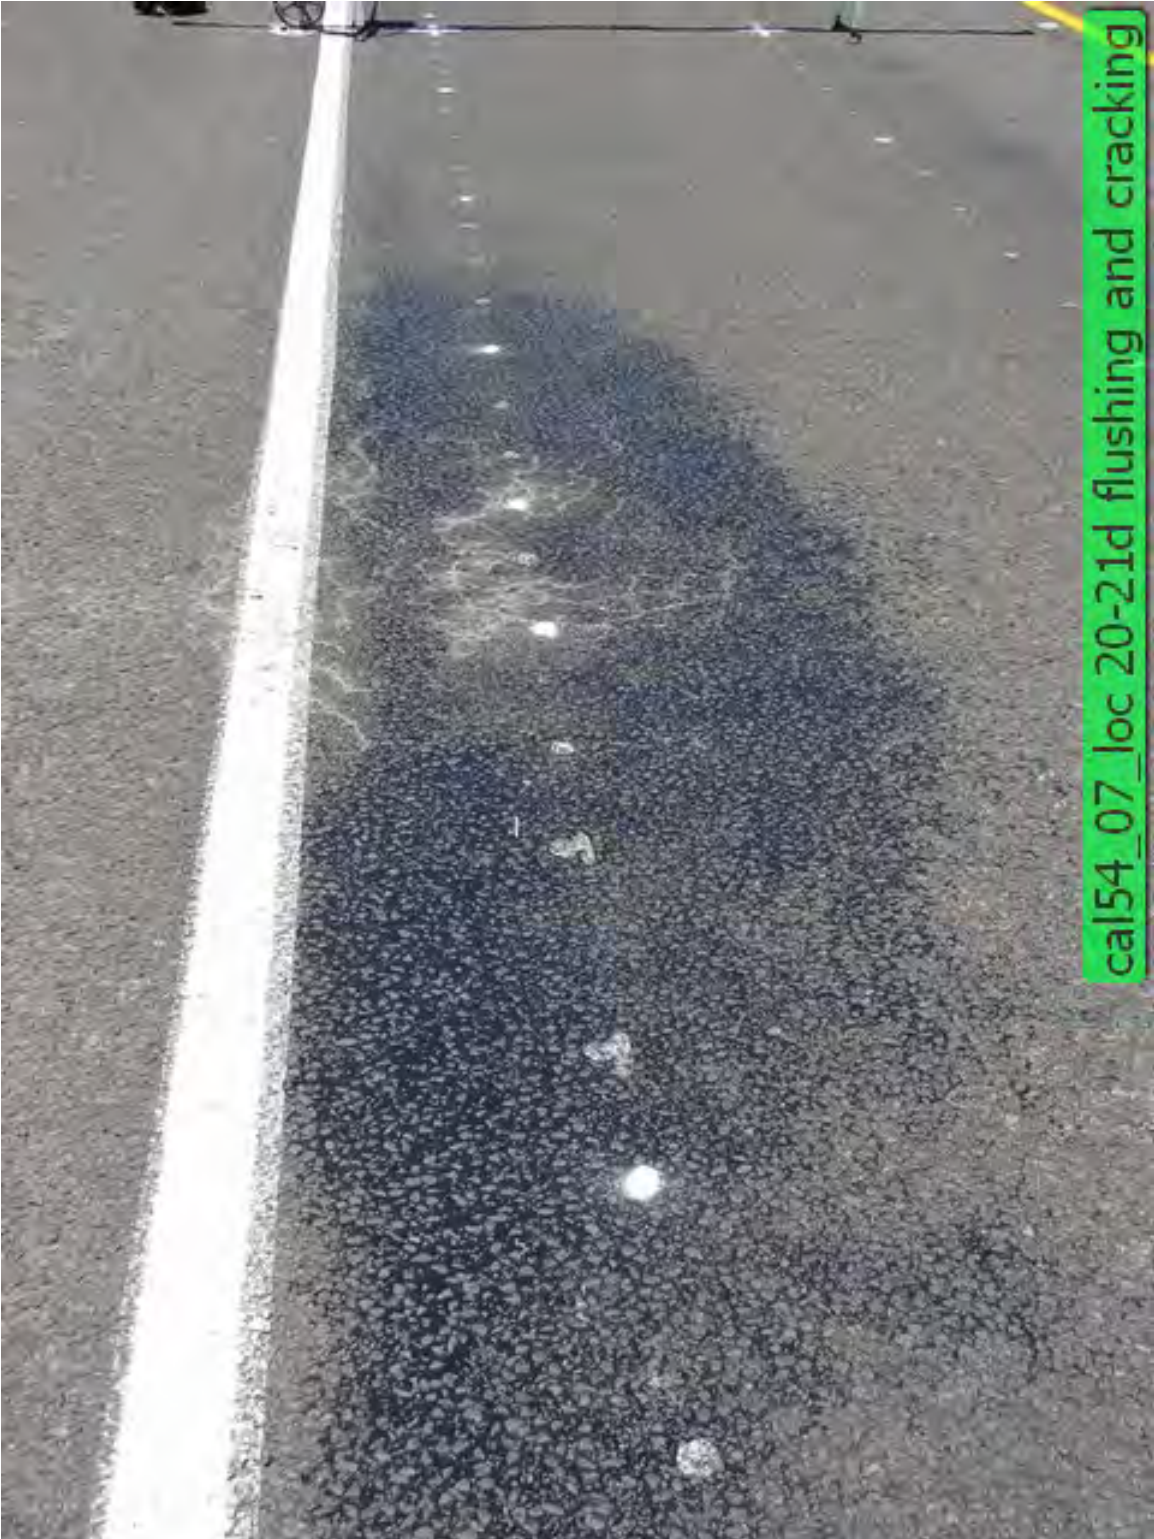
Figure A.2 Photograph 2, CAL- 54, 22 November 2007 loc 20- 21d flushing and cracking

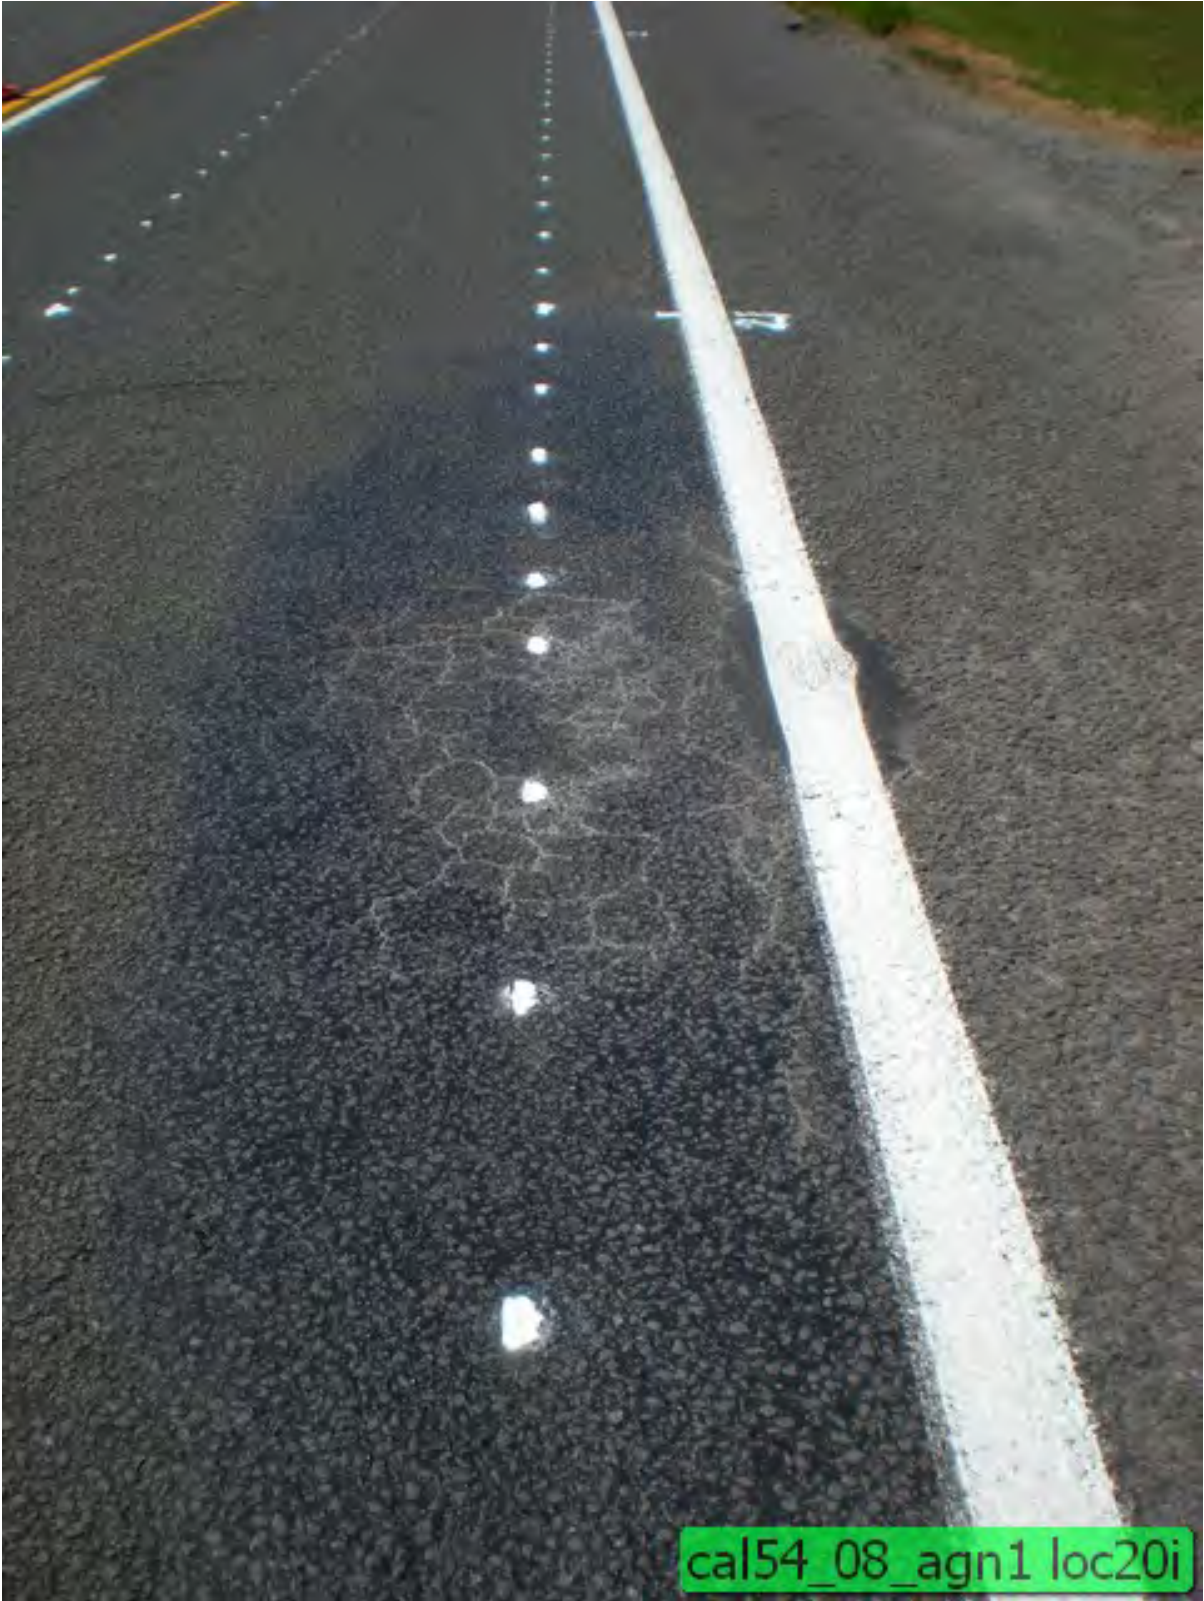
Figure A.3 Photograph 3, CAL- 54, 21 November 2008 loc 20- 21d flushing and cracking

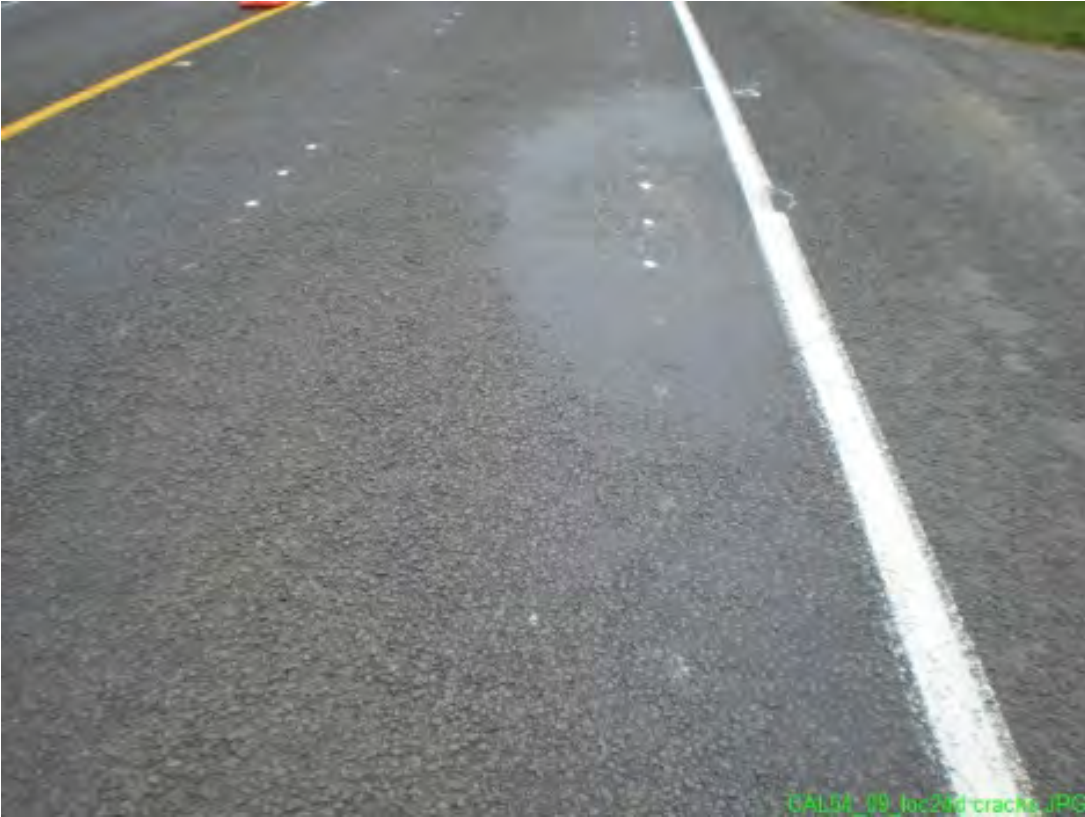
Figure A.4 Photograph 4, CAL- 54, 6 December 2009 loc 20- 21d flushing and cracking

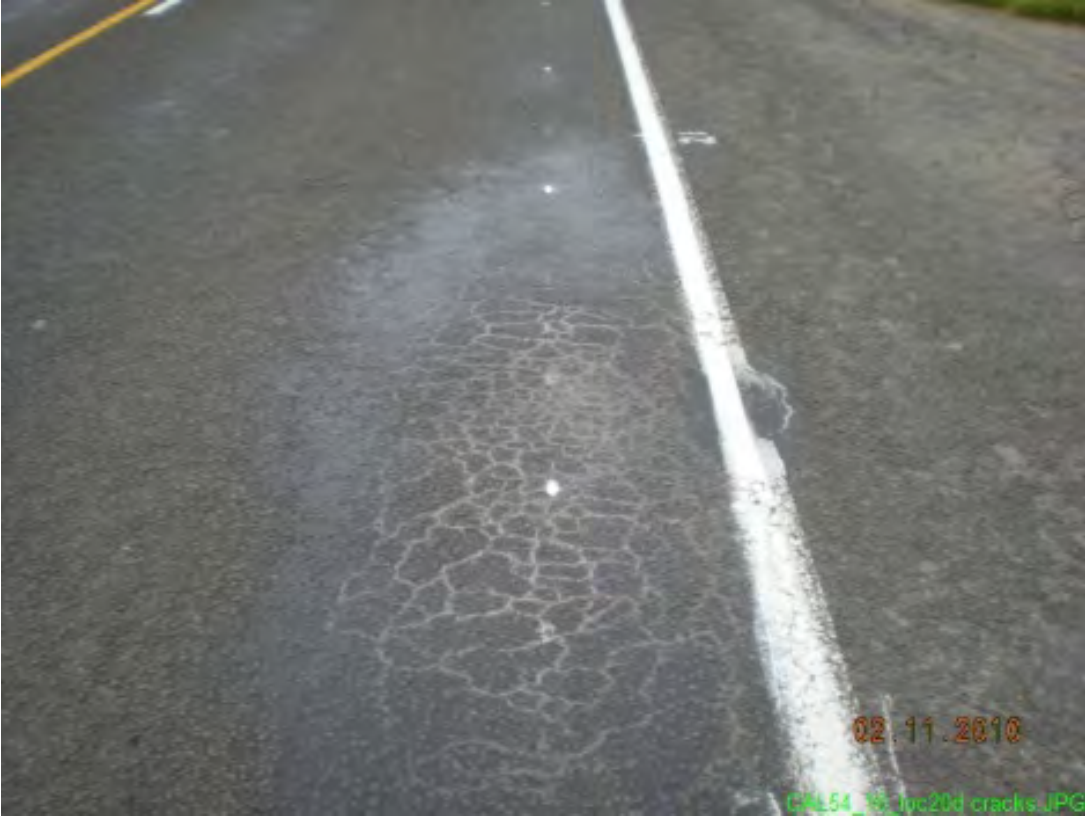
Figure A.5 Photograph 5, CAL- 54, 2 November 2010 loc 20- 21d flushing and cracking

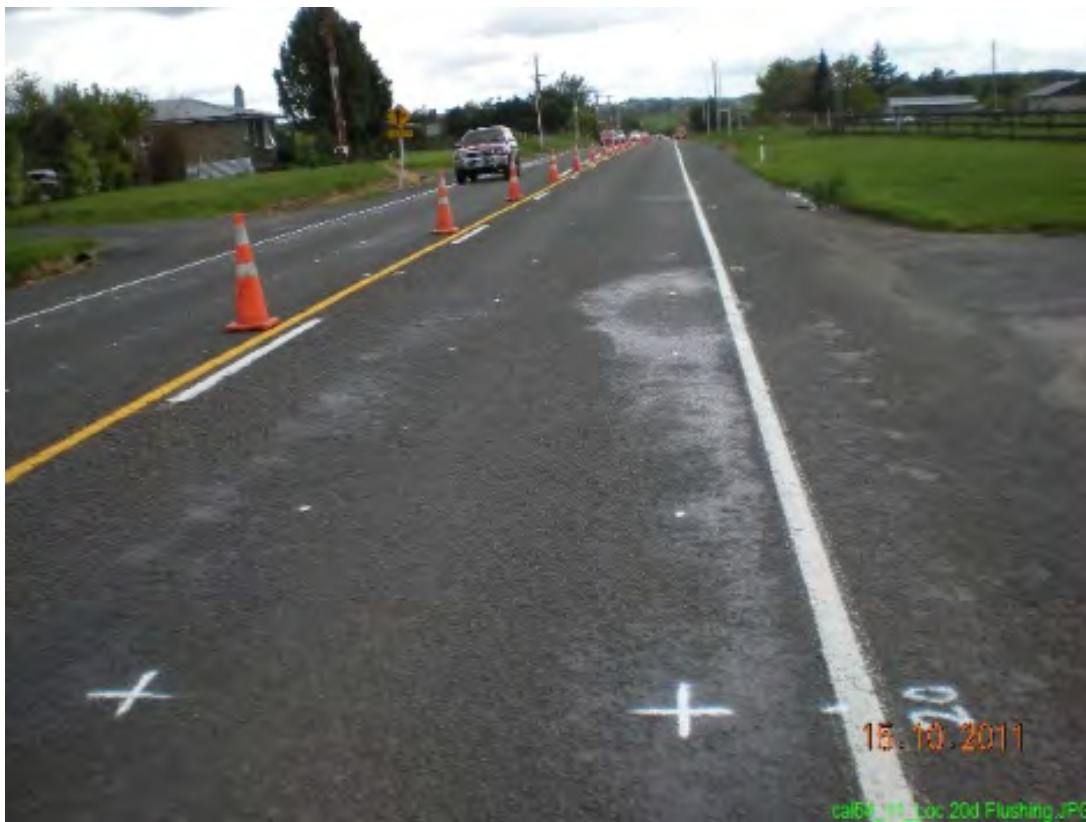
Figure A.6 Photograph 6, CAL- 54, 15 October 2011 loc 20- 21d flushing and cracking

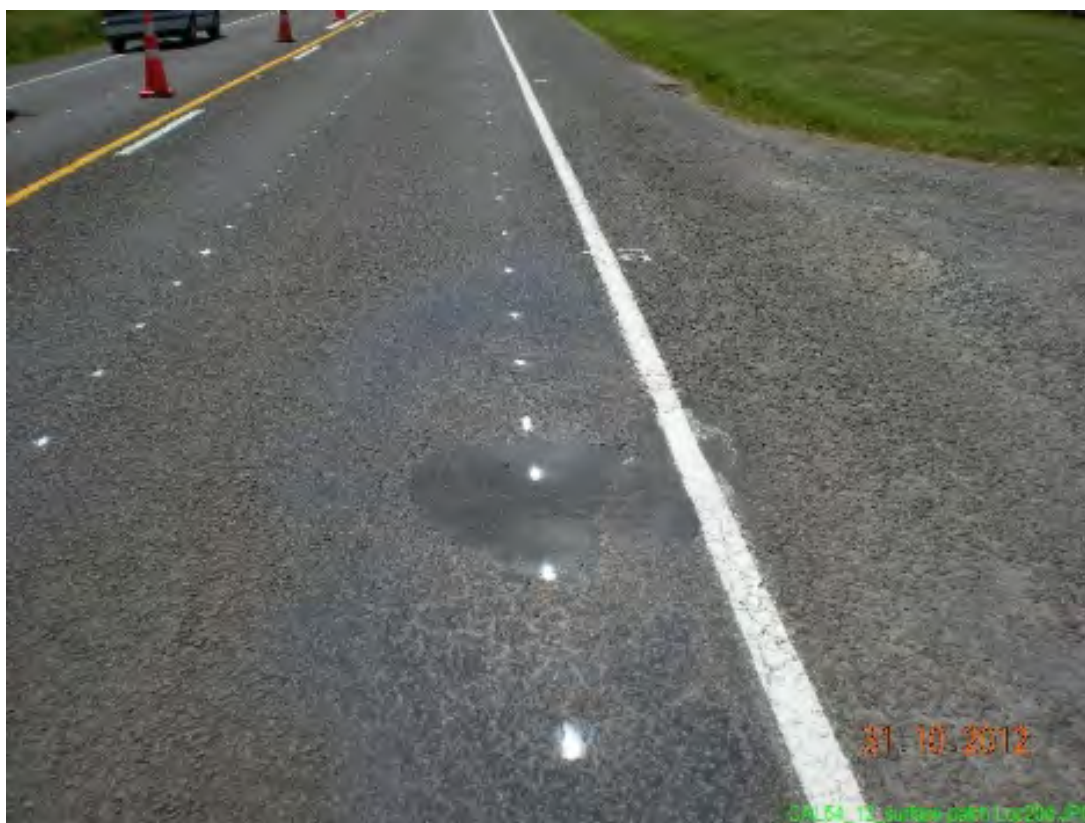
Figure A.7 Photograph 7, CAL- 54, 31 October 2012 surface patch loc 20d
