Analysis and interpretation of New Zealand long-term pavement performance data December 2017

KL Neaylon, R Davies, L Harrow and R Henderson
Opus Research, Opus International Consultants

NZ Transport Agency research report 633
Contracted research organisation – Opus International Consultants

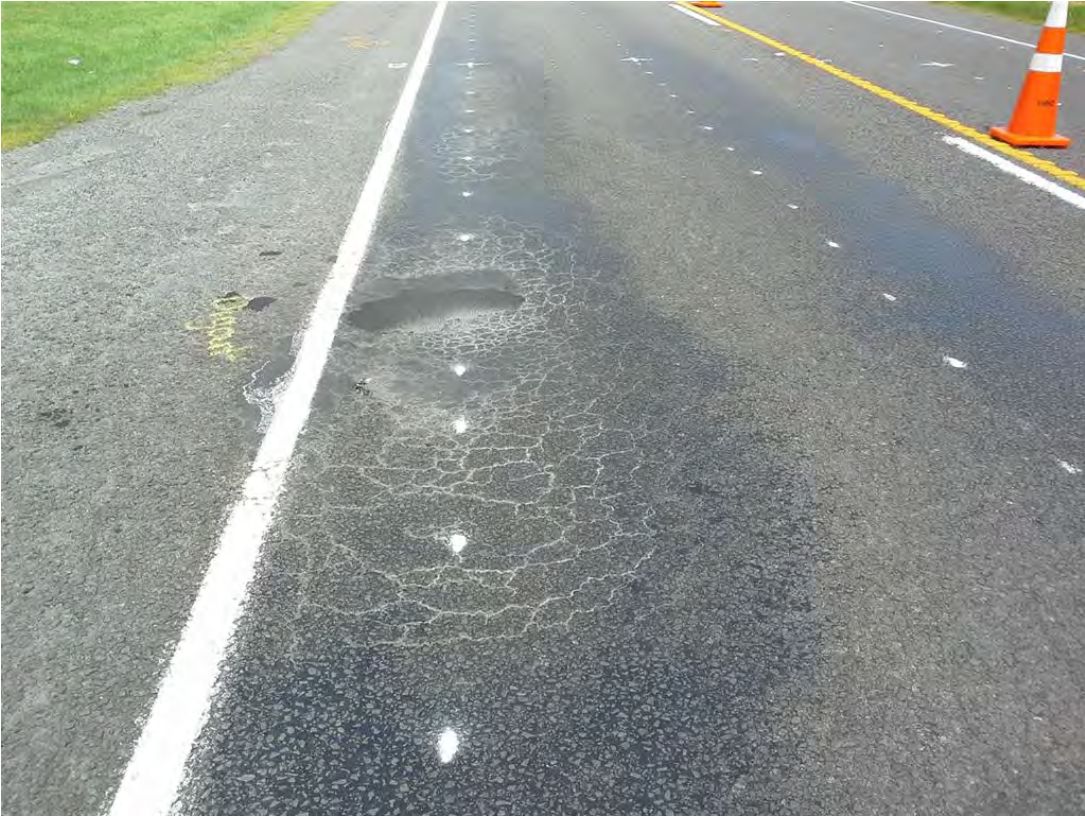
Figure A.8 Photograph 8, CAL- 54, 7 October 2013 loc 20- 21d flushing and cracking

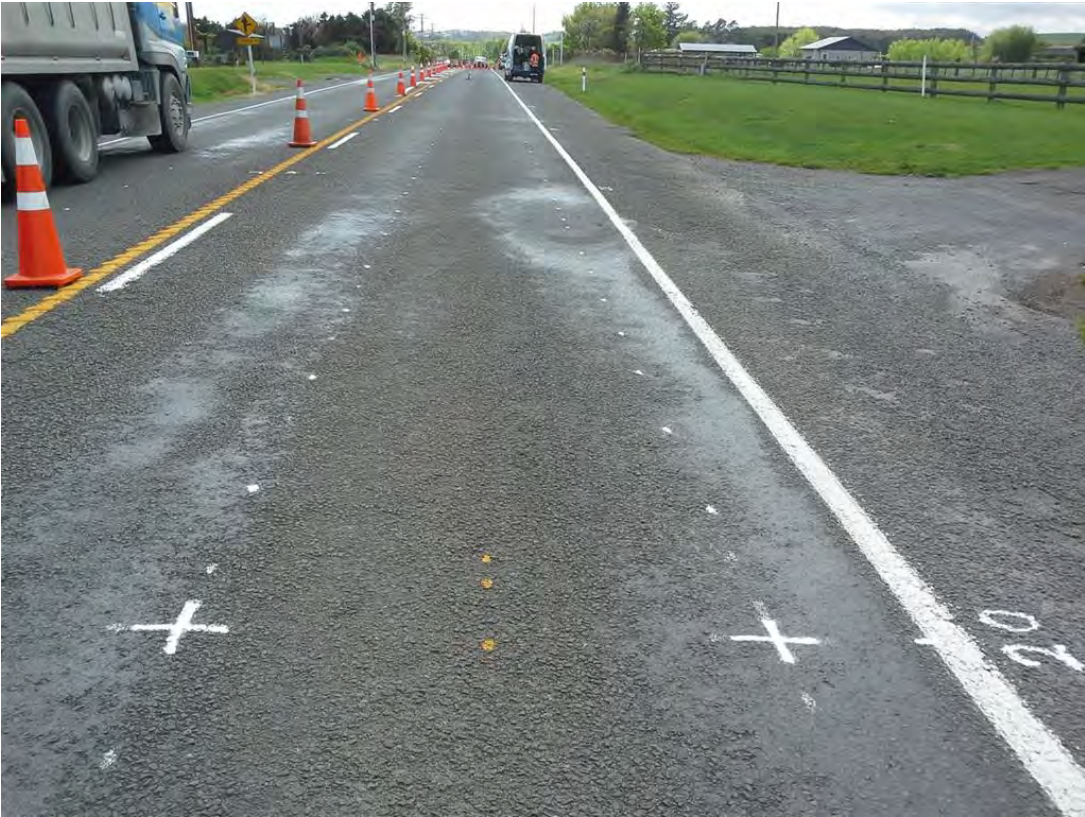
Figure A.9 Photograph 9, CAL- 54, 17 October 2013 loc 20- 21d flushing and cracking

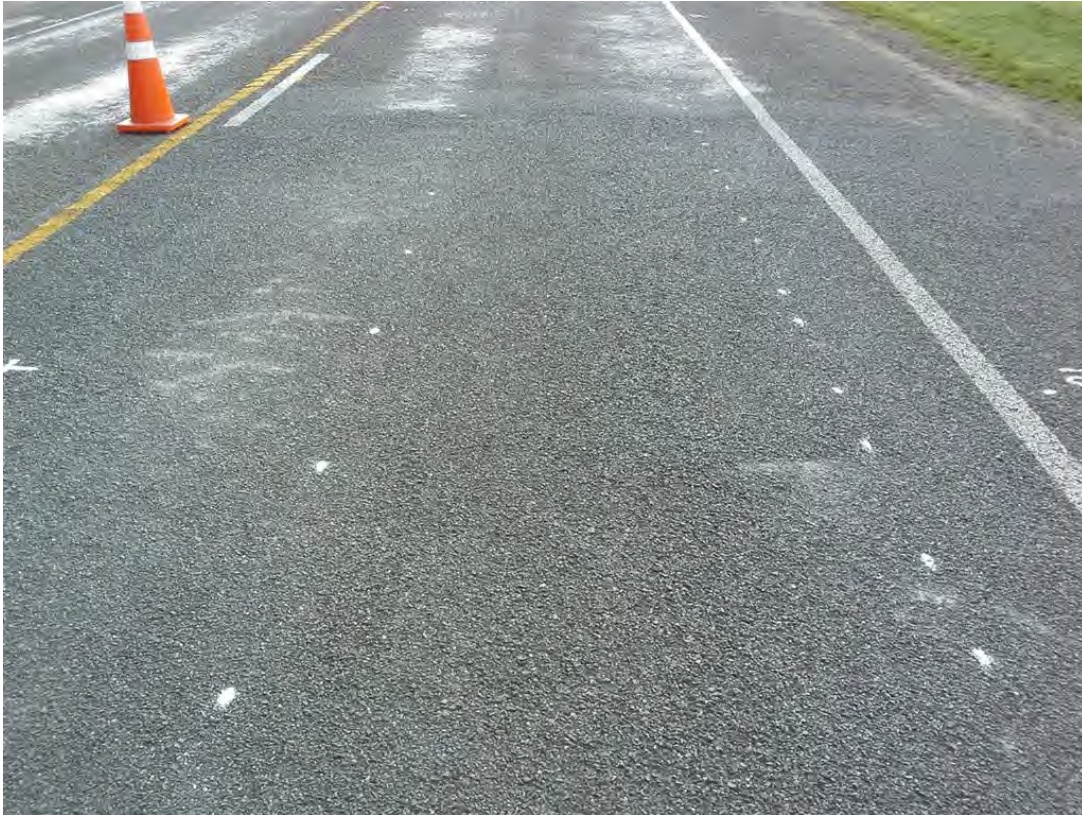
Figure A.10 Photograph 10, CAL- 54, 5 November 2014 loc 20- 21d cracking in the 2014 maintenance repair

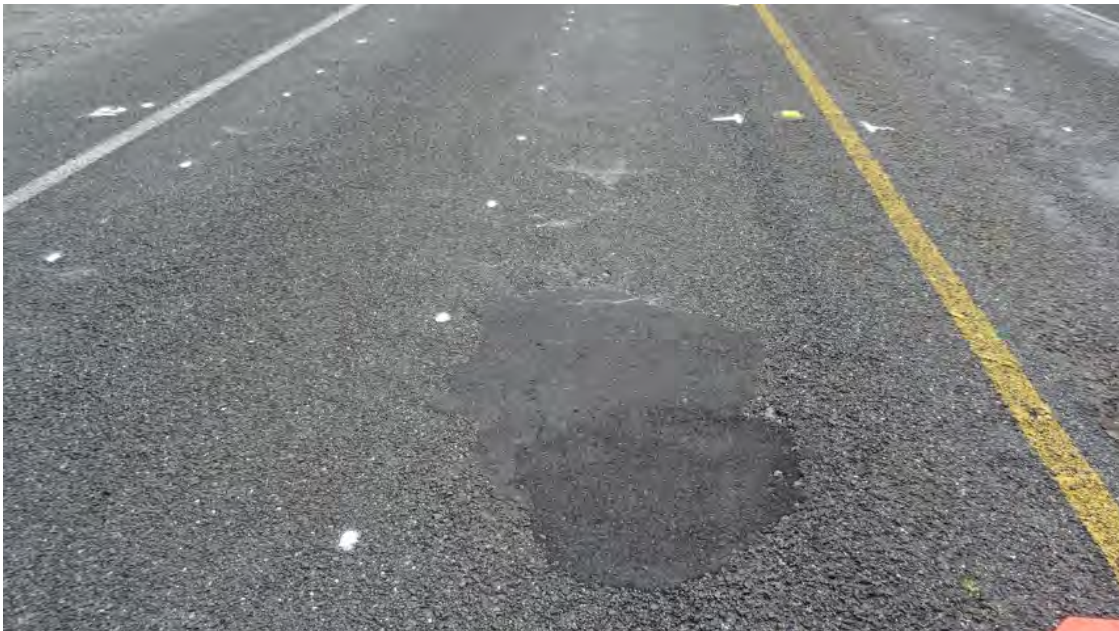
Figure A.11 Photograph 11, CAL- 54, 29 October 2015 loc 20- 21d cracking and patching in the 2014 maintenance repair
