Christchurch City Council City Streets Unit

Road Safety Audit and Inspection

**Riccarton Road
Deans Avenue to Curletts Road**

June 2002

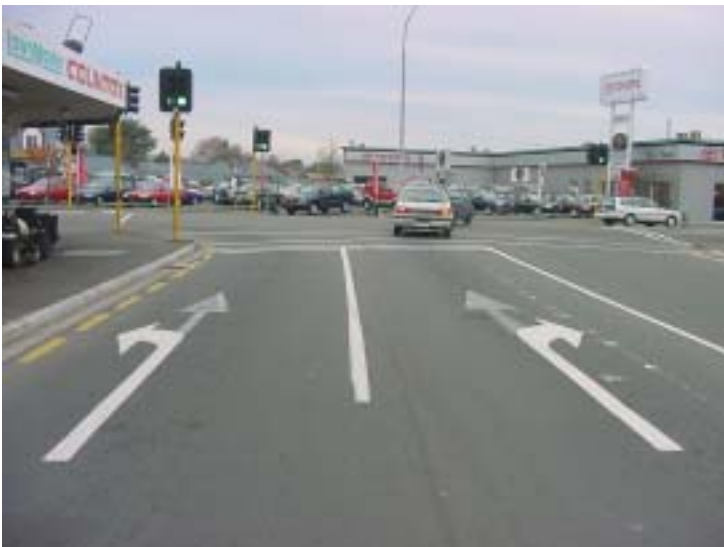
All road markings were generally in poor condition.

Example of redundant markings that are still visible – Clyde Road

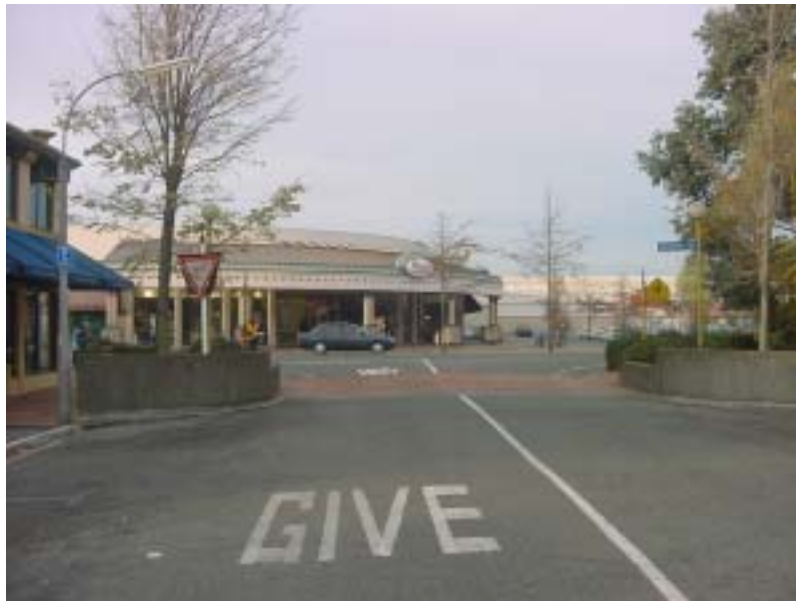
Example of an obstruction, which is not delineated with red RRPM's – Kauri Street intersection.

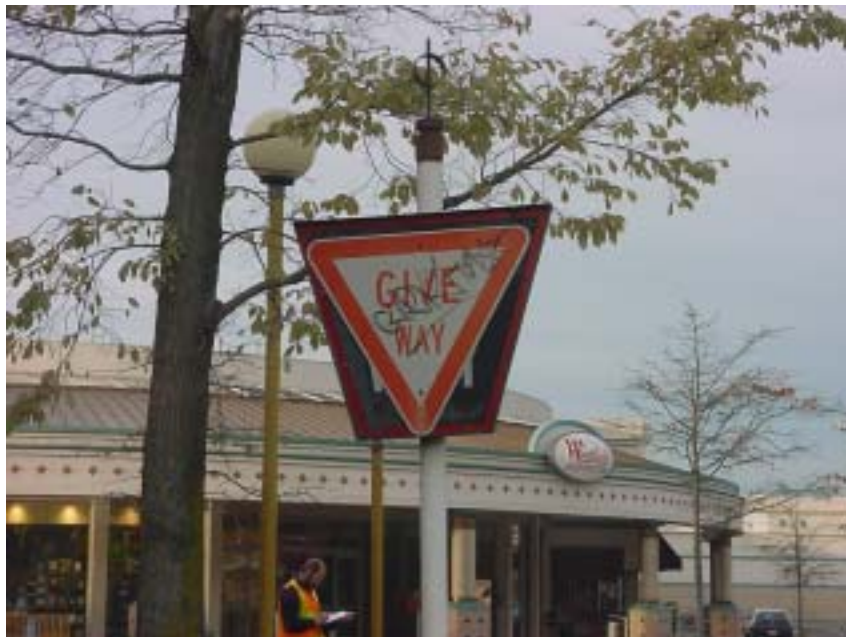
Example of damaged intersection control sign installed over “old” style sign – Kauri Street intersection

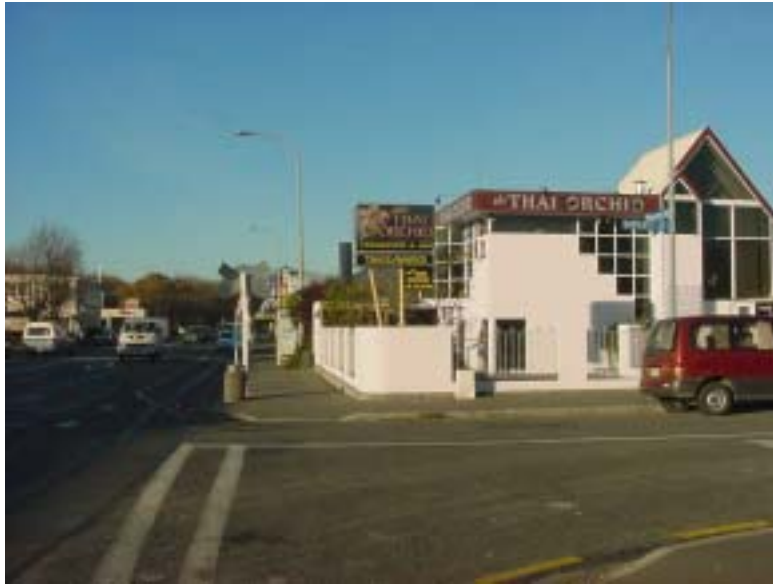
- Street nameplate signs are of varying standard and in many cases are located in positions where they are not visible to road users on the main route;
- Parking control signs are of varying standard, are generally in poor condition and are erected at varying heights and angles to the main route;
- The signage associated with the railway crossing is in poor condition and is to the “old’ standard;
- Many intersection control signs are damaged and some have been erected over the old shape signs. The latter feature makes the identification of the side road control type difficult for main route road users.

Example of a badly located Street Name Plate that is not visible from Riccarton road – Bartlett Street intersection.

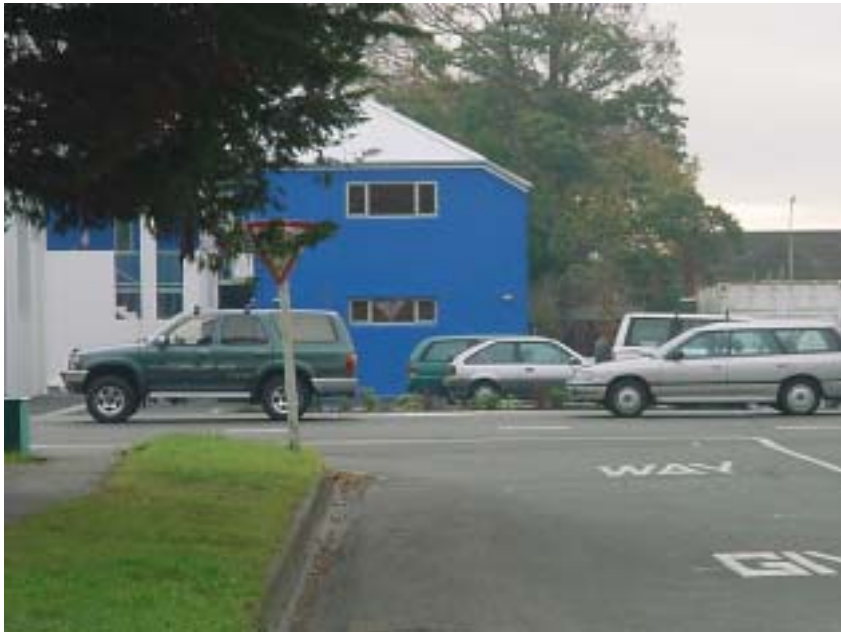
Vegetation is obscuring signs, blocking visibility and sight distances, overhanging the carriageway and footpaths and affecting pedestrians. See photograph below.

Example of vegetation overhanging footpath and blocking visibility to signage

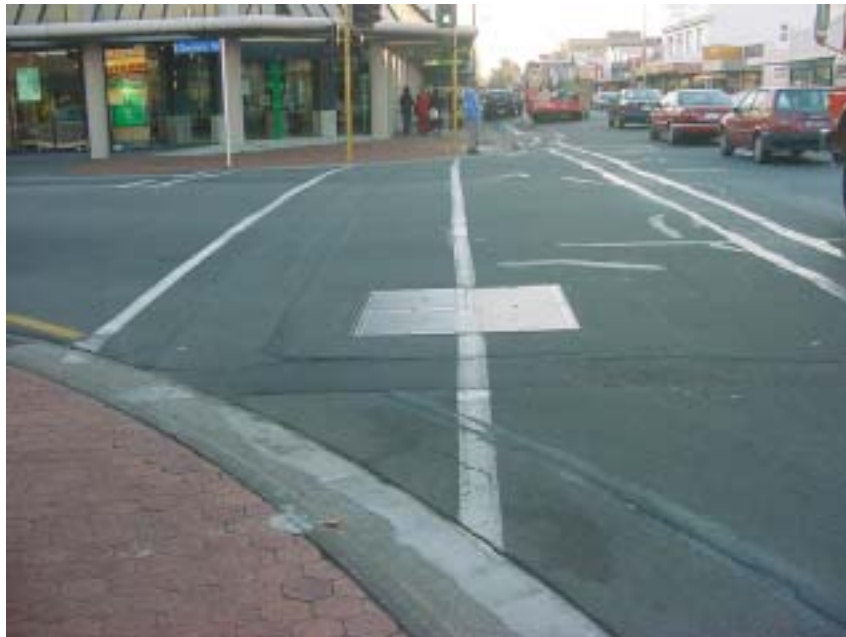
- Cut downs at kerb and channel interface are generally of poor condition and require reconstruction to remove steps and improve slopes for mobile scooters and wheelchairs as well as pedestrians;
- Surfacing on footpaths is very rough and uneven/stepped in many places;
- Surfacing across the carriageway at road crossing points is rough and stepped in many places;
- In some locations remedial work on service trenches is of a poor standard. When this defect occurs in a pedestrian travel path the resulting trip hazard is of concern.

Example of poor pedestrian cut downs, trenches that have been poorly repaired and could be trip hazards and slippery service cover plates.

- Review existing condition of pedestrian cut downs, footpath and crossing point surfacing and manage replacement with remedial actions being prioritised to ensure the removal of the most hazardous defects first;
- Investigate the real needs required for disabled persons at crossing points and implement remedial repairs ASAP to effect immediate improvements for users of mobile scooters and wheelchairs;
- Risk level – “**High Risk**”.

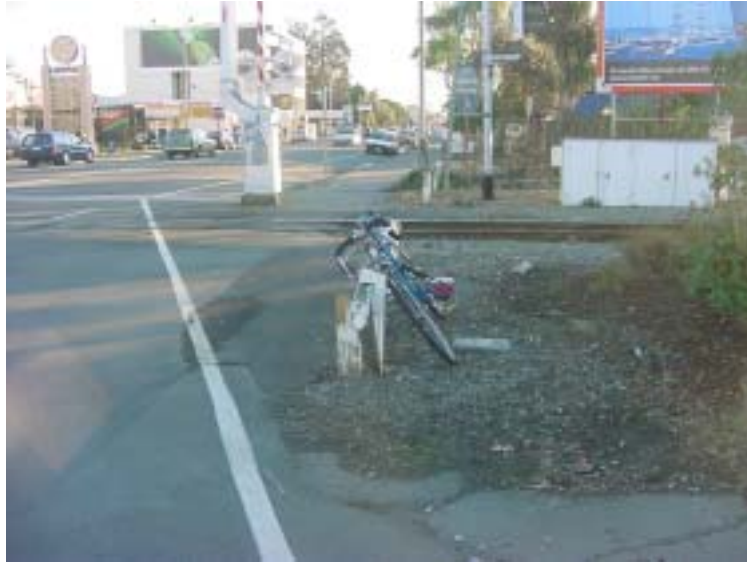
- There is a pedestrian verses vehicle conflict on the north eastern side of the crossing, where the footpath is not defined. This could lead pedestrians into conflict with eastbound vehicles left turning into Mona Vale Avenue;
- The roadside barriers on both sides of the road adjacent to the crossing are a timber post and rail and are in poor condition. In the event of a wayward vehicle impacting the barriers the rail could be a hazard that may increase the severity if the crash.

View looking west showing the pedestrian/vehicle conflict area where the footpath terminates and the roadside barrier.

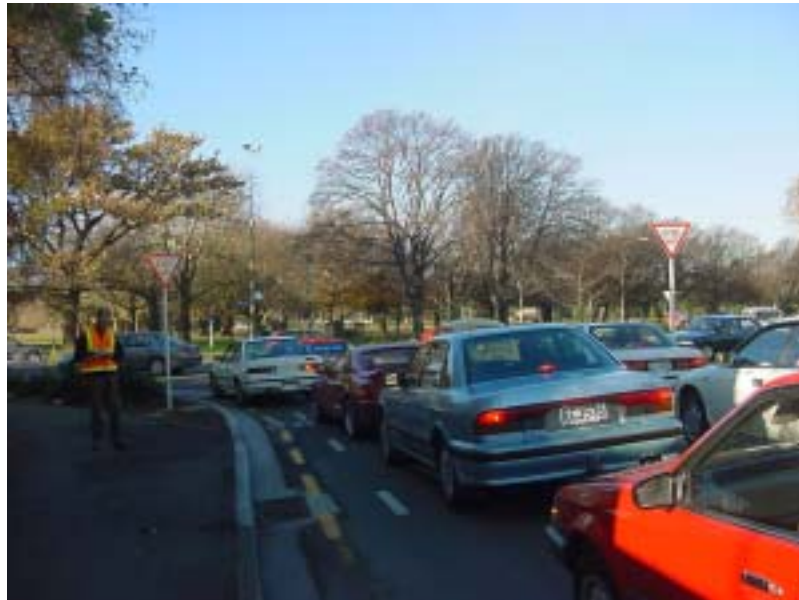
View looking east, on the approach to Deans Avenue Roundabout, showing an inadequate cycle lane. Note position of sump grate.

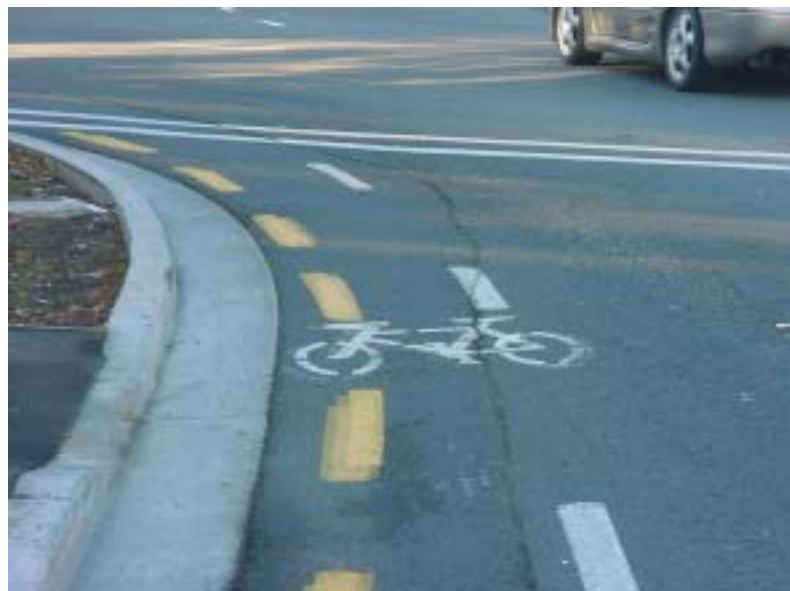
Close up, showing narrow cycle lane and cycle marking extending into live lane

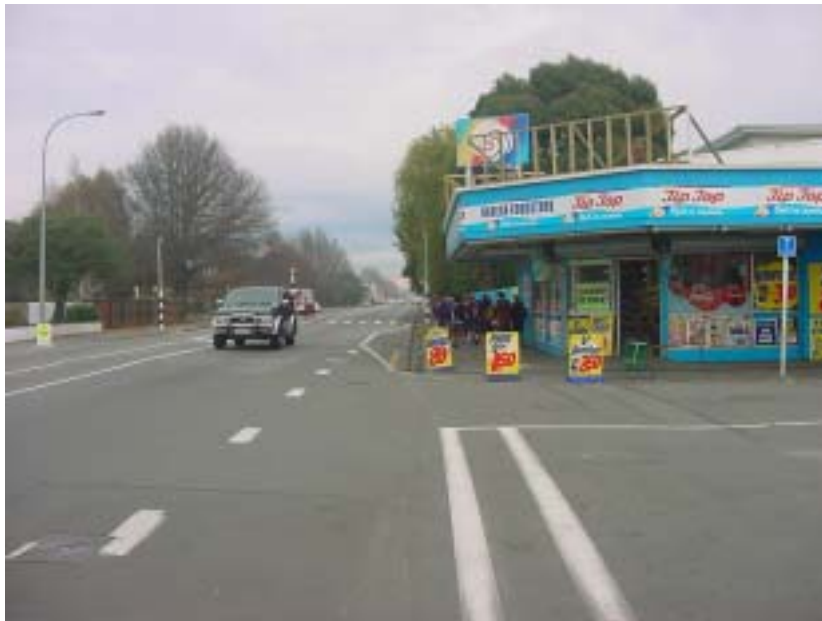
Example of excess signage – Puriri Street intersection

- Where appropriate the Christchurch City Council should review conditions of Resource Consents for roadside activities, with respect to advertising signage and where necessary take appropriate enforcement action;
- Risk Level - “**Medium Risk**”.

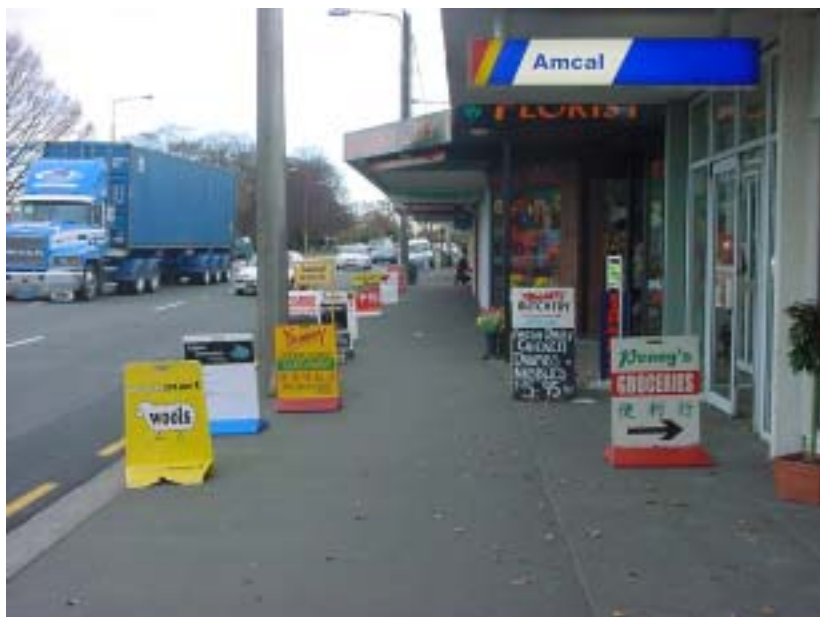
Example of excess signage – Church Corner.

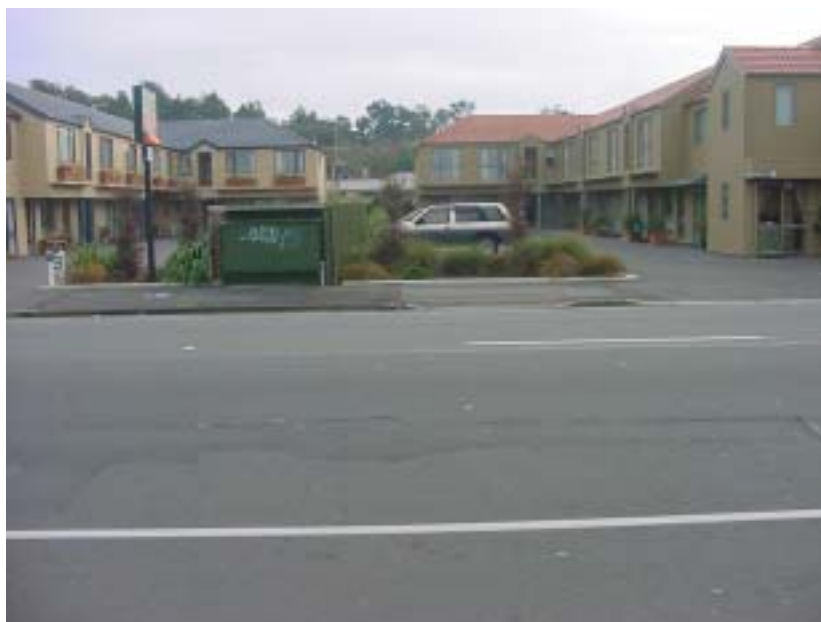
Suggested Pedestrian crossing point location adjacent No 140 on the north side of Riccarton Road

- Consider relocating the pedestrian crossing at Bartlett Street further to the east and installing Bulbous kerbs and a central splitter island to accent the existence of the crossing;
- Consider the installation of a pedestrian refuge adjacent to the Westfield Shopping Centre adjacent to the redundant vehicle crossing at No 140 Riccarton Road. See photos below.

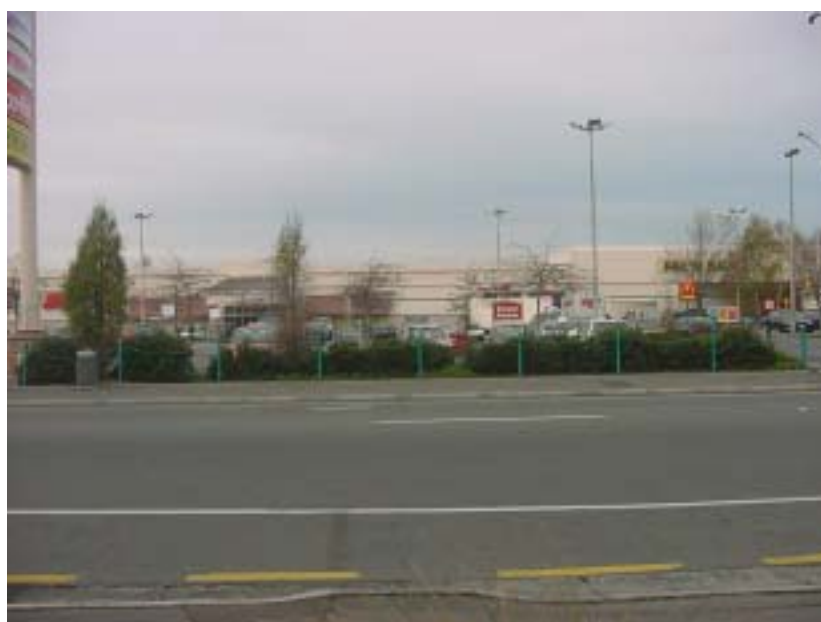
Suggested Pedestrian crossing point location on the south side of Riccarton Road. Note the pedestrian access from the shopping centre car park may need to be relocated.

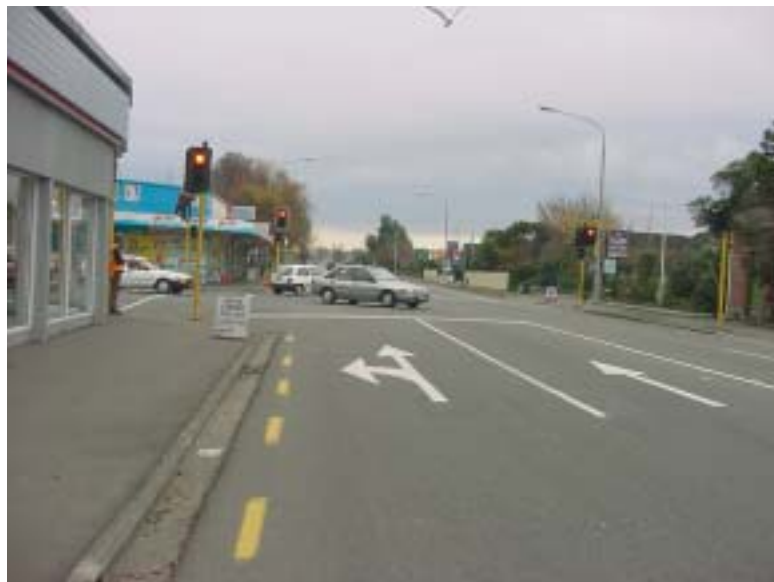
Looking west on approach to Wharenui Road intersection - Note two through lanes

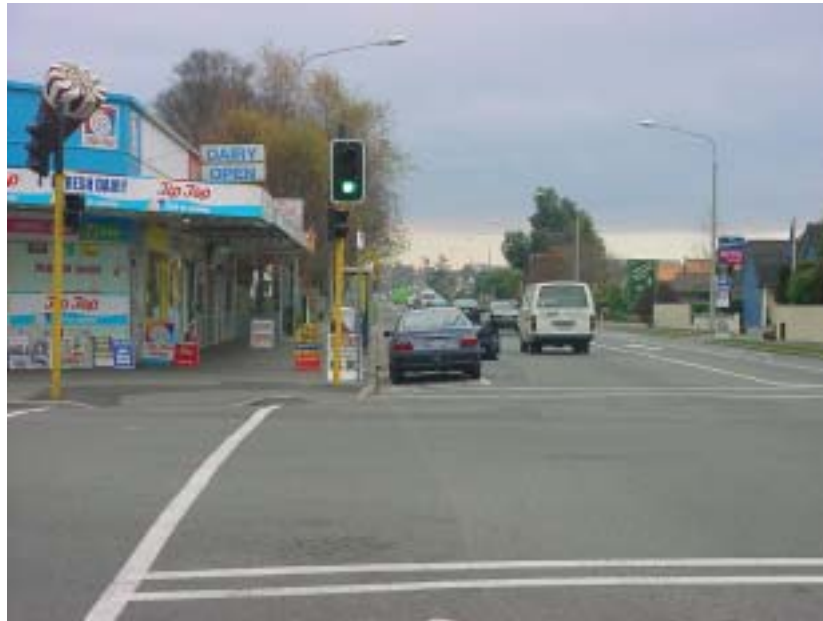
- Clyde road – east bound – no stopping restriction east of the intersection too short. No merge advisory signs installed;
- Wharenui Road intersection – westbound – Two lanes at the traffic signal controlled intersection are forced to merge into one lane through the intersection because of parked cars on the west side exit. No merge advisory signs installed;

Looking west on exit from Wharenui Road intersection - Note no merge length because of parking area - two lanes must merge through intersection.
