Executive Summary:

3. OGPA cleaning trial

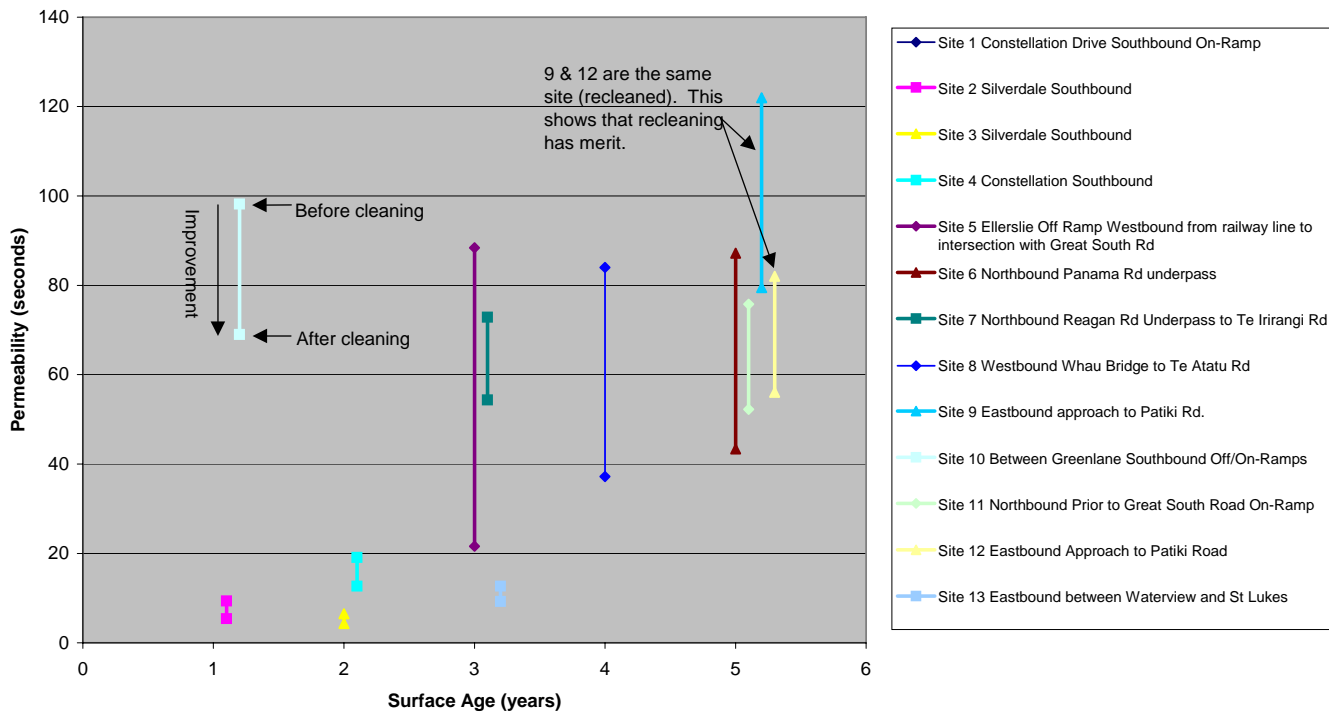
OGPA Permeability against Surface Age

Figure 1 shows a summary graph of the average permeability readings plotted against surface age. This shows which sites improved more than others. The graph shows the average permeability reading of the OGPA before the site was cleaned and the permeability reading after cleaning was completed. The decrease in permeability time shows the improvement achieved in OGPA drainage. Site 10, between the Greenlane southbound off and on ramps, has been used an example to demonstrate how the chart should be interpreted.

In general it was found that following cleaning of the OGPA the permeability did improve (substantially in some cases). It appears that better results were found in surfacing up to 2-3 years old. Surfacing older than this were found to be more clogged and although the permeability could be improved it was not to the same state as new.

Figure 1 shows clearly that sites of three years or older can have significant improvements in permeability achieved. Sites 9 and 12 (which are in fact the same location) show that repeated cleaning has merit. It would be interesting to discover if further recleaning could achieve an even better permeability outcome.
