# Ultra High-pressure Watercutting – Rejuvenating the microtexture of polished surfacings

Waters, J.C.<sup>1</sup>.

<sup>1</sup> *Fulton Hogan Limited, Christchurch, New Zealand*

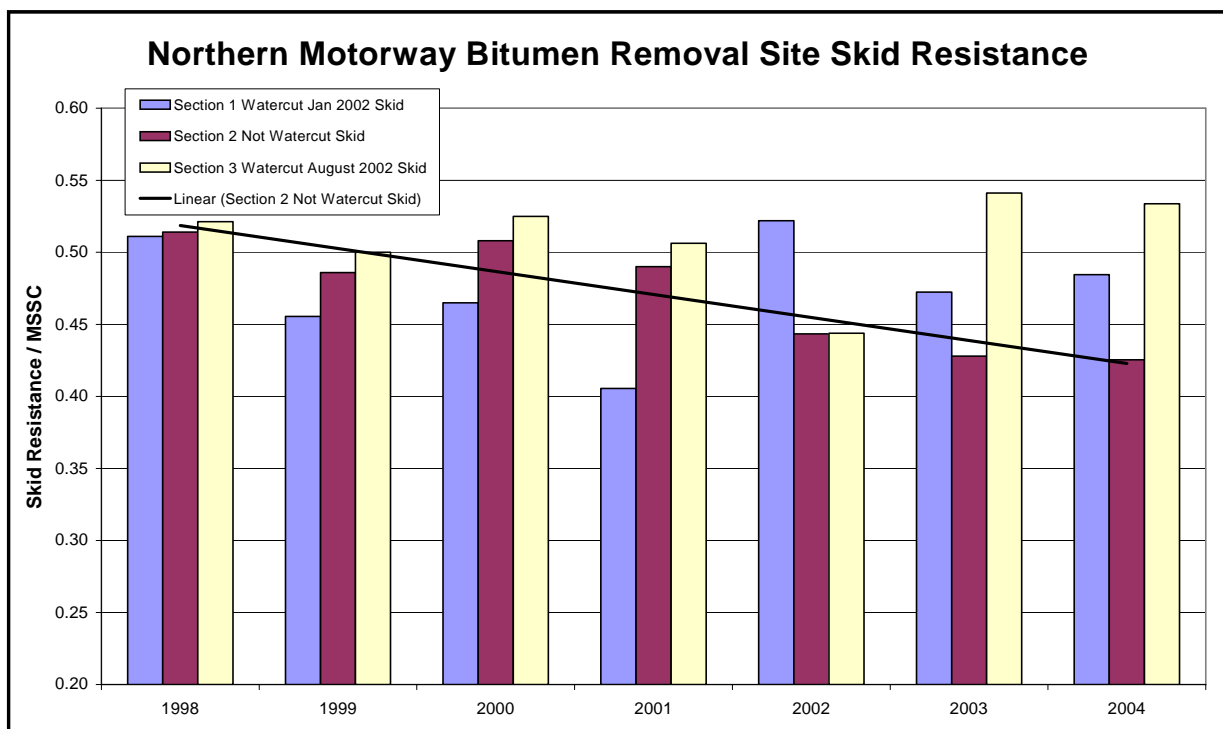
Figure 3. Northern Motorway Trial Site SCRIM+ Skid Resistance Measurements.

Section 1 was watercut in January 2002, Section 2 has not required treatment, and Section 3 was watercut in August 2002. Macrotexture and microtexture data from the SCRIM+ machine from 1998 to present has been summarised in Appendix Tables 2 and 3. Figure 3 shows that the friction levels for the two watercut sections were reset to a level similar to that of the grade 3 and grade 5 two-coat chipseal when it was constructed in 1996 while the friction value for the uncut section has continued to degrade.

This showed that the watercutting process improved both the macrotexture and the microtexture but the rate of deterioration of the restored microtexture was still unknown, and whether the microtexture restoration was applicable to all or only certain types of seals and aggregates remained unproven.

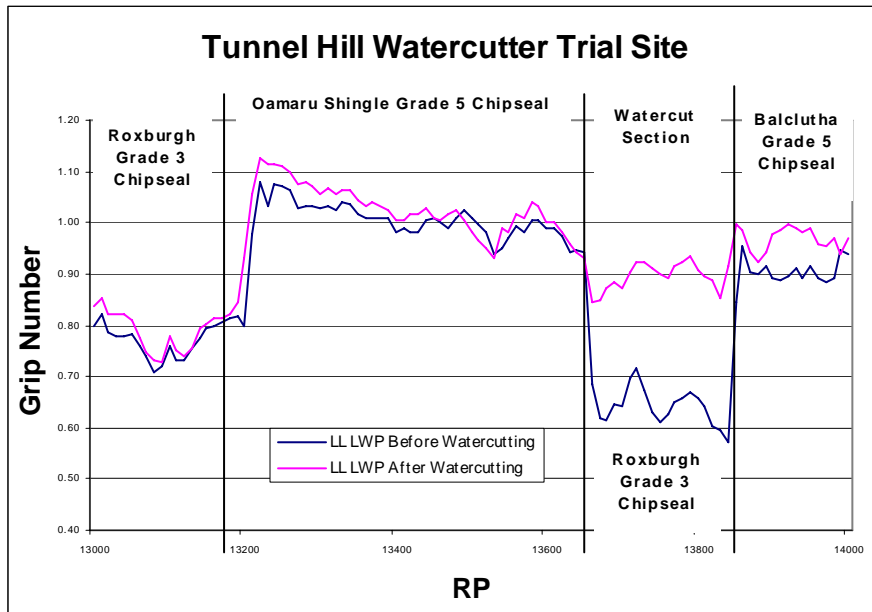
Figure 4. Tunnel Hill Watercutter Trial Site

Figure 4 shows the Griptestter Measurements for the Left Lane Left Wheelpath over the entire Tunnel Hill Site including: the 11-year-old Roxburgh Grade 3 chipseal section (the control), the 14-day-old Oamaru Shingle Grade 5 chipseal section, the watercut 12-year-old Roxburgh Grade 3 chipseal section, and the 15-day-old Balclutha Grade 5 chipseal section. On this site the chipsealing had been completed before any Griptestting took place so only watercutting took place between the before and after Griptestting.

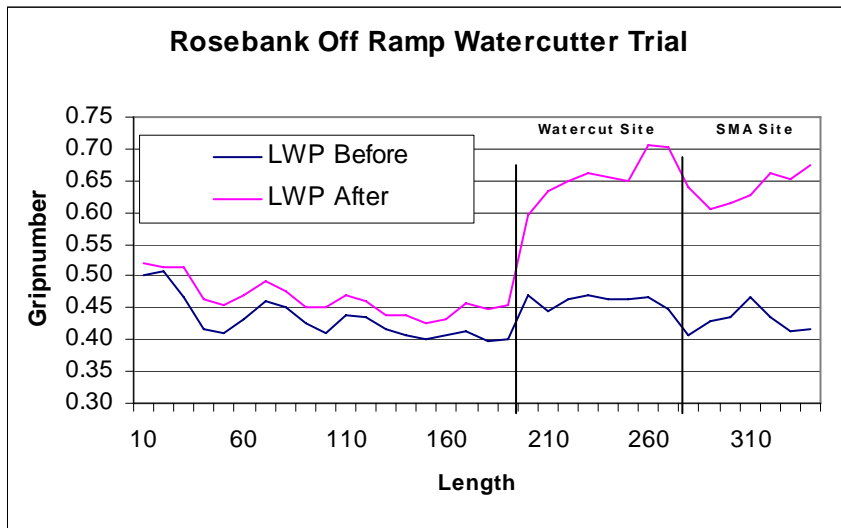
Figure 5. Rosebank Off Ramp Watercutter Trial Site

Figure 5 shows the Griptestter Measurements before and after resurfacing for the Left Wheelpath for the entire length of Rosebank Site. The data includes: the untouched OGPA that was the control section, the watercut section, and the section resurfaced with SMA. On this site the griptestting was carried out over the entire site before any resurfacing was carried out, the watercutting and laying of SMA took place then the griptestting was carried out over the entire site. The change in skid resistance on the control section is due to environmental factors as the section was untrafficked and so physically unaltered during watercutting and the laying of the SMA.

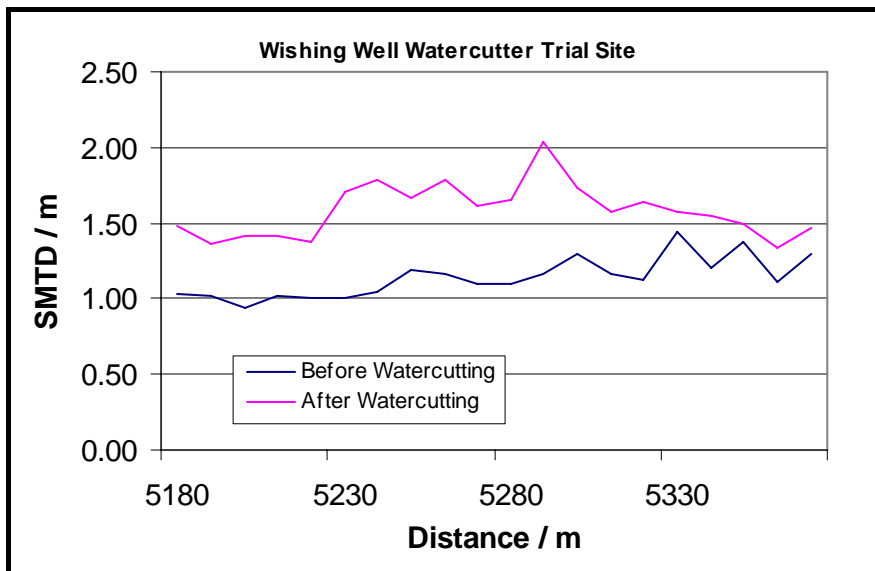
Figure 6. Wishing Well Texture Measurements.

Figure 6 shows the Minitexture Meter measurements for the Right Lane Left Wheelpath on the Wishing Well Site Watercut Section. The change in texture depth is relatively small because the existing seal was polished with only minor areas with binder rise.

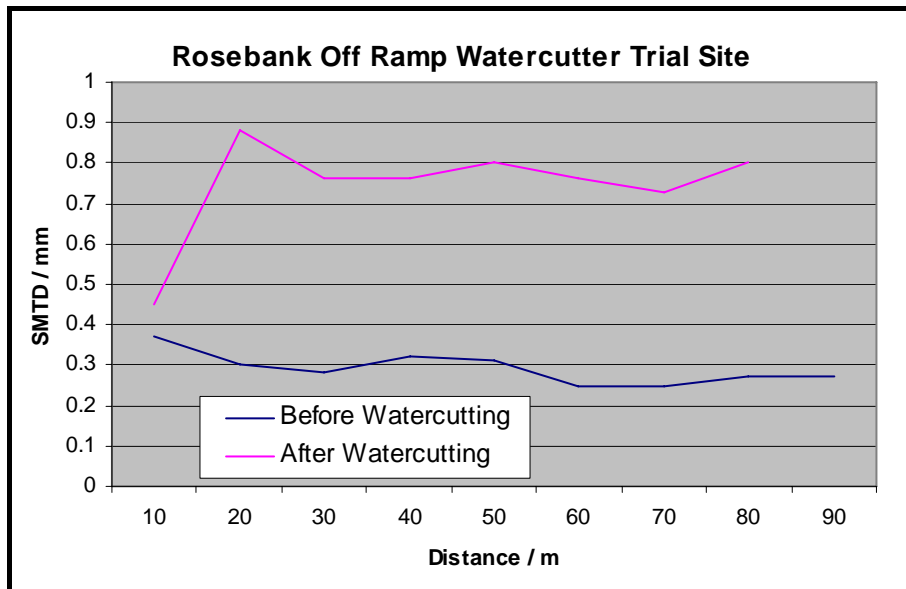
Figure 7. Rosebank Off Ramp Texture Measurements.

The change in texture depth on the polished porous asphalt surface was due to the watercutter removing the detritus from the surface voids while refreshing the microtexture on the aggregate. Figure 7 shows the substantial improvement (0.5mm SMTD) on the texture depth.
