INVESTIGATION INTO THE HIGH INCIDENCE OF PAVEMENT CHIP LOSS

Transit New Zealand Research Report No. 25

NORMAN G MAJOR, FIPENZ
Roading Consultant, Wellington

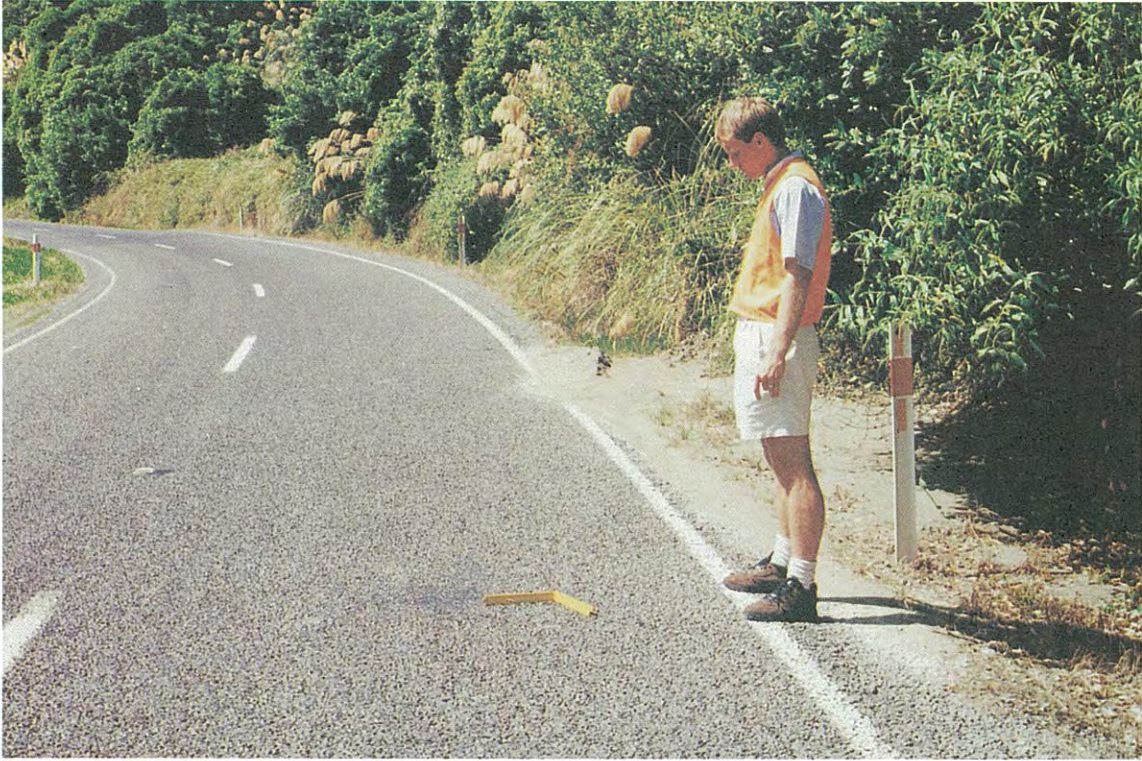
**SH4****11 Jan 1993**

Upper: General view of site.

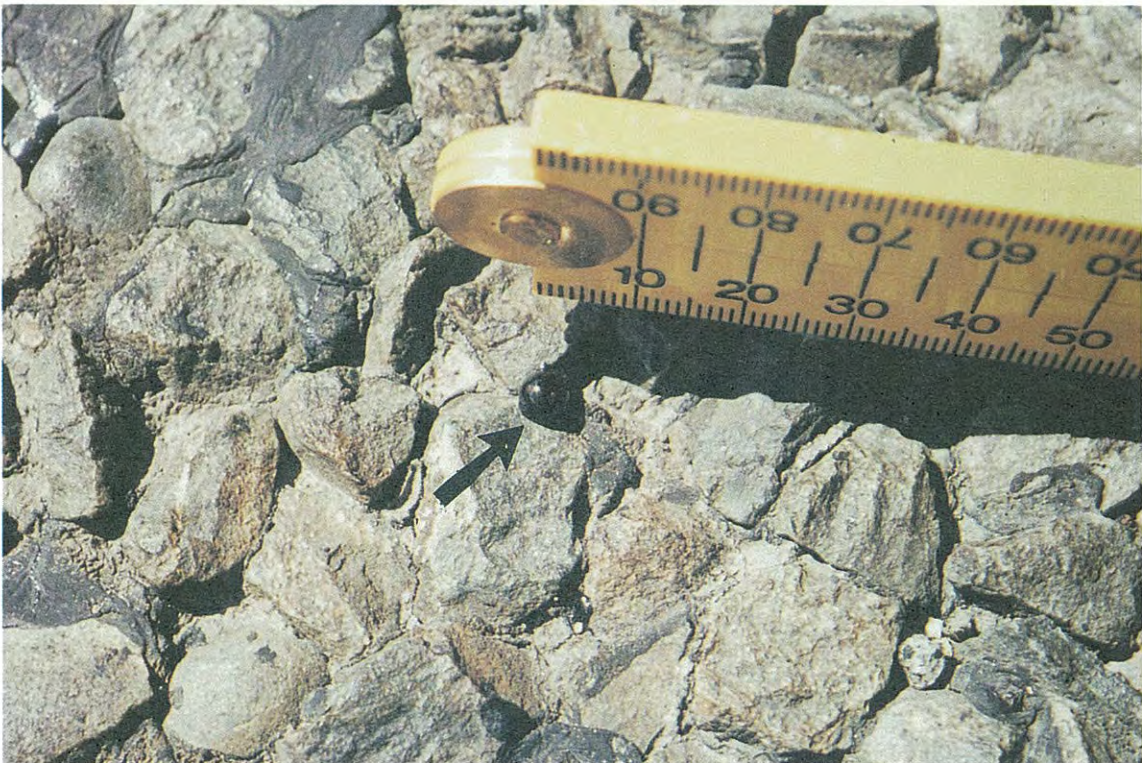
Incidences of "spot bleeding" (bubbles and small patches of bitumen squeezing up to the surface between chips) were seen on sites from Auckland to Invercargill while carrying out this survey (see first photo in Appendix 7). An explanation for this kind of bleeding is considered to be binder rise induced by high water vapour pressure in the basecourse. Spot bleeding occurs without embedment of chips into the substrate, and is distinguished from "bleeding" caused by excess binder, in which binder flows on the road surface.

Vapour pressure-induced binder rise is caused by high water vapour pressure in dense and relatively impermeable basecourse with low voids within the mineral aggregate which, after prolonged wet periods, can become near-saturated. A rapid onset of hot weather can produce a significant rise in water vapour pressure. (For example, an increase in basecourse temperature from 20° to 30°C results in an increase in water vapour pressure of about 170mm water gauge.)

It is important that the cause of bleeding is identified because, if the two kinds of bleeding are confused, the mistaken reaction may be to reduce bitumen application rates. Thus if the cause for the bleeding is vapour pressure-induced binder rise, decreased bitumen application could lead to chip loss.

Lower: Concern to keep binder application rates low to minimise "bleeding" just does not work where the binder is driven to the surface by dense, wet basecourse.

Note fresh bitumen bubble (arrowed) at bottom left corner of the ruler's shadow.
