Progressive Underslip Stabilisation Using Gravel Columns

Transfund New Zealand Research Report No. 208

GHD Ltd

Transfund NZ commissioned GHD Ltd to monitor the performance of an innovative stabilisation method designed and implemented by GHD's Geotechnical Team. The stabilisation method consisted of the construction of deep *graded gravel columns* to provide positive subsurface drainage to the failure planes within a slip site. This monitoring was undertaken as a part of the stabilisation of a road embankment slip at Snake Hill (SH1 RP 144/11.34).

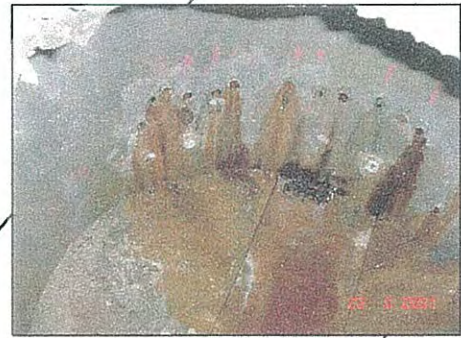
VIEW OF COLLECTION MANHOLE

During the post construction period the column drains were seen to continuously discharge large volumes of water into the manhole. This confirmed that they were draining subsurface water, which is considered to have contributed to progressive failure of the slip at this site.

- The MDPE pipes selected were greater in size than would be required under normal operational conditions. This is to allow for any unexpected blockages within the 63mm diameter pipes. Inspections of the manhole outlets of the 63mm diameter pipes are required on a six-monthly basis. Any laminite build-up needs to be cleared immediately;
