Factors Affecting Multiple Chipseal Layer Instability

G. F. A. Ball, J. E. Patrick, P. R. Herrington
Opus International Consultants Ltd

Land Transport New Zealand Research Report 278

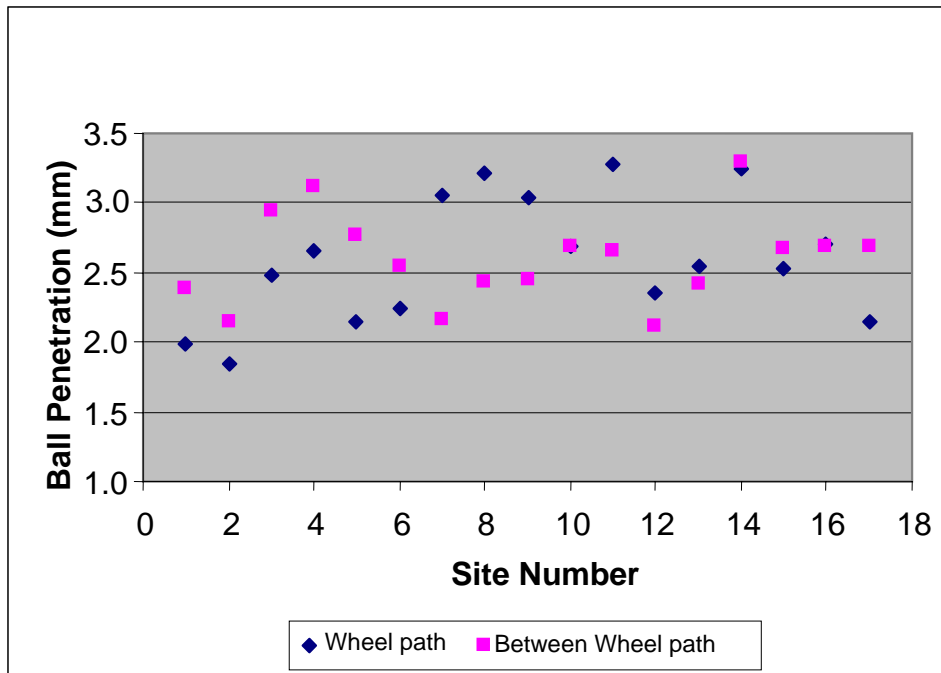
Figure 5.1 Ball penetration results for between wheelpaths and for wheelpaths for Bay of Plenty sites 1-6, Hawke's Bay sites 7-12, & Mid Canterbury sites 13-17.

The ball penetration test does not show any relationship with a site's potential for early flushing as is shown in Figure 5.1, where sites 1-6 are Bay of Plenty sites, 7-12 Hawke's Bay, and 13-17 are the Mid Canterbury non-flushed sites.

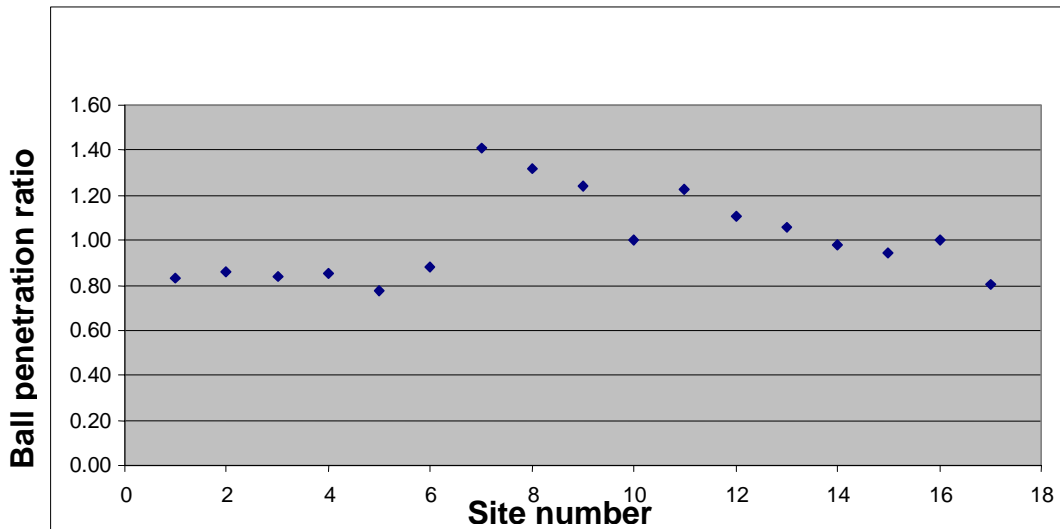
Figure 5.2 Ball penetration ratio for Bay of Plenty sites 1-6, Hawke's Bay sites 7-12, & Mid Canterbury sites 13-17.

In contrast to the compaction test, the ratio of the in-wheelpath ball penetration to the between-wheelpath penetration does not correlate with flushing potential, as shown in Figure 5.2. There is an apparent regional effect, with the ratios for Bay of Plenty sites (1-6) being generally lower than those for the Mid Canterbury sites (13-17), which in turn tend to be lower than Hawke's Bay sites (7-12). The reason for this is not immediately apparent and further research would be needed to find the cause of this trend.

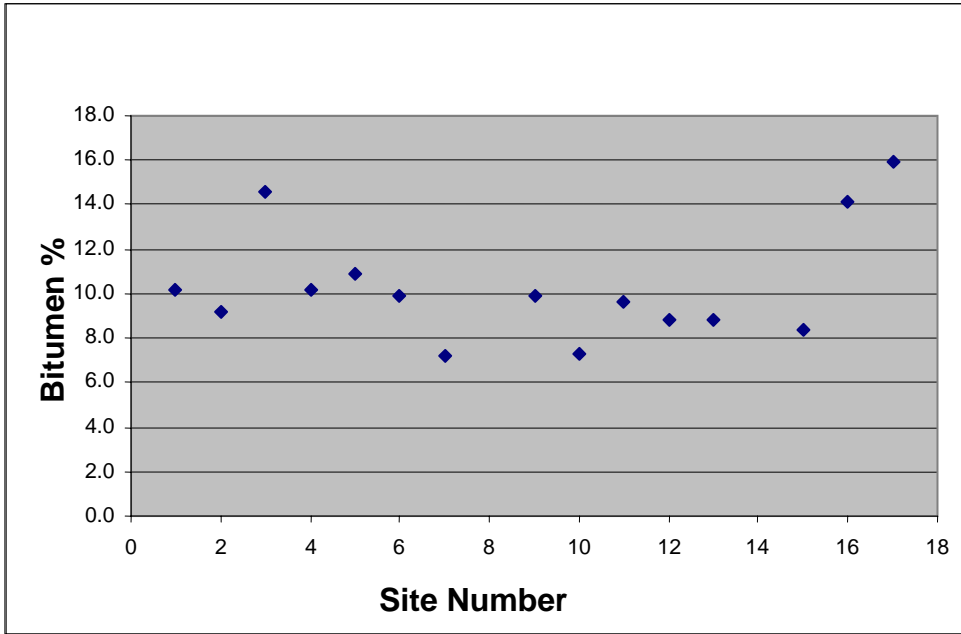
Figure 5.3 Bitumen contents (%) for Bay of Plenty sites 1-6, Hawke’s Bay sites 7-12, & Mid Canterbury sites 13-17.

Figure 5.3 shows the distribution of bitumen contents with site number. Sites 14-17 are the Mid Canterbury sites that do not show premature flushing yet sites 16 and 17 have comparatively high bitumen contents.

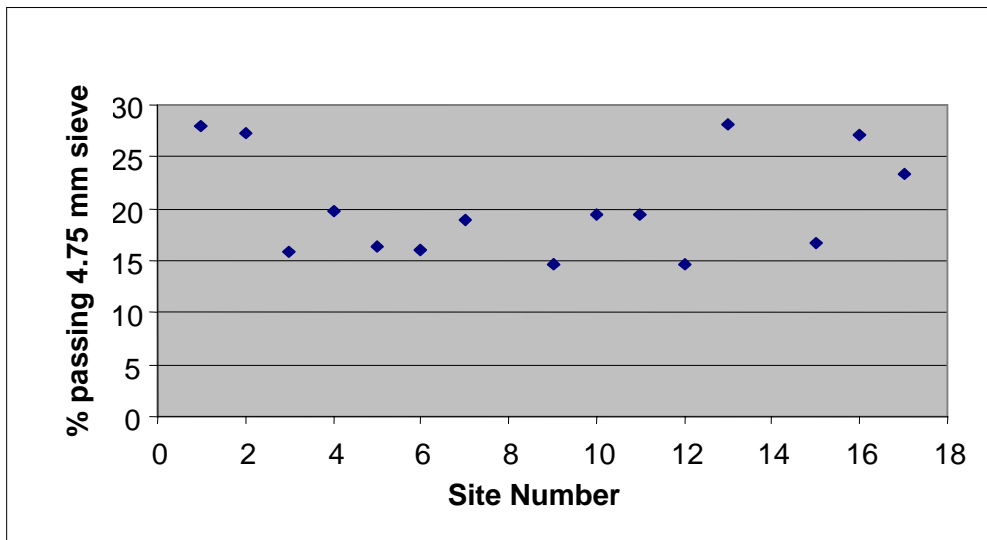
Figure 5.4 Aggregate fines (as % passing 4.75 mm sieve) for Bay of Plenty sites 1-6, Hawke’s Bay sites 7-12, & Mid Canterbury sites 13-17

Figure 5.4 gives the percentage passing the 4.75 mm sieve versus site number. Sites 1, 2, 13, 16 and 17 have more than 20% passing the 4.75 mm, while the other sites are more coarse graded.

At first sight there is no relationship between fines content and liability to flush. However sites 1 and 2 in the Bay of Plenty are special cases. They have high percentages passing the 4.75 mm sieve and have flushed early. On both sites a two coat grade 2/5 seal was

constructed in 1998, and it was resealed within one year. This suggests that a construction fault in the sealing operation has led to the reduced subsequent life.

If we then ignore sites 1 and 2, the trend may be for high fines content to correlate with low susceptibility to flushing.

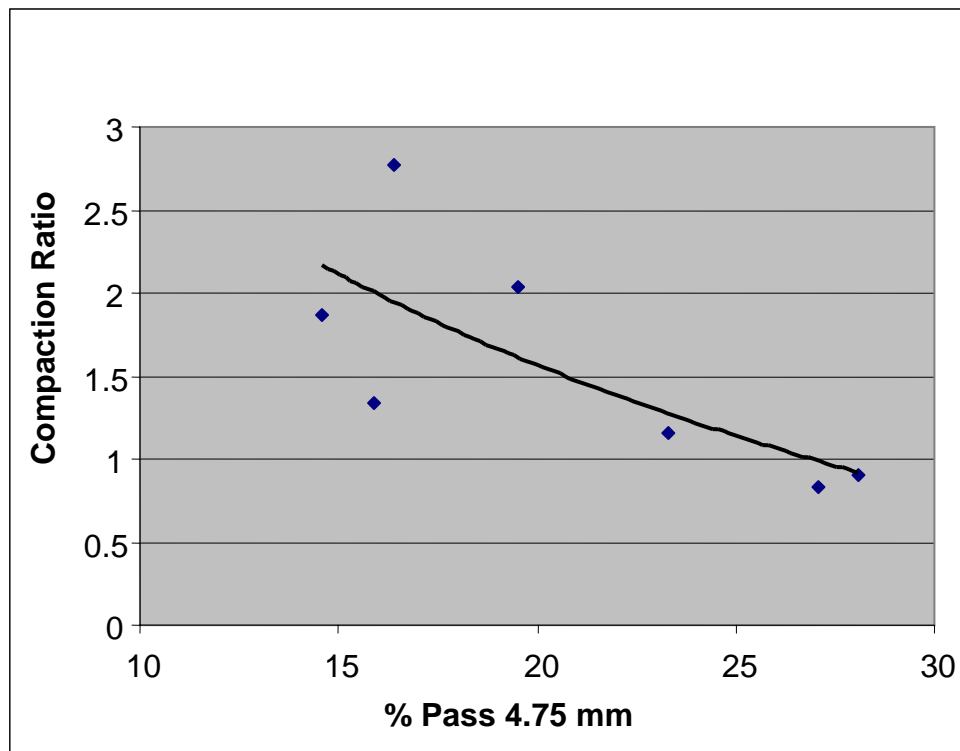
Figure 5.5 Effect of fines (as % passing 4.75 mm sieve) on compaction ratio.

If the shear test can be considered a method of ranking a seal's 'risk' of instability (high compaction ratio), then Figure 5.5 indicates that a relationship exists between the percentage passing the 4.75 mm sieve and shear properties.
