## MIN-3848 Report on the failure of the SH35 Mangahauini Bridge

17 June 2022

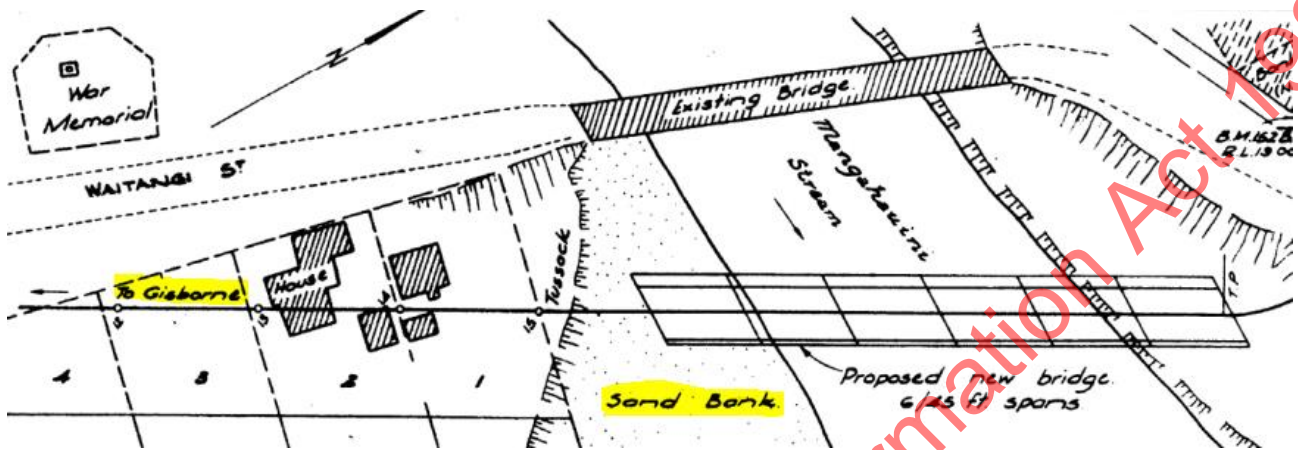
Figure 1-1 : Snip from as-built drawings showing plan of Mangahauini No. 1 Bridge

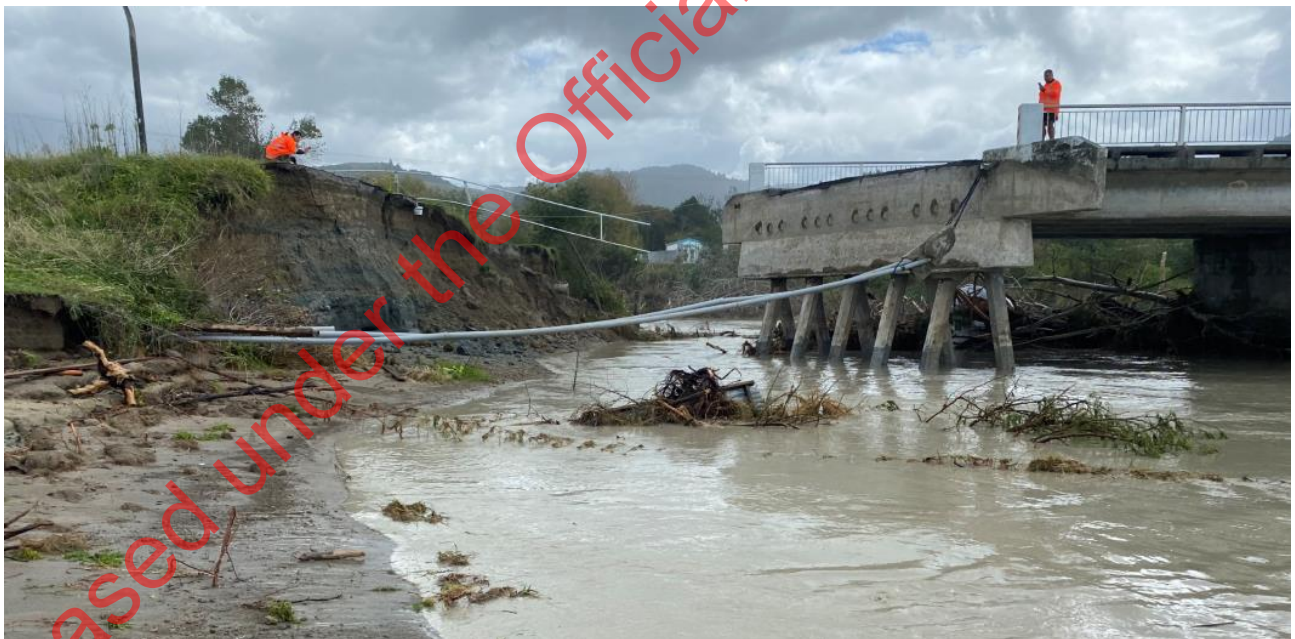
Figure 1-2: Looking upstream, showing washed out abutment and gap to the road

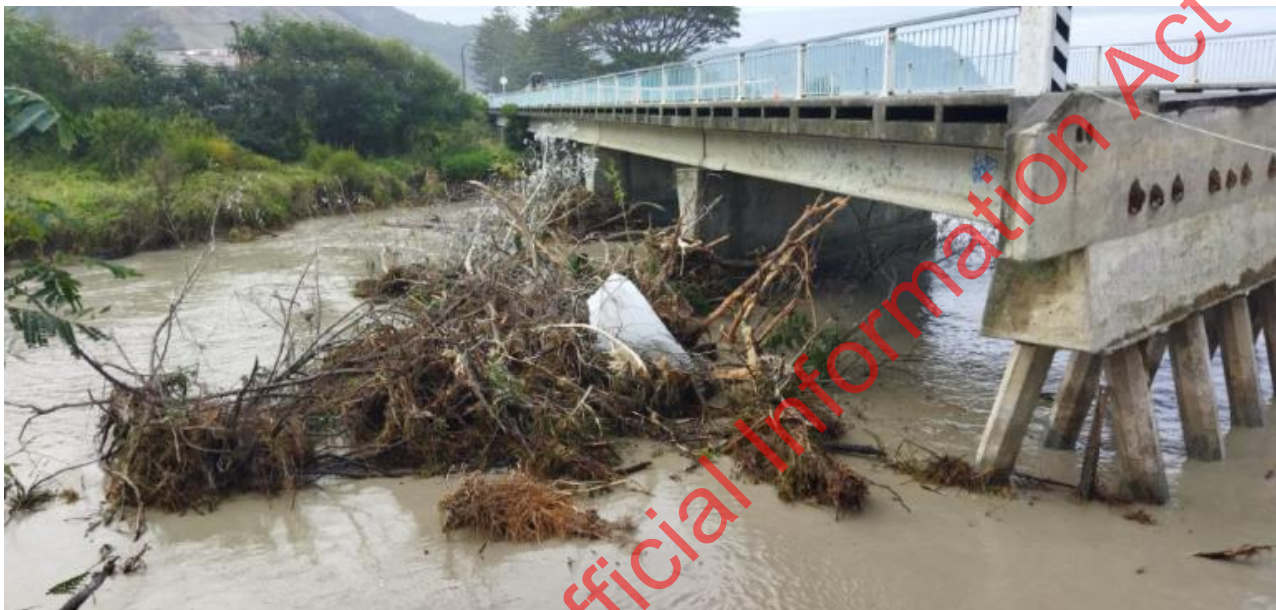
Figure 2-1 : Woody debris upstream of southern end span. (Failed abutment approach is at RHS)

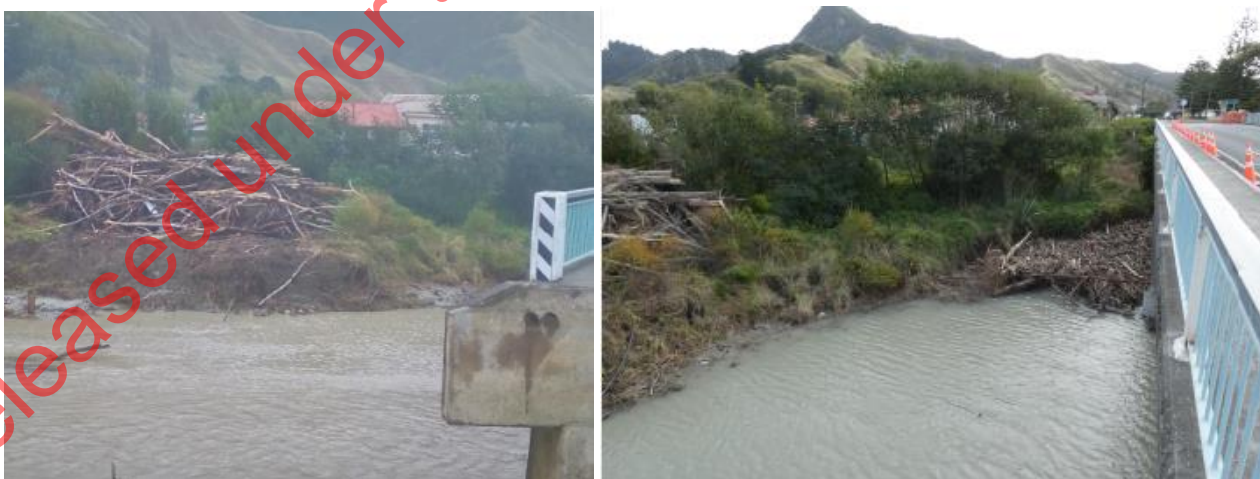
Figure 2-2: Logging type debris on left bank upstream of and at northern end of bridge
