# **Auckland Harbour Bridge Alliance**

# Special Structural Inspection Box Girder Internal Special 4

## Box Girder Internal Special 4 – 2020/2021

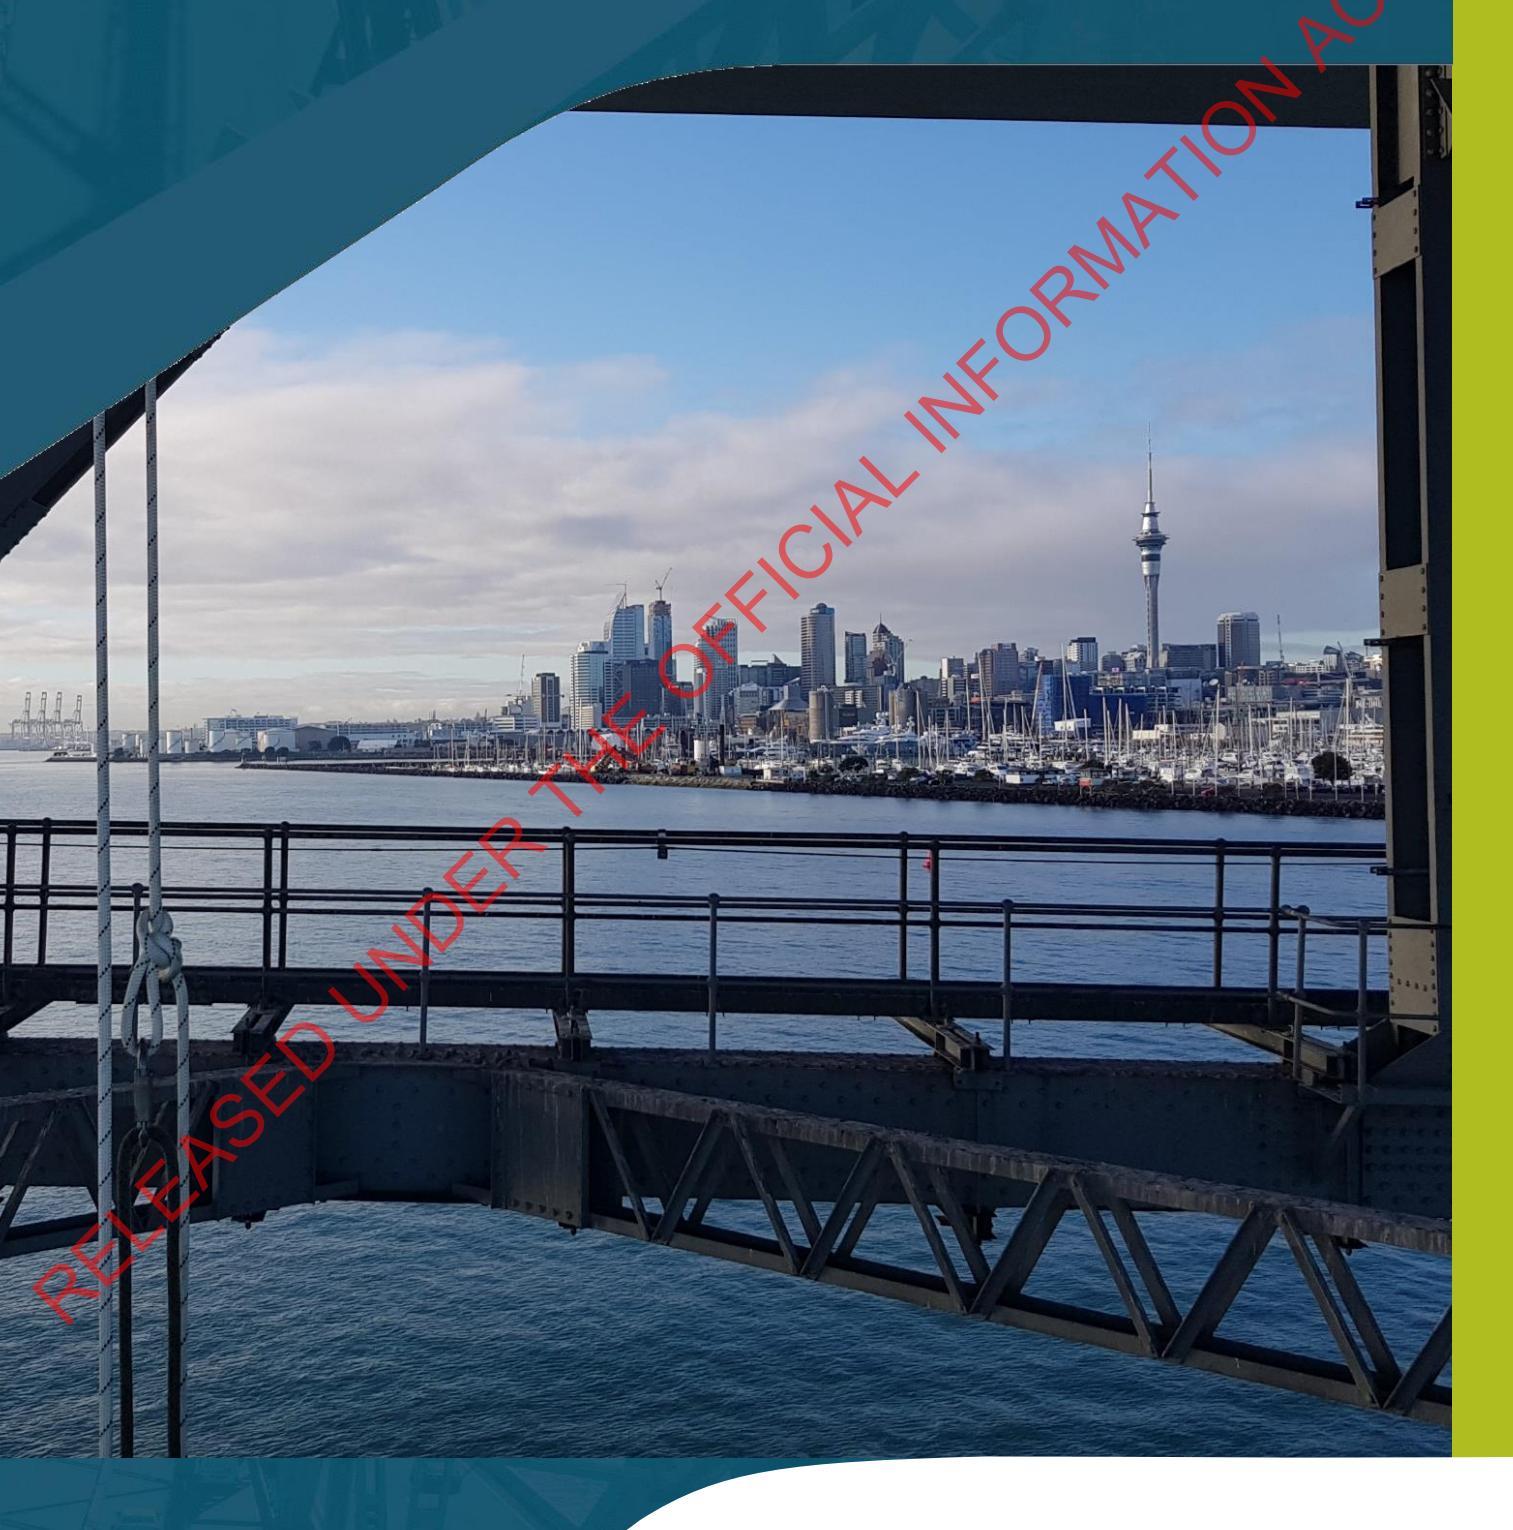
Photo ID	Marking Code	Description of Defects	Maintenance/ Repairs Recommendations	Maintenance/ Repairs Priority & Timeframe
BGI-1	S	- wB 90/2.5 Ews fficin	HARANGE BORNATIO	AC
		West box outer. Box 80 between crossbeams 2 and 3. Vertical stiffener to web weld crack.	Weld crack repair	M 1-2 Years
et l'	AST
