Auckland Harbour Bridge
Resource Consents for Discharge of
Abrasive Blast Products

Annual Report

July 1996

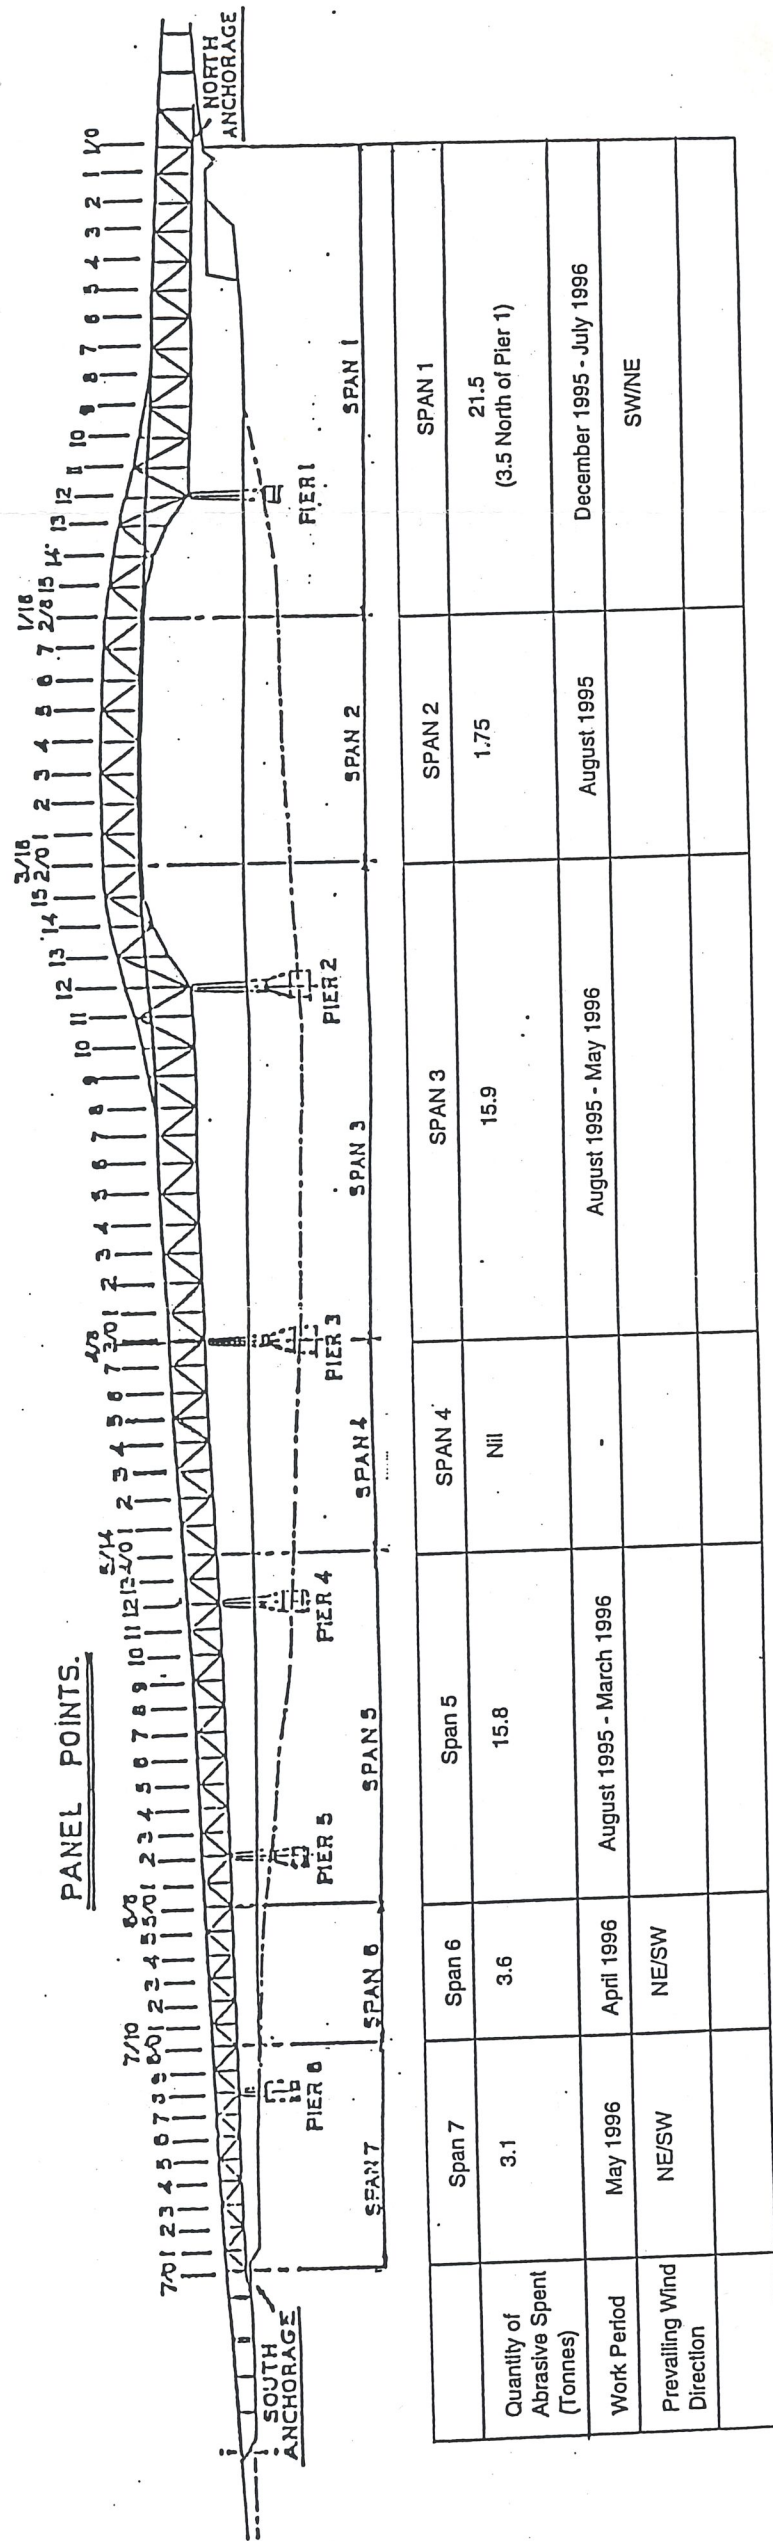
FIGURE 1 : Location and Extent of Abrasive Blasting on the Auckland Harbour Bridge (July 1995 - July 1996)

During the period August 1995 to July 1996 abrasive blasting operations have been carried out on the following areas of the bridge (see fig. 1).

Span 1 Abrasive blasting was carried out in this span between December 1995 - July 1996. The blast cleaning operation has been predominantly carried out south of Pier 1. 84% of the blasting carried out in this area was south of Pier 1. The remaining 16% completed north of Pier 1 was carried out on areas above the water. No blasting was carried out on areas above land.

Span 2 Abrasive blasting was carried out in this span during August 1995. Blasting was confined to the eastern side of the overarch and consisted of spot blasting areas of paint breakdown followed by sweep blasting. Blasting was carried out on 13 days with the total quantity of abrasive spent being approximately 1.75 tonnes.

Span 3 Abrasive blasting was carried out in this span between August 1995 and May 1996. The total quantity of abrasive spent in this area was approximately 15.9 tonnes.

Span 5 Abrasive blasting was carried out in this span between August 1995 and March 1996. The total quantity of blasting abrasive spent in this area was approximately 15.8 tonnes.

Span 6 Blasting was carried out in this span during April 1996. The wind direction during this period was from the north-east and south west. The total quantity of blasting abrasive spent in this area was 3.6 tonnes over a period of 10 days.

Span 7 Blasting was carried out in span 7 during May 1996. The prevailing wind direction during this period was from the south-west. The total quantity of abrasive used in this area was 3.1 tonnes over a period of 10 days.
