18. Contaminated land

Figure 18.1: Sites investigated for potentially contaminated land

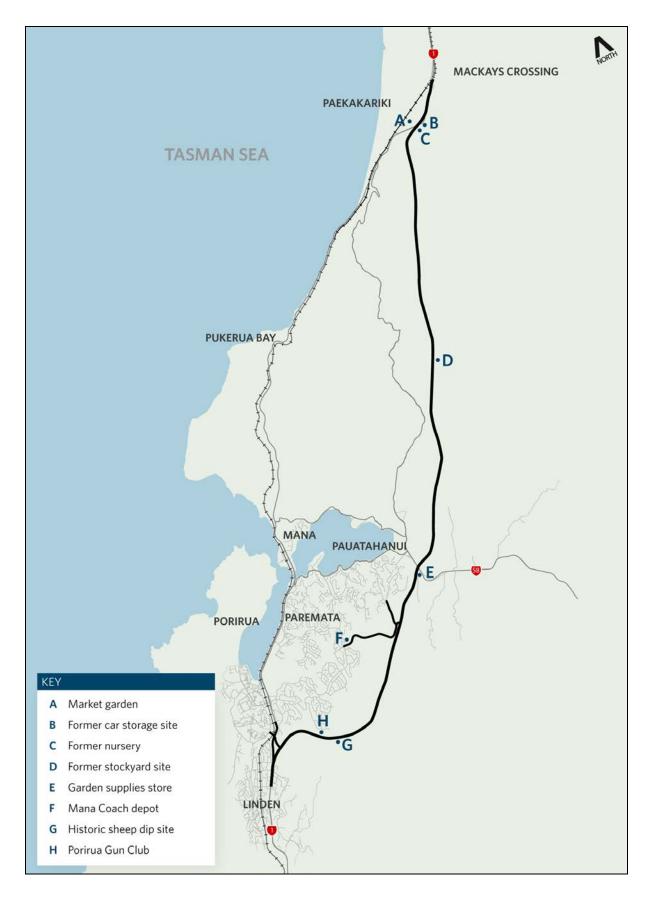
Within these areas, the contaminated land assessment identified several sites where contaminants of concern are present, and which could pose a human health risk and / or an ecological risk. These sites were (with the indicative location shown in Figure 18.1):

- **Site A** (Pt Lot 4 DP 4269): A market garden, where hazardous materials have been stored and pesticides, herbicides and fertilisers have been applied;
- **Site B** (Lot 1 DP 53032): An area that was formerly used (prior to purchase by the Crown) for storage of imported cars prior to their distribution around New Zealand;

- **Site C** (Lot 1 DP 47726): Former nursery, where pesticides have been used and heavy metal concentrations have been detected. Asbestos is present in building materials on the site;

- Site D (Section 1 SO Plan 402089): A former stockyard site, where metals are present;
- **Site E** (Section 4 SO Plan 38167): Garden supplies store and green waste composting facility, where pesticides have been applied, and treated timber has been stored, used and burned at the site. The site also contained an outhouse and above-ground tanks for fuel storage;

- **Site F** (Section 353 Porirua District): Mana Coach depot, where vehicles are stored and repaired, and fuel and other hazardous materials are stored;

- Site G (Pt Lot DP51158): GWRC historic sheep dip site, where pesticides are present; and
- **Site H** (Section 1 SO Plan 36634): Porirua Gun Club, where ammunition and clay targets have contaminated the soil.

The land contamination study also identified that it is possible that there may be UXO present at MacKays Crossing, adjacent to SH1, where past military activities were conducted.
