Deterioration of Prestressed Concrete Bridge Beams

S.M. Bruce, P.S. McCarten, S.A. Freitag, L.M. Hasson

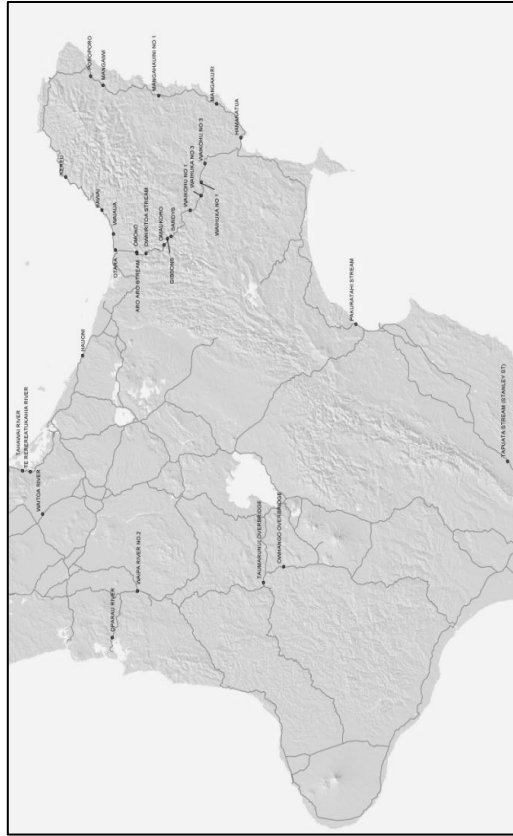
Figure 3.1 Location of bridges selected for inspection related to corrosion.

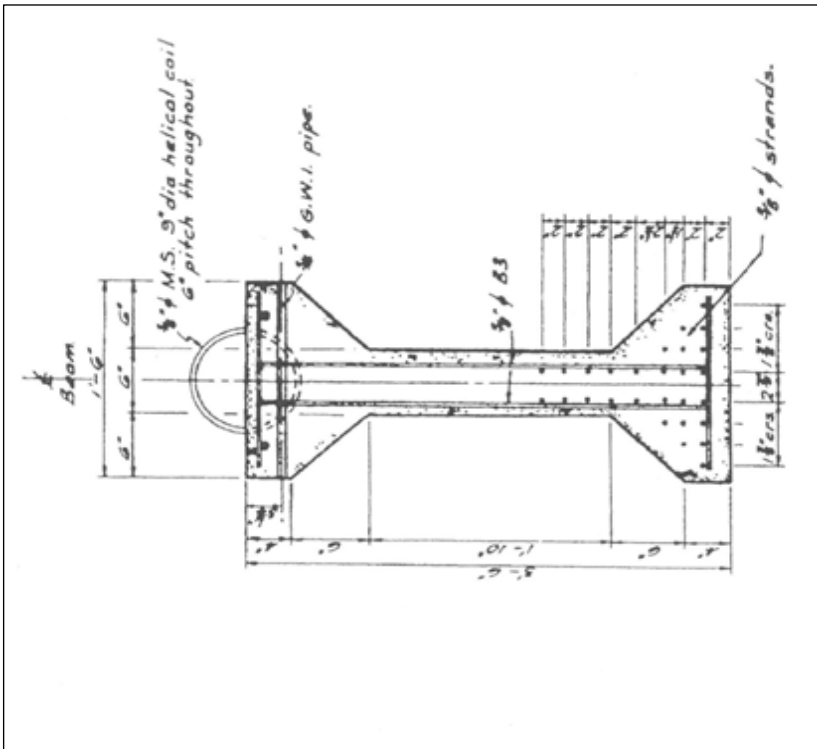
Figure 4.3 'Second generation' H20-S16-T16 design for a 45-foot span (Stirrat & Huizing 1961).

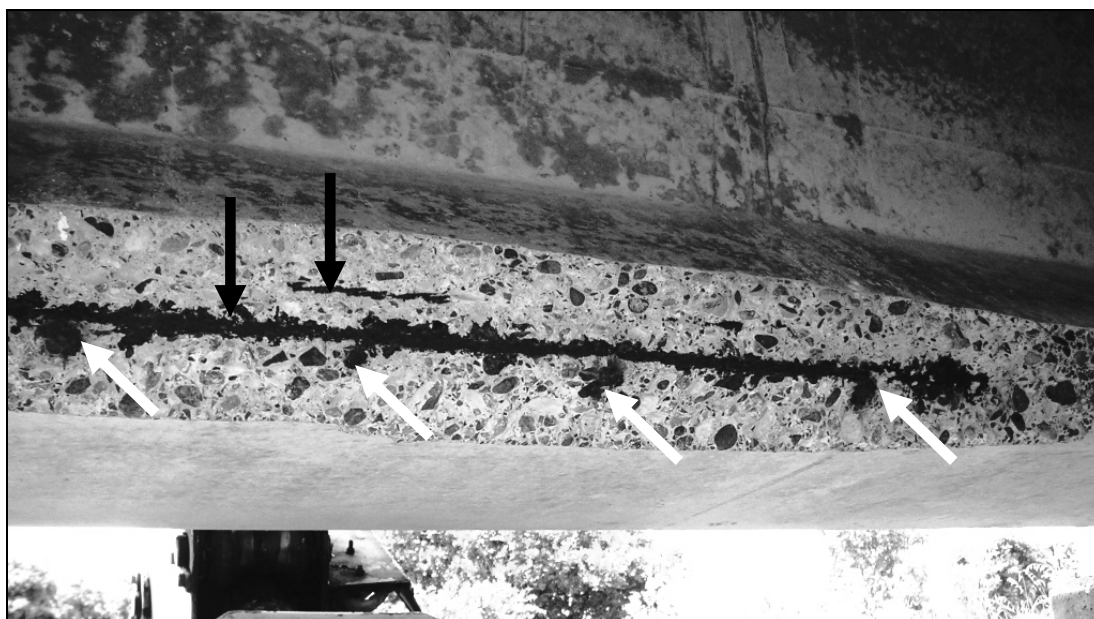
Figure 5.1 Spalling over prestressing strand on the Hamanatua Stream Bridge, Span BC.

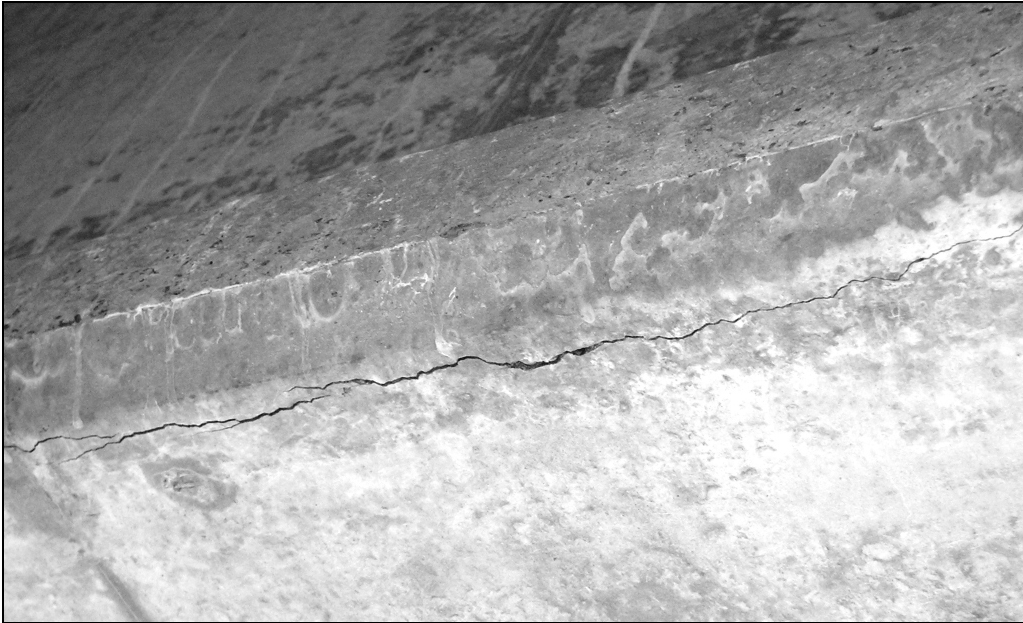
Figure 5.2 Cracking over a prestressing strand on the Hamanatua Stream Bridge.

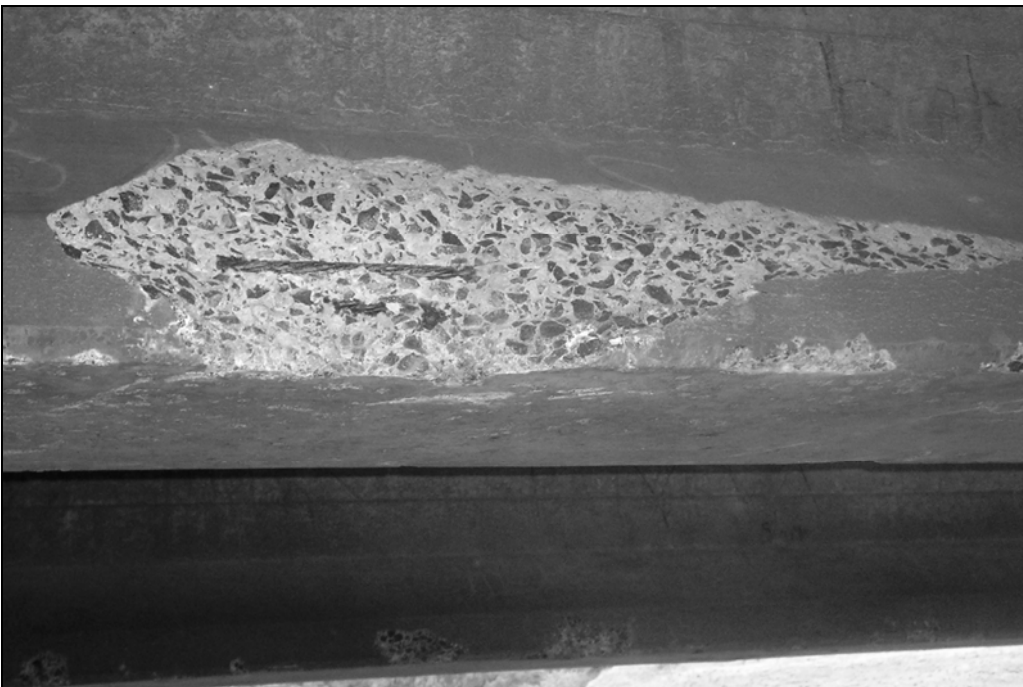
Figure 5.3 Corroding strand on Hawai River Bridge. This spall was caused by impact damage rather than corrosion.

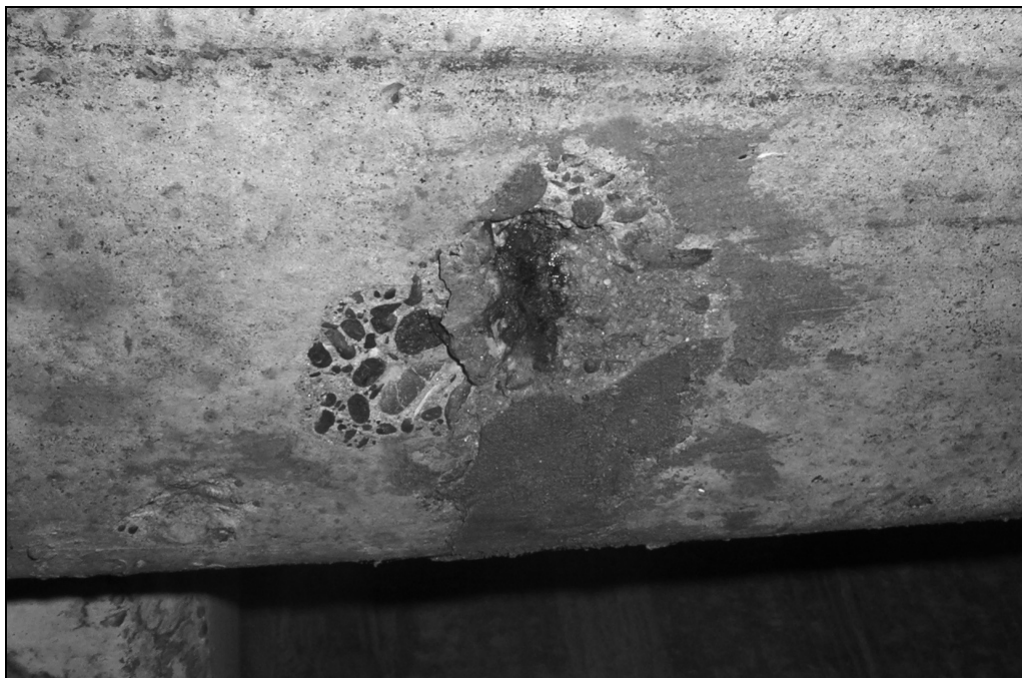
Figure 5.4 Spalling associated with low cover over a stirrup on the beam soffit, Kereu Bridge.

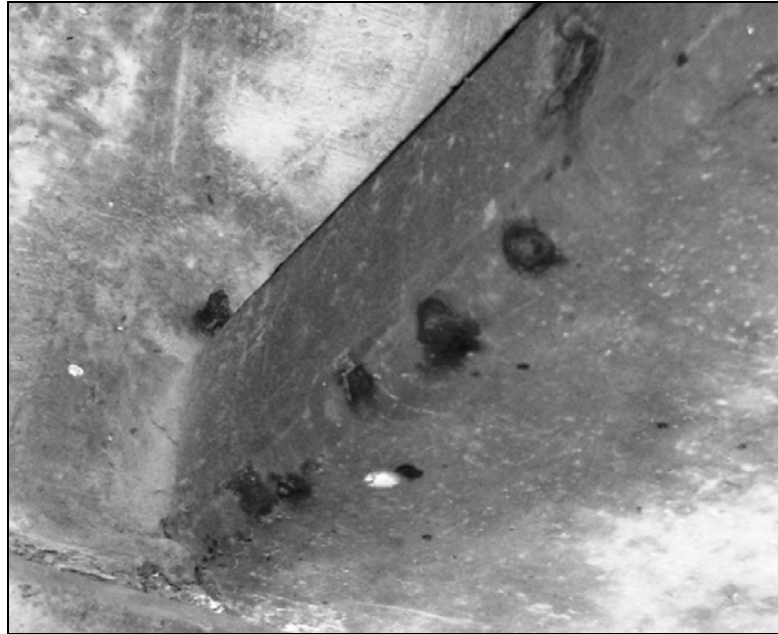
Figure 5.5 Corroding stirrup ends close to surface on Hawai River Bridge.

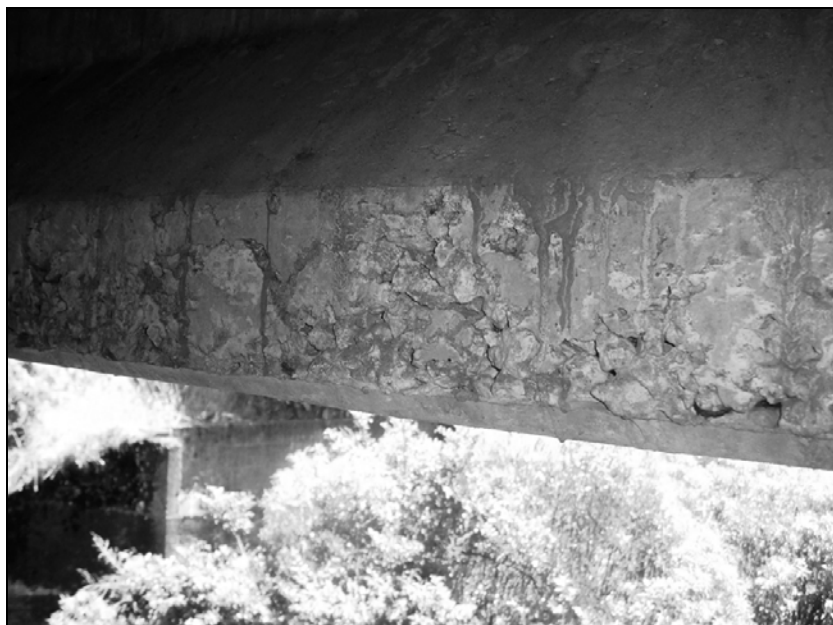
Figure 5.6 Poor compaction on beam, Sandy's Bridge.

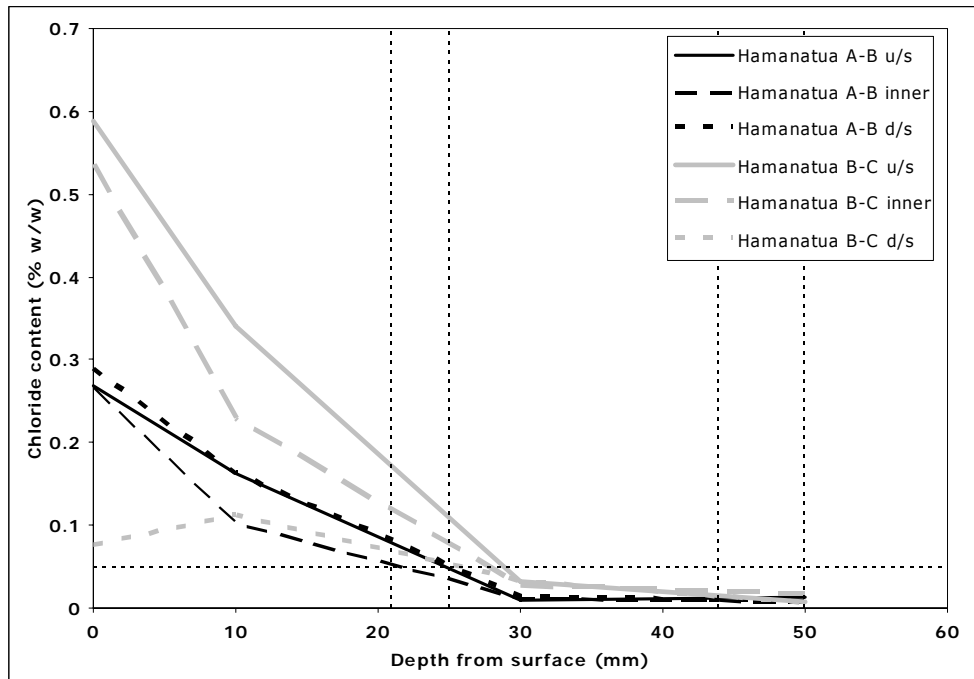
Figure 5.7 Chloride content v. depth from surface on the Hamanatua Stream Bridge.

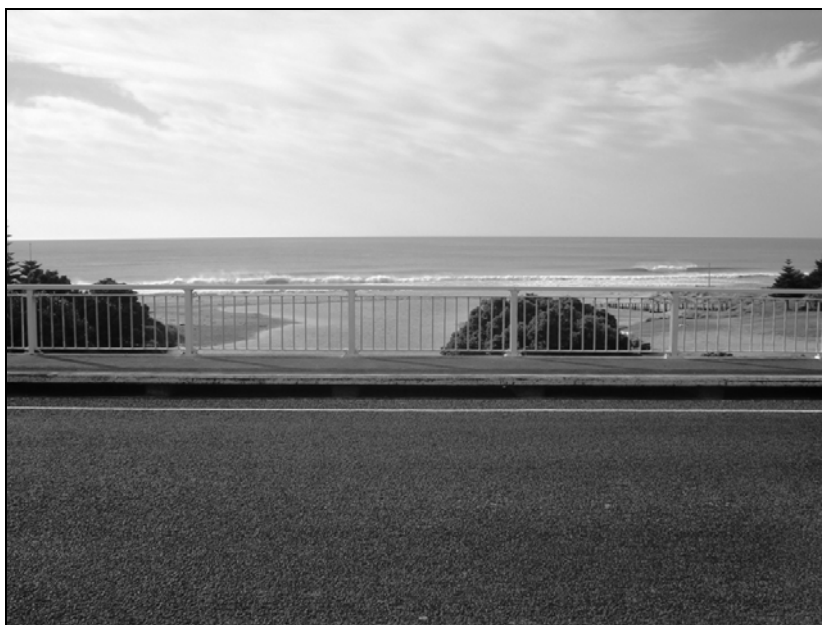
Figure 6.1 Proximity of the Hamanatua Stream Bridge to open surf beach.
