# **Concrete pile durability in South Island bridges**

**September 2011**

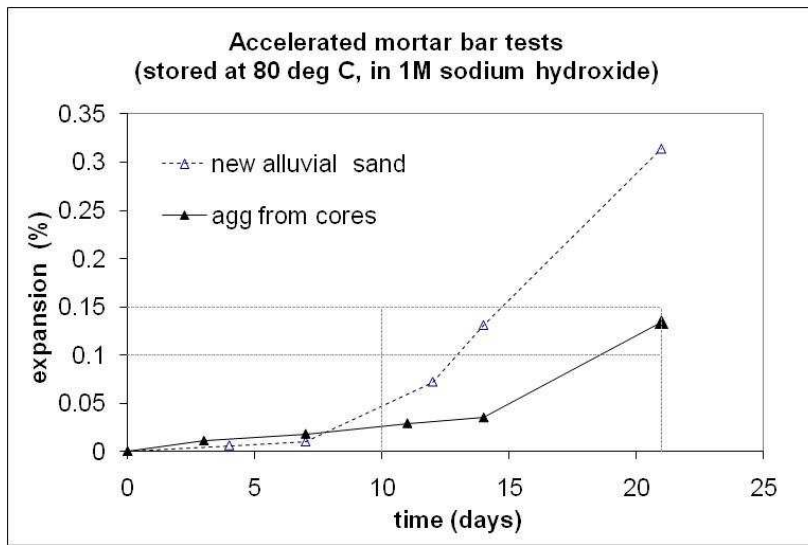
Figure 2.1 Accelerated mortar bar test results. Criteria for assessing results are at right

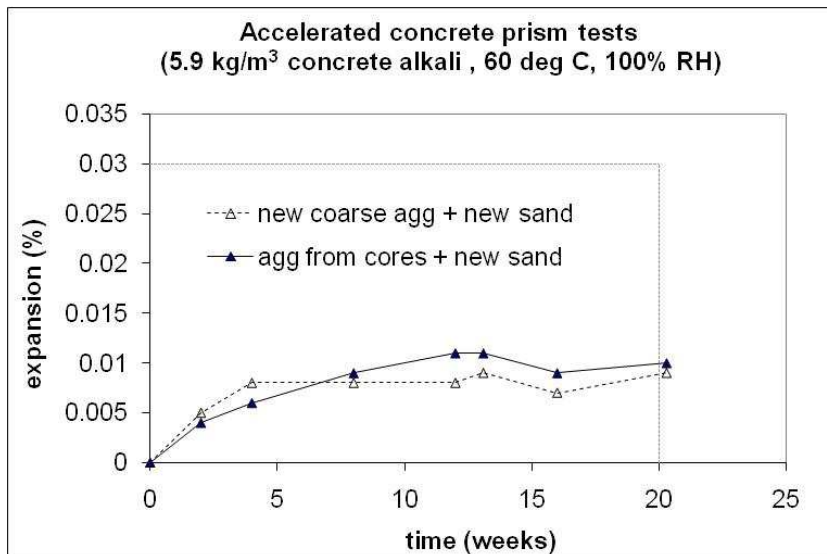
### 2.1.3 Discussion

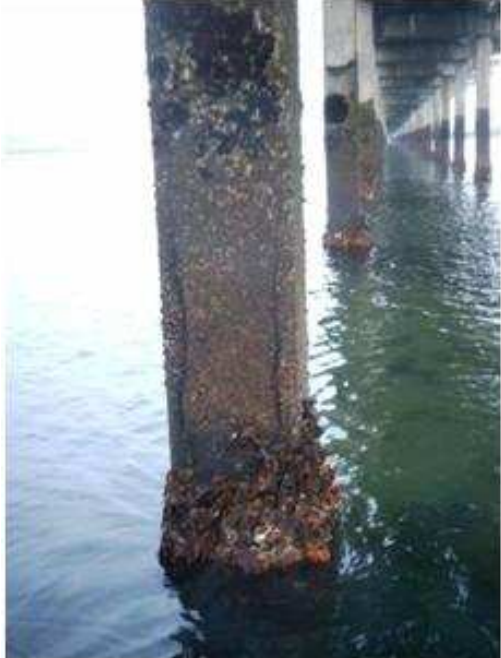
**Figure 3.1b** Pile cracks caused by reinforcement corrosion (typically wider above high-tide level)

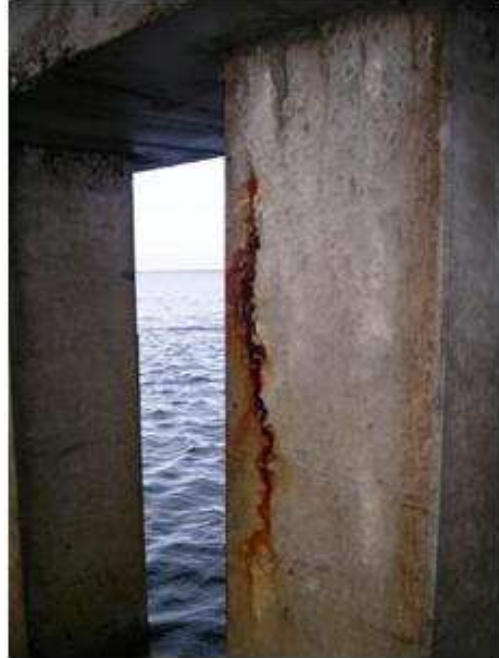
**Figure 3.1c** Minor ASR/DEF cracking (arrowed)

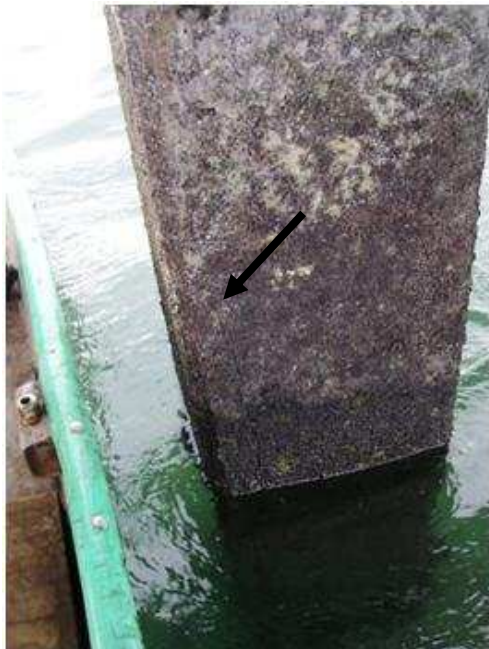
**Figure 3.1d** Extensive ASR/DEF damage

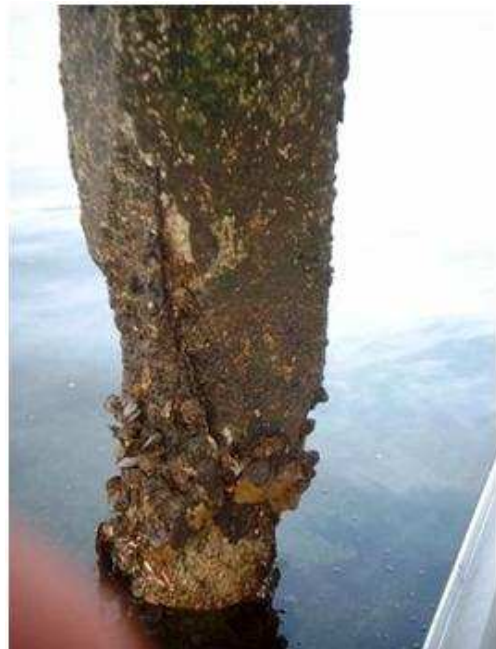
**Figure 3.2** Extensive pile cracking (structure M, Nelson; see also chapter 4)

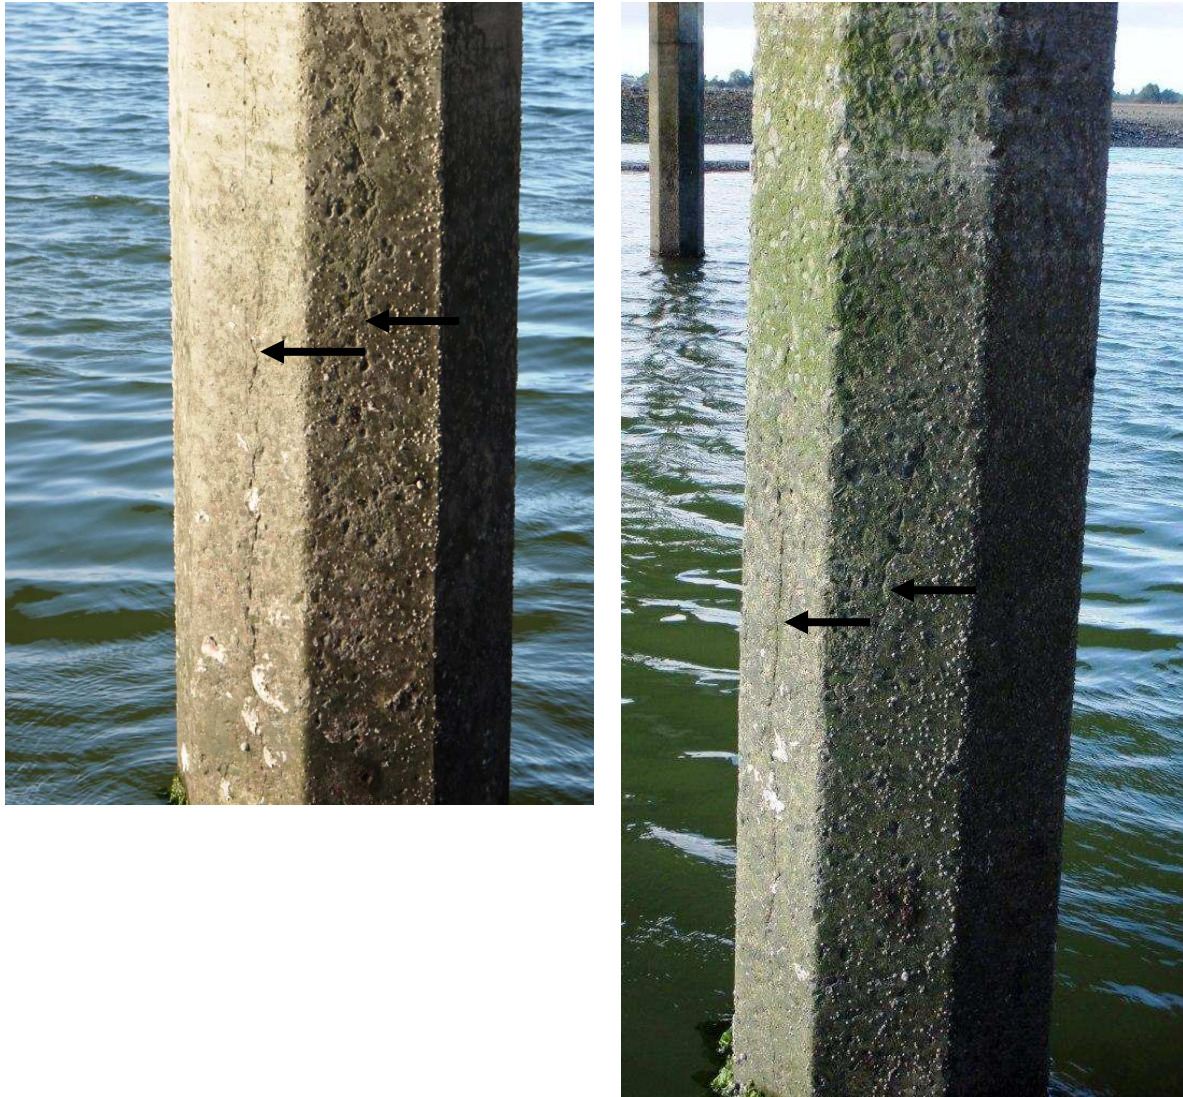
**Figure 3.3** Minor pile cracking at and below tidal zone (structure Wh, Southland; see also chapter 4)

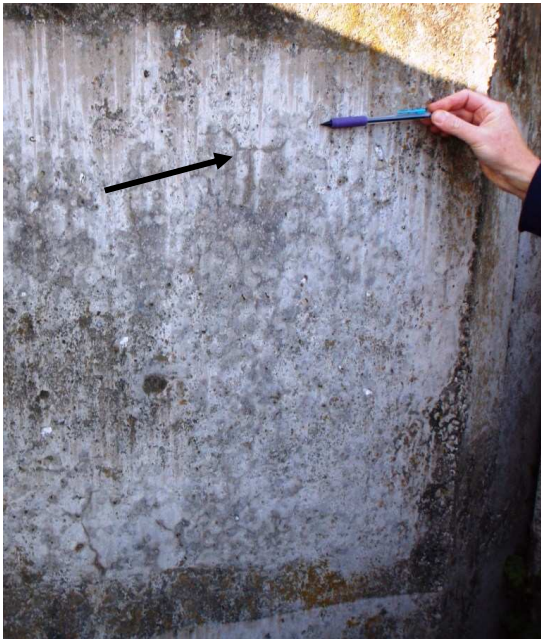
**Figure 3.4b** Efflorescence on uncracked pile (structure 'O', Southland; see also chapter 4)

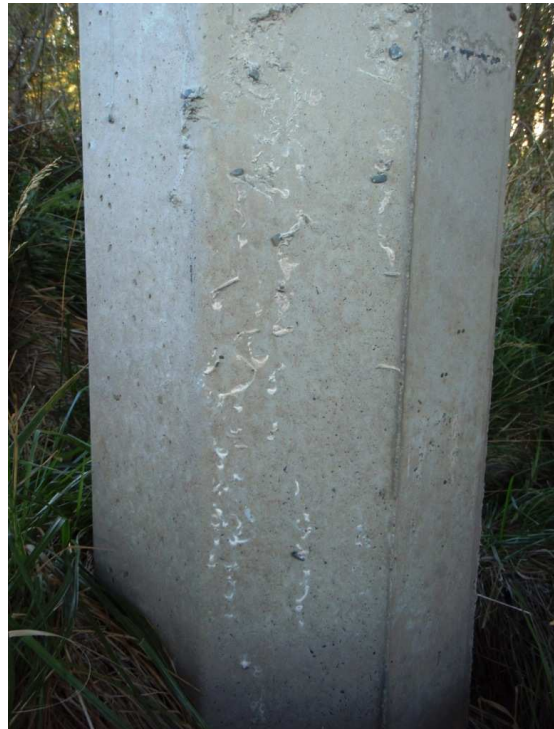
### 3.2.3 Discussion

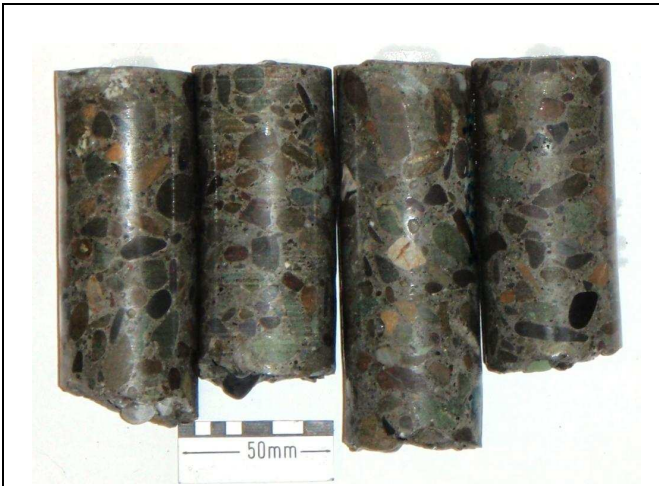
Structure Br (coarse aggregate  $\leq 25\text{mm}$ )
