TECHNICAL REPORT 17

CONTAMINATED LAND ASSESSMENT

NOVEMBER 2016

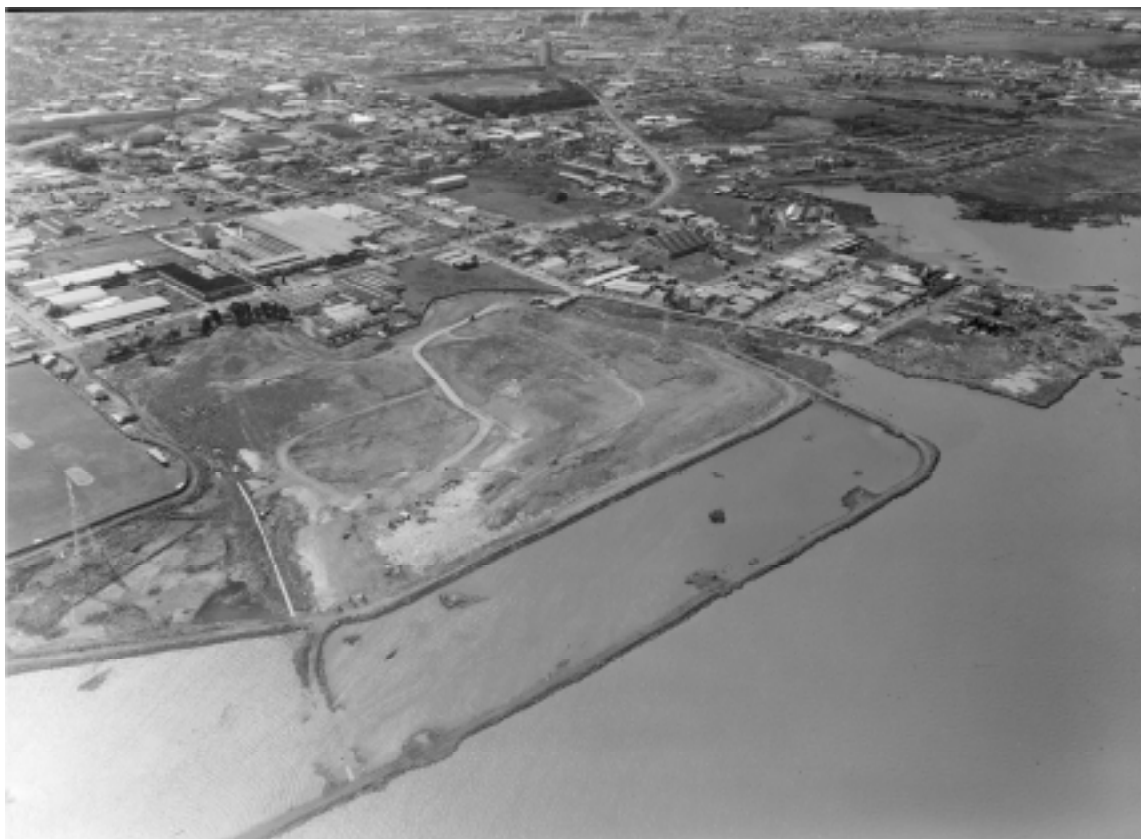
Figure 2-1: Photograph of Pikes Point 1975

An oblique aerial photograph from 1975 showing reclamation and filling at the Pikes Point West reclamation and closed landfill is provided in Figure 2-1. The photograph is taken from the west towards the area between Waikaraka and Miami Stream (Miami Parade). This photograph illustrates the earth bunds that were built to progressively form the margins of the filled area with fill placement occurring within the bunded area during construction. A line of trucks can be observed tipping what appears to be refuse or waste material into the Pikes Point West landfill area, with a bulldozer nearby. Dumped soil/material is also evident across the reclamation area. Pikes Point East landfill can be observed in the background, with filling activities evident and a large remaining area yet to be reclaimed.

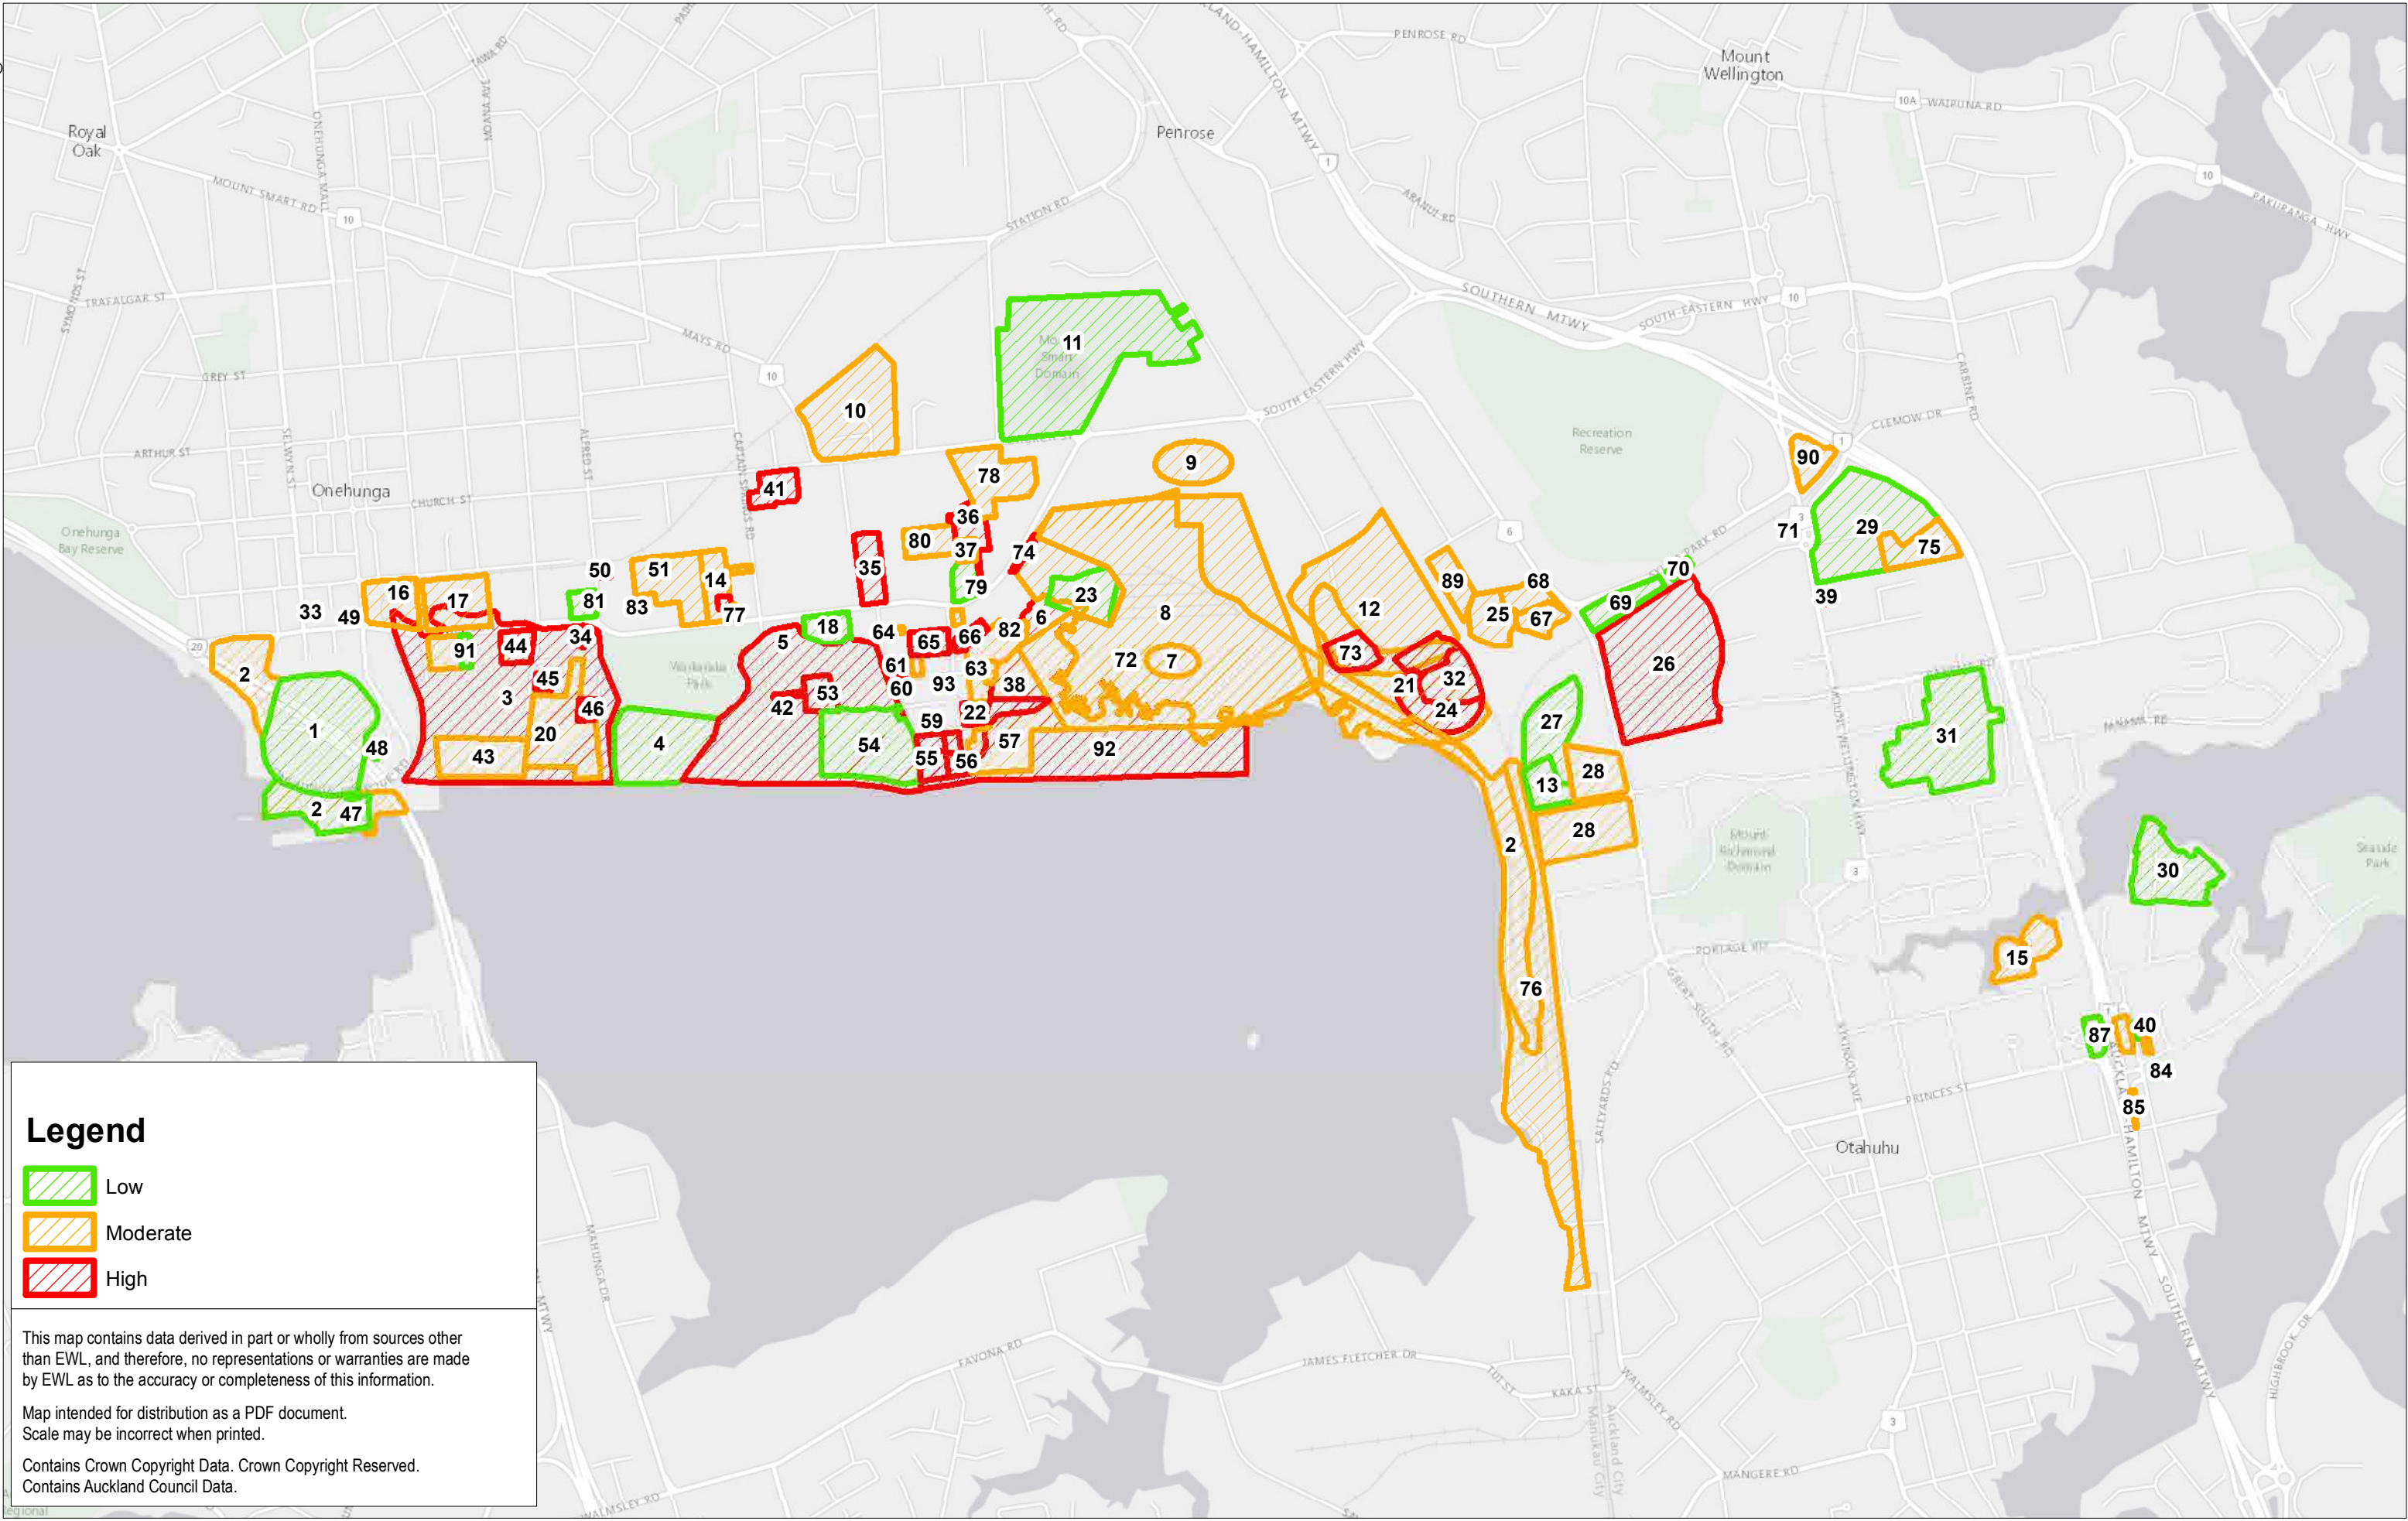
Discipline: Environment	Title: Contaminated Land Preliminary Site Investigation HAIL Map
Drawing No: GIS-CL-AEE-001	Rev: A

The PSI (Appendix A) found that there is a high number and density of actual and potential Hazardous Activities and Industries (HAIL) sites in the Project area. Figure 1 in Appendix B shows the identified HAIL sites. The activities and industries represented in the area include most of the MfE HAIL categories, thereby resulting in a wide range of potential contaminant types and sources.
