Subject: RE: Photos 12 March Okahu Viaduct and Okahu precast deck at Wilson Precasting, Otago - Confidential

Subject	12-11 OKAHU VIADUCT	Discipline	STRUCTURAL
Title	PRECAST DECK PLANKS REINFORCEMENT DETAILS - SHEET 3	Drawing No	P2Wk-DRG-SE-19-0107
		Rev	1

This report formerly outlines to NX2, and if necessary, the NZTA, two potential failure modes associated with the viaduct decks. One failure mode is associated with the sudden failure of the precast deck panels during construction. The other failure mode is associated with a premature decline in deck durability during its service life.

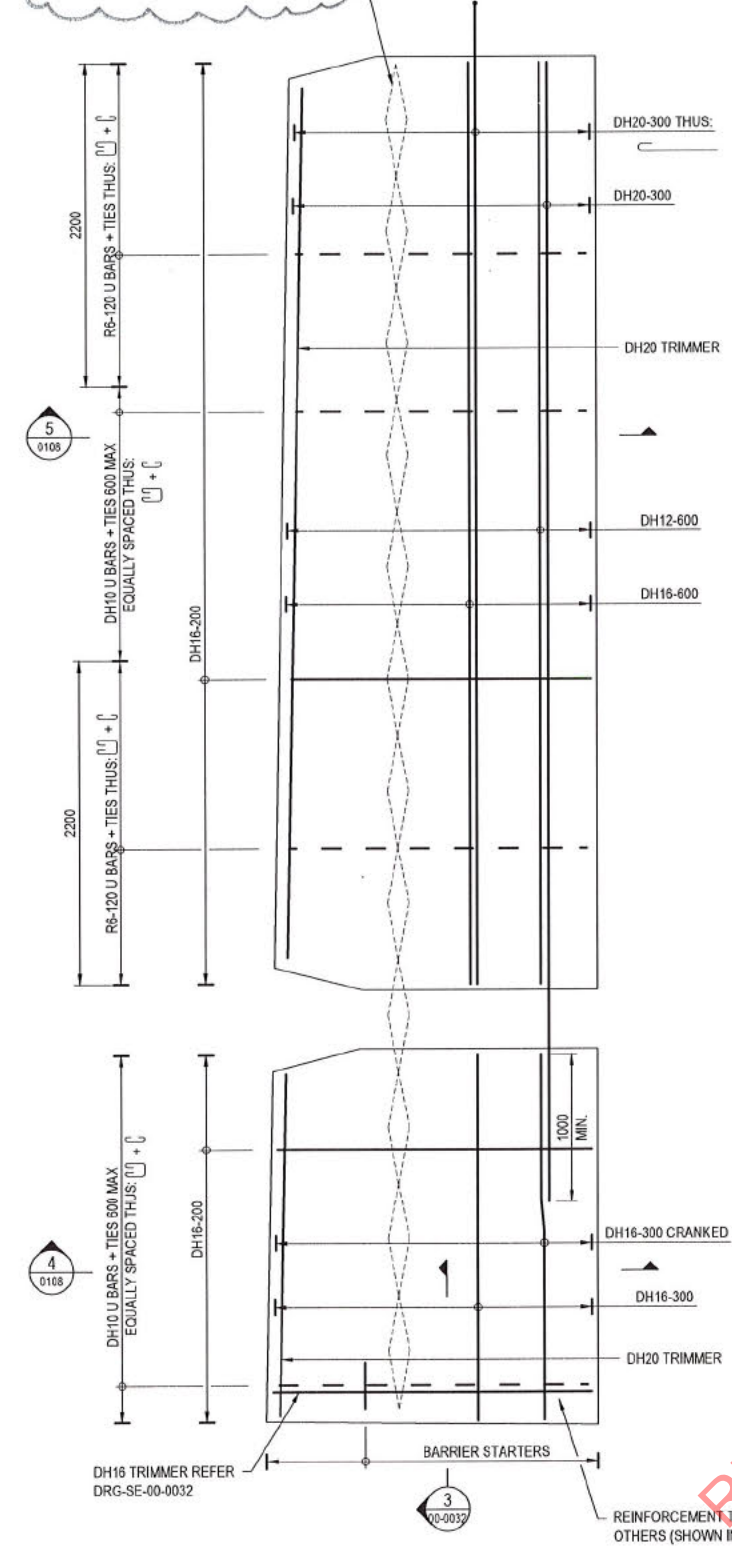
REINFORCEMENT TRUSSES BY OTHERS. SIZE AND SETOUT TO BE DETERMINED BY C.J.V. (SINGLE TRUSS SHOWN INDICATIVELY)

**C** PANEL TYPE S REINFORCEMENT DETAILS  
1:25(A1), 1:50(A3)

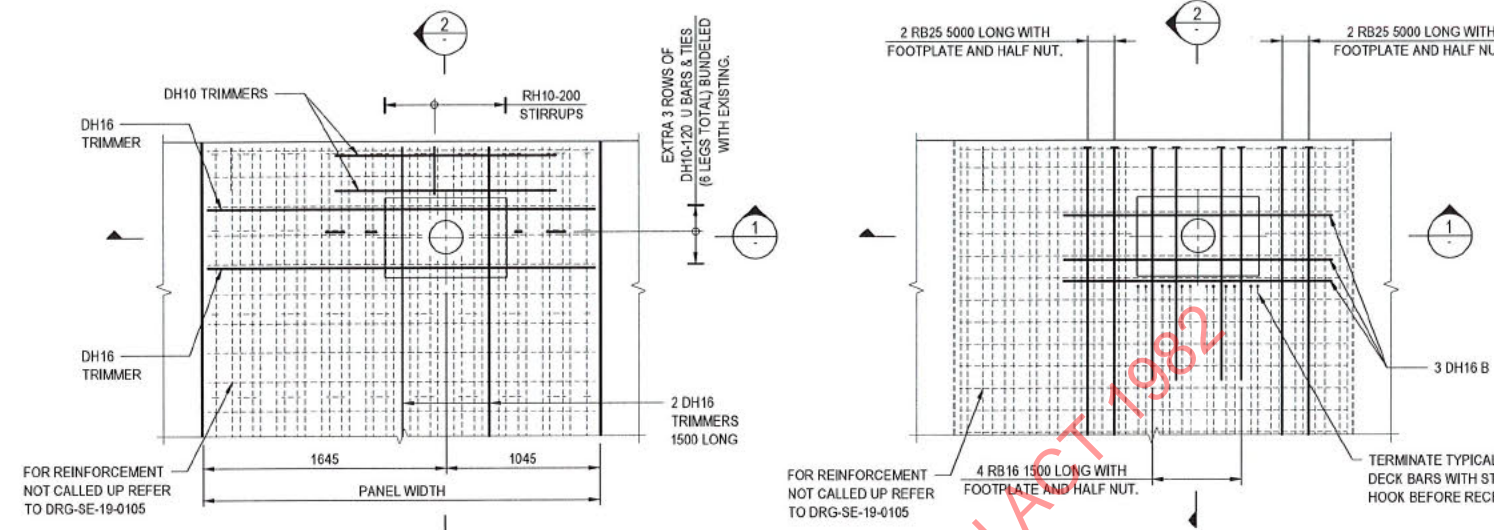
**C** PLAN- PRECAST PANEL AT CATCHPIT  
ADDITIONAL REINFORCEMENT  
1:25 (A1), 1:50 (A3)

**D** PLAN- INSITU DECK AT CATCHPIT  
ADDITIONAL REINFORCEMENT  
1:25 (A1), 1:50 (A3)

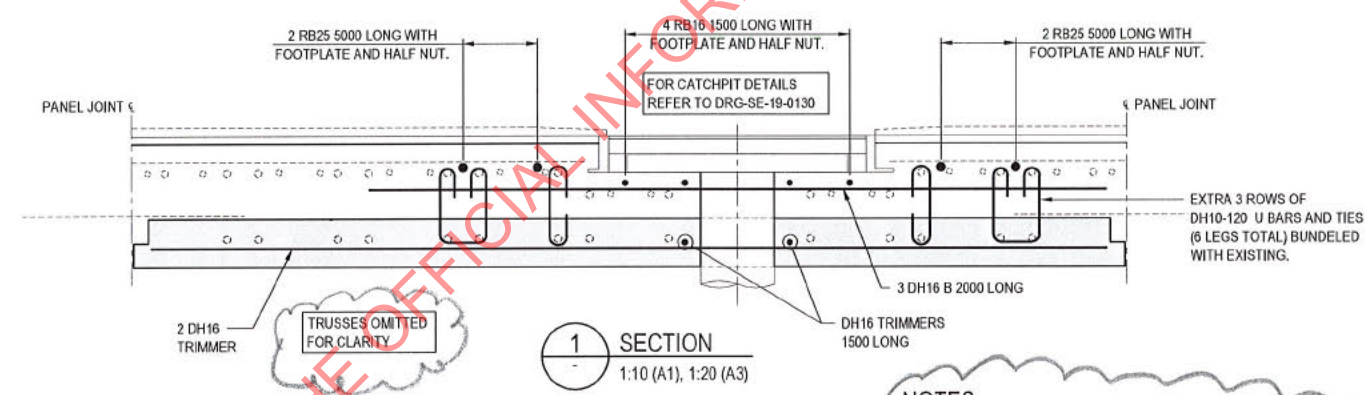
**1** SECTION  
1:10 (A1), 1:20 (A3)

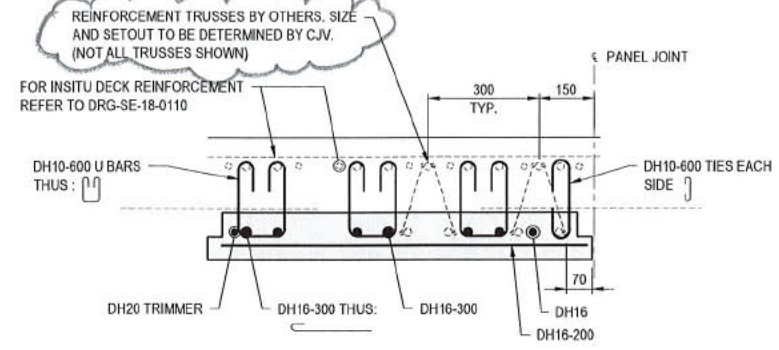
**4** PANEL TYPE C AND E REINFORCEMENT DETAILS  
1:10(A1), 1:20(A3)

NOTE:  
PANEL TYPE C DRAWN,  
PANEL E SIMILAR
