From: s 9(2)(a)
Sent: Monday, 25 May 2020 11:02 AM
To: 'Barry Wright' <Barry.Wright@nzta.govt.nz>
Subject: RE: Query P2W Viaducts

Okahu & Puhoi Viaducts

Deck System Review

16 March 2020

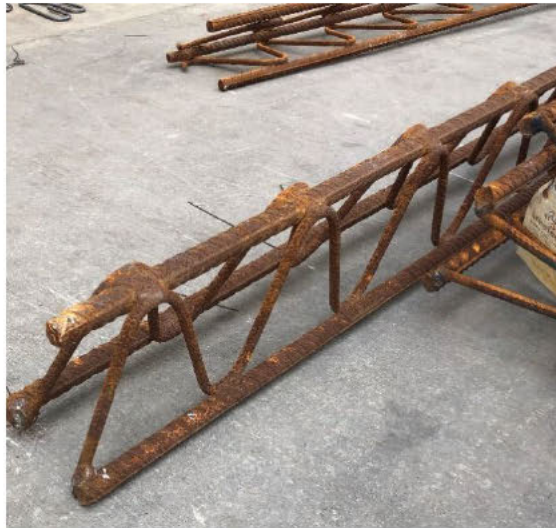
All precast panels are stiffened with TRT's at 300mm centres across the typically 2.7m panel width. Each TRT has a single HD20 rebar top chord and two HD20 rebar bottom chords. The vertical centroid distance between top and bottom chords is 154mm for the Okahu viaduct and 174mm for the Puhoi viaduct. The chords are held apart by diagonal HD10 bent 'zig-zag' diagonals which are welded (4mm fillet to the outside and inside bend) to the chords at 200mm centres. Typical TRT's are shown in Photo 1.

Photo 1: Typical Temporary Reinforcement Trusses prior to the bottom chords being cast into the 130mm thick precast deck panel.

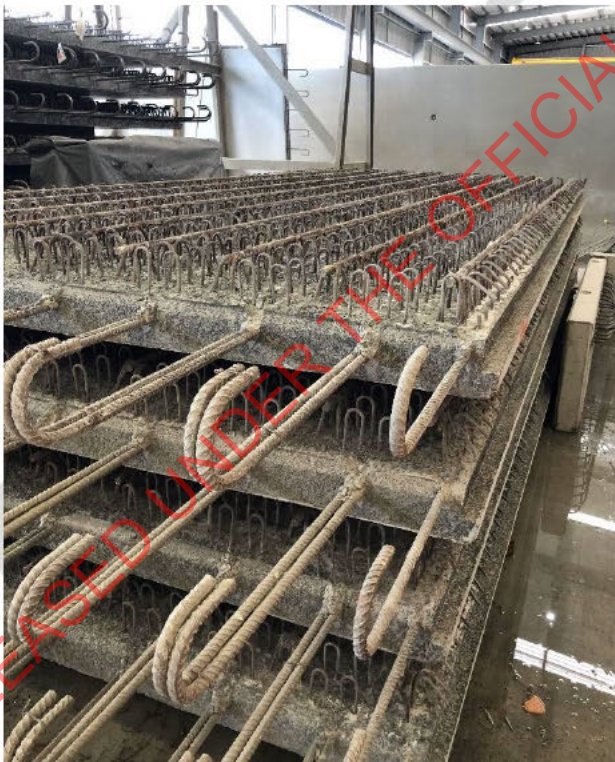
█ understands only the precast panels for the Okahu viaduct have been cast to date. These have been cast at Wilsons Precast, Heritage Way, Otara, Auckland. Photos 2 and 3 below show some of these panels and these photos were taken on 12 Mar. 2020. █ are unsure how many of these precast panels have been cast to date.

Photo 2: Typical centre precast deck panels stacked and ready to be transported to the Okahu site.

- Additionally, the precast panels appear not to have been cambered and are flat. This can be seen in Photos 2 and 3 above. [REDACTED] calculate by simple elastic theory that the Okahu centre panel have midspan deflections of over 30mm occurring during the topping pour. This will cause 'ponding' of the topping concrete and exacerbate both the deflections and the compression of the TRT top chords. Any mounding of the topping concrete during the pour will further exacerbate deflections and top chord compressions although temporarily.

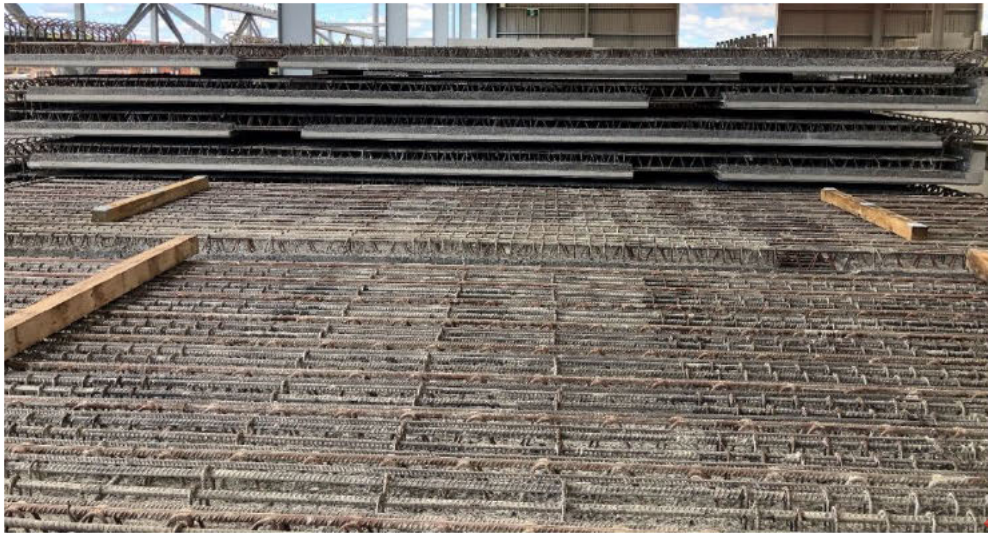
Photo 3: Typical outer precast deck panels stacked and ready to be transported to the Okahu site.

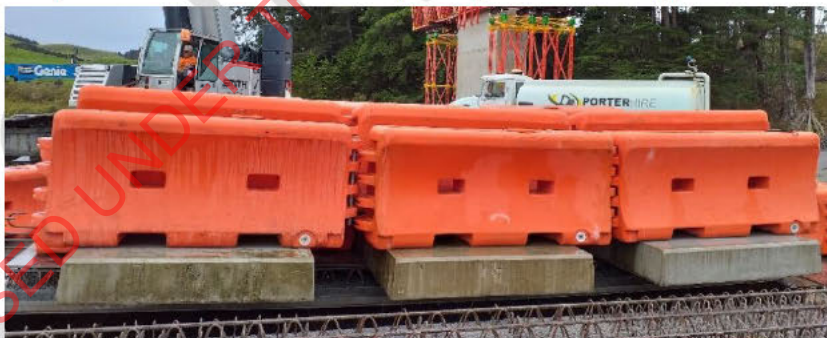
- No solutions to prevent this failure mode have been presented at this stage.
- [REDACTED] have received load testing results for a centre and an outer precast panel of the Okahu viaduct. The load tests were required by drawing P2Wk-DRG-SE-19-0107 Rev. 1. [REDACTED] have reviewed a package consisting load test planning documents, emailed results, and photographs for the load testing carried out on the 23rd and 27th Aug. 2019. Generally, the measured deflections were slightly less than half that expected by elastic theory. This suggests the deck panels were effectively twice as stiff as would be expected using typical material properties. This further suggests that the formwork panels (from plywood) placed direct onto the TRT top chords are clamped to the top chords by the kentledge (precast segment stacking cradles of 4.0tonne weight and filled Traffix Water-Wall barriers each of 0.5tonne weight) during load testing formed a rudimentary but effective composite top flange to stiffen the precast panel; and thereby result in abnormally low deflections. It is suggested if further load testing is carried out on the precast deck panels, then the kentledge is completely separated from the TRT top chords, and it is placed such that no possible 'running' or longitudinal shear connection exists between the TRT's or precast panel and the kentledge. The precast panels should also be tested to failure so that the failure mode may be recorded. Some precast panels should be load tested with deliberately damaged (kinked) or misaligned TRT top chords to demonstrate a likely scenario. The outer panels should be loaded first between the supports, and only then on the cantilever as this loading reduces compression in the TRT top chords spanning between the supports.

Photo 4: This shows load testing of an Okahu centre panel.

3. Conduct further load testing of the already cast Okahu viaduct precast deck panels. Ensure the panels are accurately supported to mimic loading of the topping pour as accurately as possible. Ensure kentledge offers no lateral restraint to the TRT top chords or provides any top flange effect to authentically mimic the wet concrete topping loading. Test panels with undamaged TRT top chords and those with deliberately damaged or misaligned TRT top chords. Test to failure and note the failure mode. Place kentledge only between the lines of support first; not on the cantilever portion of the outer panels. Record loading and deflections accurately. It is suggested that a professional testing agency or the University of Auckland Civil Engineering school be engaged to assist NX2 develop a thorough load testing regime for the precast deck panels.

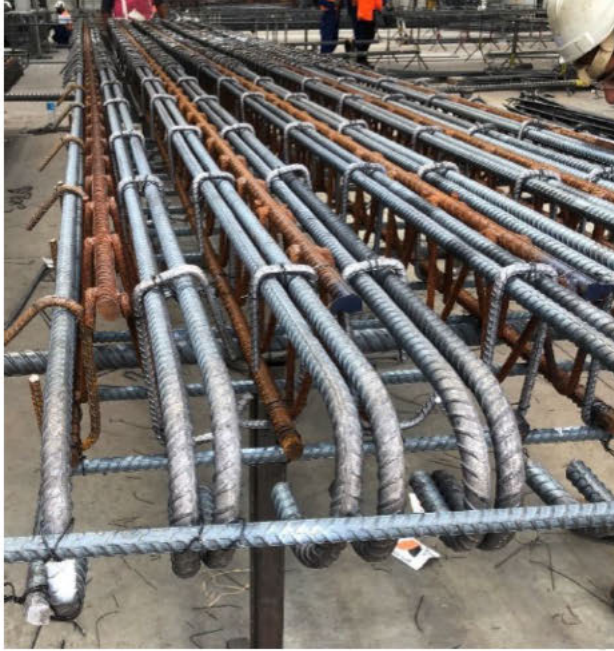
- The permanent deck is therefore expected to behave like a series of stiffer links connected by less stiffer connections at points where bending moment is highest. The higher strains associated with the sharper deck curvature will cause cracking in the deck cover concrete. That is to top cover concrete above the girders and the bottom cover concrete between the girders.

Photo 5: This shows one of the less typical Okahu deck panels in the process of being tied. It shows the extent of reinforcement within the deck panels made-up with the TRT's (shown rusted) and the permanent top reinforcement (shown grey).

- Further cyclic traffic loading will also result in the fractured TRT chords 'working' within the deck creating cavities for moisture to collect. This could cause premature corrosion of all the reinforcement within the deck close to these locations.
- It is difficult to estimate the reliable life of the deck, but it is not expected to behave as a typical RC bridge deck slab with only gradual changes of stiffness as transverse reinforcement is carefully curtailed to suit moment demands.
- No solutions to prevent this failure mode have been presented at this stage.
- No evidence of past performance of this type of deck with embedded and fractured TRT's have been presented at this stage.
- To reiterate [REDACTED] have made no analysis of the permanent deck.

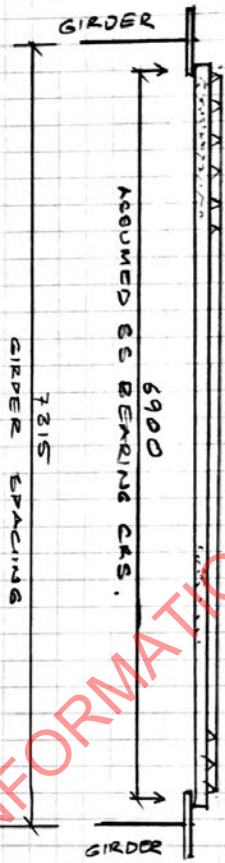
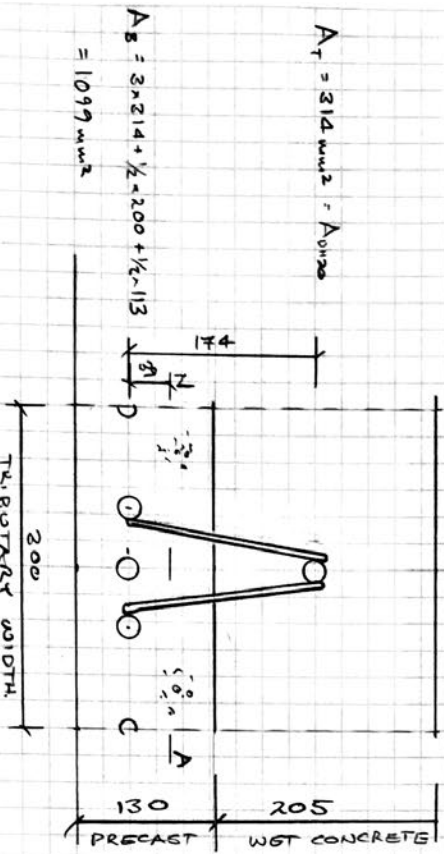
CROSS SECTION

PUBLIC VIADUCT - CENTRE PANEL
 SIMPLY SUPPORTED MODEL

BOTH PRECAST PANEL WITH 174 DEEP TRUSSES @ 200 C/S.

$$A_T = 314 \text{ mm}^2 = A_{\text{truss}}$$

$$A_B = 3 \times 214 + \frac{1}{2} \times 200 + \frac{1}{2} \times 113 = 1099 \text{ mm}^2$$

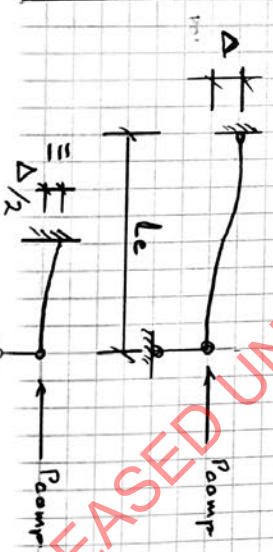
ADDITIONAL BENDING MOMENT

$$M_B = P_{comp} \Delta / 2 = 94 \times 0.001 = 0.094 \text{ KNm}$$

BENDING STRESS IN TOP CHORD

RECOMMEND ACTIONS INDEPENDENTLY VERIFY

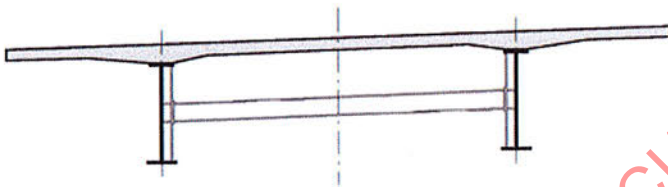
The steel girder bridge predominates among the composite solutions employed in Europe, and has the cross girders generally located around the mid depth of the main beams (Figure 1). The deck slab spans transversely and is supported by the main girders. In such situations the distance between cross beams is between 6 - 10 mand they do not have shear connectors.

Figure 1: Cross girder at mid depth (Europe detail shown).

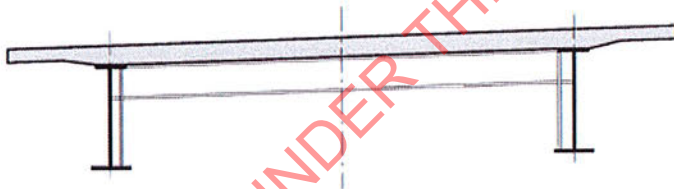
Figure 2: Cross girder also supporting the slab (Europe detail shown).

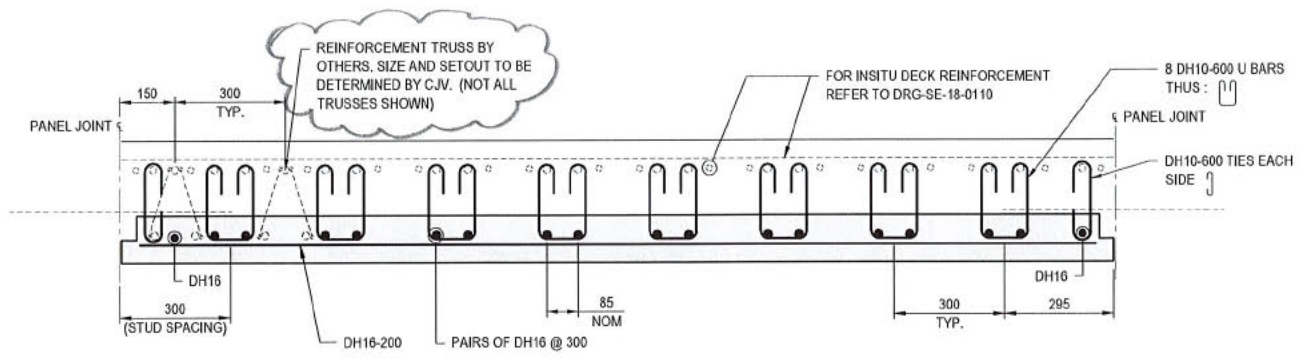
1 PANEL TYPES A, A1, F AND H REINFORCEMENT DETAILS
1:10(A1), 1:20(A3)

NOTE:
PANEL TYPE A DRAWN,
PANELS A1, F AND H SIMILAR

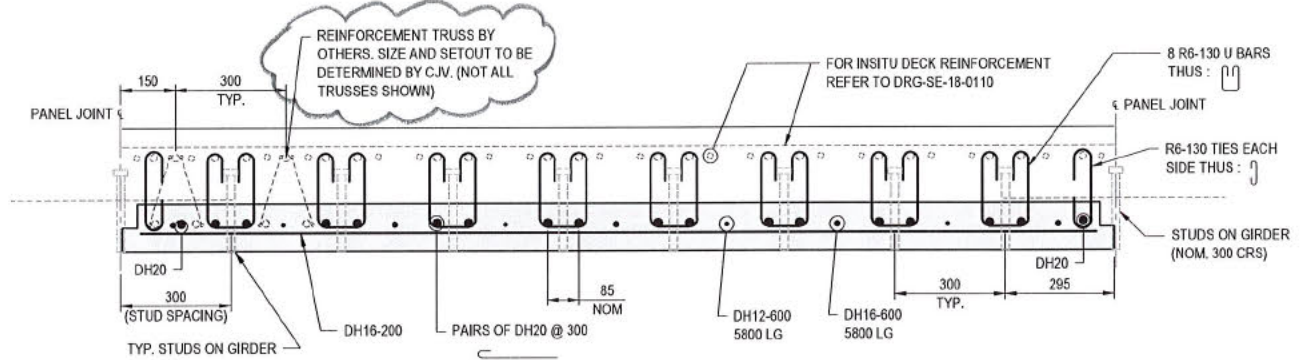
2 PANEL TYPES A, A1, F AND H REINFORCEMENT DETAILS
1:10(A1), 1:20(A3)

NOTE:
PANEL TYPE A DRAWN,
PANELS A1, F AND H SIMILAR

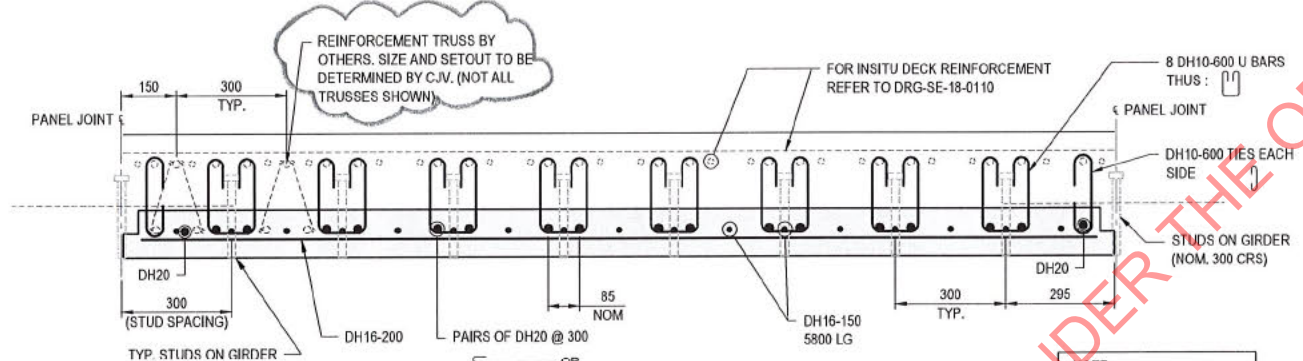
3 PANEL TYPES B, B1, G AND J REINFORCEMENT DETAILS
1:10(A1), 1:20(A3)

NOTE:
PANEL TYPE B DRAWN,
PANELS B1, G AND J SIMILAR

NOTE:
U BARS MAY BE REPLACED WITH CLIPS OF SAME DIAMETER AND SPACING
i.e. =>

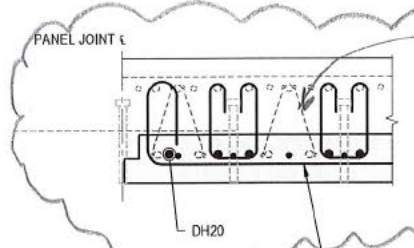
A PROPOSED CJV ALTERNATIVE OPTION TO REPLACE END TIE WITH DH16 HOOK BAR
1:10(A1), 1:20(A3)

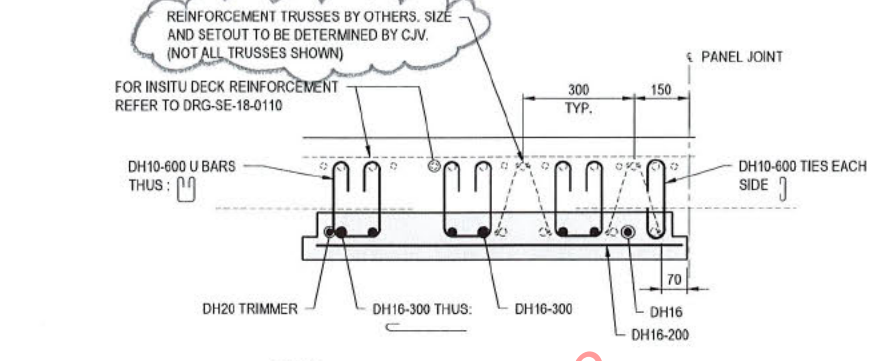
4 PANEL TYPE C AND E REINFORCEMENT DETAILS
1:10(A1), 1:20(A3)

NOTE:
PANEL TYPE C DRAWN,
PANEL E SIMILAR

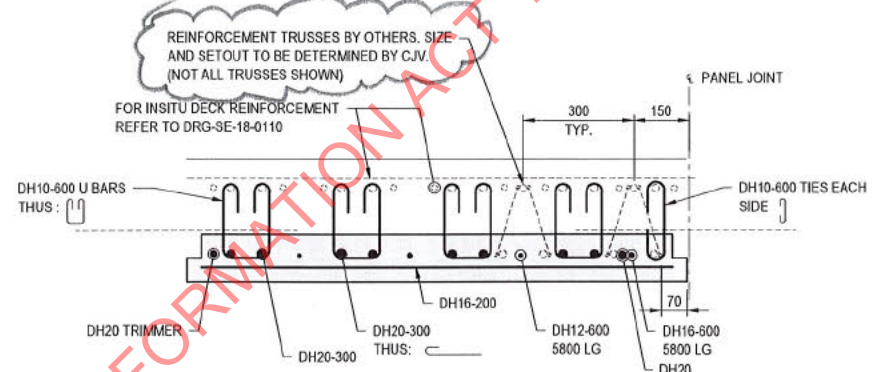
5 PANEL TYPE C AND E REINFORCEMENT DETAILS
1:10(A1), 1:20(A3)

NOTE:
PANEL TYPE C DRAWN,
PANEL E SIMILAR

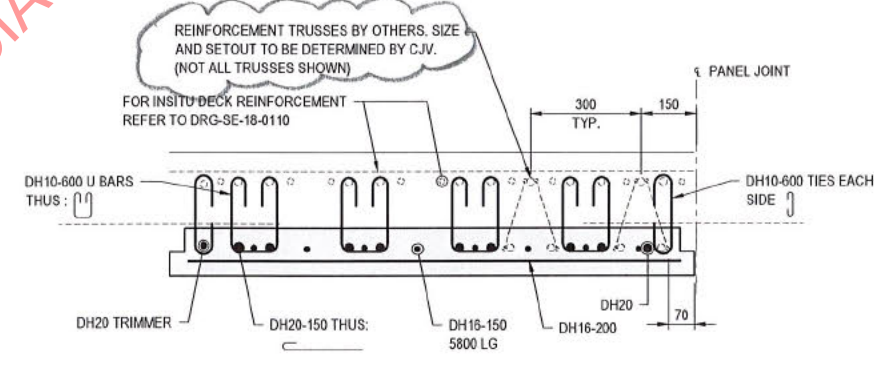
6 PANEL TYPE D REINFORCEMENT DETAILS
1:10(A1), 1:20(A3)
