**Subject:** RE: Photos 12 March Okahu Viaduct and Okahu precast deck at Wilson Precasting, Otago  
- Confidential

Upon a request by NX2 (NX2Group – PPP special purpose vehicle to deliver P2Wk project for the NZTA) for s 9(2)(a) to peer review a temporary works component associated with the deck construction for both the Okahu and Puhoi viaducts two significant deck failure modes have been discovered. The temporary works concerned is the 'lynch-pin' for both modes of failure.

This report formerly outlines to NX2, and if necessary, the NZTA, two potential failure modes associated with the viaduct decks. One failure mode is associated with the sudden failure of the precast deck panels during construction. The other failure mode is associated with a premature decline in deck durability during its service life.

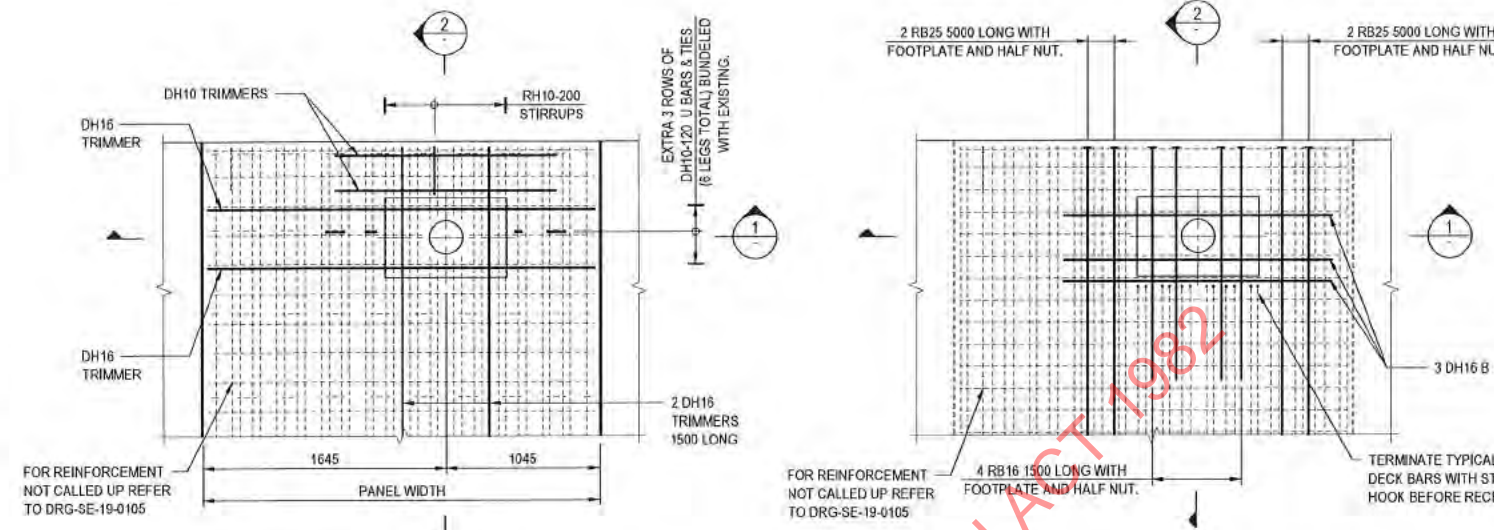
**C** PLAN- PRECAST PANEL AT CATCHPIT  
ADDITIONAL REINFORCEMENT  
1:25 (A1), 1:50 (A3)

**D** PLAN- INSITU DECK AT CATCHPIT  
ADDITIONAL REINFORCEMENT  
1:25 (A1), 1:50 (A3)

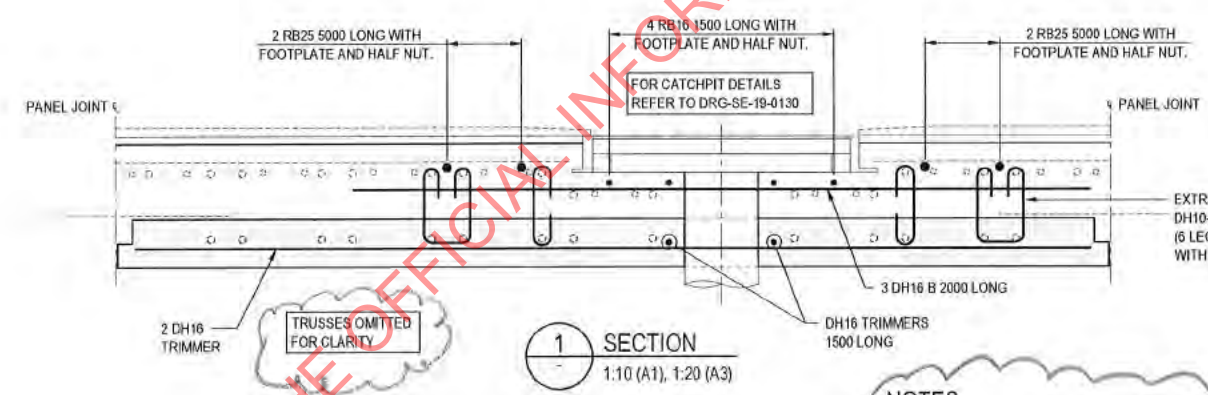
**1** SECTION  
1:10 (A1), 1:20 (A3)

3. THE TEMPORARY REINFORCING TRUSS IS CONSIDERED REDUNDANT FOR THE PERMANENT WORKS DUE TO FATIGUE ISSUES CAUSED FROM WELDING OF THE TRUSS BARS.
  4. THE CONSTRUCTOR SHALL PROVIDE ADEQUATE LATERAL SUPPORT TO PREVENT THE PRECAST PANEL FROM DISPLACING OFF THE STEEL GIRDER FLANGE.

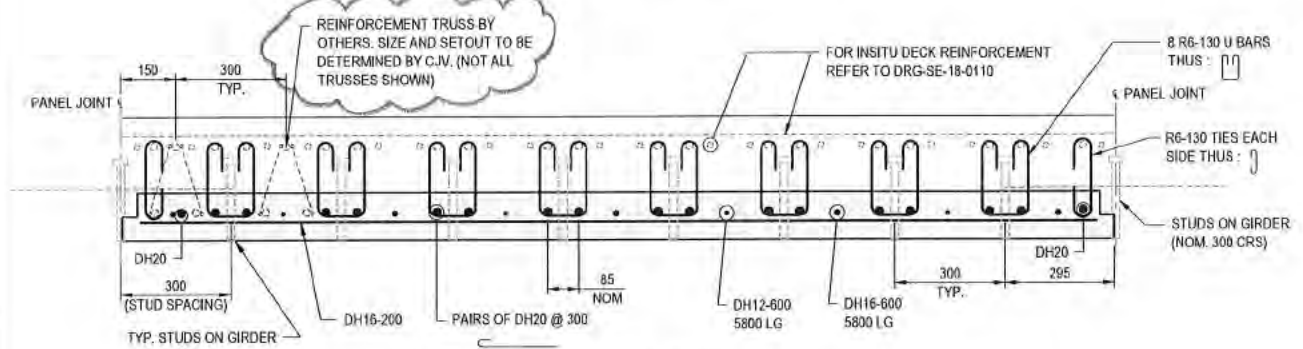
**2** PANEL TYPES A, A1, F AND H REINFORCEMENT DETAILS  
1:10(A1), 1:20(A3)

NOTE: PANEL TYPE A DRAWN, PANELS A1, F AND H SIMILAR

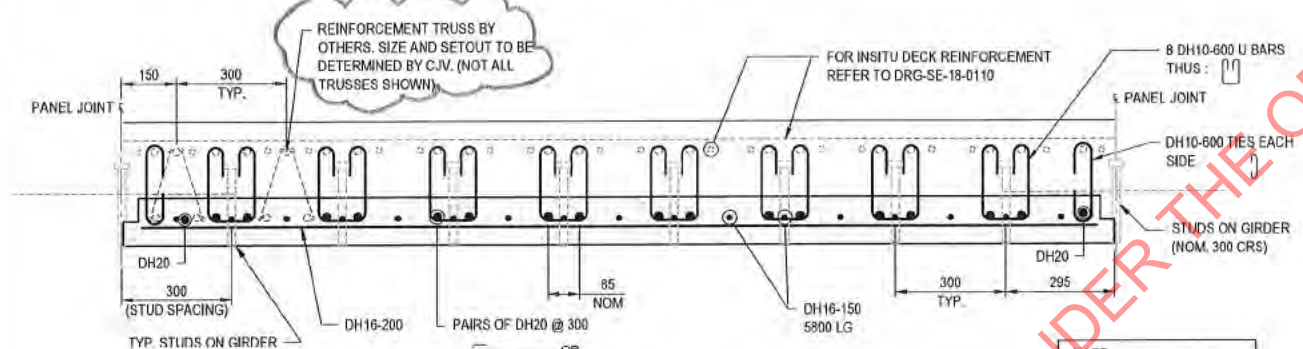
**3** PANEL TYPES B, B1, G AND J REINFORCEMENT DETAILS  
1:10(A1), 1:20(A3)

NOTE: PANEL TYPE B DRAWN, PANELS B1, G AND J SIMILAR

NOTE: U BARS MAY BE REPLACED WITH CLIPS OF SAME DIAMETER AND SPACING  
i.e. =>

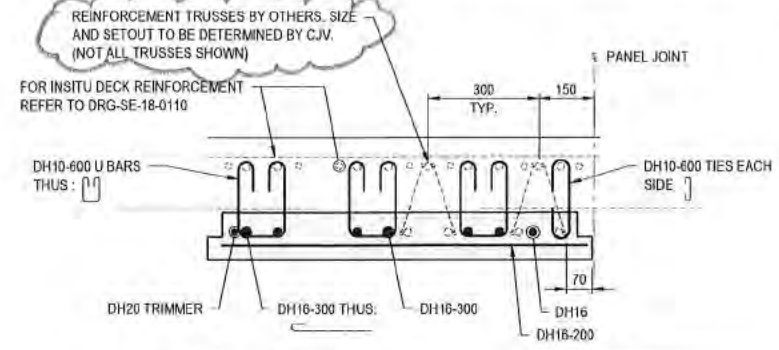
**4** PANEL TYPE C AND E REINFORCEMENT DETAILS  
1:10(A1), 1:20(A3)

NOTE: PANEL TYPE C DRAWN, PANEL E SIMILAR

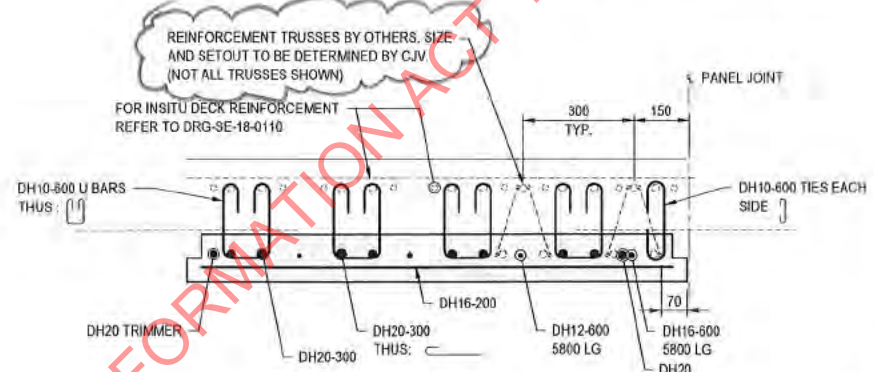
**5** PANEL TYPE C AND E REINFORCEMENT DETAILS  
1:10(A1), 1:20(A3)

NOTE: PANEL TYPE C DRAWN, PANEL E SIMILAR

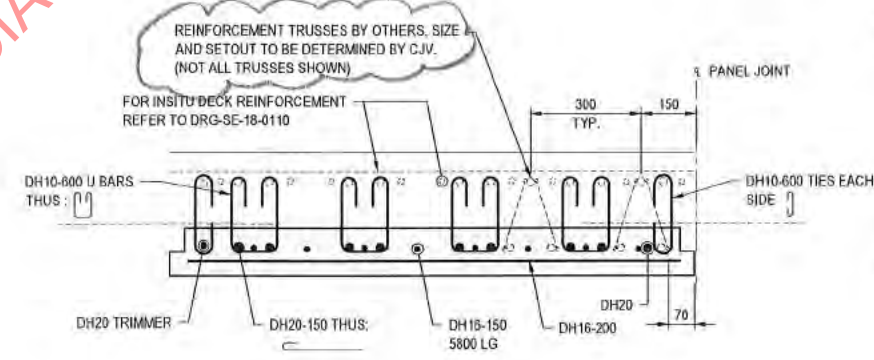
**6** PANEL TYPE D REINFORCEMENT DETAILS  
1:10(A1), 1:20(A3)
