Let's Get Wellington Moving

COBHAM DRIVE CROSSING MONITORING REPORT

4 SEPTEMBER 2023

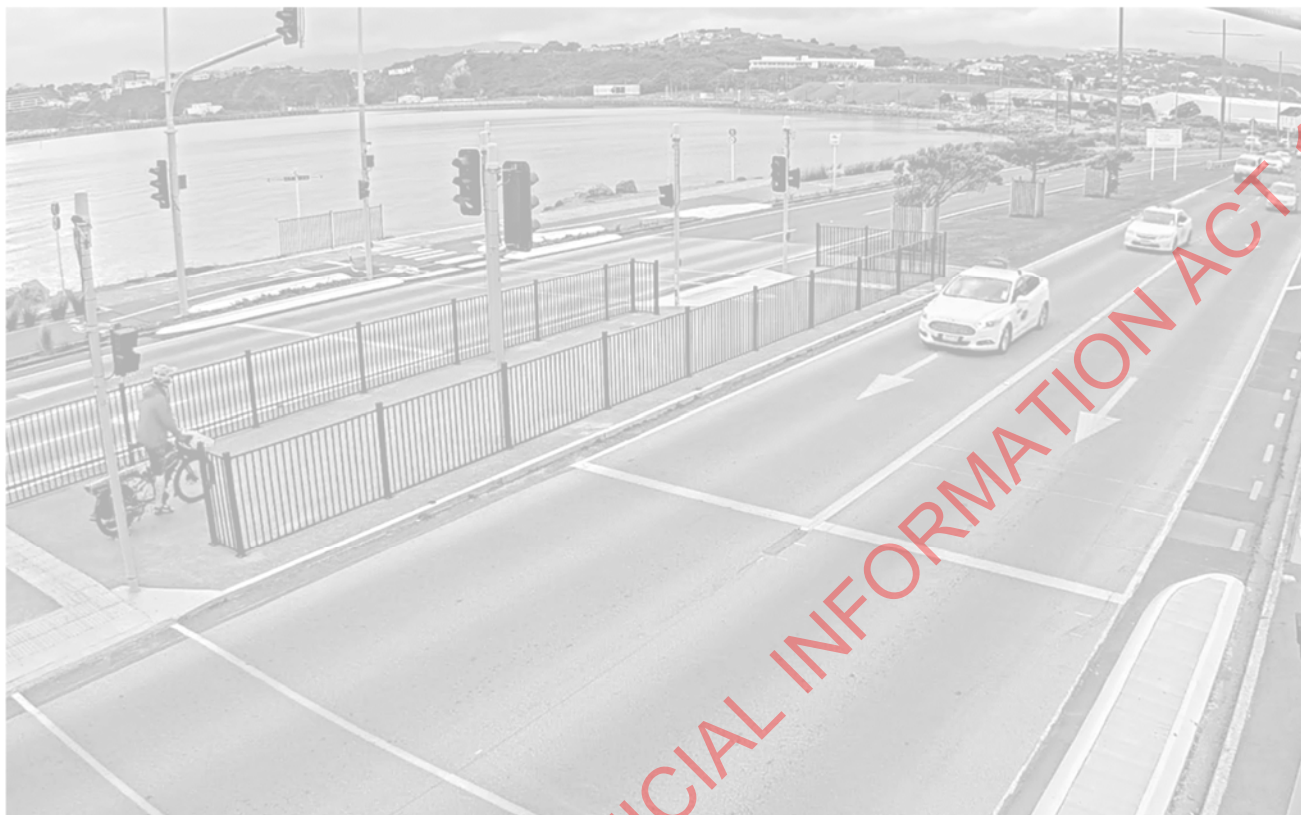
Figure 1: Viewpoint from CCTV camera

Two weeks of video footage (Sunday 11 June – Saturday 24 June 2023, 6am-9pm each day) was recorded from the CCTV camera (refer Figure 1) at the crossing. The following two days of video footage were analysed.

As can be seen by the viewpoint in Figure 1, not all elements of the crossing are clearly visible including the signal aspects for westbound traffic and the waiting area on the southern side of the crossing. As such the analysis undertaken has worked within these limitations.

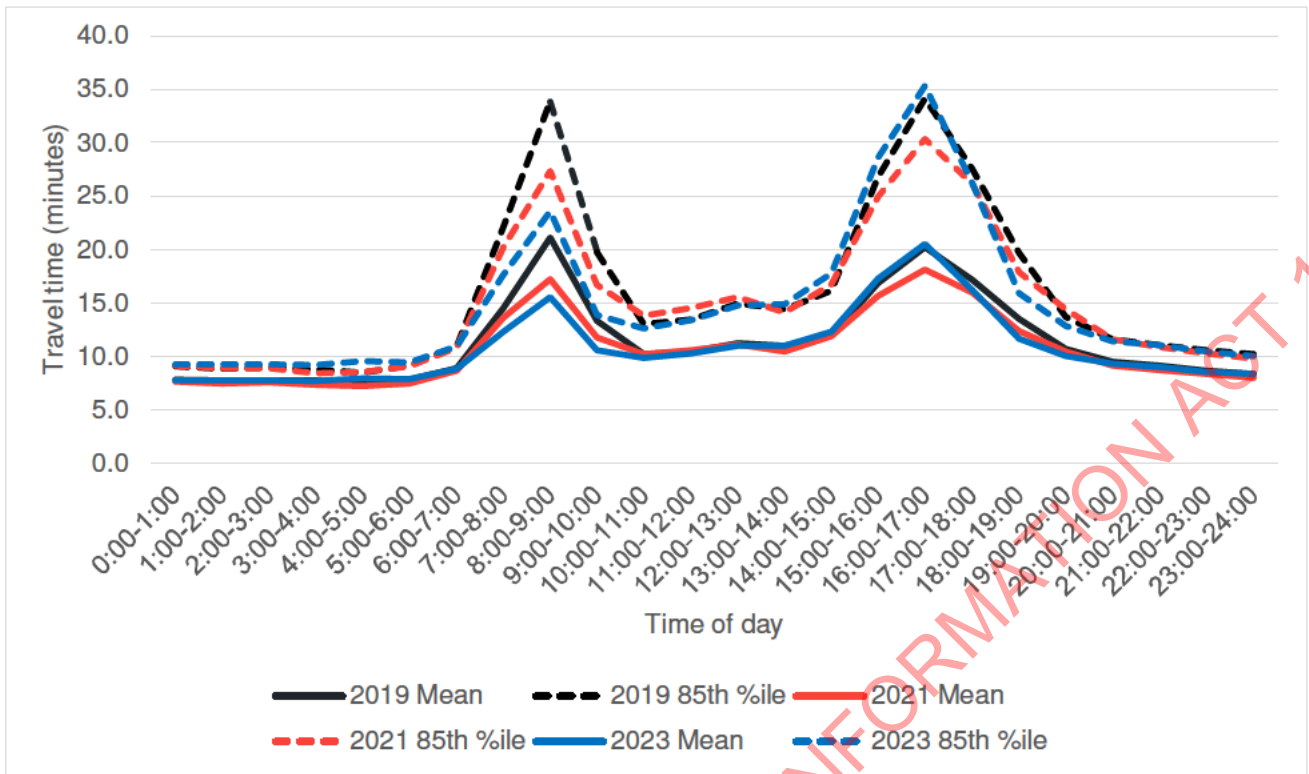
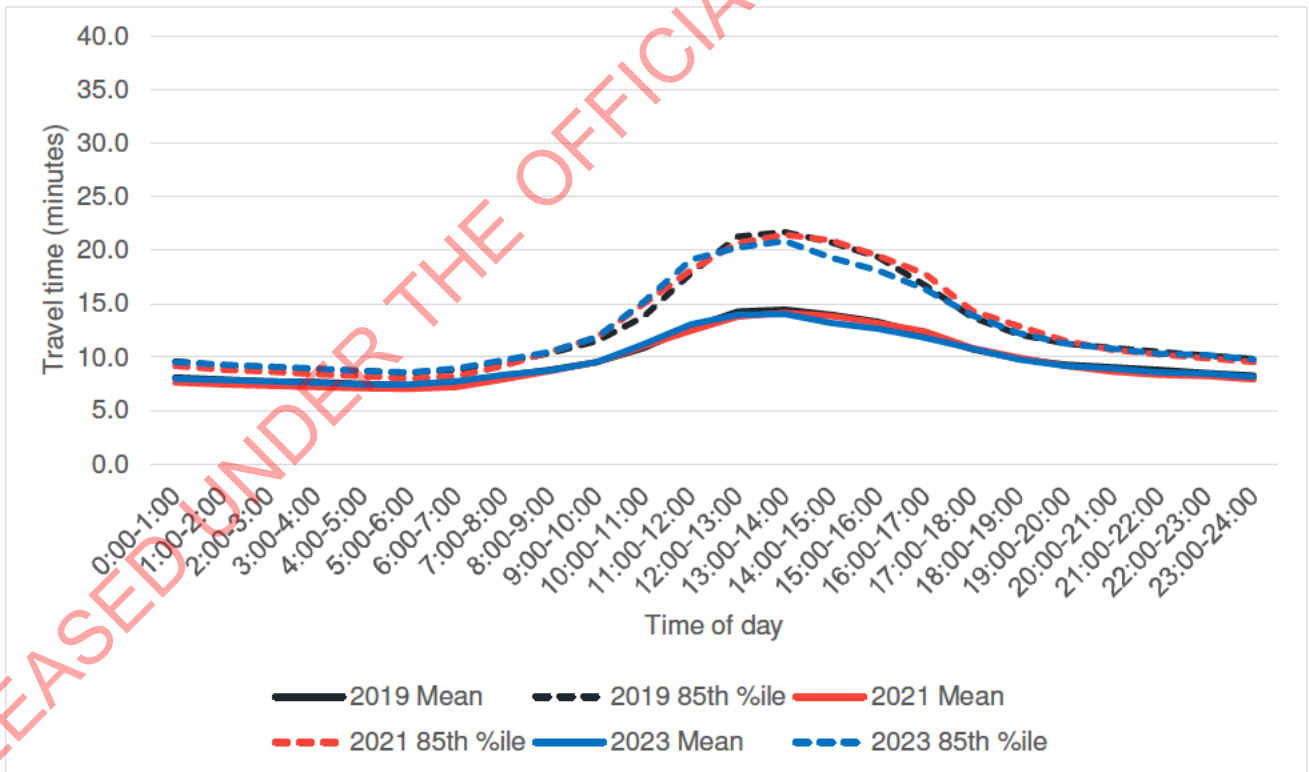
Figure 4 - Figure 7 below show the travel times by time of day for the different directions for weekday and weekend for the Miramar to Willis Street route.

The table above and figures below show no consistent patterns of changes in travel times through the project area. The following observations are made:

- There has been limited change in travel times in the southbound direction across the three time periods both on weekdays and weekends,

- In the northbound direction:
 - The AM peak (weekday) shows travel times have improved across the three periods (lowest travel times in 2023),
 - The PM peak (weekday) shows travel times are similar in 2023 to 2019,
 - The weekend peak travel times have worsened across the three periods (longest travel times in 2023).

It is difficult to identify a clear conclusion about whether the crossing has had an impact on travel times through the area. As noted above, traffic flows adjacent to the site have changed because of Covid-19. Covid-19 restrictions changed travel patterns, some of those behavioural changes have remained following the removal of restrictions including more working from home which makes drawing conclusions challenging.

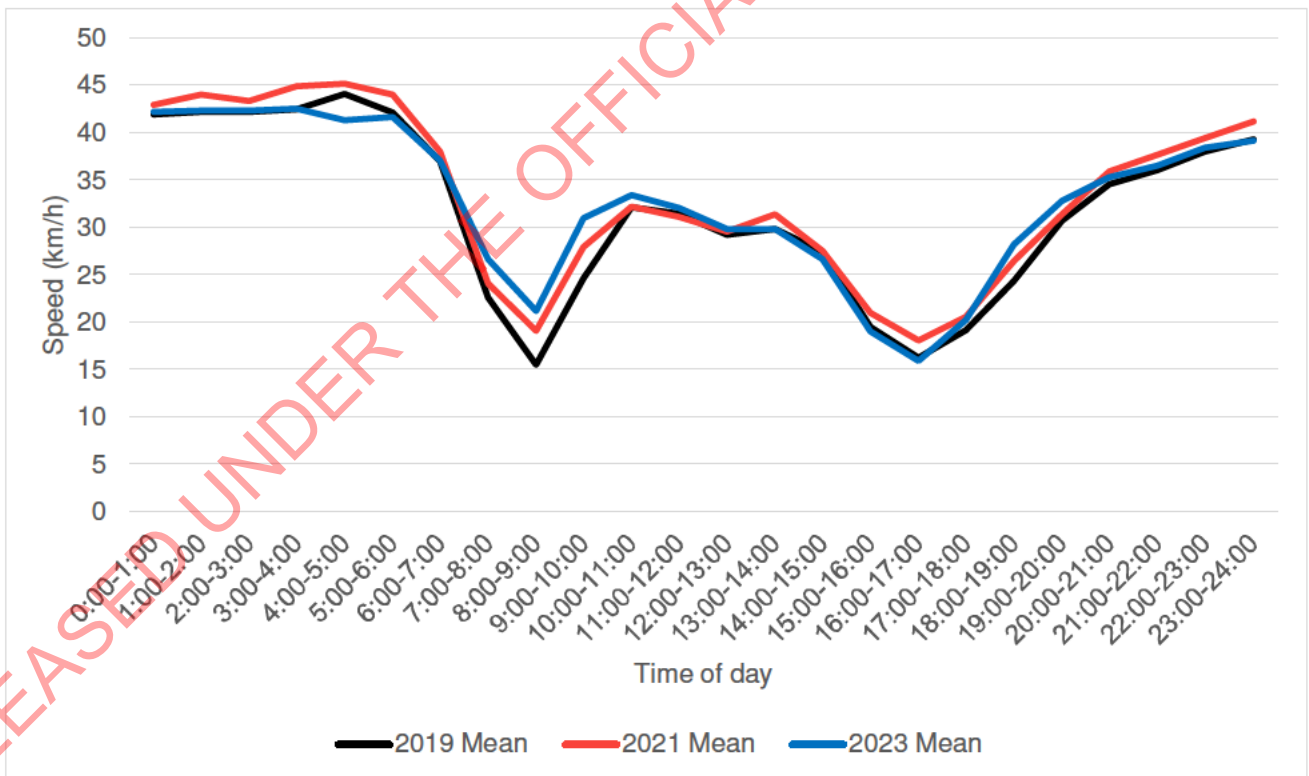
Speeds are the inverse of travel times and therefore similar conclusions apply to the speeds along the routes. Figure 8 - Figure 11 below show the travel times by time of day for the different directions for weekday and weekend for the Miramar to Willis Street route.

The figures below show no consistent patterns of changes in vehicle speeds through the project area. The following observations are made:

- There has been limited change in vehicle speeds in the southbound direction across the three time periods both on weekdays and weekends,
- In the northbound direction:
 - The AM peak (weekday) shows vehicle speeds have improved across the three periods (fastest vehicle speeds in 2023),
 - The PM peak (weekday) shows vehicle speeds are similar in 2023 to 2019,
 - The weekend peak vehicle speeds have worsened across the three periods (slowest vehicle speeds in 2023).

It is difficult to identify a clear conclusion about whether the crossing (and speed limit changes) have had an impact on vehicle speeds through the area. As noted above, traffic flows adjacent to the site have changed because of Covid-19. Covid-19 restrictions changed travel patterns, some of those behavioural changes have remained following the removal of restrictions including more working from home which makes drawing conclusions challenging.

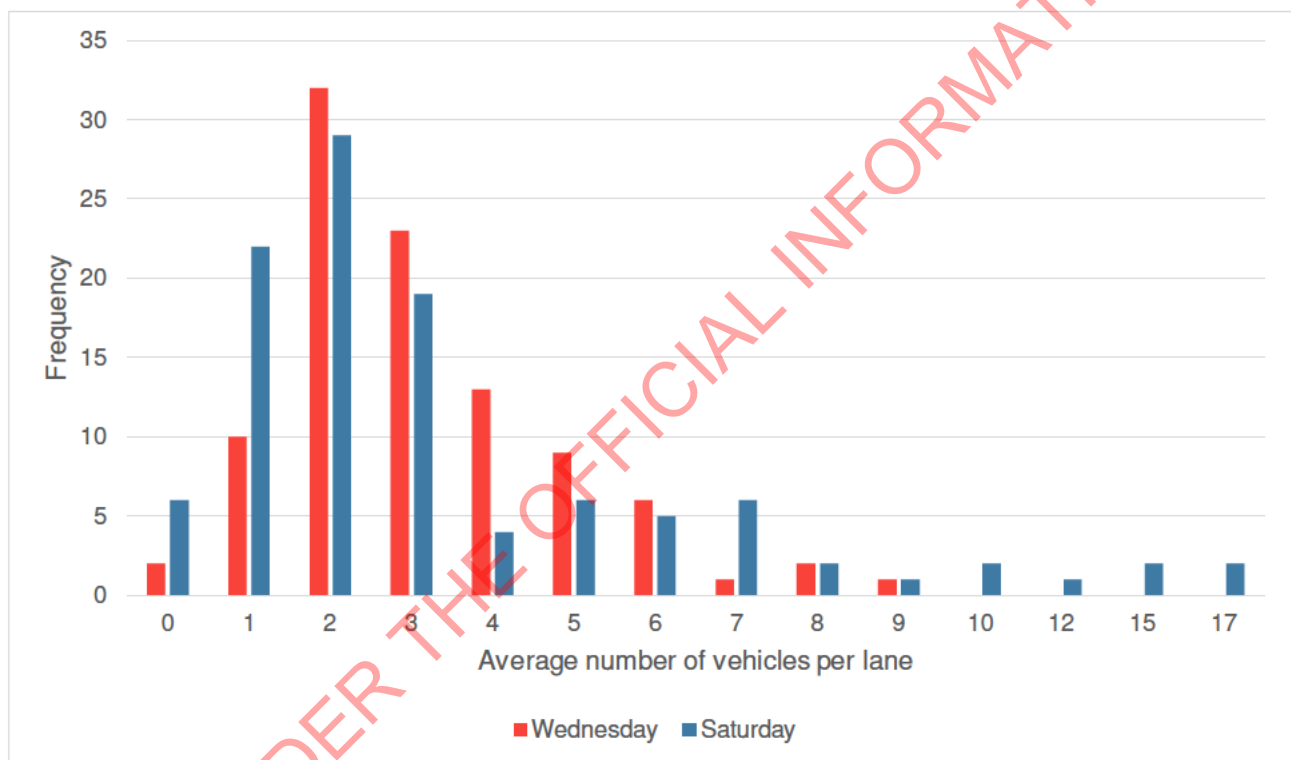
Figure 12: Average vehicles queued per lane westbound when signal turns green

Figure 12 below shows the distribution of average vehicles queued per lane in the westbound direction from the video data analysis. The eastbound direction was not able to be captured due to the view of the camera.

The figure indicates that the majority of occasions that vehicles are stopped by the crossing, queuing does not exceed more than five vehicles per lane. Weekday and weekend distributions are largely similar with a slightly wider distribution on the weekend.

The maximum average queue per lane identified was 17 vehicles which, based on 7m per vehicle, equates to a queue of around 120m. The distance from the crossing to the roundabout is approximately 150m. Due to the position and angle of the camera, for longer queues it was difficult to determine which vehicles were completely stopped.

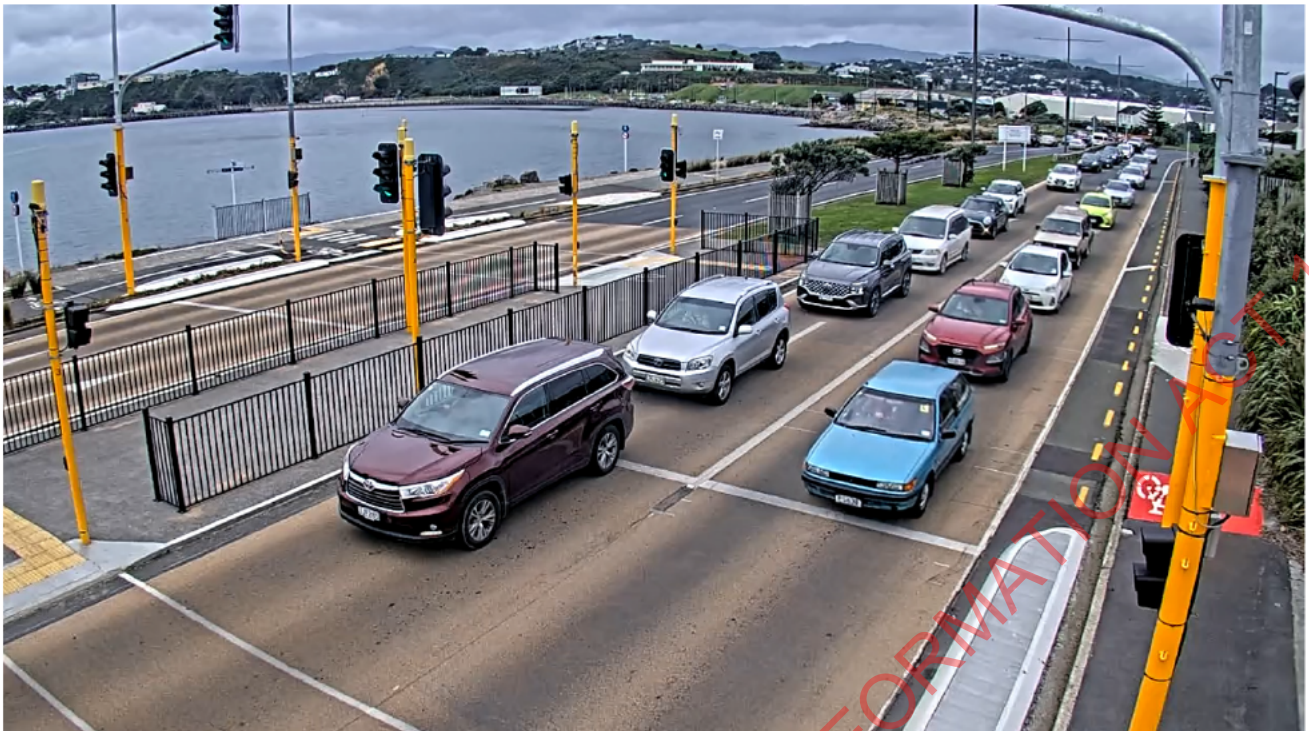
Figure 13: Vehicles queued from downstream constraint (Saturday at around 11.45am)

Further analysis showed that queues of 10 vehicles or more (average per lane) only occurred between 11am and 1pm on Saturday. This time period was also when queues back through the crossing from downstream constraints were noted. Figure 13 below shows stopped vehicles in a queue extending back from a constraint downstream of the crossing. Therefore, although the long queues are recorded when the crossing was operated they are primarily due to downstream constraints.

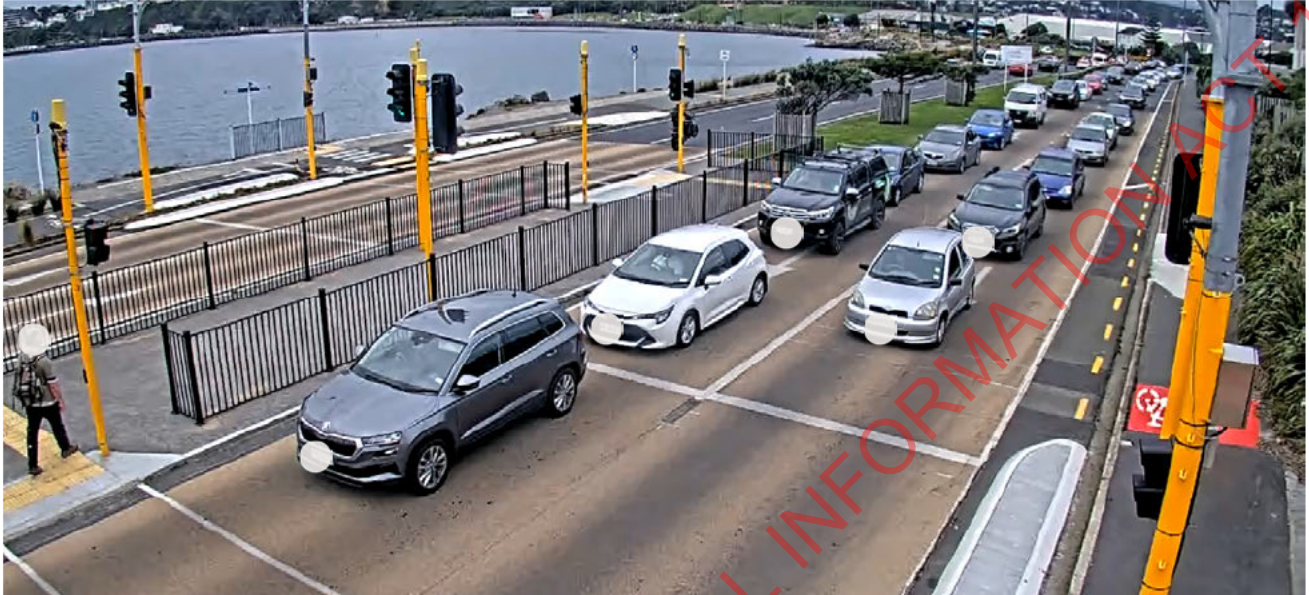
The figure indicates that in approximately 10% of instances a vehicle was recording as being queued in front of the limit line. There does not appear to be a significant difference by day of week or direction of travel. Figure 15 below shows an example of where a vehicle is queued in front of the limit line due to waiting in a queue from a downstream constraint and Figure 16 shows an example of where a vehicle is queued in front of the limit line due to late stopping for the crossing. In some instances vehicles were noticed to creep forward in anticipation of the signal changing to green.

Figure 15: Vehicles queued in front of limit line (Saturday at around 11.50am)

Figure 16: Vehicles queued in front of limit line (Saturday at around 10.30am)

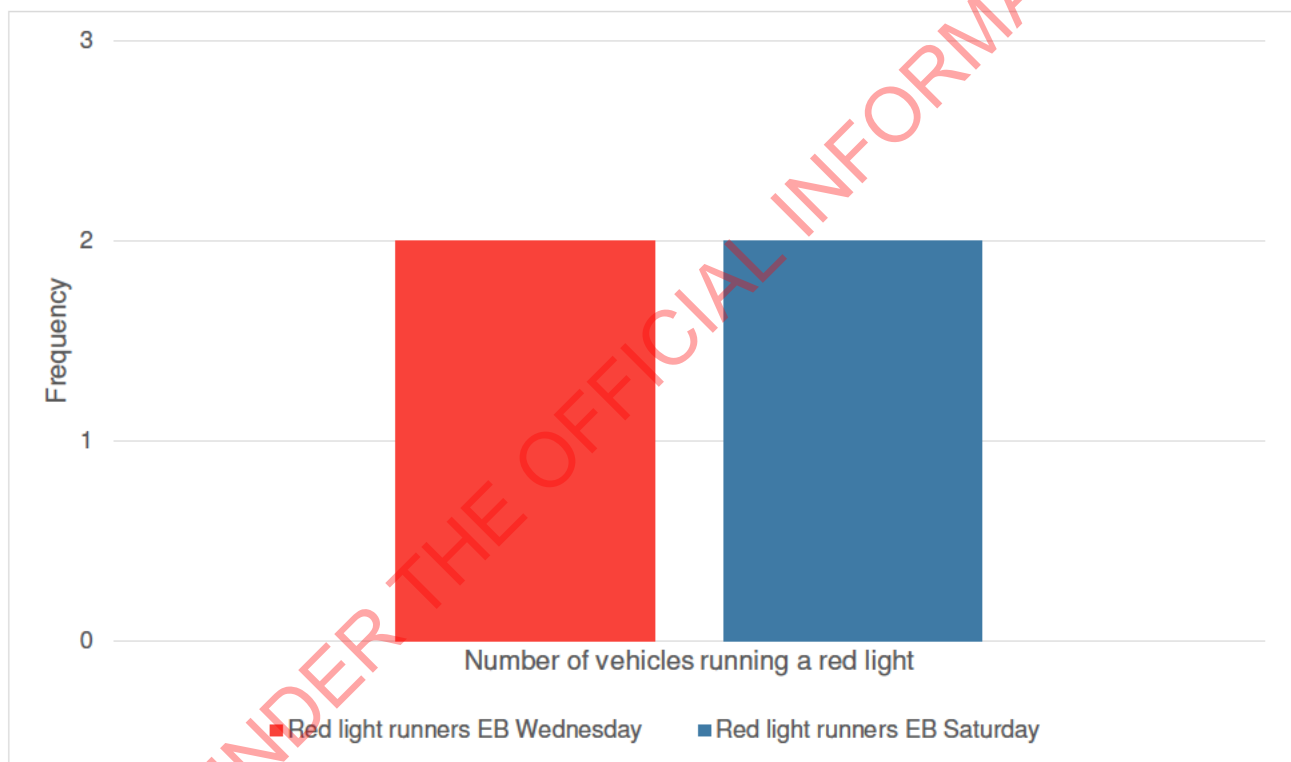
Figure 17: Number of red light runners by day

Figure 17 below shows that two vehicles were identified as running a red light on each of the two days analysed. All the instances occurred in the eastbound direction. It should be noted that the westbound signals are not visible from the camera, so the assessment was based on the crossing signal display.

One potential incident per day equates to approximately 0.5% of users being out at risk (refer crossing use information in section 3.4 below). In both instances, the vehicles did not appear to be travelling significantly above the posted speed limit of 60km/h (based on judgment as accurate speed information was not available). A potential incident between a crossing user and a vehicle travelling at speeds over 30km/h has a higher potential for serious injury or death to result.

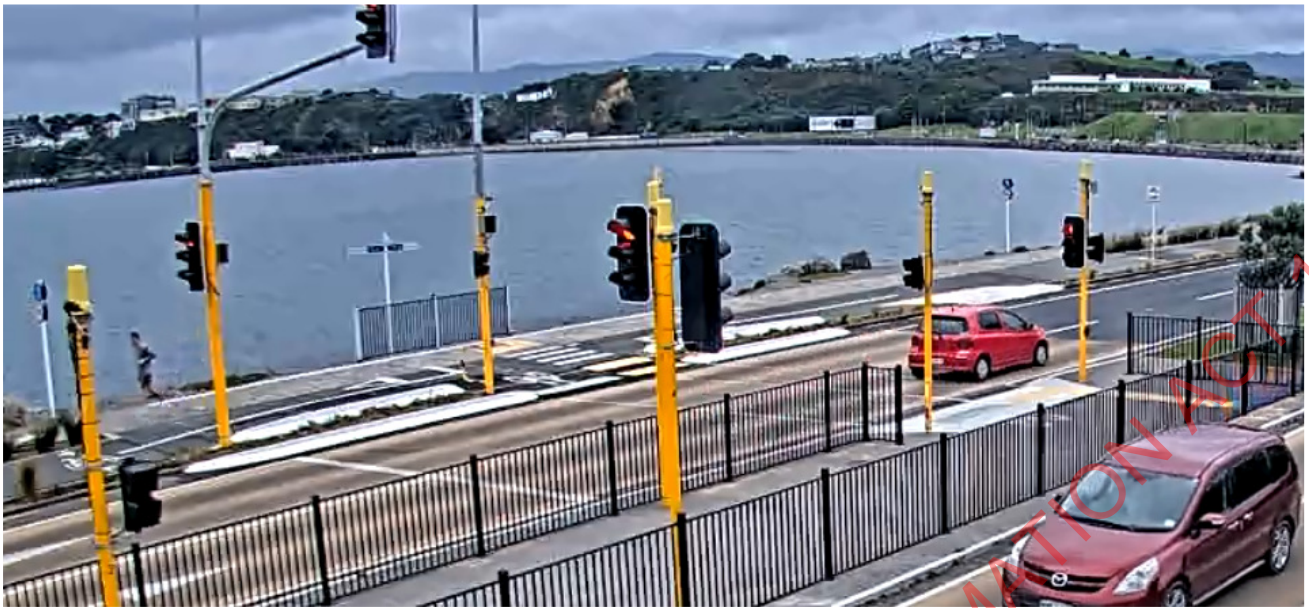
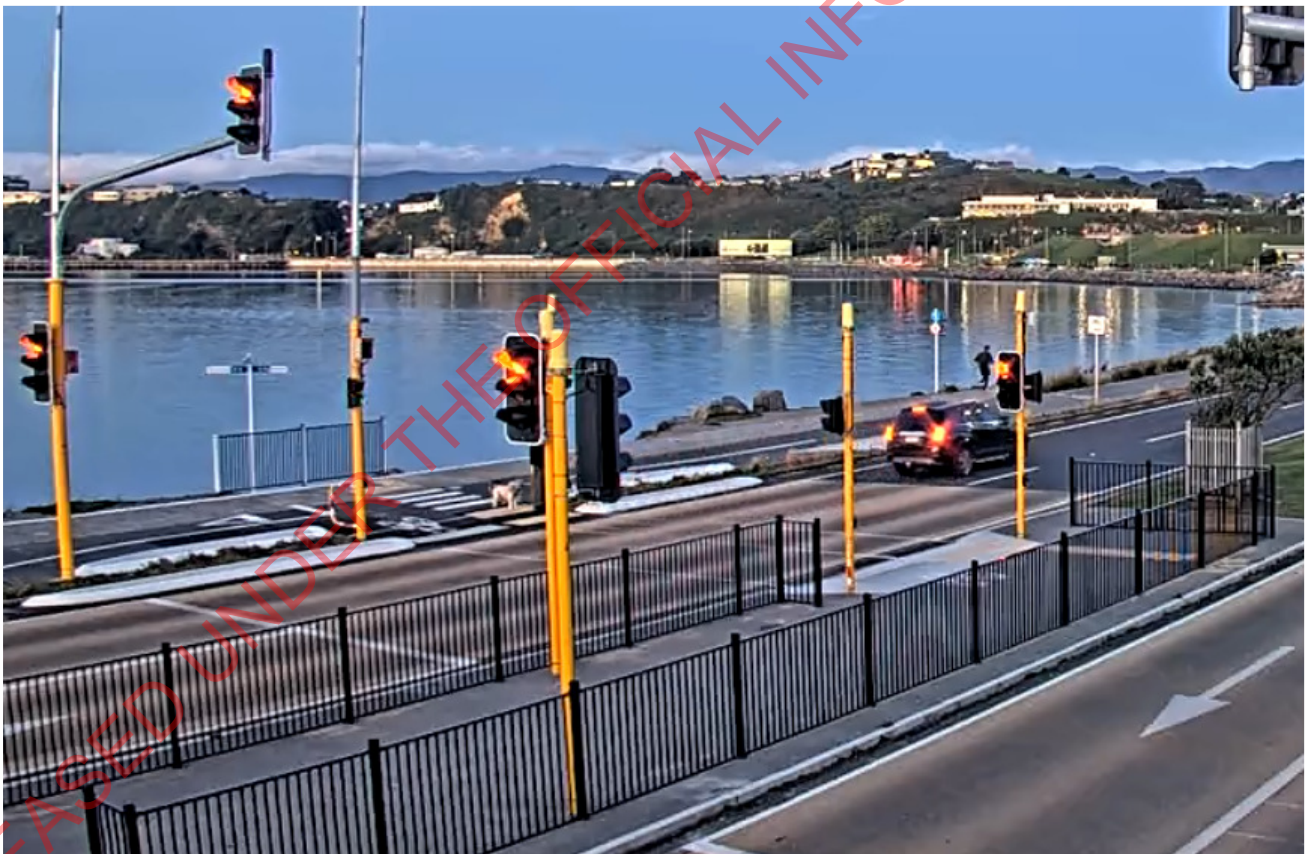
Figure 18 and Figure 19 below show the red-light runners, in the Saturday occurrence the crossing user had crossed prior to the signal changing to red for vehicles. In the Wednesday occurrence the vehicle ran the red signal while a user was waiting to cross but the vehicle passed the crossing within the all red time (Figure 19 shows the point in time when the crossing signal changed to green for the crossing user).

Figure 18: Eastbound vehicle running a red light (Saturday at around 10.15am)

Figure 19: Eastbound vehicle running a red light (Wednesday at around 5.00pm)

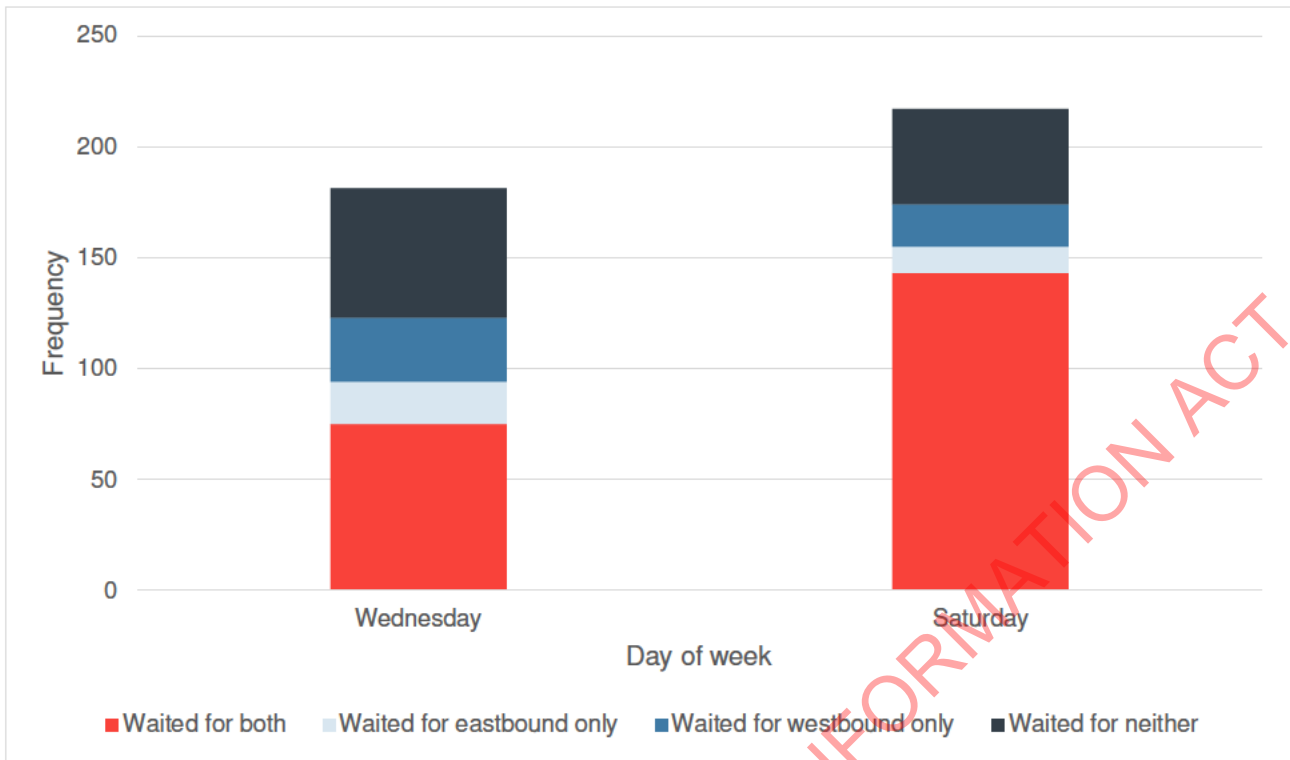
Figure 21: Number of people who wait for the crossings by day of week

Figure 21 below shows the total number of people using the crossing by day of the week (from the video analysis) and also shows how many of those people activated the crossing.

- On average the crossing is used by 180-220 people per day (compared to the 80-100 activations recorded by the system shown in Figure 20),
- Approximately half of people using the crossing on the weekday and a third of people on the weekend did not activate the crossing for one or both legs of the crossing and instead crossed in a gap in traffic,
- 13 people were identified as crossing the road directly adjacent to the crossing in the grass area to the east of the crossing.

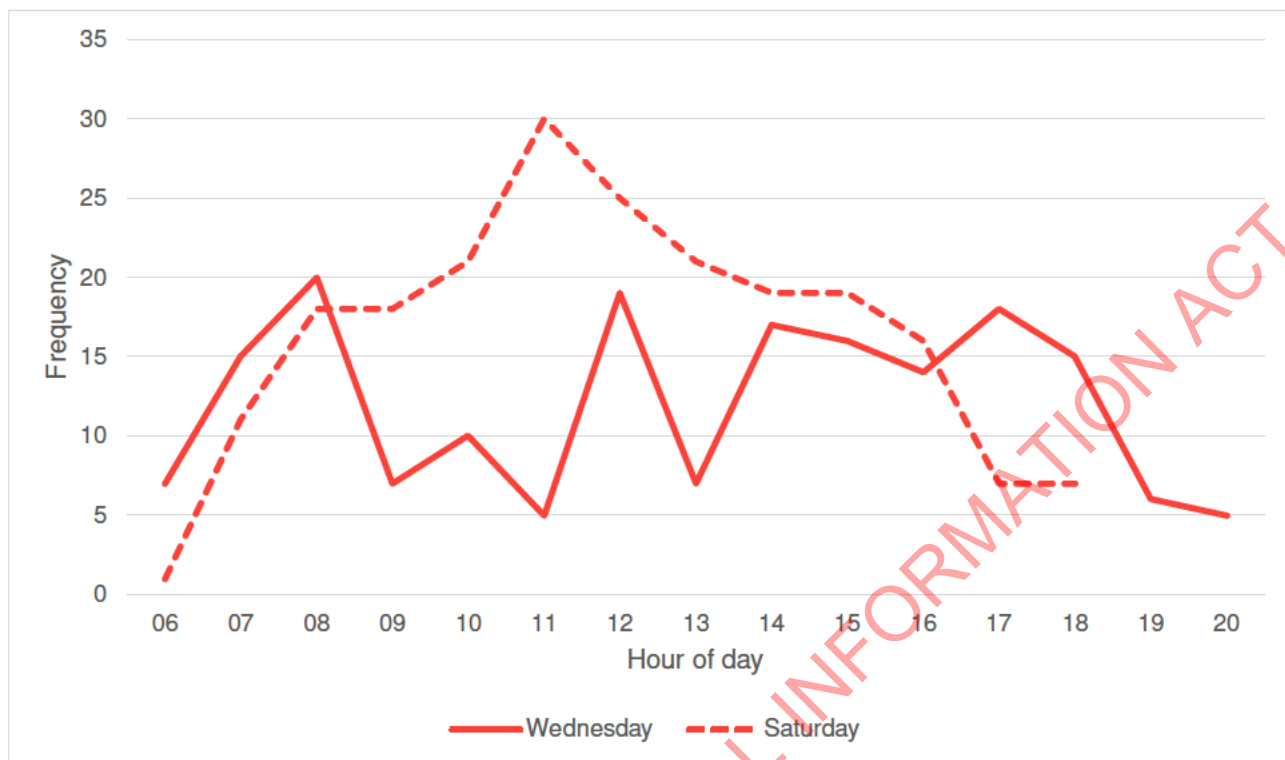
Figure 23: Number of people crossing the road by time of day

Figure 23 below shows the number of people crossing the road from the two days of video analysis and reflects similar patterns to the activations recorded in the control system shown in Figure 22.
