Ngā Ūranga ki Pito-One Shared Path

30% Detailed Design

Prepared for Te Ara Tupua Alliance
Prepared by Beca Ltd

5 September 2022

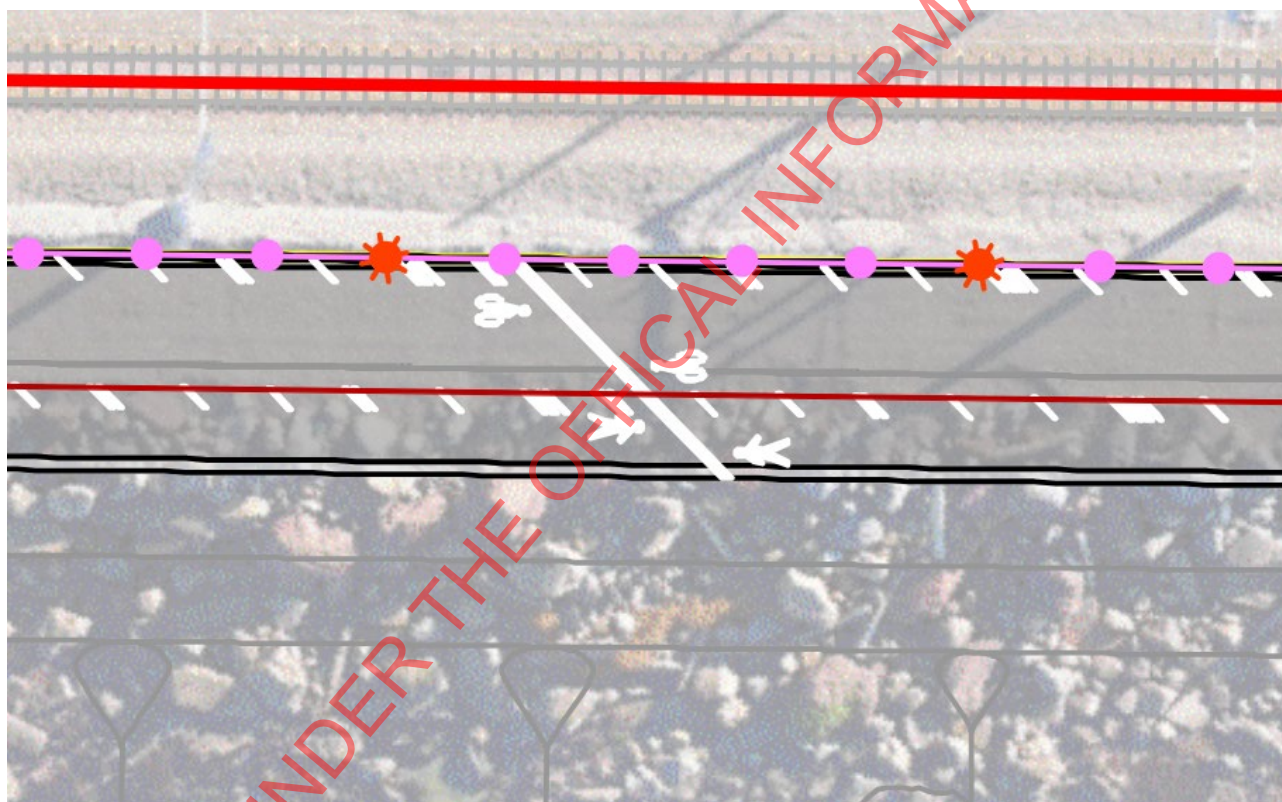
The preliminary drawings identify the pathway will be split with visual cues provided to demarcate separation between people walking and people cycling. During the project briefing the design team highlighted that a delineation strip was being provided to provide the visual separation, however, material choice has not yet been confirmed. It is conceptually shown as a directional tactile paver with painted hatching (or similar) which will provide a colour and texture difference.

The proposed pathway width could present risks of groups of walkers 3-4 abreast overlapping the cyclepath and may cause friction with cyclists as they protrude into the cycle path.

Figure 2: Example of the existing layout with visual delineation demarcating the pedestrian and cycle movements

It is recommended that an option to provide a full, shared path with no delineation along with behavioural influencing signage and marking to reduce friction between users.

It is also recommended that the disability sector is consulted about the use of tactile pavers along the length of the route.

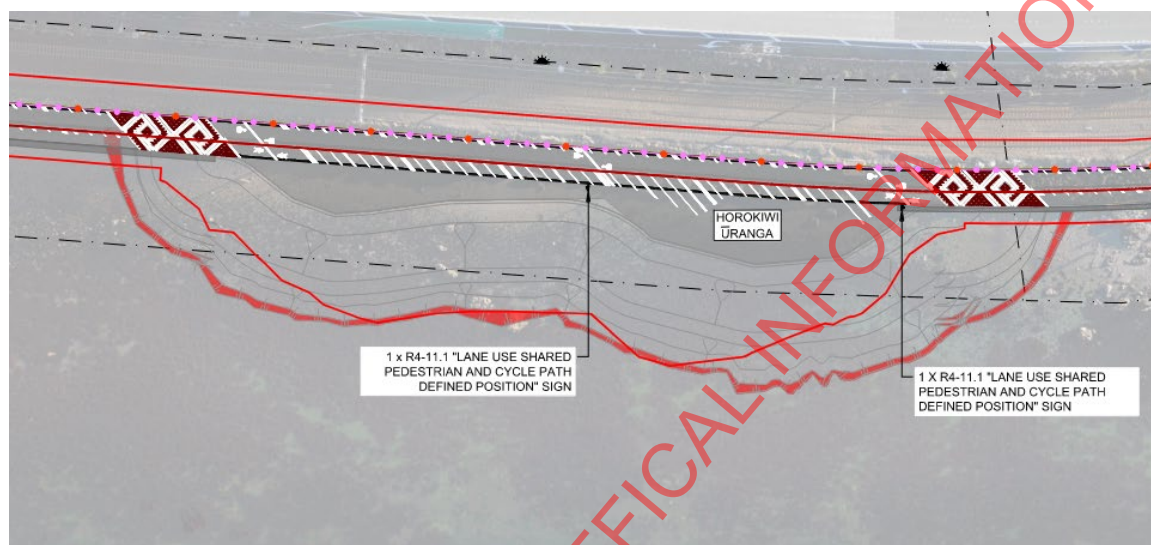
There are 6 proposed Uranga sites spread along the route which provide great amenity for path users. These areas provide seating, lookout and artwork which tell a story of the place. This will enhance the journey experience and enable people to stop, rest and gain knowledge before continuing along the route. Due to the length of the route the safety audit team questioned whether there were opportunities to integrate more secondary pause points (ie. Seating/ small stopping areas) to allow further opportunities for people to stop and rest along the journey. These sites will also be very popular destinations at the weekends for recreational users and require adequate space for movement as well as passive recreation.

Some Uranga sites are larger and have the ability to accommodate a walkway that is separate from the main shared path. This will provide relief from cyclists for pedestrians and enhance the separation of the modes.

Figure 3 Uranga layout requires further demarcation of movement vs. seating areas

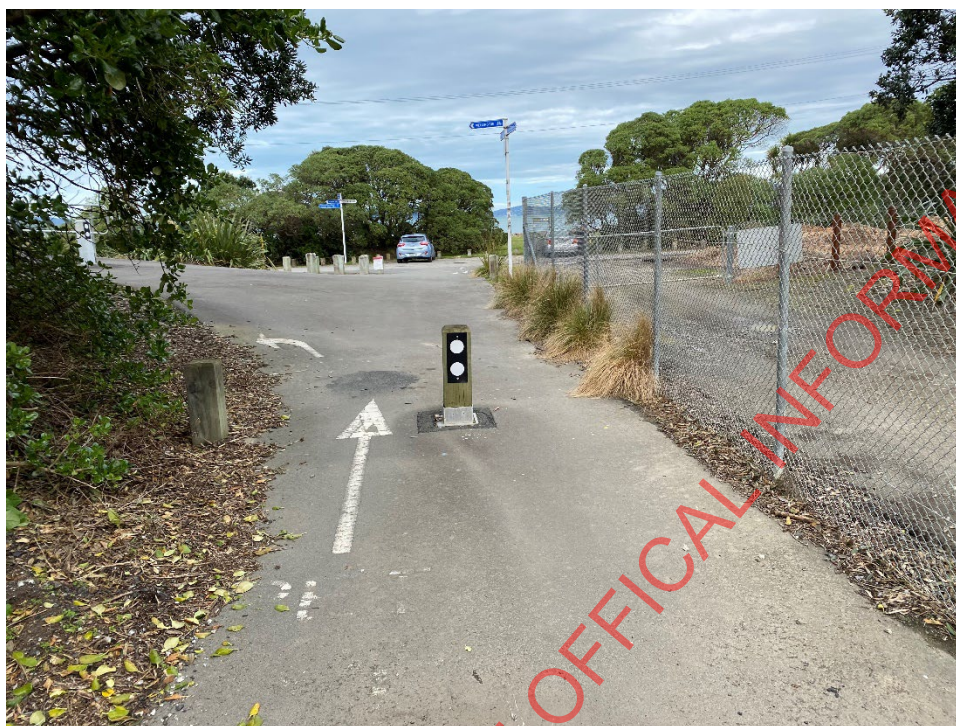
There are a number of areas that include landscaping adjacent to the path which could impede on the visibility of other shared path users approaching one another especially in areas where the path curves around obstacles including the underpass bridges and existing planted areas.

There are also existing areas of planting that create hiding opportunities and reduce path width through the existing pathway section adjacent to Hutt Road.

Figure 4 Example of unpruned vegetation inhibiting visibility.

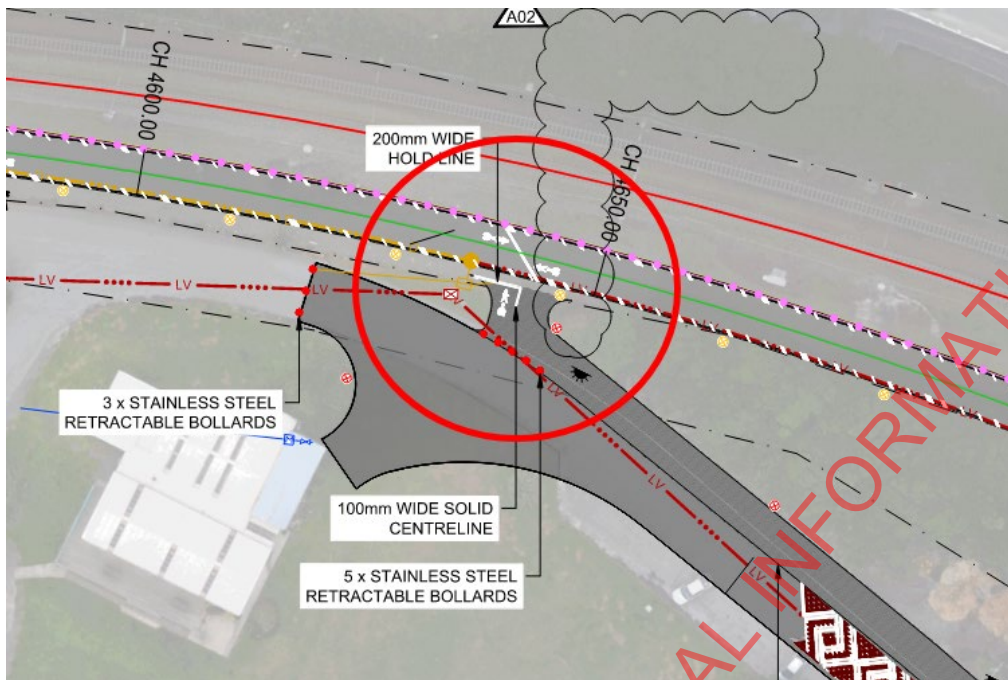
There is no wayfinding signage indicated on the plans. Consider providing wayfinding signage, map boards and signs highlighting distance to key destinations. A critical area for wayfinding includes at the Y junction in the shared path to both Hōniana Te Puni Reserve and Hutt Road.

Figure 5 Circled intersection for wayfinding required to enable clear directions for path users

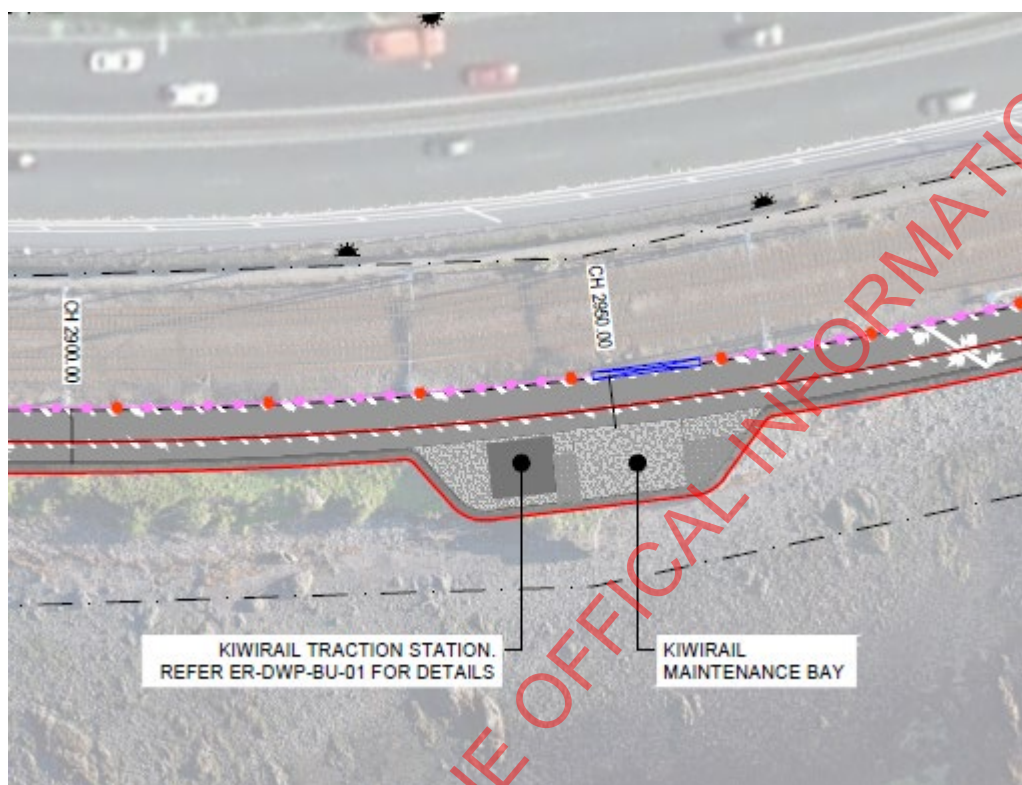
The existing KiwiRail Traction station shows a maintenance bay where vehicles are likely to park up during times of maintenance. This may cause conflict with shared path users.

Figure 6 KiwiRail Maintenance Bay located at CH2950m

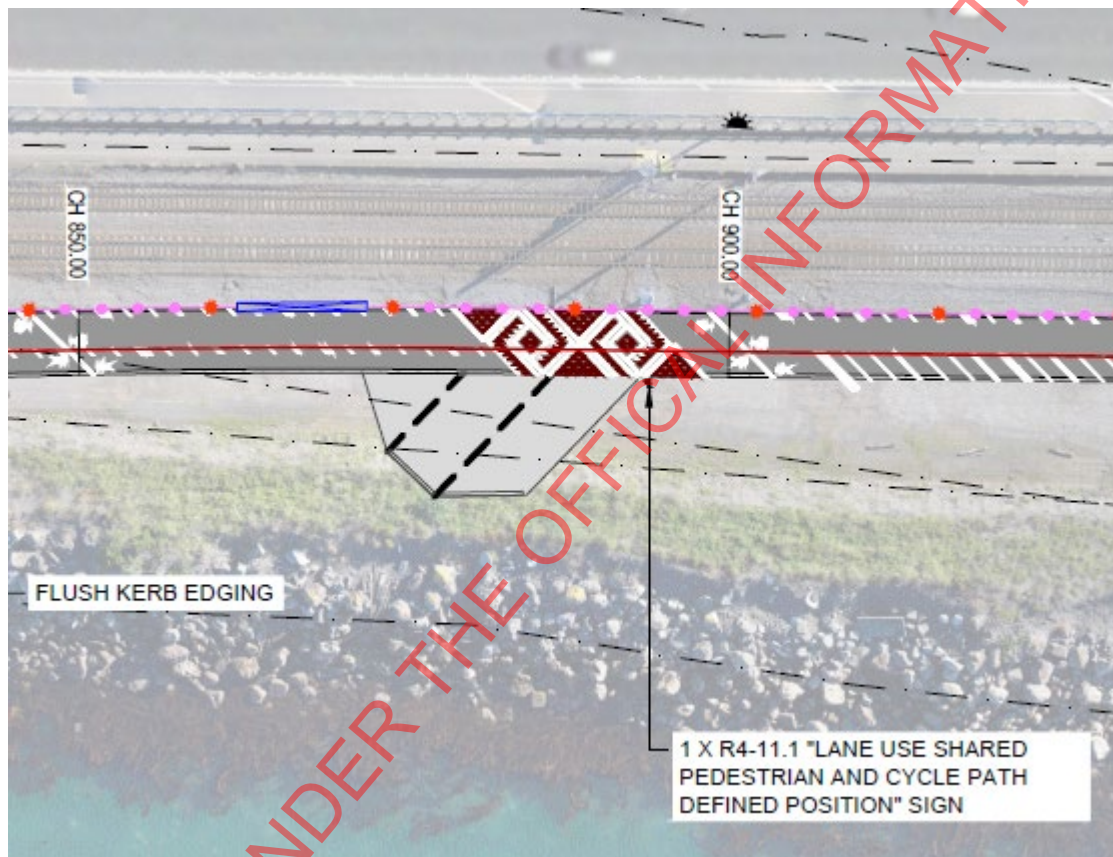
There are a number of maintenance bays for maintenance vehicles to park along the route. These areas have the potential to cause conflicts between vehicles and shared path users

Figure 7 Maintenance Bay located at CH880m

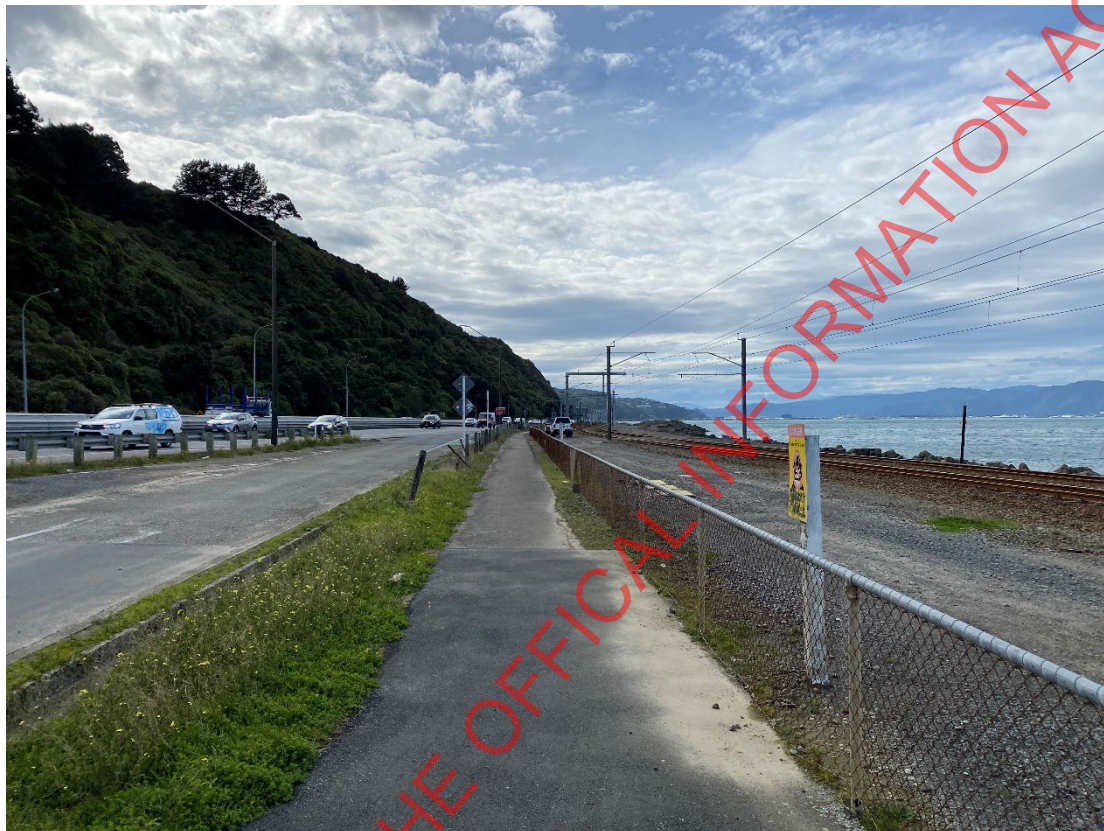
The existing path near Ngauranga Station shows evidence that gravel and construction debris have been spread across the pavement adjacent to the vehicle access within the KiwiRail yard. This causes a risk to cyclists getting punctures or sliding, particularly at corners. There is no evidence that sweeping had taken place recently to remove gravel.

Figure 8: Gravel and debris creeps on existing path near Kiwirail access track

Include appropriate mitigation to reduce the amount of gravel and debris that enters the shared path area from adjacent KiwiRail yard access roads. Consideration should be made for the maintenance and sweeping regime that is required to keep the pathway clear of debris and gravel. Or, better still, to seal the adjacent access lane which will remove the hazard completely or alternatively, construction a concrete nib to limit the amount of gravel.

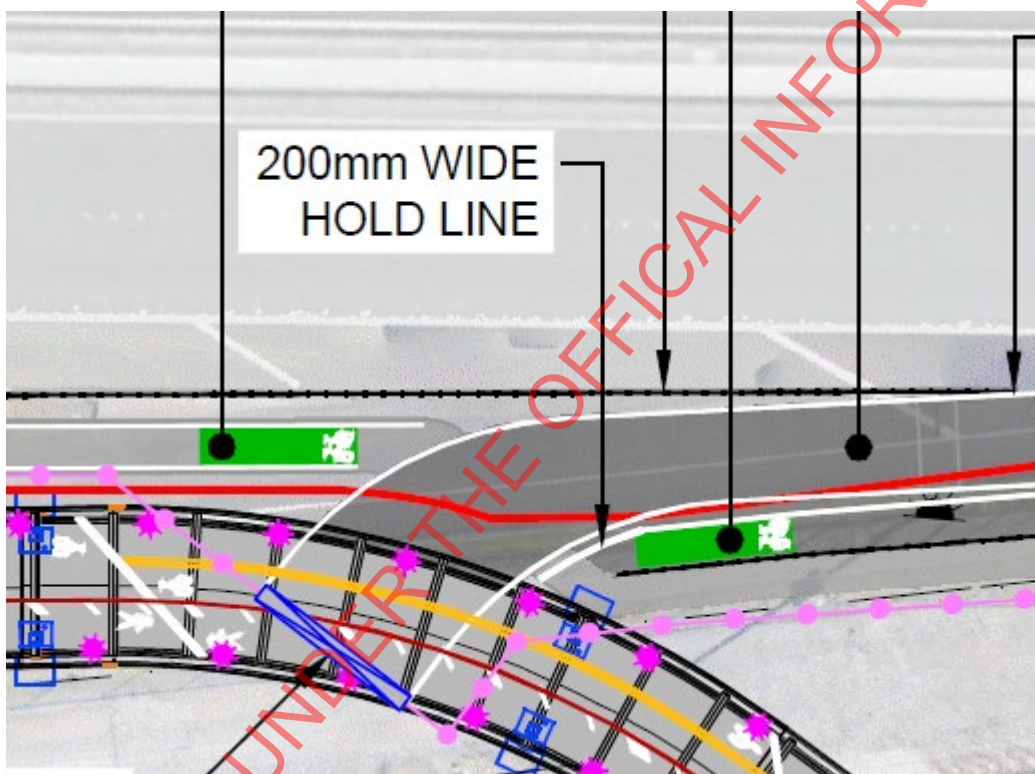
The access from the SH2 shows a formal cycleway with green markings which crosses the KiwiRail access lane. This may tend to encourage cyclists (especially the high speed cyclists) not to use the new shared path and to use the SH2 shoulder all the way from Petone to Ngauranga. We believe that this access should be a last resort only cyclepath and only if cyclists find themselves on SH2 and need to exit.

Figure 9: Cyclepath crossing over KiwiRail Access Lane.

- that this access from the shoulder be a subtle (i.e. last resort) exit.
- Include appropriate signage installed at the Northern end of SH2 that encourages all cyclists to use the shared path and not SH2 as well as appropriate signage to indicate to any cyclists on SH2 that they must exit at this location before going onto the Thorndon Quay raised motorway.
- Include appropriate design elements to avoid conflict between KiwiRail users and cyclists such as giveway and warning signage and markings.
- It is recommended that the movement path for cyclists across the access lane should be at 90 degrees to the vehicle movements. An example of this layout is shown in Figure 9.

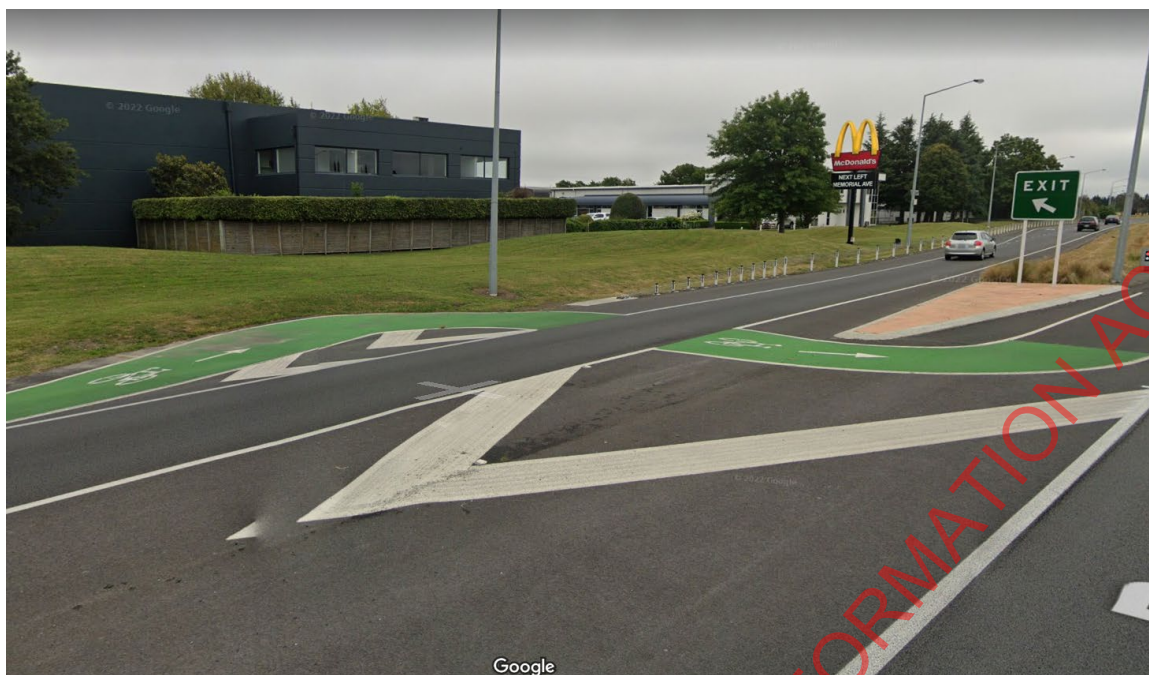
Figure 10: Example of bicycle crossing at off ramp at 90degrees to the movement

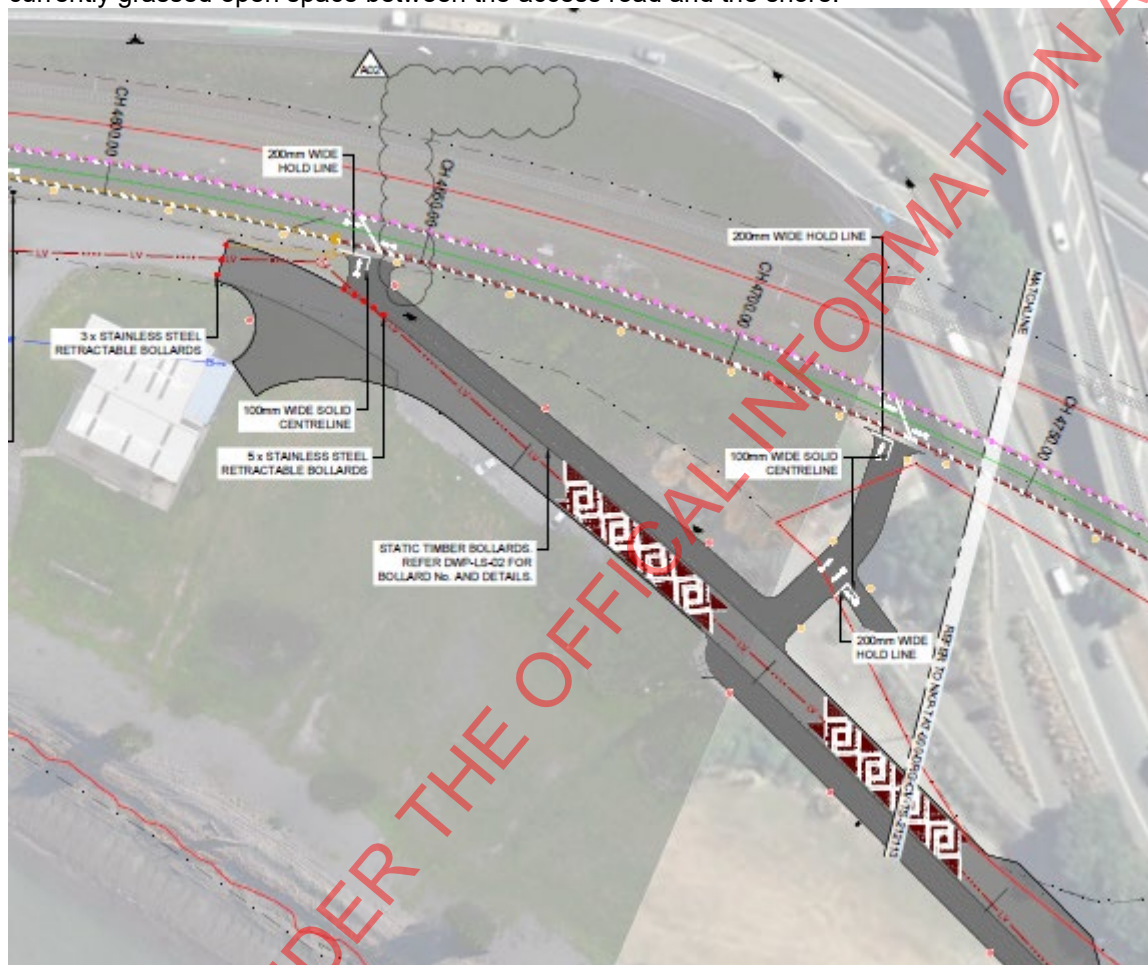
The shared path has been designed hard against the Access Road to the Water Ski club in the area to the west of the Korokoro bridge and South of the Water Ski Club Buildings. However, there is opportunity here to fully separate the shared path from the access road by creating a meandering path through the large currently grassed open space between the access road and the shore.

Figure12: Area where there is opportunity to separate the shared path from the access lane.

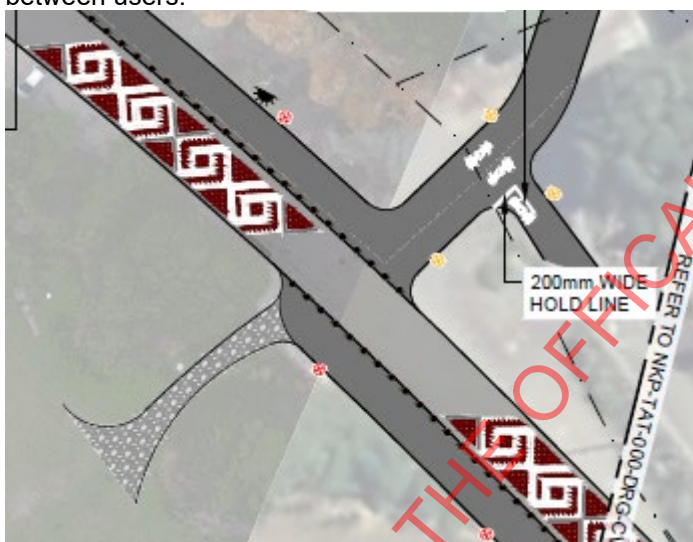
The shared path crosses the existing access lane in order to access the Petone foreshore path. This is a conflict point between vehicles using the access lane and shared path users. It is not clear in this design who has priority therefore will create confusion for users and thereby increasing the risk of collision between users.

Figure 13: Crossing point of Access lane by shared path

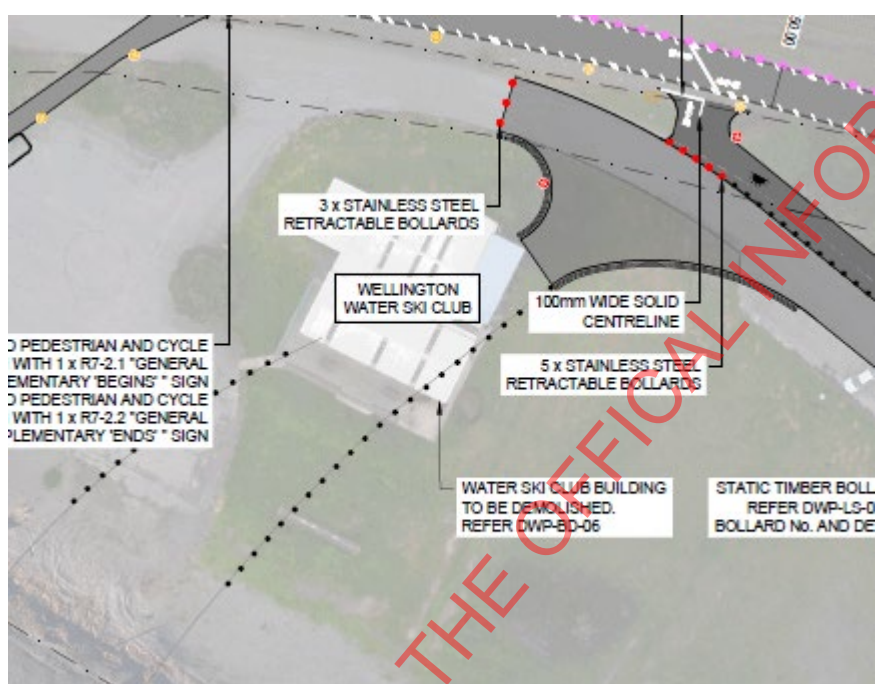
The proposed boat ramp access appears to have limited area for car and trailers to make turning and reversing manoeuvres. Vehicles with boat trailers (especially rowing skiffs) require large amounts of turning space to access the boat ramp. Providing a reduced area for manoeuvring could create issues with conflict with other vehicles and shared path users.

Figure 14: Boat Ramp area with very limited turning space.

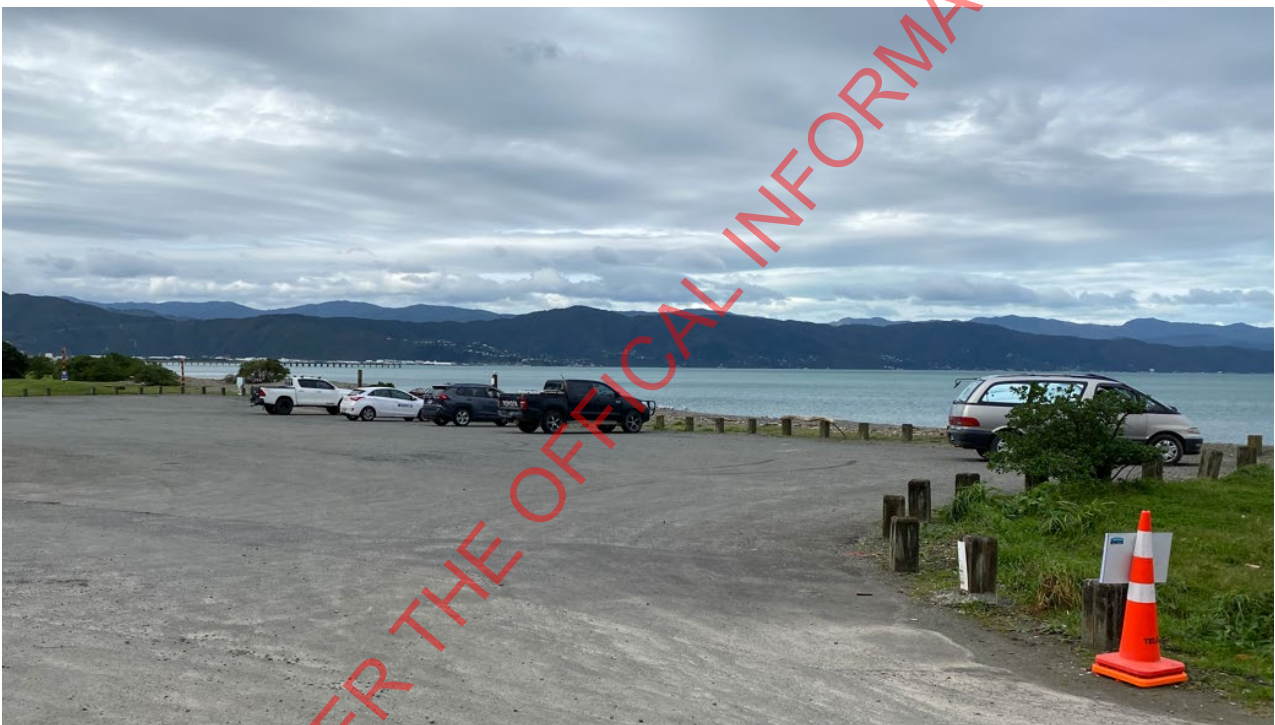
It was evident during our site visit that the Boat Club and Water Ski Club area is a popular destination for people walking their dogs and is likely to become even more popular for people accessing the new pathway. There is limited provision for parking in the reserve area which could result in parking non-compliance.

Figure 15: Foreshore Area around Boat Club is currently a popular location for public to park and walk.

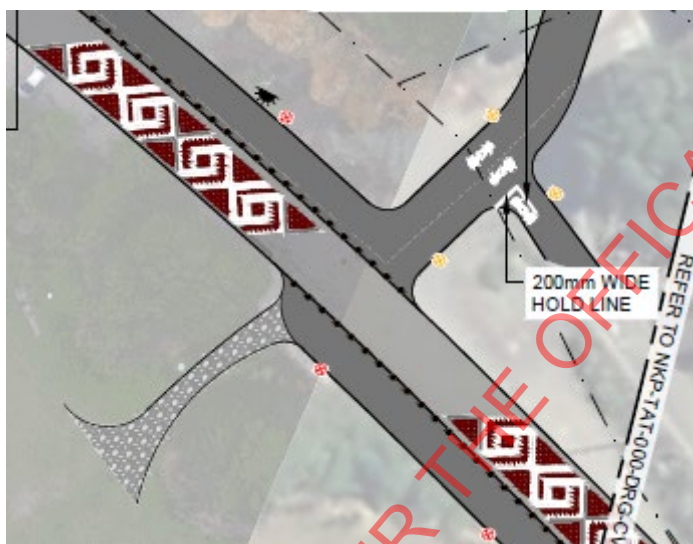
This area is a conflict zone with the different users including vehicles on the access lane, cyclists and walkers on the hazard path and other users within the park area itself. This area has potential to cause collisions between all the users.

Figure 16: Shared path crossing at boat access road

Provide traffic calming measures and bollard placement to enable a seamless journey for both pedestrians and cyclists. It is recommended that the option is explored to include a raised platform across the access road to retain the shared path at one level. A raised platform will also encourage slower speeds by car drivers.

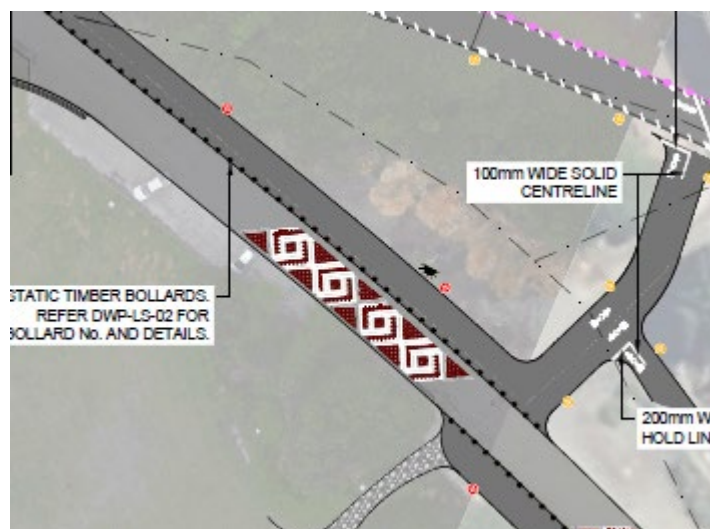
The cultural pattern on the boat ramp access lane is the same pattern that is used throughout the shared path route. This creates confusion for the users and could cause shared path users to think that they are on the shared path when in fact they are on the access road.

Figure 17: Cultural Marking on Access Lane (also used on shared path)

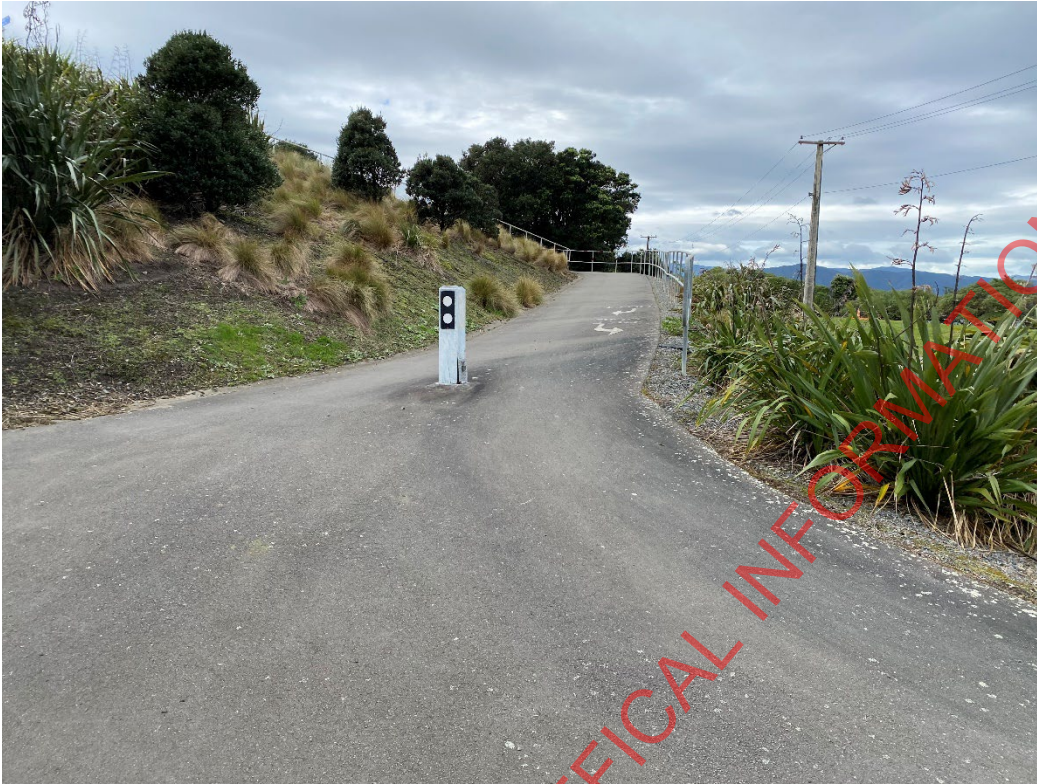
The connection pathway between Honiana Te Puni Reserve and the Hutt Road connection also provides a link to the Pito-One off ramp overbridge. There is a risk of people descending the ramp and approaching the pathway intersection at speed and crashing with other users.

Figure 18: Ramp from connecting pathway to Hutt Road with potential speed issue.

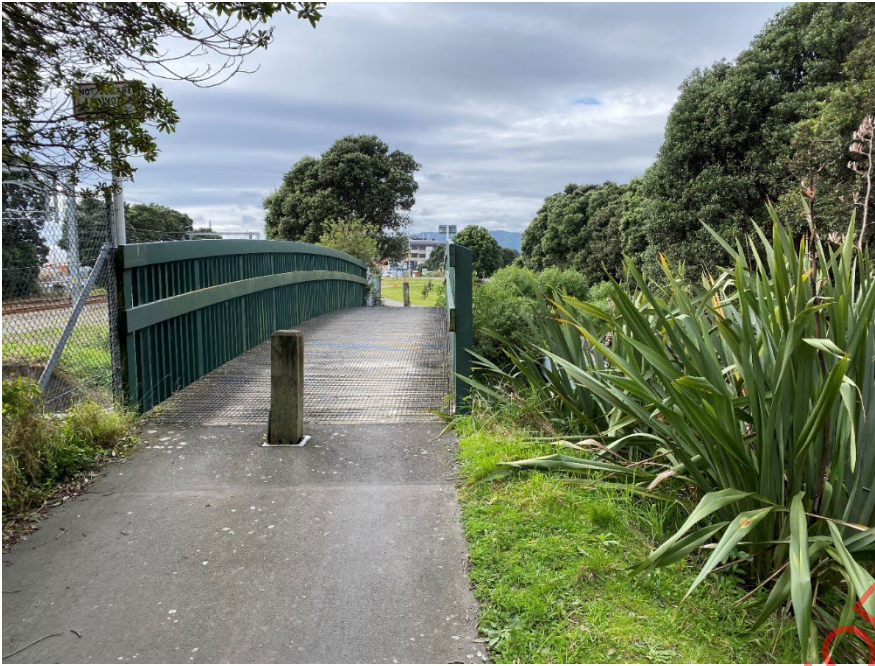
The safety audit team support the replacement and widening of the existing 2.1m wide bridge in Honiana Te Puni Reserve. While the existing bridge is in reasonably good condition, it is narrow and could cause conflict issues between users as the demand along the route increases.

Figure 19: Existing pedestrian bridge within Honiana Te Puni reserve

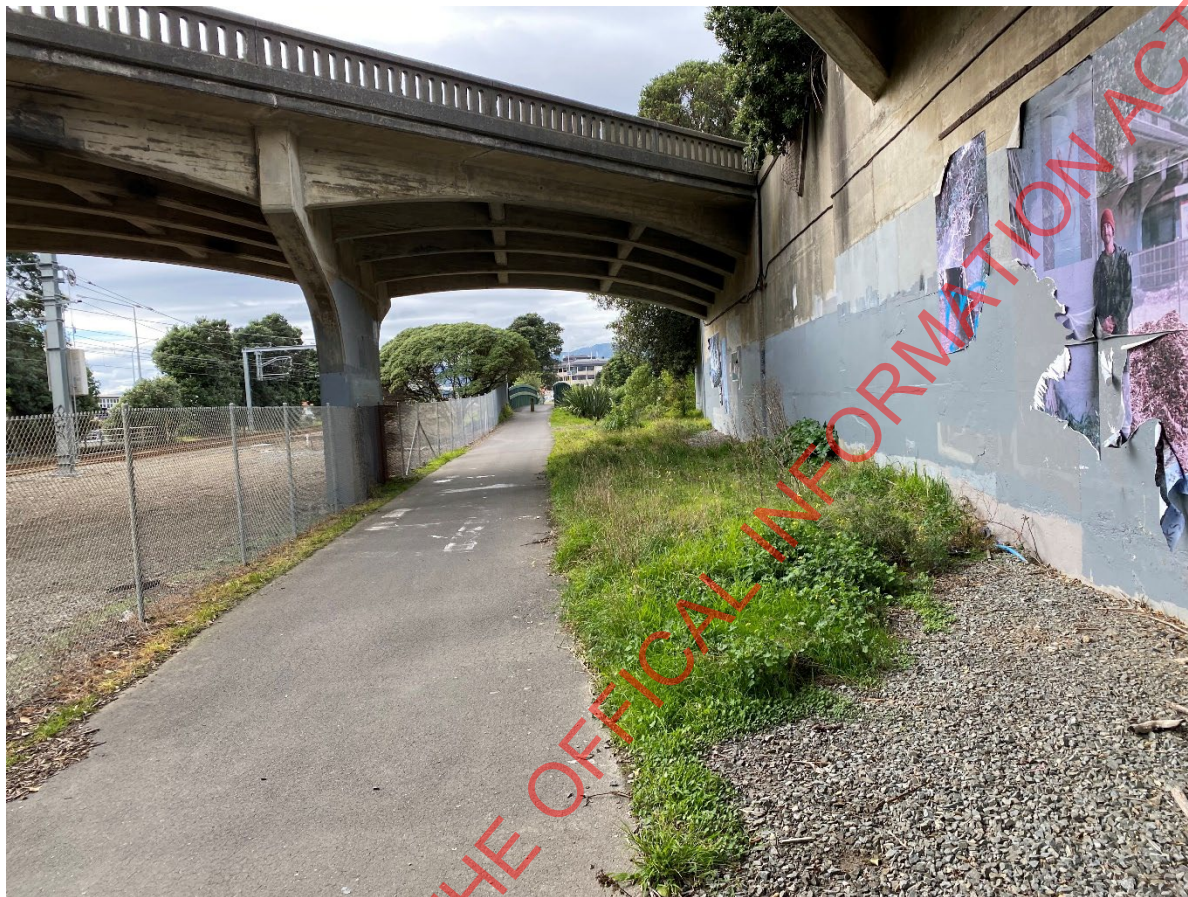
The existing path within the Honiana Te Puni reserve is an isolated area which has no passive surveillance, no lighting, no readily available escape routes, is a high noise area from nearby trains and traffic, has graffiti and torn posters, which all combine to create an intimidating environment for users, particularly after dark.

Figure 20: Existing intimidating environment below underpass

We recommend that there is design intervention through this area to provide a non-intimidating and well-lit environment.

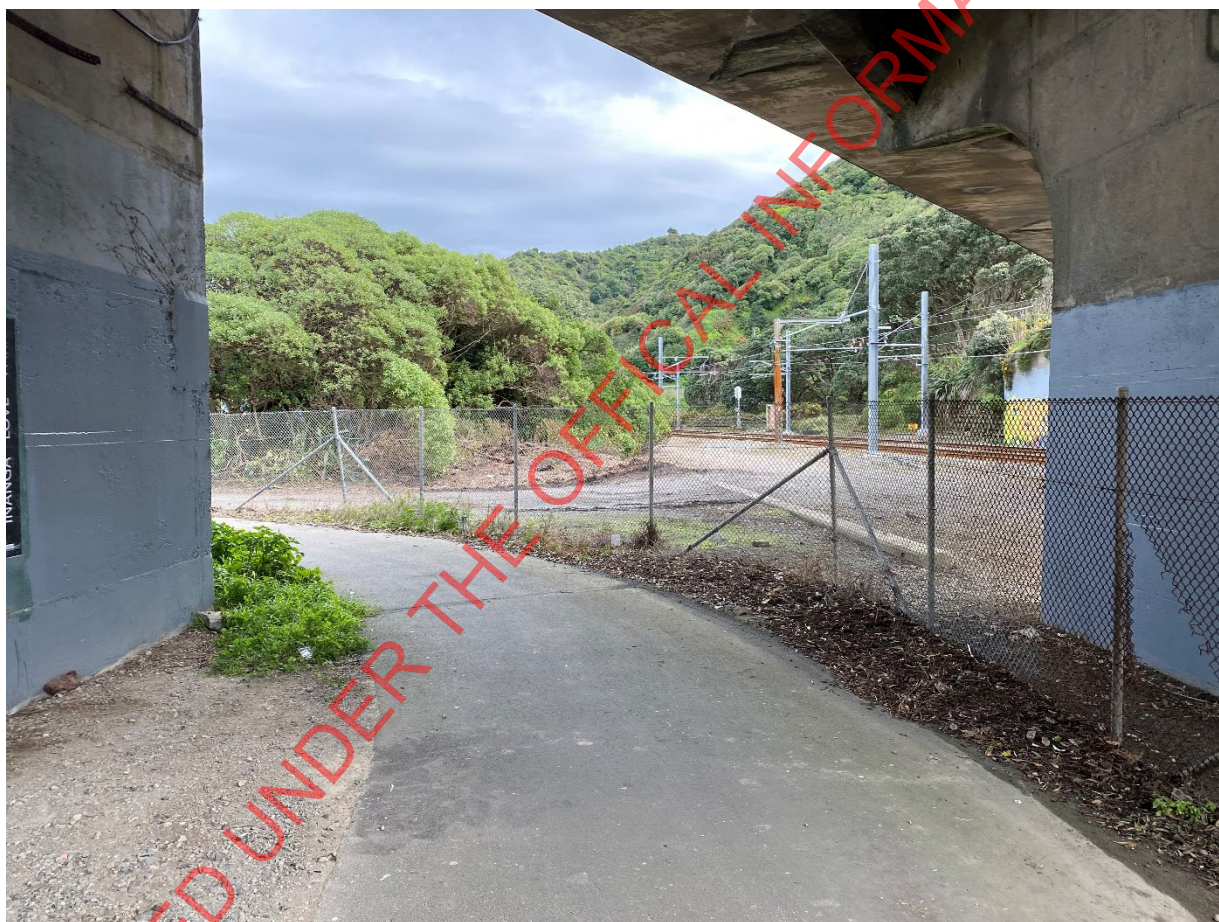
There is an existing tight corner with very limited visibility to oncoming path users. This has the potential to cause collisions between path users particularly with fast moving cyclists and other cyclists or pedestrians.

Figure 21: Existing tight corner below underpass

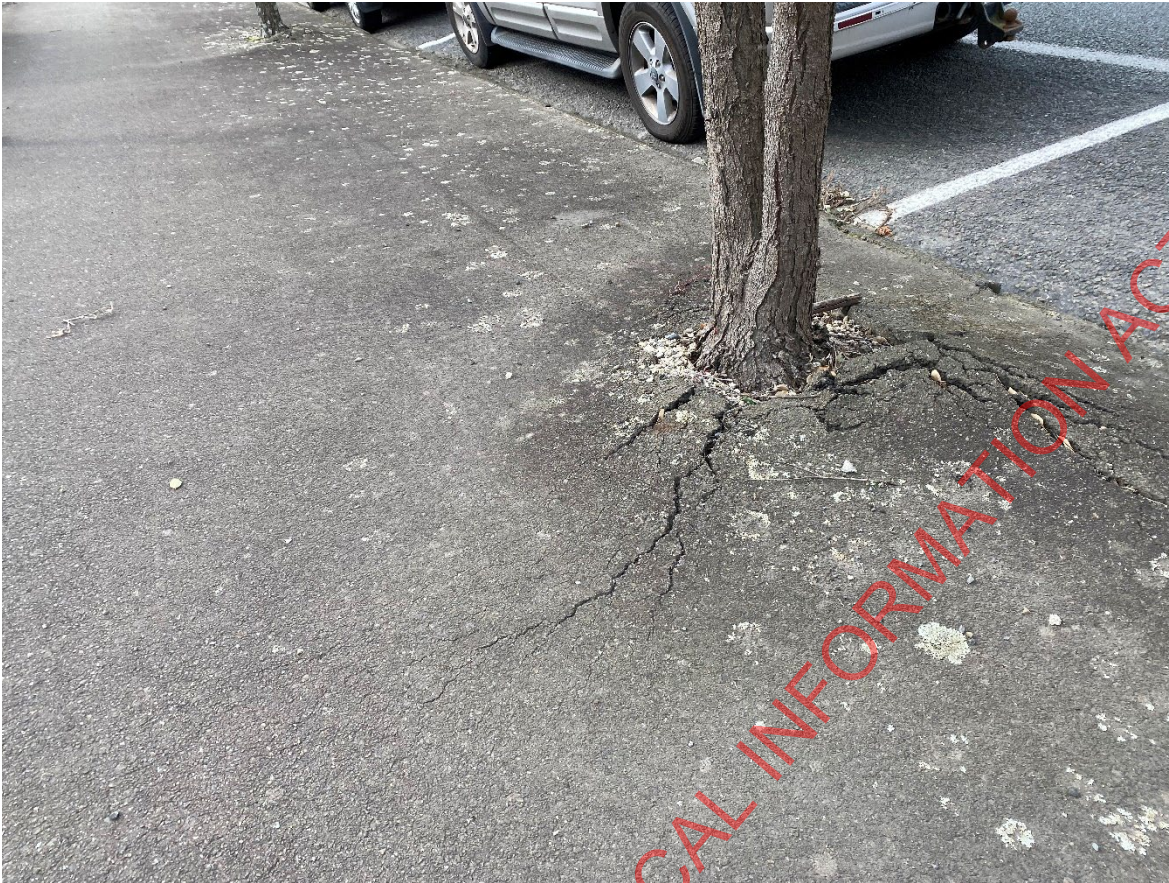
The existing trees near the connection point with the Melling Shared path (currently under construction) have caused an uneven path surface along the existing shared path adjacent to Hutt Road.

Figure 22: Existing uneven path adjacent to Hutt Road.
