SH25A Taparahi Slip

Remediation Options Report

Prepared for Waka Kotahi NZ Transport Agency - Hamilton Prepared by Beca Limited

17 July 2023

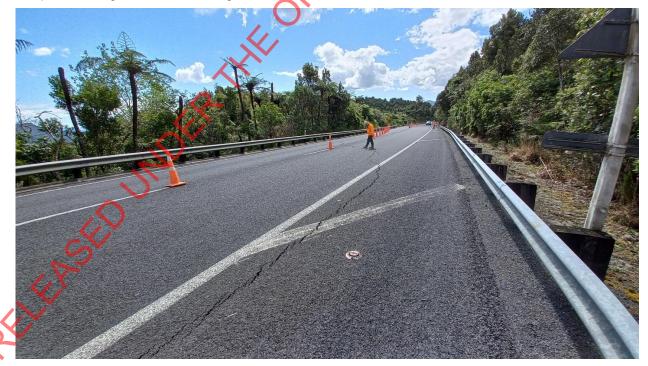
Figure 3.1 – Initial cracking of pavement observed on Monday 16 January 2023.

Initial cracking across both east and west bound lanes was first observed on 16 January 2023 at around 9.30am. Beca and Higgins re-inspected the site at around 3pm and observed cracking up to 30mm wide. Refer to Figure 3.1. Cracking continued to develop across both traffic lanes, increasing in width by around 5mm to 15mm a day in the following weeks until failure of the embankment occurred.

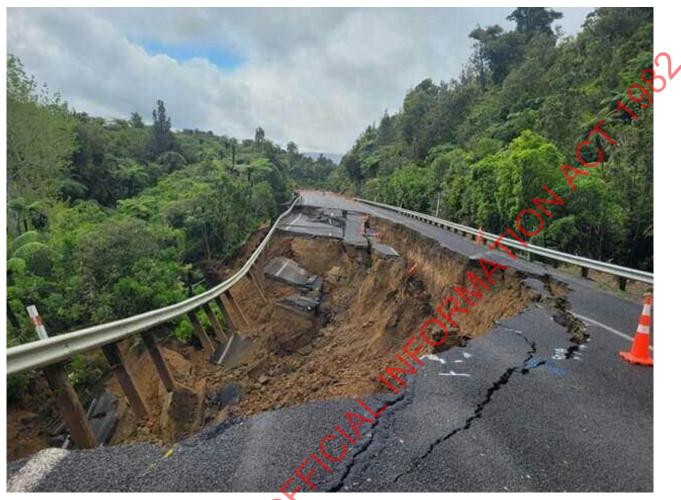
Figure 3.2 – First failure of the embankment on Saturday 28 January 2023.

The embankment failed initially over a 60m length on Saturday 28 January. Refer to Figure 3.2.

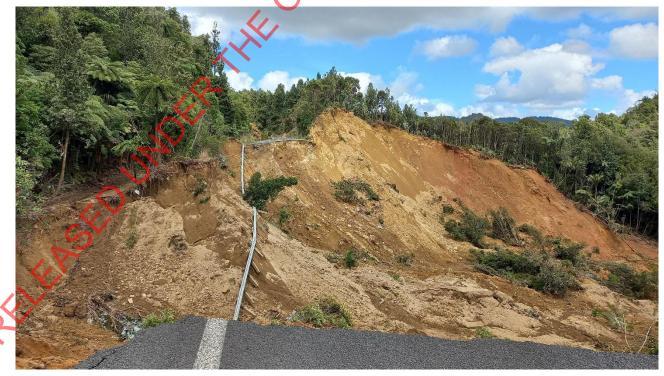
Figure 3.3 – Secondary failure of the embankment Wednesday 1 February 2023.

A second failure increased the length of the slip to around 110m on Wednesday 1 February. The second failure included in situ soils within adjoining property to the east. Refer to Figure 3.3.

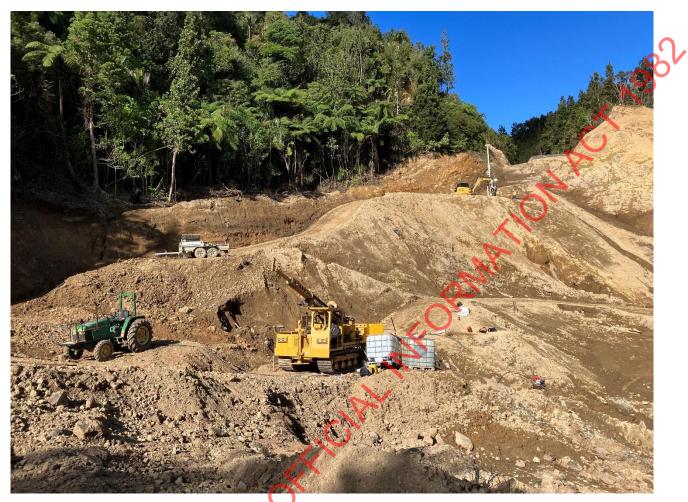
Figure 3.4 – Current condition of the slip scarp. Photo taken during geotechnical investigations 29 March 2023.

Over steepened slopes around the margins of the slip scarp were trimmed back in March and April 2023. These site works also included forming site access tracks within and above the slip area to facilitate a more comprehensive geotechnical investigation.

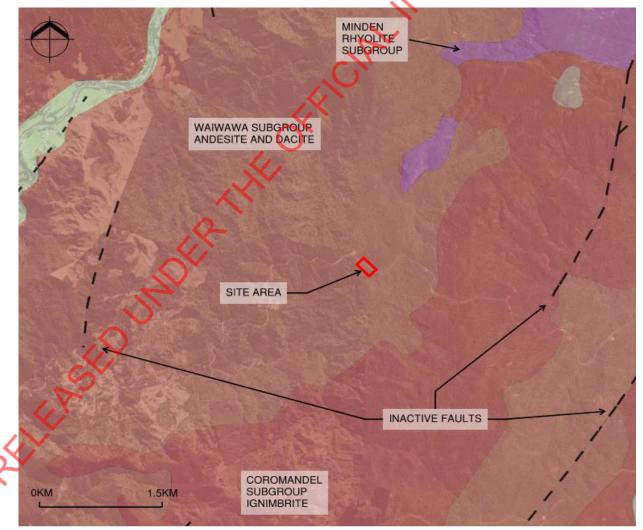
Figure 4.1 – Geological map of the area. The site area is identified as a red rectangle.

The geological map shows the area of the landslide to be entirely within the Walwawa Subgroup Andesite and Dacite, part of the Coromandel Group. These were deposited some 5 million to 10 million years ago. Minden Rhyolite Subgroup, part of the Whitianga Group, is mapped about 1km to the north/northeast of the site. Coroglen Subgroup Ignimbrite, part of the Whitianga Group, is mapped about 1km to the east, refer to Figure 4.1.

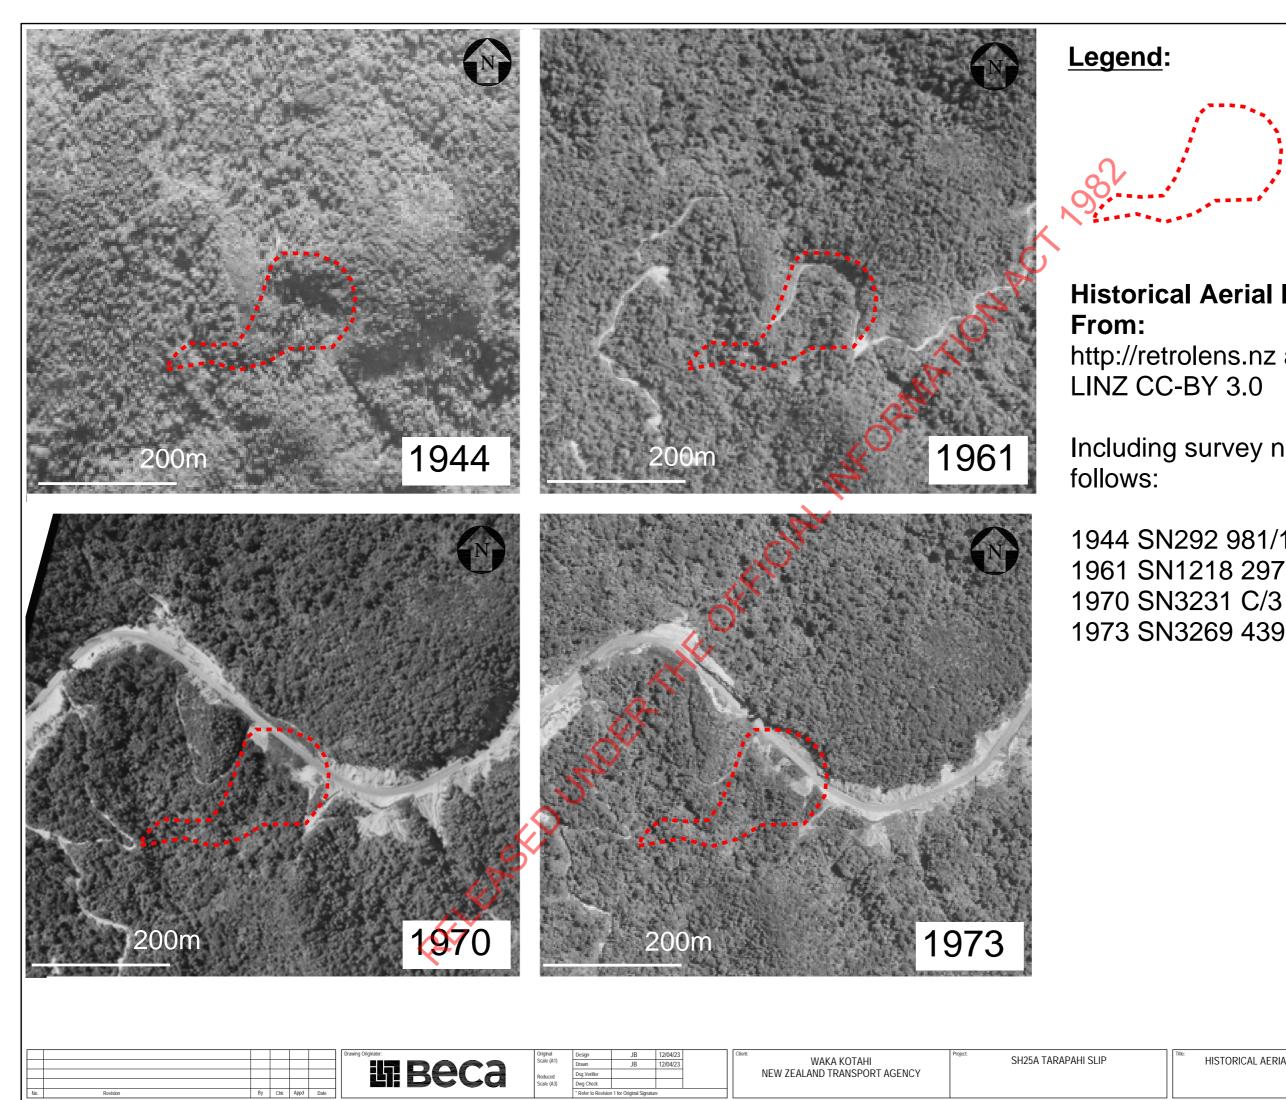
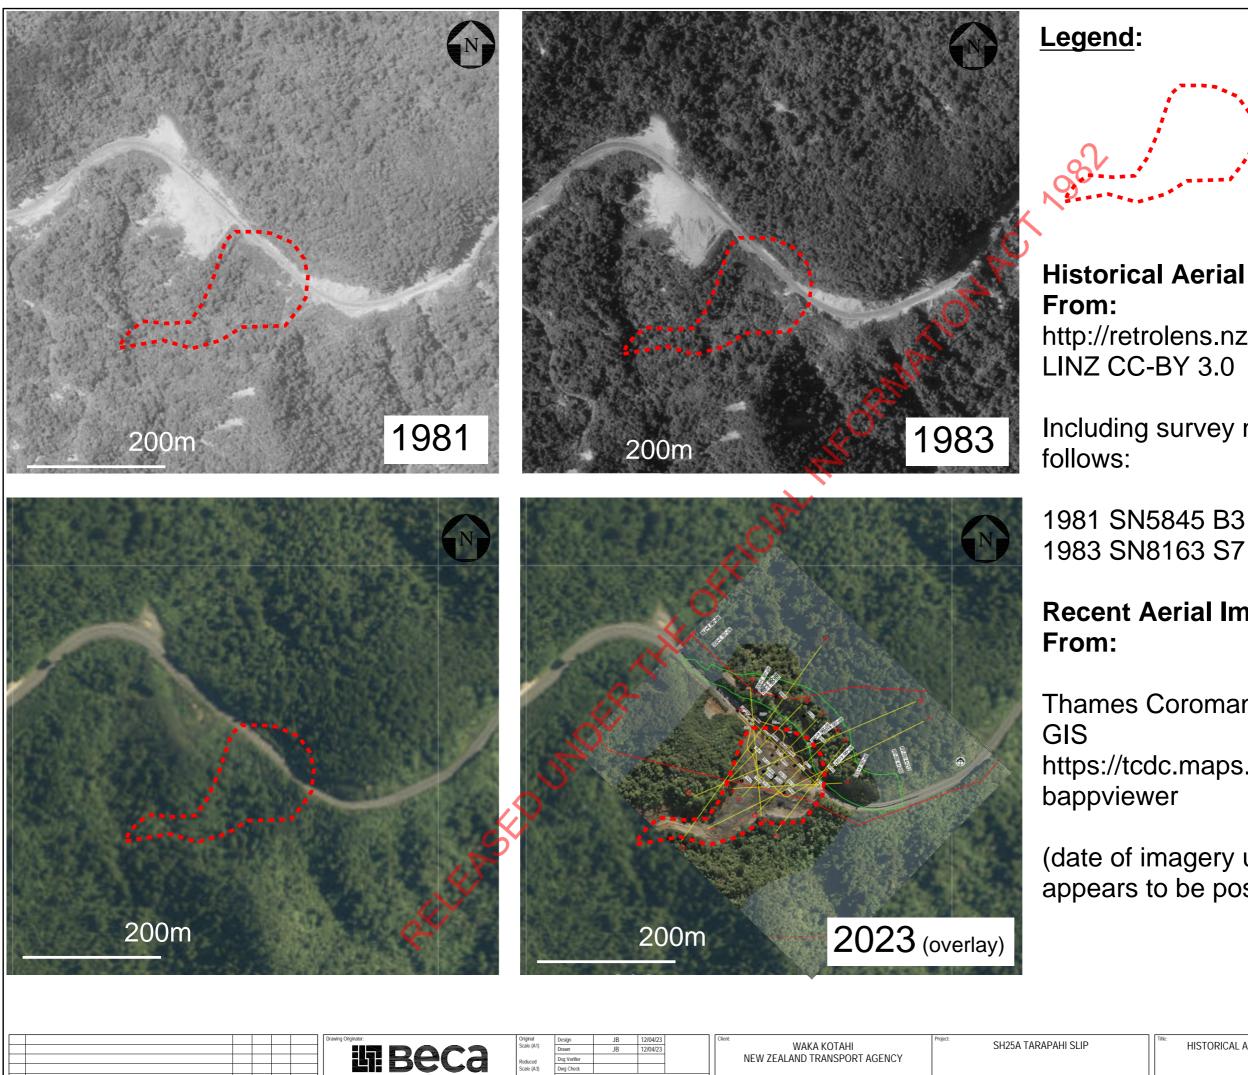
HISTORICAL AERIAL IMAGERY	Discipline		
	Drawing No.	Rev.	L
	SKETCH 01	A	I

Historical Aerial Imagery Sourced

1944 SN292 981/12 1961 SN1218 2978/12 1973 SN3269 4399/9

A review of the lineaments and historical instability features within the area using aerial photographs and topographic maps found that southwest-northeast lineaments dominate, with another influential set of lineaments in the southeast-northwest direction. Offsets in streams within the area indicate there has been past lateral displacement, potentially orientated roughly north-south and passing to the west of the slip site. Children to have resulted from past tectonics and seismic activity that took place or since the rock was first deposited. Refer to Appendix D for a plan showing identified lineaments.
