# **Safety Camera System**

**Tāmaki Makaurau Expansion Project**

**Phase 2 – Point to Point Corridors**

**Safety Camera Draft Site Assessment Report**

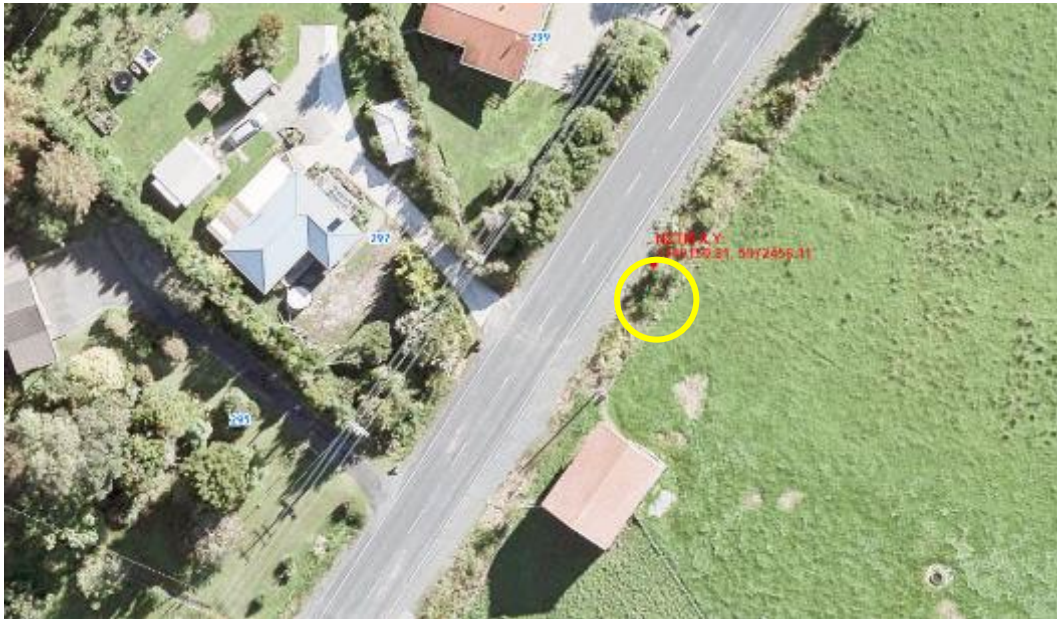
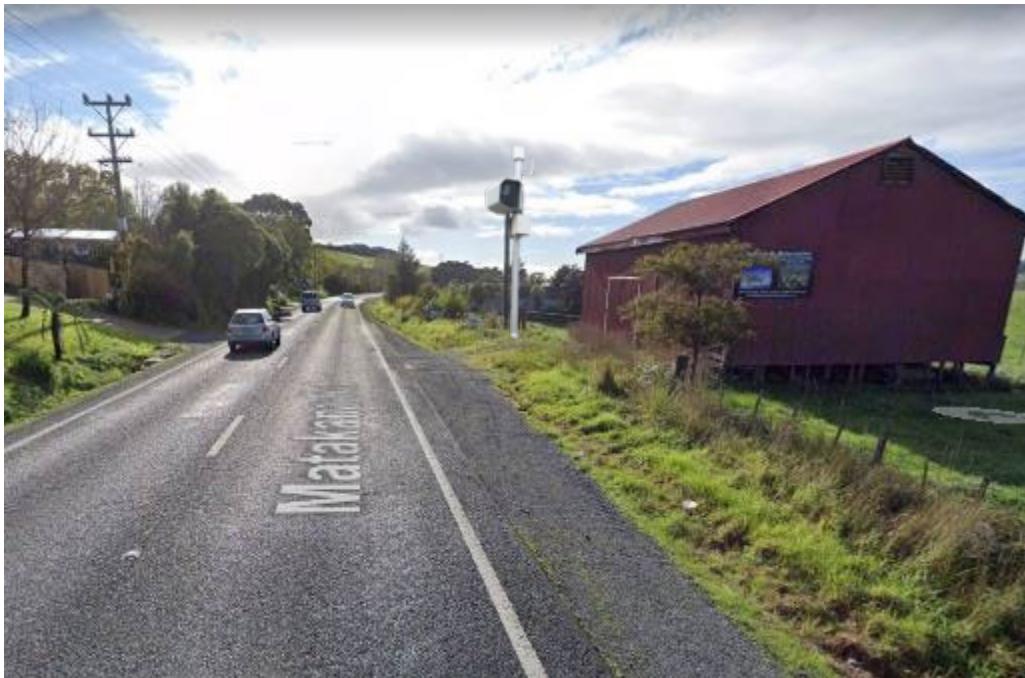
**Installation location for the first camera**

Following a site inspection, the installation location for the southern camera was confirmed at  $-36.381466, 174.662860^\circ$  opposite 297 Matakana Road with the camera facing south.

Power is to be taken from a powerpole across the road so trenching and installation of a TUD from which camera power will be drawn is required.

Access will be constructed to allow safe parking of maintenance vehicles behind the safety barrier.

A protective barrier is recommended for this installation site.

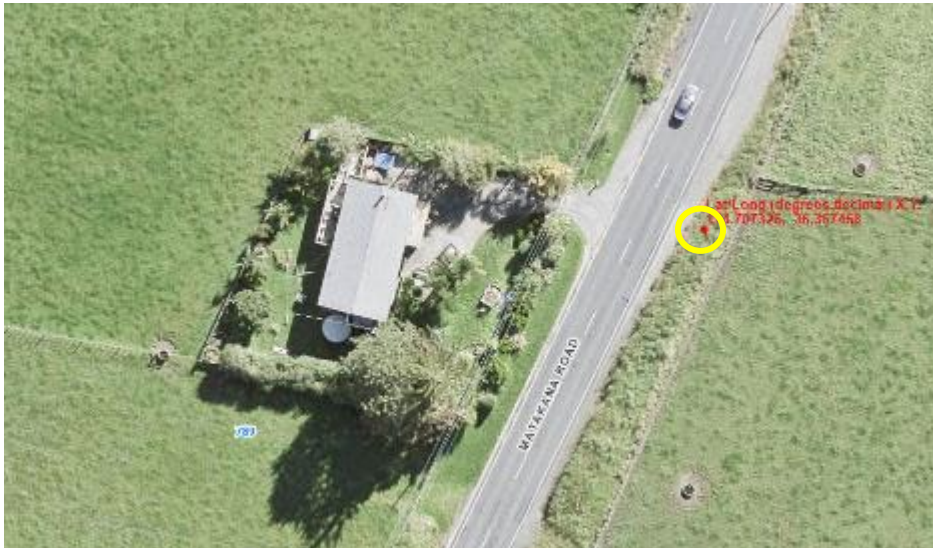
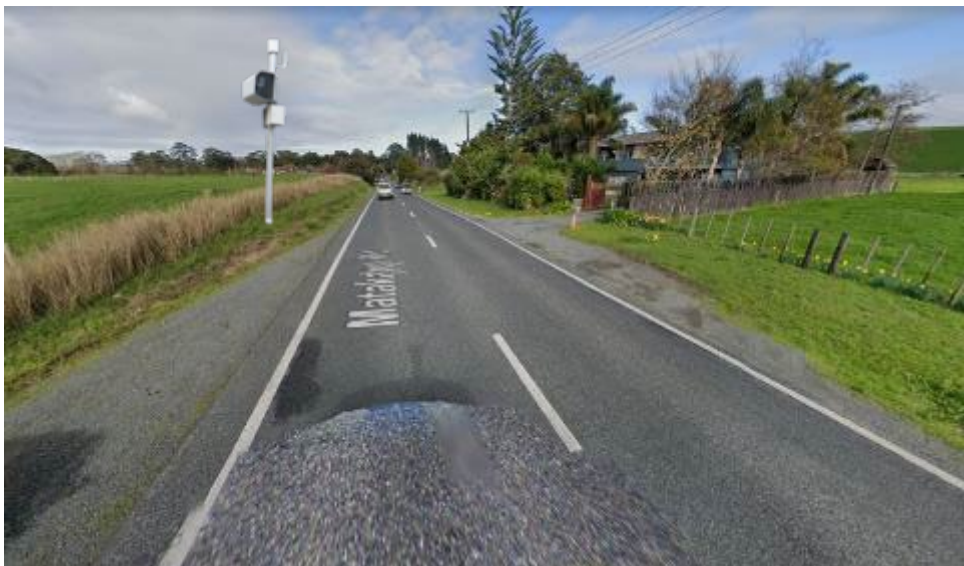
Installation location for the second camera

Following a site inspection, the installation location for the southern camera was confirmed at  $-36.367648, 174.707326^{\circ}$  opposite 789 Matakana Road with the camera facing north.

Power is to be taken from the adjacent powerpole, with the installation of a TUD from which camera power will be drawn is required.

Access will be constructed to allow safe parking of maintenance vehicles behind the safety barrier.

A protective barrier is recommended for this installation site. .

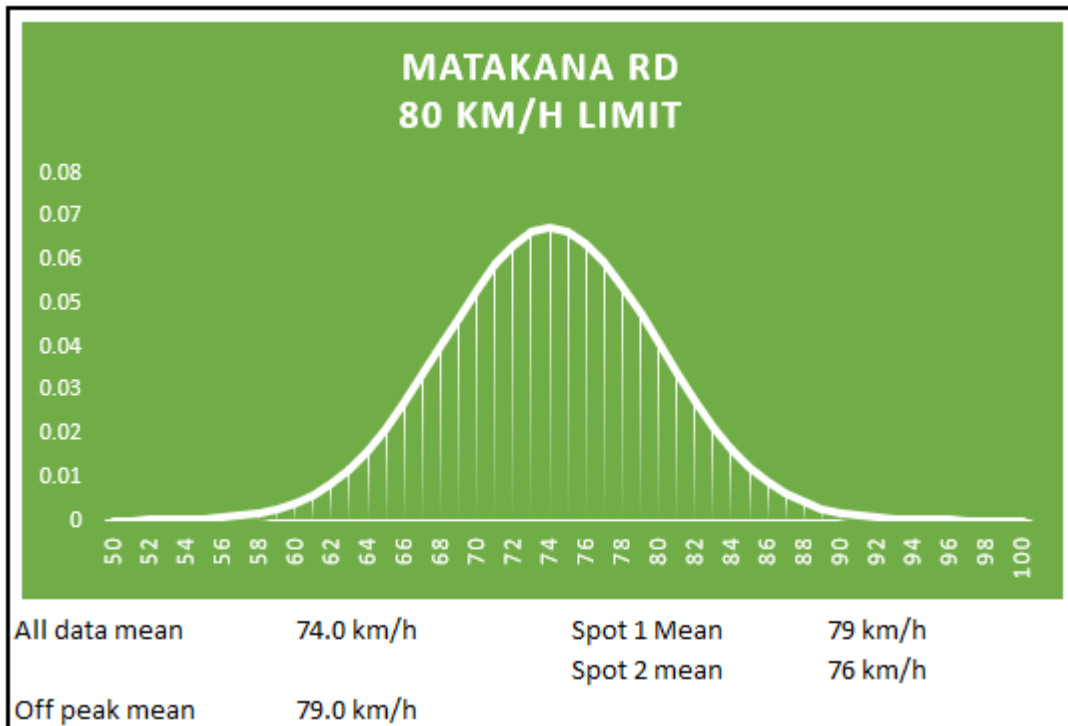
**Average Speed profile**

The free flow mean speed is 79 km/h which is within the 5% criteria for a camera.

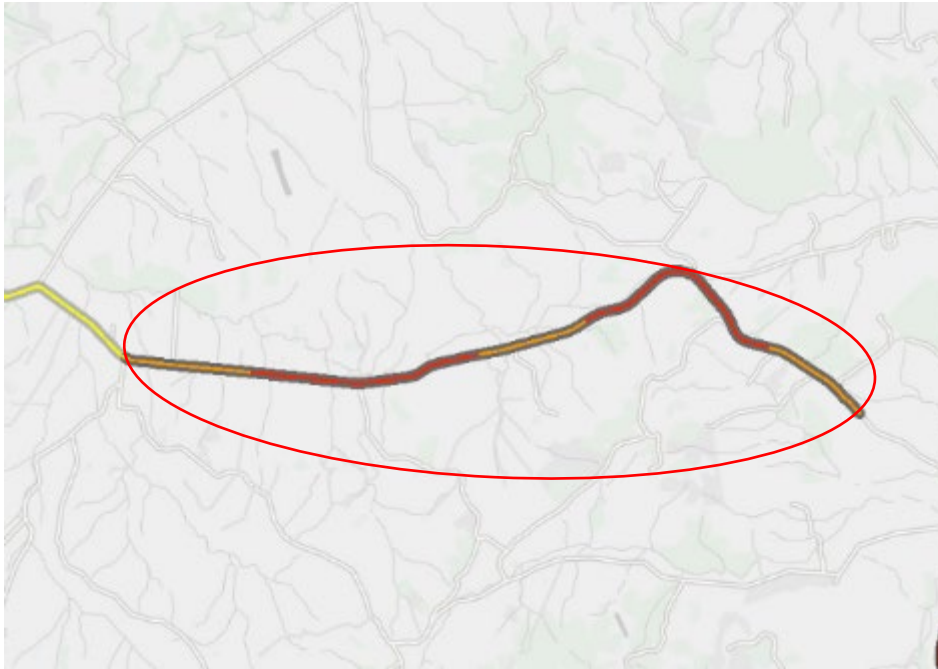
Site Location Risk map for identified corridor

The corridor is a 6.6 kilometre zone between numbers 117 and 793 Kahikatea Flat Road. GPS coordinates for the extents are -36.64349 174.63110°, and -36.640405, 174.563963°

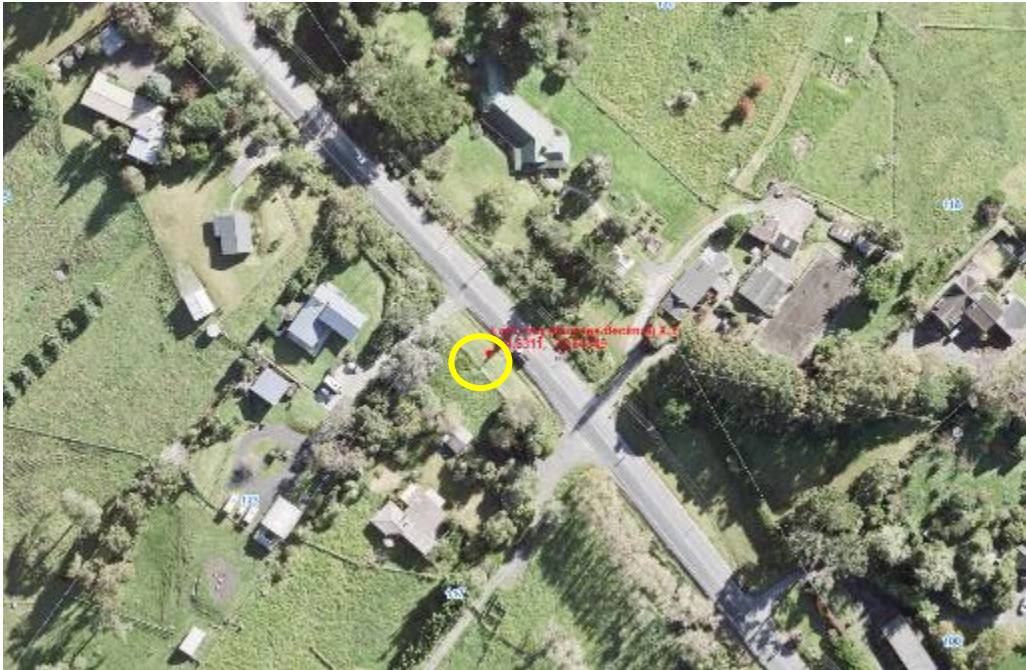
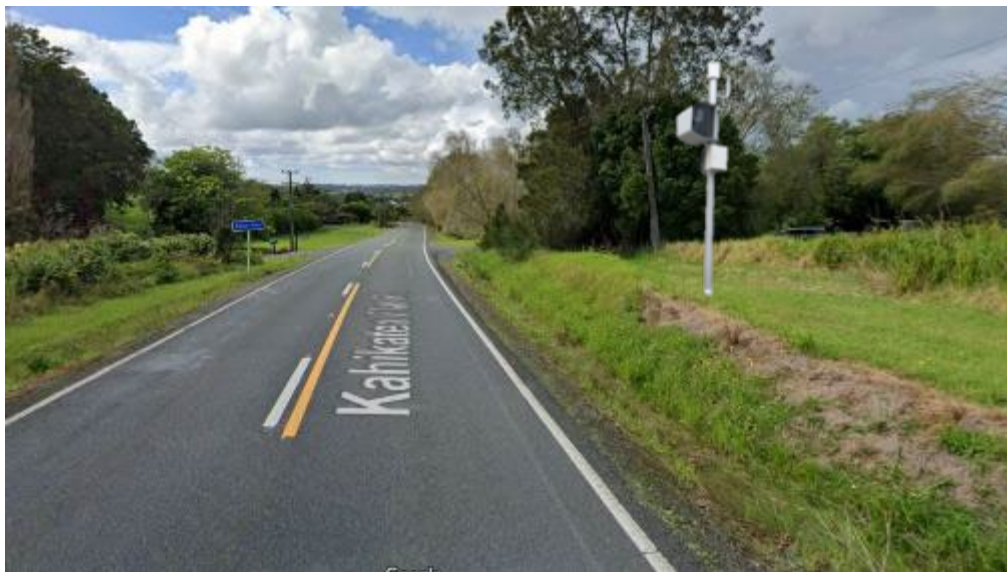
### Installation location for the first camera

Following a site inspection, the installation location for the eastern camera was confirmed at - 36.64349 174.63110° outside 117 Kahikatea Flat Road with the camera facing south.

Power is to be taken from an adjacent powerpole requiring trenching and installation of a TUD from which camera power will be drawn is required.

The need for a protective barrier is being explored for this installation site.

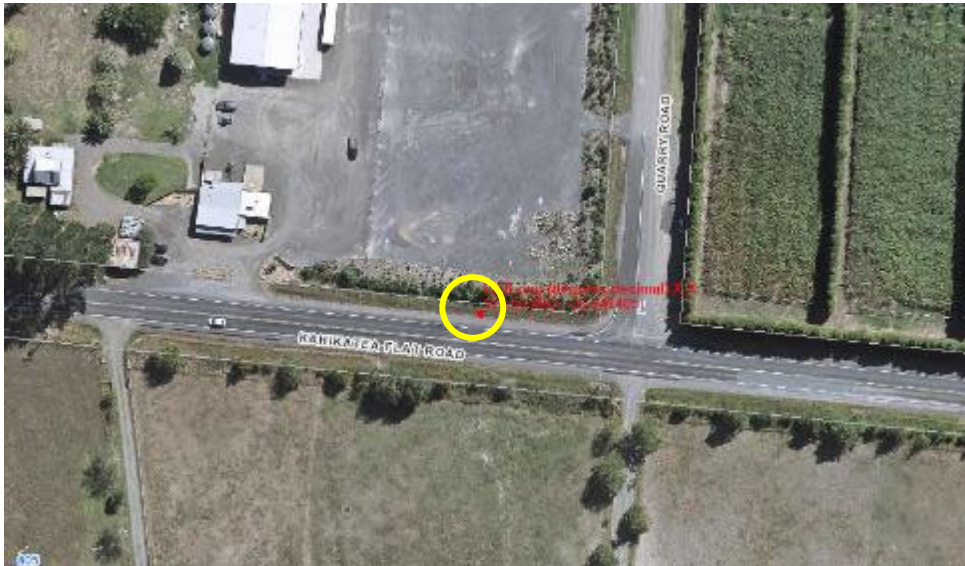
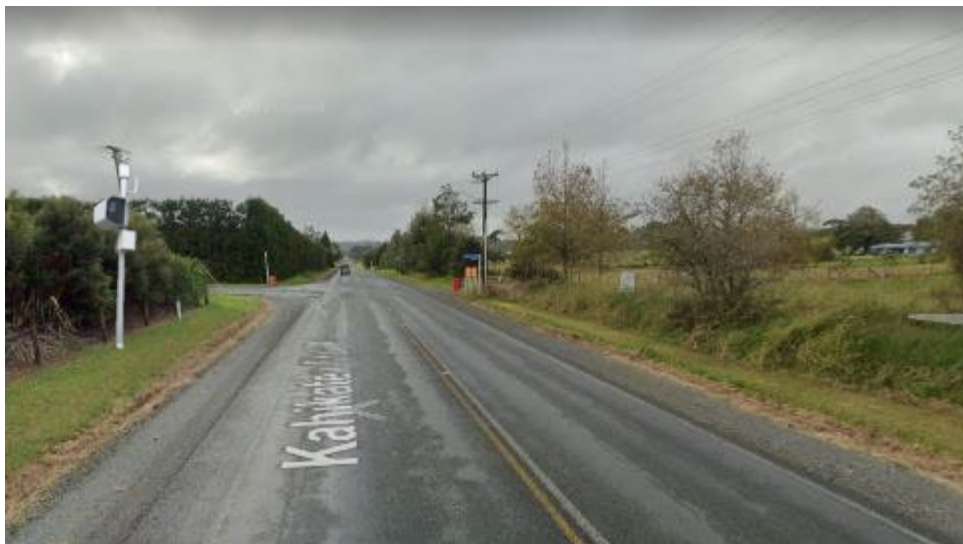
### Installation location for the second camera

Following a site inspection, the installation location for the southern camera was confirmed at - 36.640405, 174.563963° opposite 793 Kahikatea Flat Road with the camera facing north.

Power is to be taken from the adjacent powerpole, with the installation of a TUD from which camera power will be drawn is required.

A protective barrier is recommended for this installation site. .

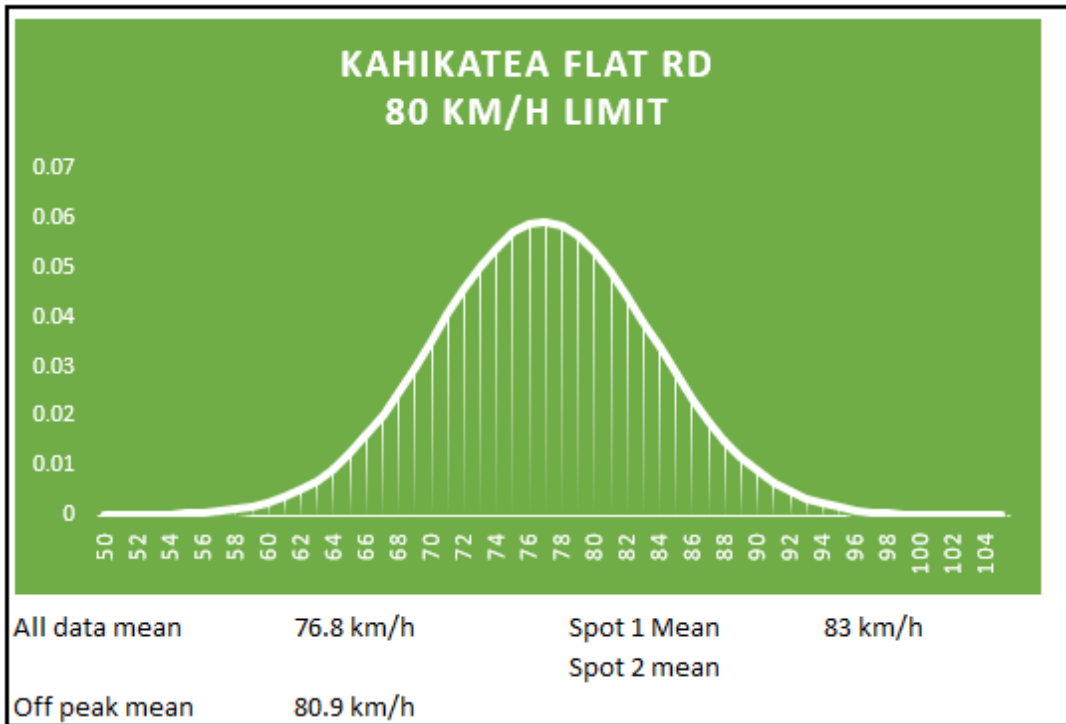
**Average Speed profile**

The free flow mean speed is 81 km/h which is within the 5% criteria for a camera.

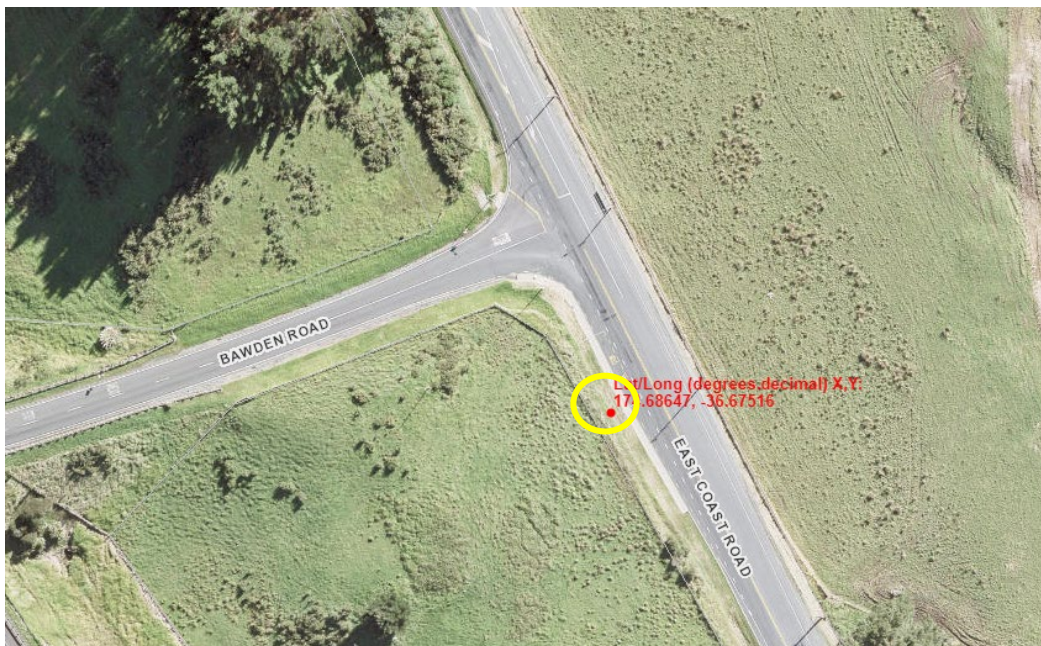
Installation location for the first camera

Following a site inspection, the installation location for the northern camera was confirmed at -36.675161, 174.686470° opposite 1627 East Coast Road with the camera facing south.

The outer edge of the foundation of the support structure will be about 7m from the white edge line sitting predominantly at about 1 metre above road level.

Power is to be taken from a powerpole across the road so trenching and installation of a TUD from which camera power will be drawn is required.

A protective barrier is recommended for this installation site.

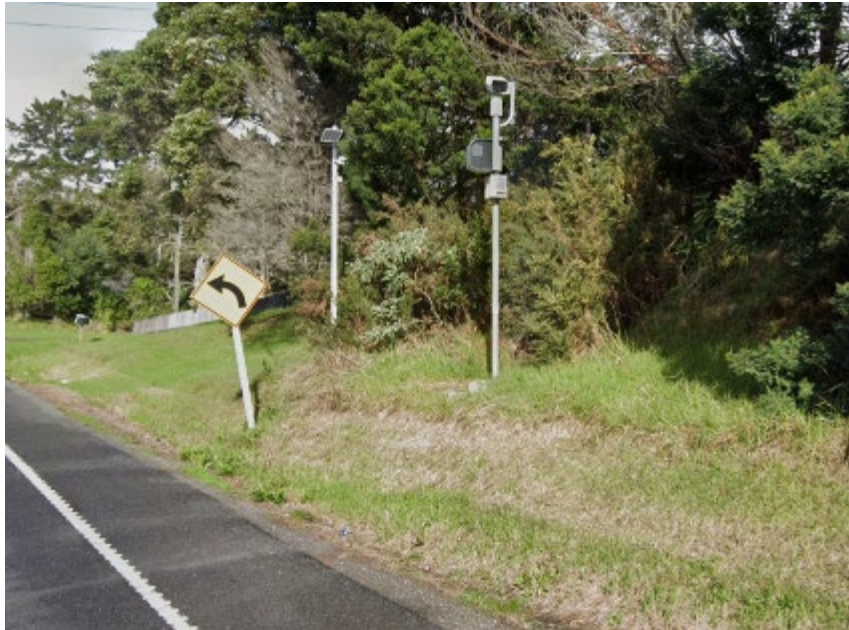
The site is an existing New Zealand Police installed and operated safety camera. It is located on top of an earth bank (about 1m above road level) on the western side of the roadway. Due to the location up the embankment there is no safety barrier at this location.

Image of existing safety camera

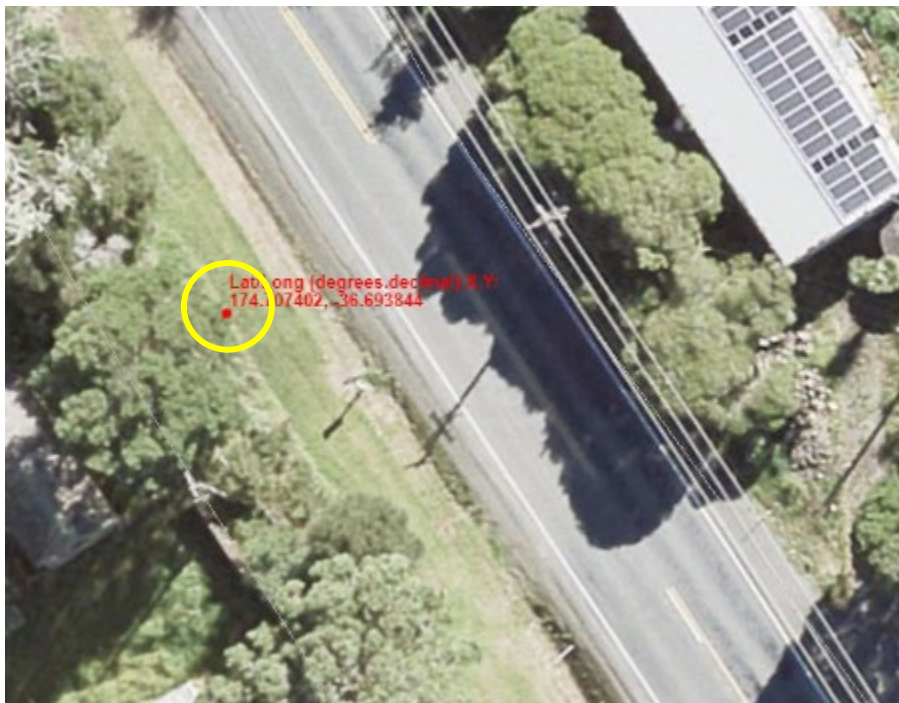
Installation location of second camera

Following a site inspection, the installation location for the southern camera was confirmed at -36.693844, 174.707402° outside 1232 East Coast Road, with the camera facing north.

Existing access is by way of parking in a nearby pull off area and walking the short distance up the earth bank.

Consideration given to forming a safe walkway to camera and possibly investigate barrier.

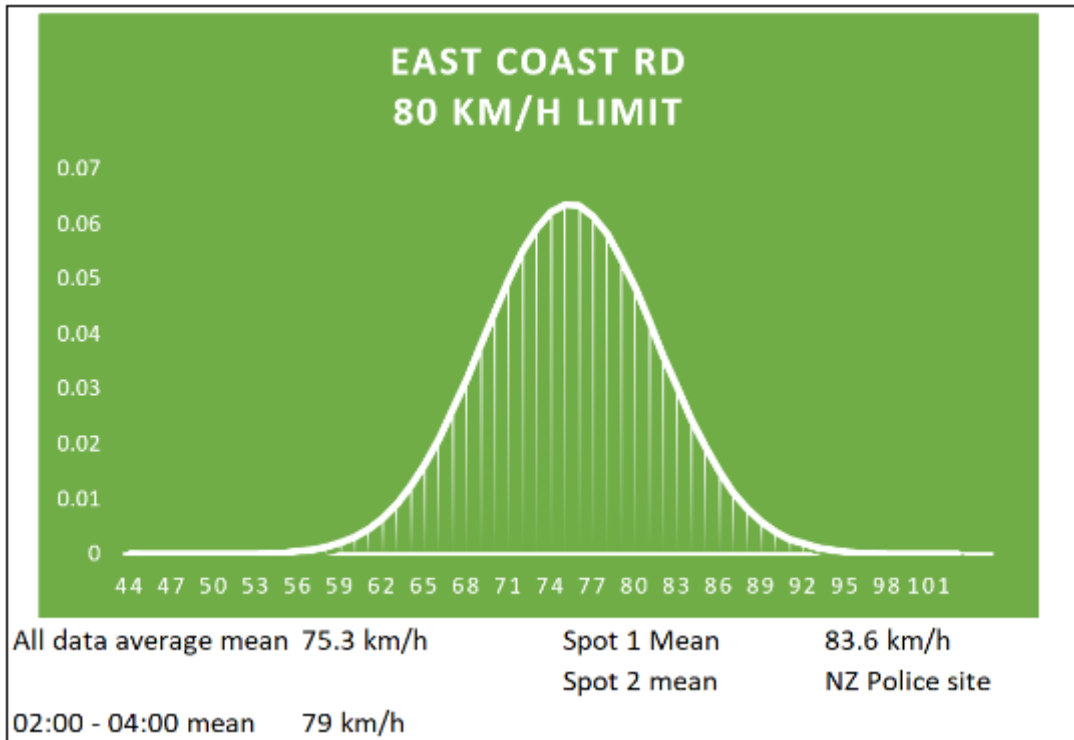
**Average Speed profile**

The free flow mean speed is 79 km/h which is within the 5% criteria for a camera.

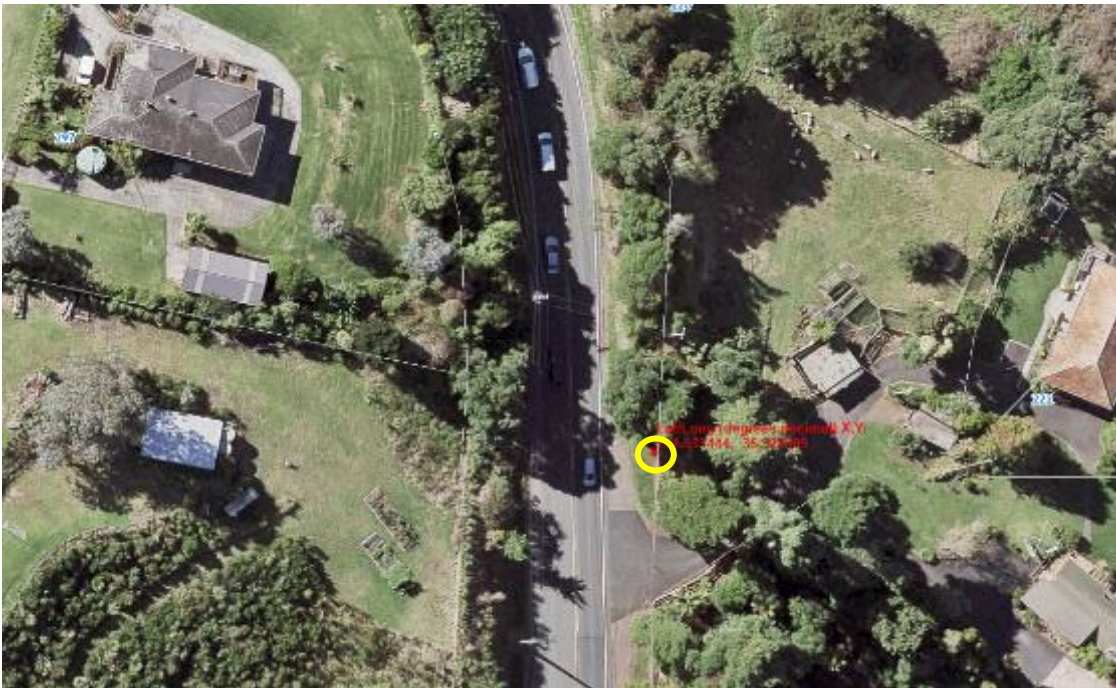
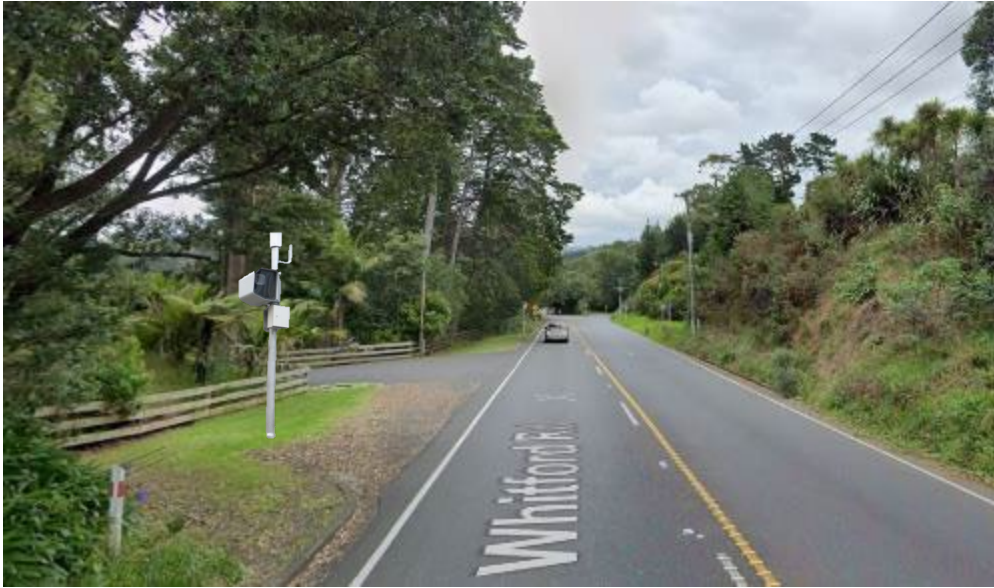
Installation location for the first camera

Following a site inspection, the installation location for the camera was confirmed at -36.922514, 174.933412°, outside 222 Whitford Road with the camera facing northeast.

Access will be constructed to allow safe entry for personnel and a parking area at the southern end of the site.

Power is to be taken from the powerpole and will require trenching and installation of a TUD from which camera power will be drawn.

A protective barrier is not required for this site.

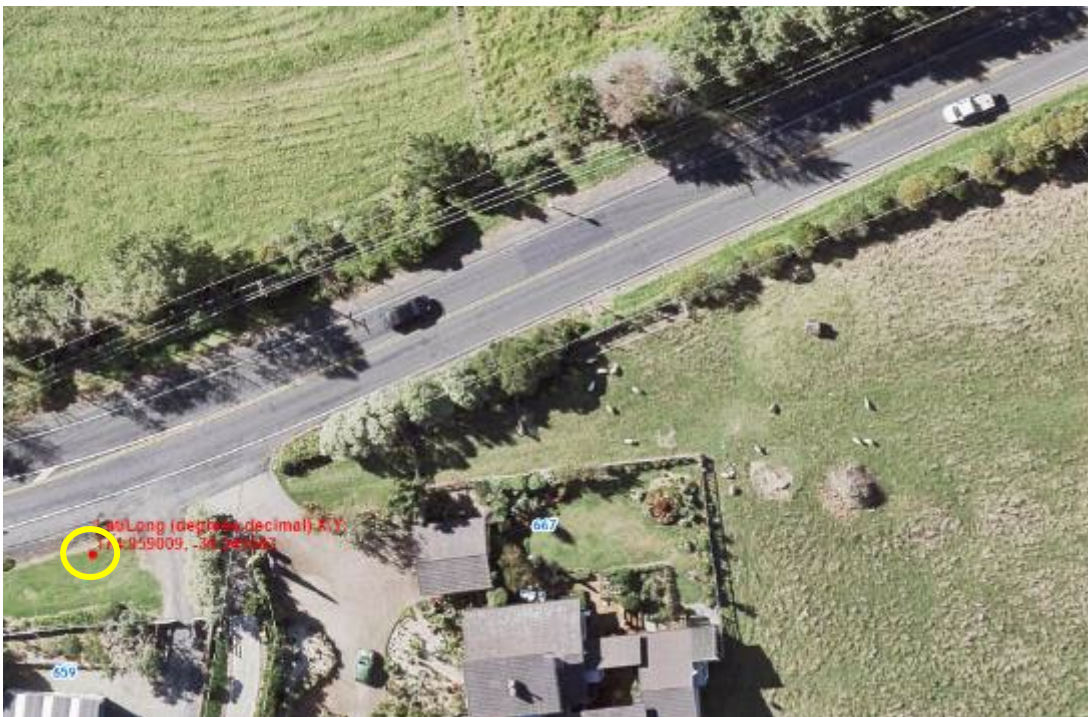
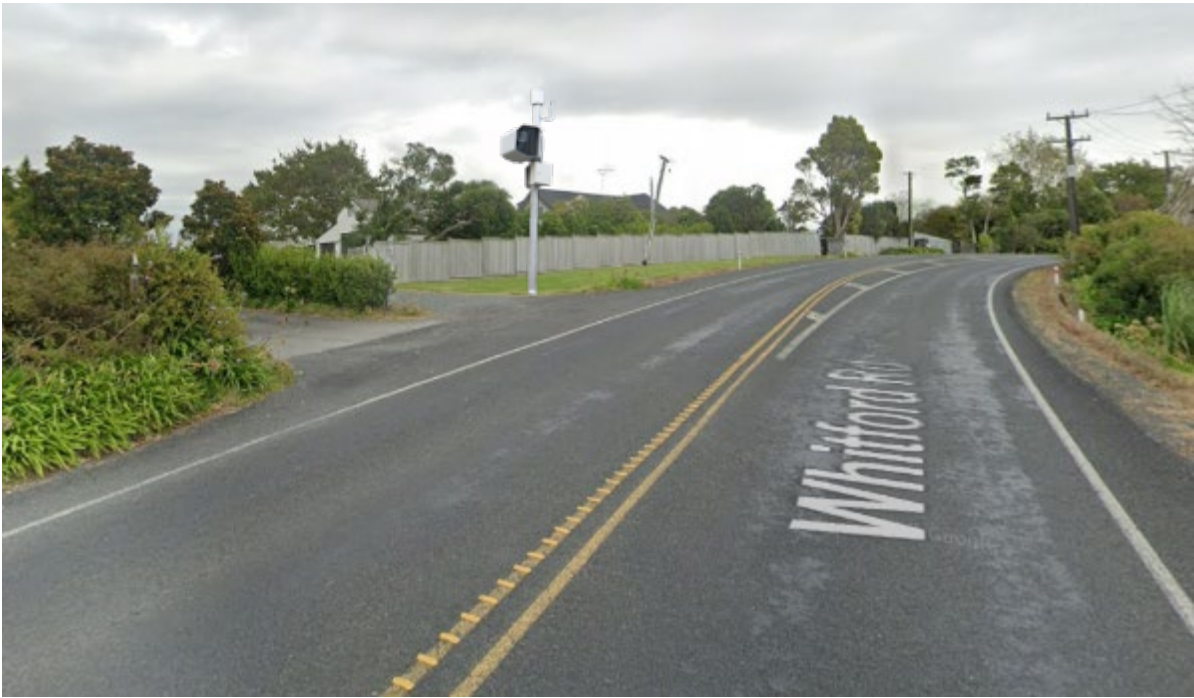
Installation location for the second camera

The second camera is to be installed opposite 659 Whitford Road (-36.945063, 174.959009). Power is available from a nearby pole. The camera will face northeast

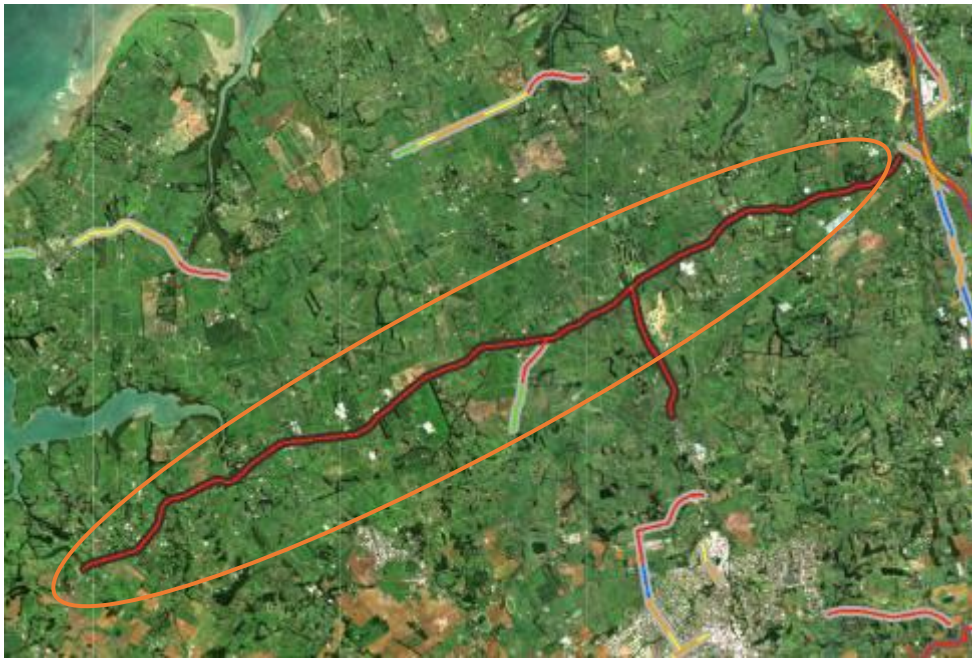
Site Location Risk map for identified corridor

Following site visits the preferred installation locations were confirmed as -37.143135, 174.875426° outside 83 Glenbrook Road and -37.166823, 174.811143° outside 721 Glenbrook Road.

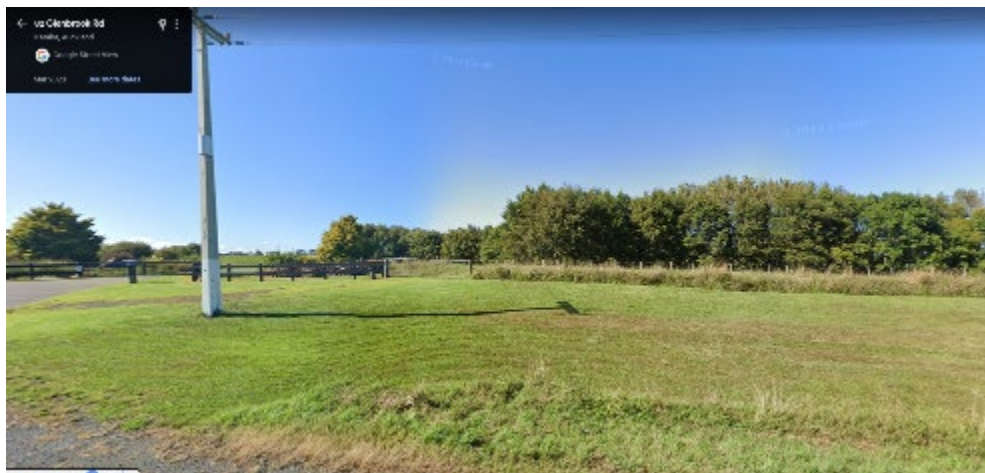
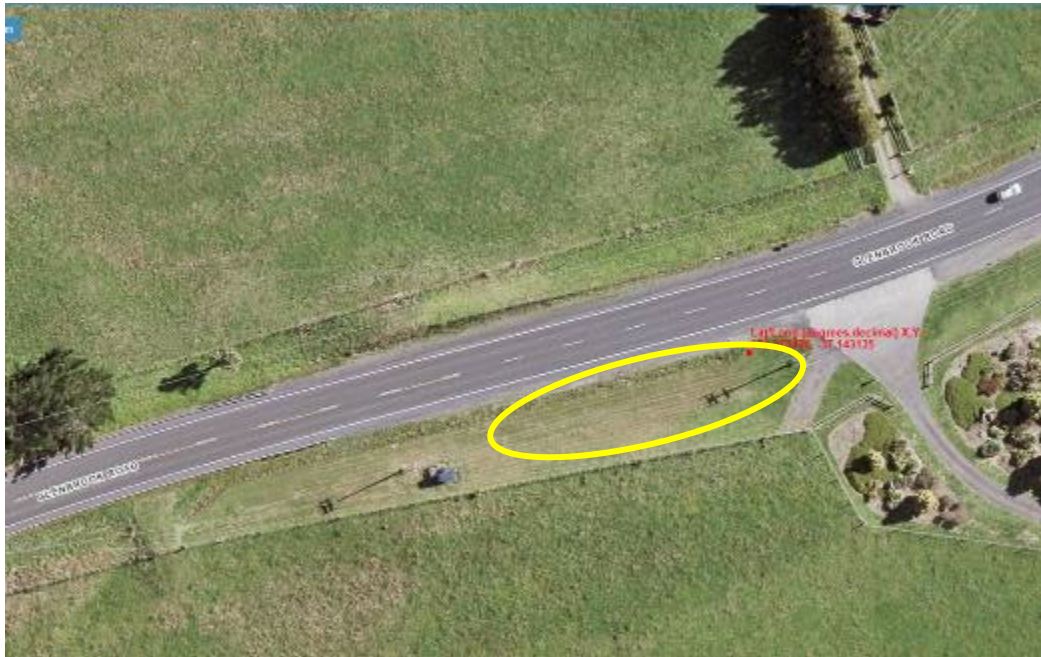
**Installation location for the first camera**

Following a site inspection, the installation location for the southern camera was confirmed at GPS - 37.143135, 174.875426° outside 82 Glenbrook Road with the camera facing west. The camera is to be installed on the south side of the road.

Power is to be taken from the existing nearby TUD.

Access will be from the nearby driveway area.

A safety barrier is required at this location.

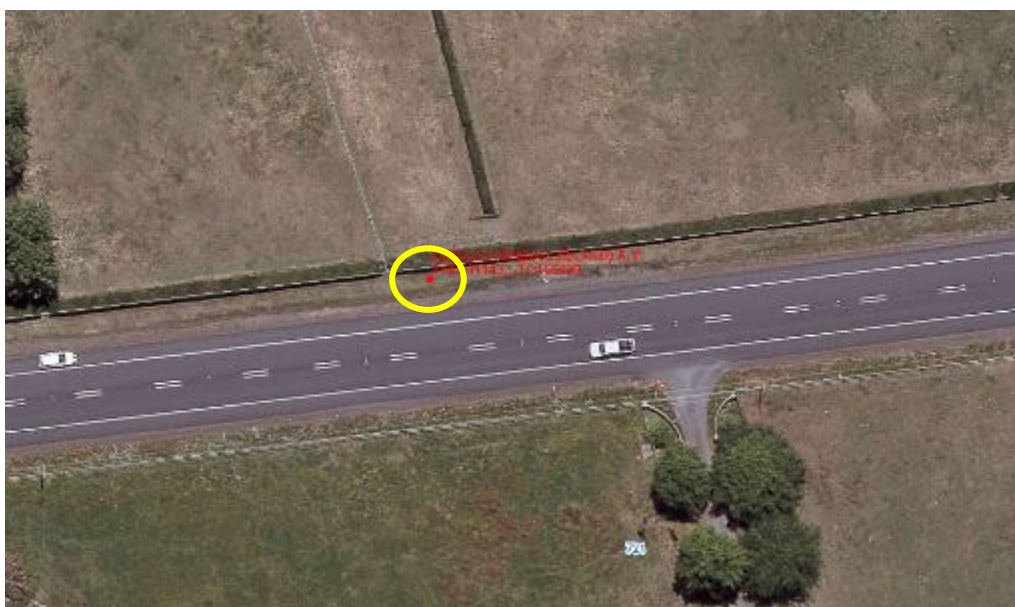
**Installation location of second camera**

Following a site inspection, the installation location for the southern camera was confirmed at - 37.166823, 174.811143°, opposite 721 Glenbrook Road, with the camera facing east. The camera will be installed on the north side of the road.

Access will be constructed to allow safe entry and exit for vehicles to a parking area located behind the safety barrier at the eastern end of the barrier.

A protective barrier is recommended for this installation site.

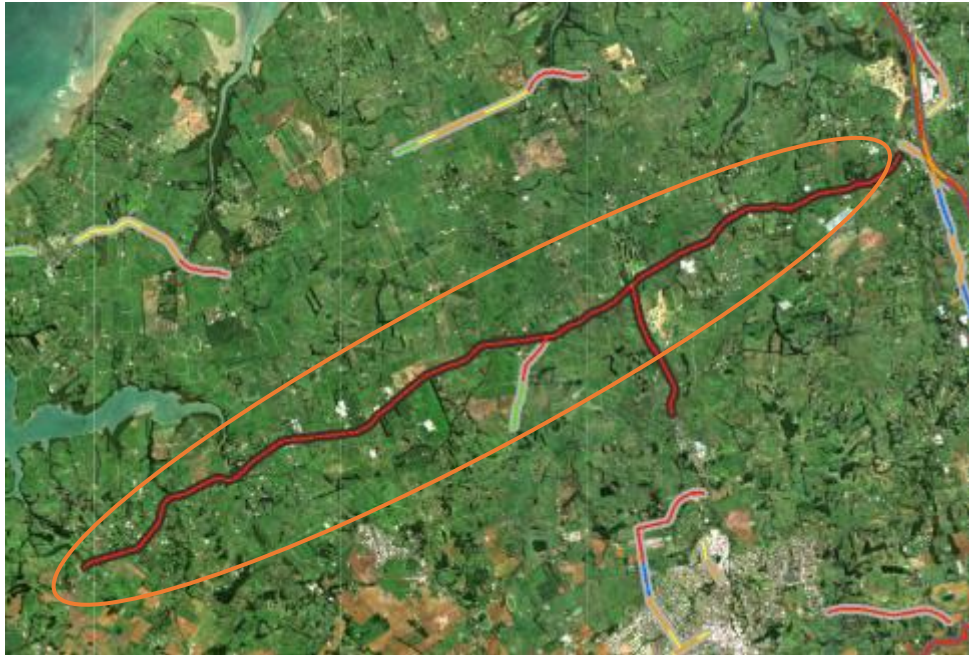
Site Location Risk map for identified corridor

Following site visits the preferred installation locations were confirmed as -37.174819, 174.789122° outside 946 Glenbrook Rd and -37.188881, 174.766308° outside 1233 Glenbrook Road.

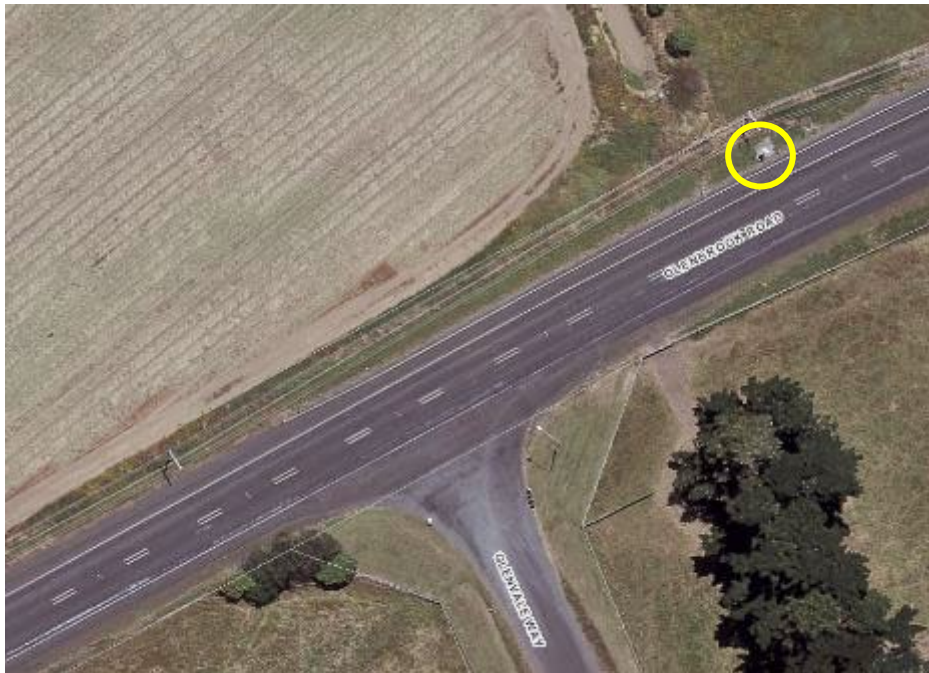
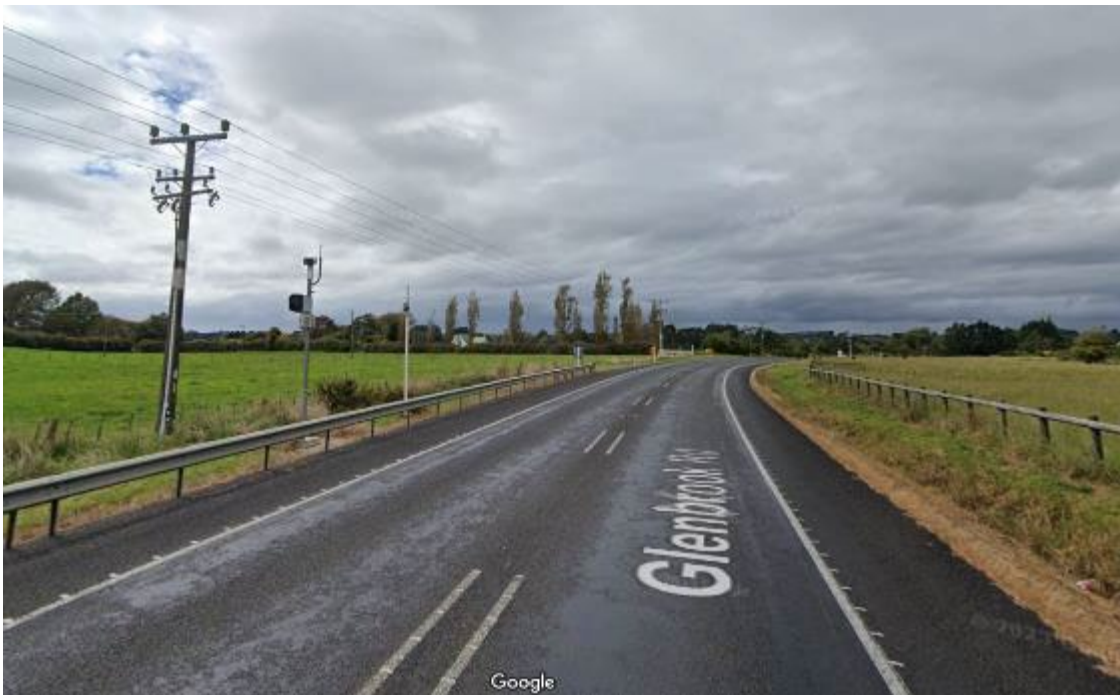
**Installation location for the first camera**

Following a site inspection, the installation location for the southern camera was confirmed at -  $37.174819, 174.789122^\circ$  outside 946 Glenbrook Rd with the camera facing west. The camera is to be installed on the north side of the road on the existing NZ Police camera pole hardware.

Power connectivity is in place at this location as is a safety barrier.

Access will be from the existing safe entry/egress lane constructed during the initial installation by NZ Police.

A protective barrier is already installed at this site.

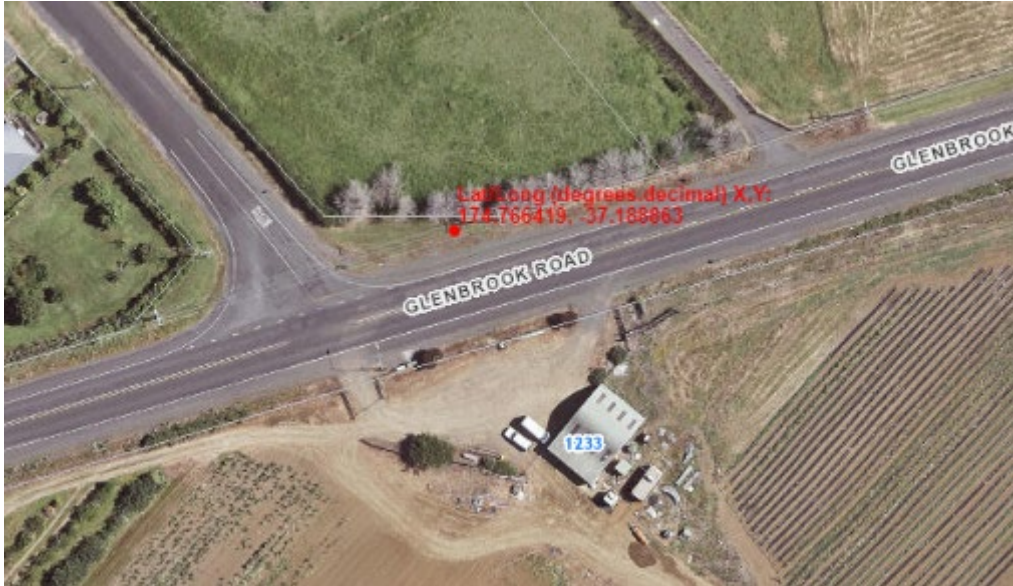
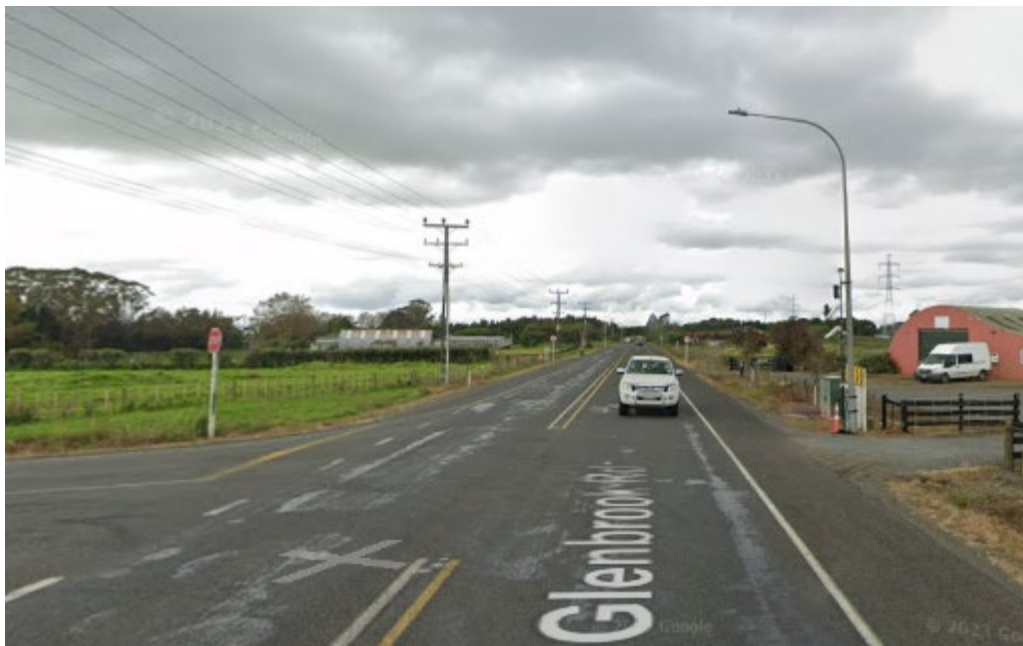
Installation location of second camera

Following a site inspection, the installation location for the southern camera was confirmed at - 37.188863, 174.766419°, opposite 1233 Glenbrook Road, with the camera facing east. The camera will be installed on the north side of the road.

Access will be constructed to allow safe entry and exit for vehicles to a parking area located behind the safety barrier at the eastern end of the barrier.

A protective barrier is recommended for this installation site.
