# Validation of the Performance of the proposed 23m B-train Pro-forma Design

NZTA

March 2019

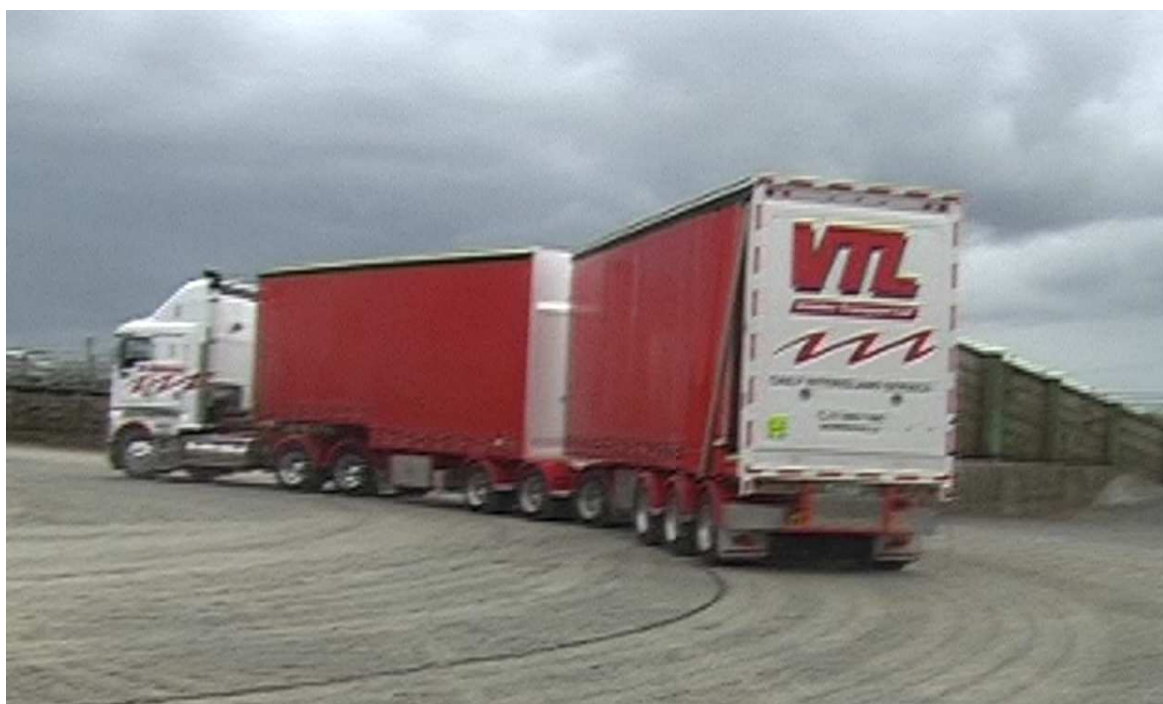
The Vowles Transport B-train during the low speed steady turning manoeuvre is pictured in Figure 1. Figure 2 shows a layout drawing of this vehicle supplied by Roadmaster Trailers who built the vehicle.

Figure 1. Vowles Transport B-train.

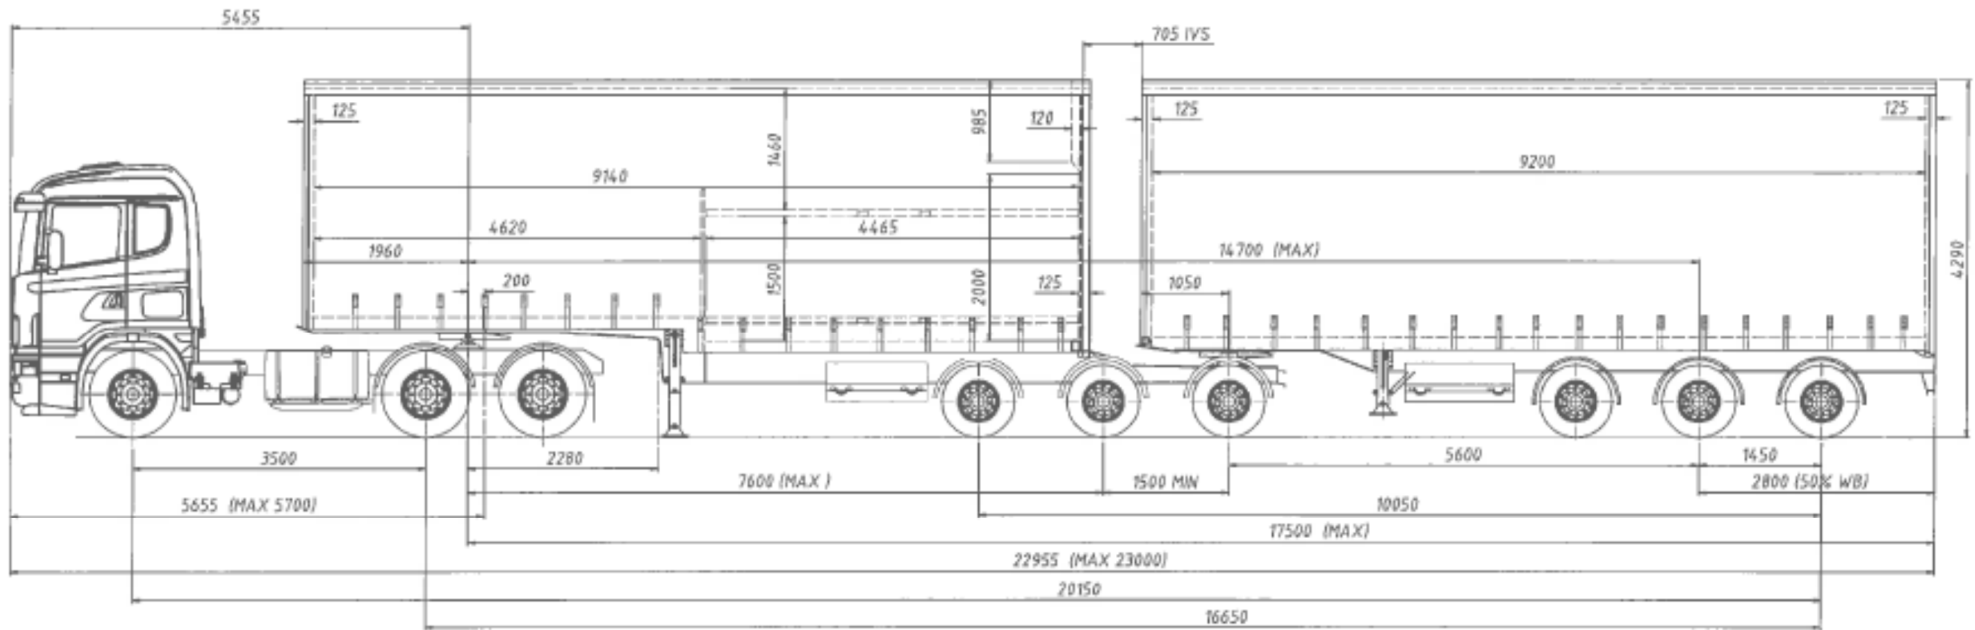
NOTE: Limited maximum wheelbase ratio :-  $7600 / 5600 = 1.36$

Figure 2. Layout drawing of Vowles Transport B-train supplied by Roadmaster Trailers.

The layout drawing is based on using a Scania tractor. The validation tests were undertaken with a Kenworth tractor which has a similar forward length but this is comprised of a longer wheelbase and a shorter front overhang. The differences in the key tractor dimensions are shown in Table 1. Note that both tractors meet all of the requirements of the proposed pro-forma design. The trailer dimensions were also checked and these were exactly as shown in the drawing (Figure 2).

Dimension	Scania tractor as shown in Figure 2	Kenworth tractor as measured
Forward length	5655mm	5680mm
Front overhang	1455mm	940mm
Wheelbase	4200mm	4740mm

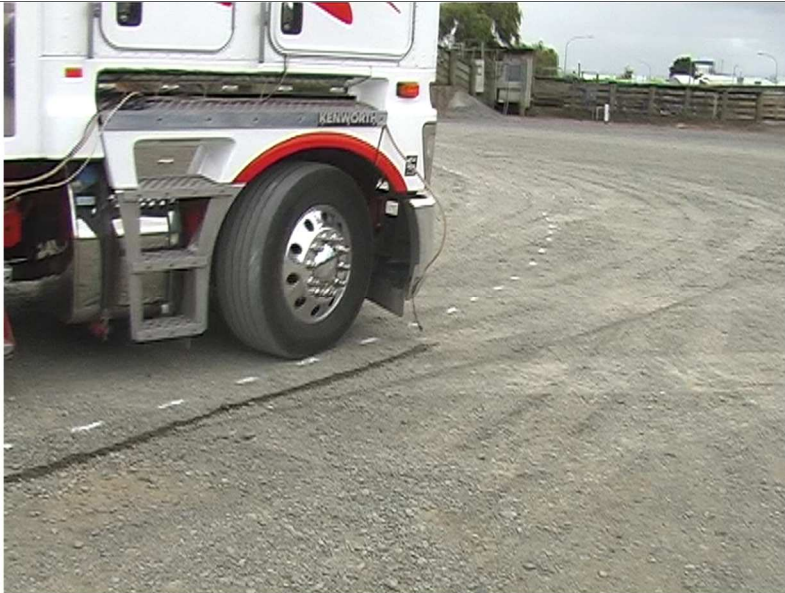
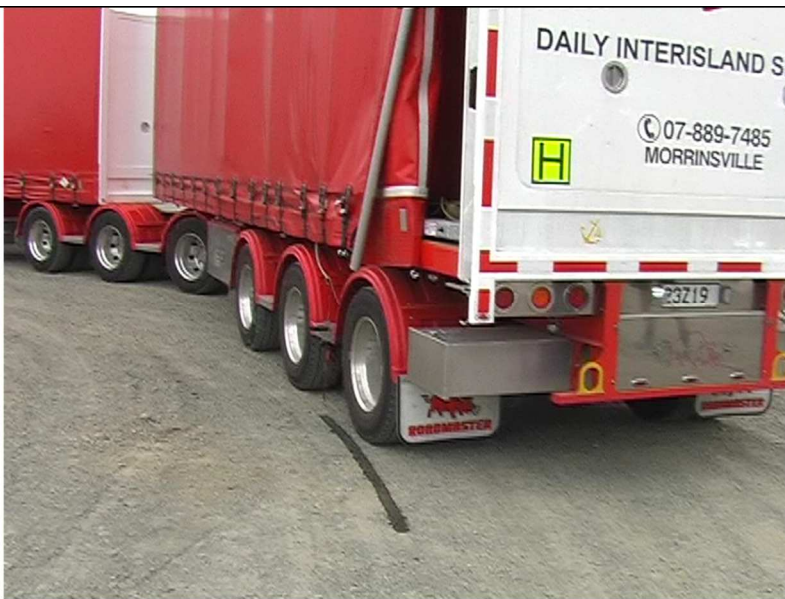
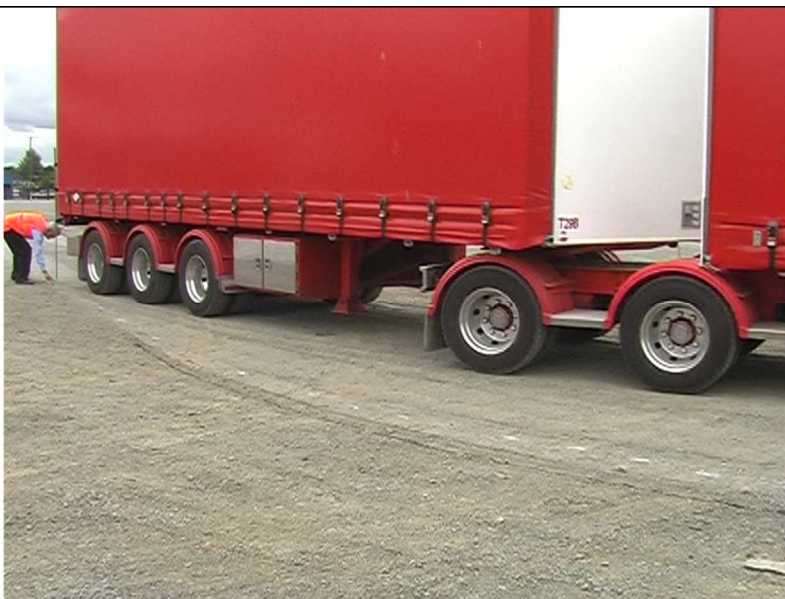
The truck was fitted with pressurised water sprayer units on the right front corner and in line with the outside edge of the left rear trailer axle group. These sprayers were activated during each test and traced out the path followed by the respective points on the vehicle. In addition a wand was strapped to the outside right edge of the rear corner of the vehicle to indicate the tail swing. The location on the ground of the projection of the wand during the turn was marked manually with pavement chalk. Figure 3 shows the two sprayers and the wand during a test.

Figure 3. Sprayer units and tail swing wand fitted to the test vehicle.

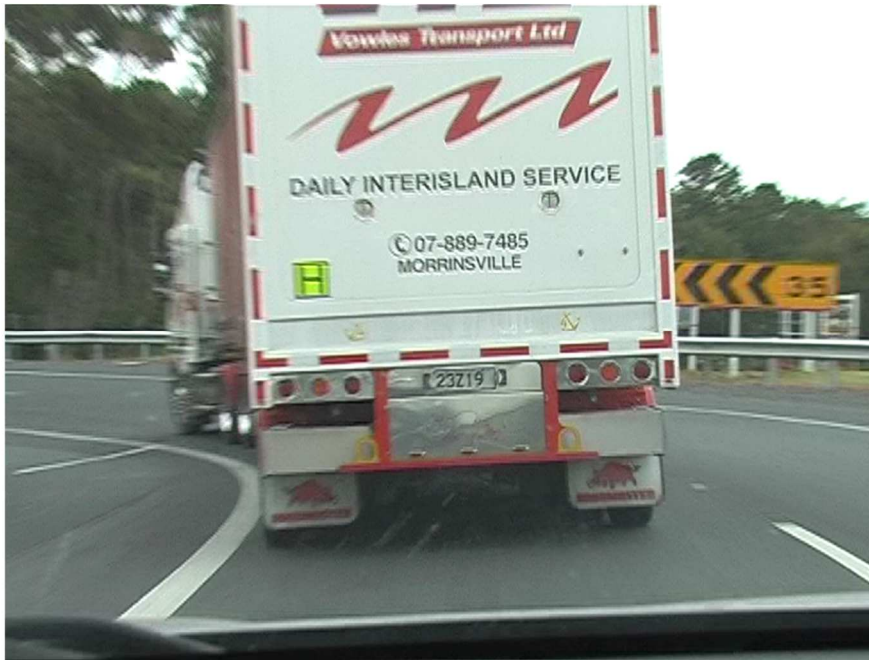
The vehicle was videoed throughout the trip using a Panasonic NV GS400 video camera. It tracked extremely well with no trailer sway at any time. On the curves, it was able to stay well within its lane and provided good clearance to the centreline. Figure 4 shows a still taken from the video of the vehicle in a left hand 35 km/h curve while Figure 5 shows it on a right hand 35 km/h curve. As can be seen the lanes are quite narrow but the vehicle had no difficulties in staying well within them and allowing adequate clearance for any similar oncoming vehicle.

Figure 4. Traversing a left hand 35 km/h advisory speed curve.

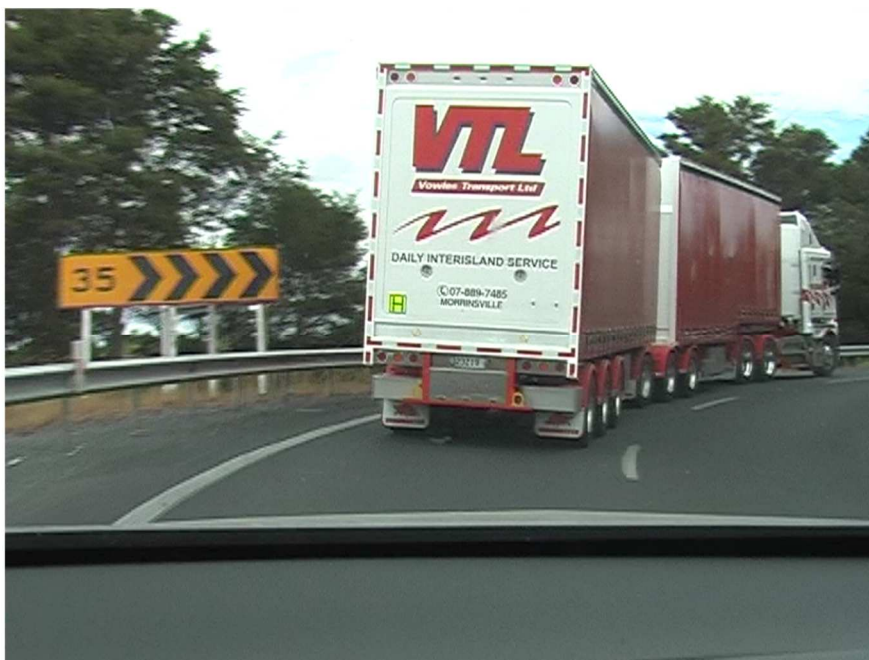
Figure 5. Traversing a right hand 35 km/h advisory speed curve.

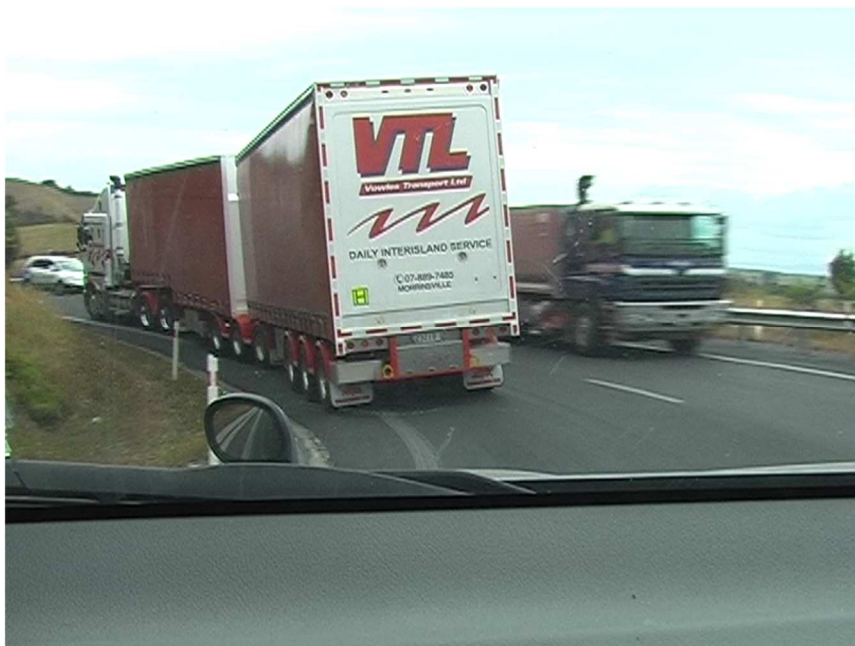
Figure 6 shows the vehicle meeting an oncoming truck and trailer while travelling through a 35 km/h curve. The driver has positioned the vehicle so that the trailers have crossed the fog-line on the left hand side of the road but they are still comfortably on the hard shoulder. The clearance between the two trucks is comfortable and there was no indication from either the path taken or the vehicle speeds that either driver had any concerns.

Figure 6. Traversing a 35km/h curve with an oncoming truck and trailer.

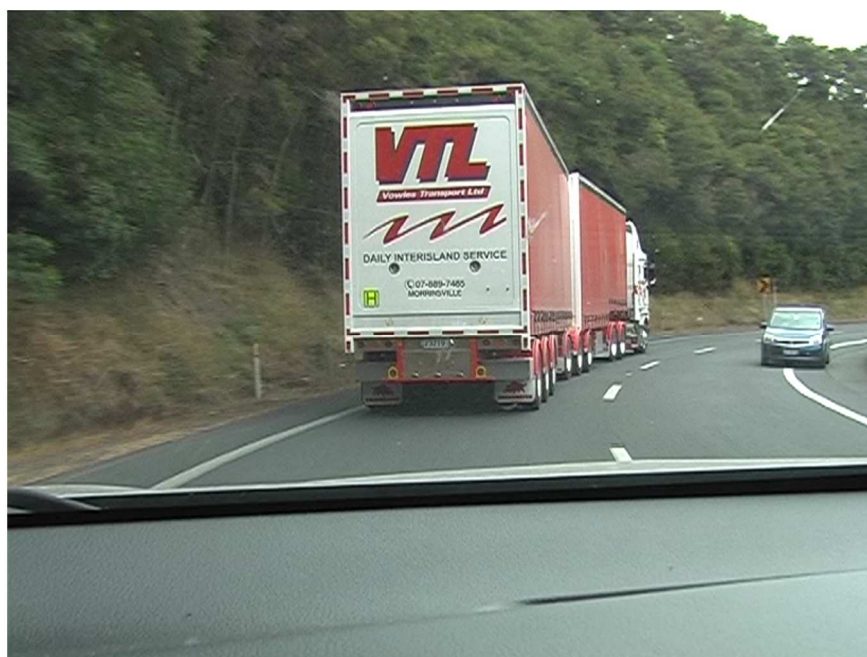
Figure 7 shows the vehicle on a moderate curve with an oncoming car. The curve had no posted advisory speed but it immediately followed a 35 km/h curve and is on an uphill gradient. The criteria for posting an advisory speed sign are based on both the severity of the curve and the 85<sup>th</sup> percentile vehicle approach speed. Thus the fact that there is no advisory speed sign does not mean that it is a high speed curve. What is notable about this image is that the car is giving the truck an unnecessarily wide berth. This may simply be the car driver cutting the corner to reduce the effective curvature or it may be excessive caution.

Figure 7. Traversing a moderate curve with an oncoming car.

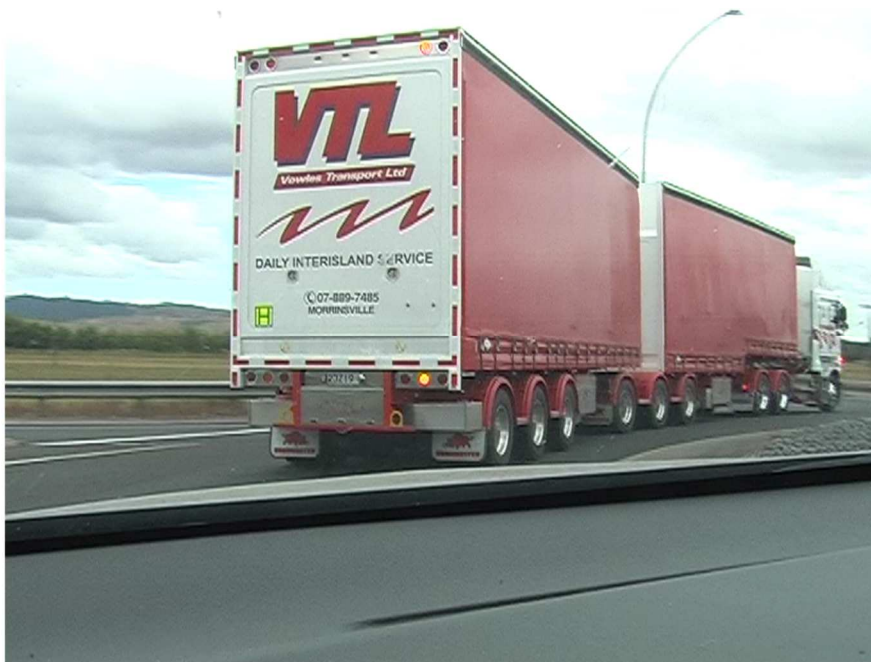
. Figure 8 shows the vehicle undertaking a right turn on roundabout and again there are clearly no issue with road space.

Figure 8. Undertaking a right turn on the roundabout at the junction of SH27 and Paeroa-Tahuna Rd.
