Transport noise Integrated noise/safety barriers

NOISE BARRIER CASE STUDY 9

Newmarket Viaduct to Greenlane Auxiliary Lane

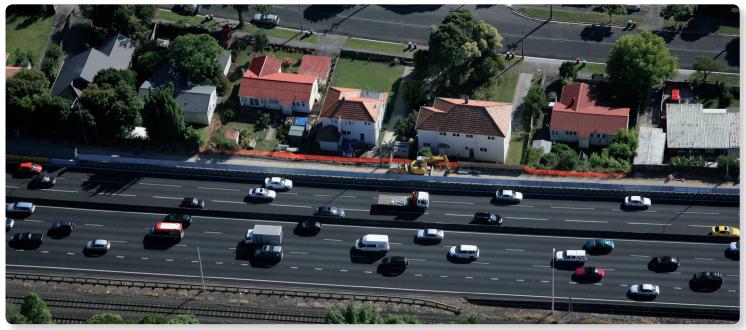
The Newmarket Viaduct to Greenlane Auxiliary Lane project under construction. The workspace was tightly constrained between live motorway lanes and residential properties.

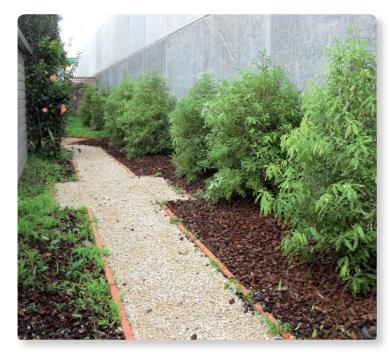
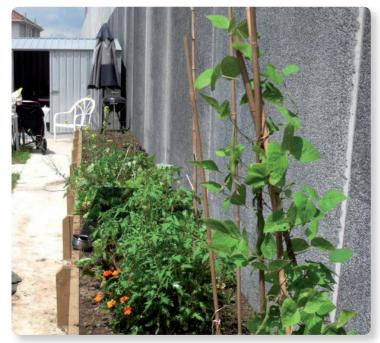
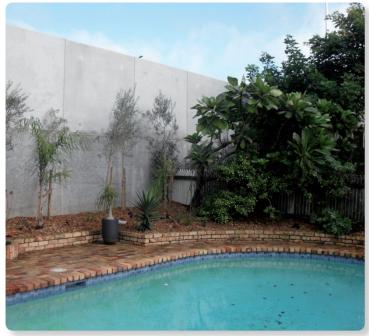
Landscape plans were tailored for each property, with residents consulted about the style of planting.

Landscaping on the residents' side of the noise barrier was not included as part of the initial design. However, towards the end of the project a landscaping budget was provided to around 35 affected residents as a way to compensate some of the visual effects of the large structures. The landscape plans were done on a property-by-property basis and residents were able to make specific requests for their property landscape plans. The plans ranged from basic tree planting in front of the noise barriers to construction of separate frames adjacent to noise barriers for climbing plants. The residential landscaping works (covered as a provisional sum under the contract), were undertaken at the end of the project.

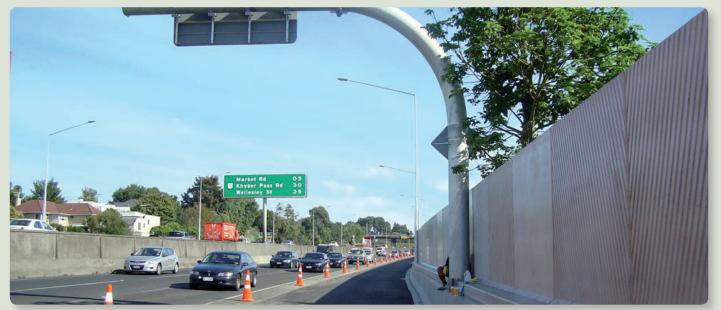
At Greenlane, camera coverage of the emergency shoulder is reduced and placement of signs was a challenge

Additionally, combined noise barriers can make it difficult and expensive to install new signs, gantries, signal poles, lighting columns, and cameras, and may also compromise their effectiveness. For example, at Greenlane the combined safety/noise barrier limits camera coverage of the southbound emergency shoulder and has also limited the locations where signs can be placed.

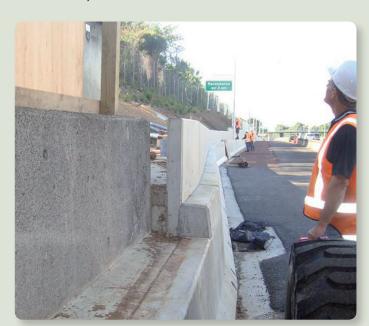
(Before) A hazard was created when the ends of the Greenlane noise barrier panels were combined with concrete safety barriers. If vehicles were to come into contact with concrete safety barriers they may impact the noise barrier end panel.

Safety inspections of these barriers have highlighted risks in regards to noise barriers which are above safety barriers. There is a potential issue with vehicle impacts to the ends of the noise barrier panels, particularly in situations where vehicles could ride over or climb concrete safety barriers prior to reaching the noise barrier, and then come into contact with end of a noise barrier panel. At Greenlane, a transition block was constructed to address this issue prior to opening the lane to traffic.

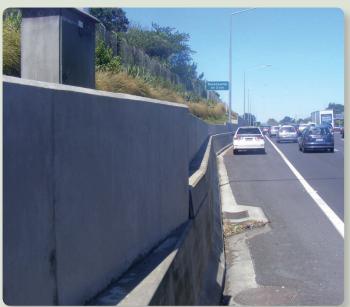
(After) This hazard was rectified by the inclusion of transition panels on top of concrete safety barriers to create a smooth change from concrete safety barriers to combined safety/noise barriers.

- Ideally noise barriers should be setback from safety barriers to avoid vehicles impacting the ends of noise barrier panels. If this cannot be achieved then transition panels between concrete safety barriers and safety/noise barriers should be used.

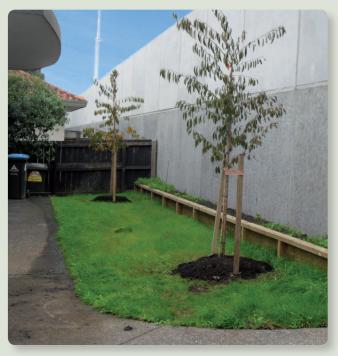
Landscaping and retaining walls mitigated some of the visual impacts of the large barriers.
