# Acoustics Research Group

## REPORT

Number: **252**

## Measurement of the Acoustic Performance of Traffic Noise Barriers on Auckland Motorways Using prEN1793-6:2011

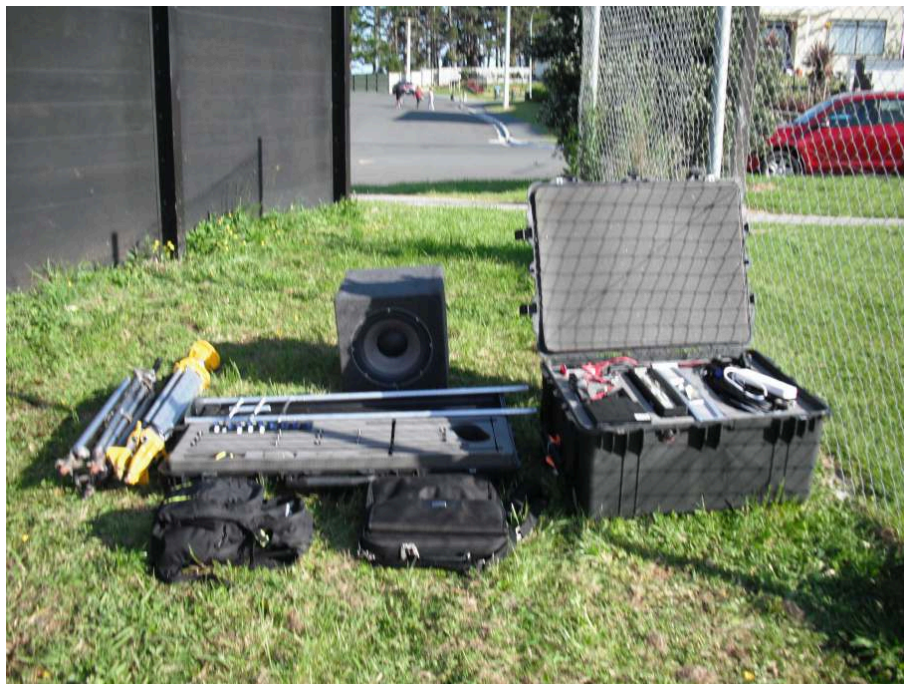
Figure 1 Measurement equipment

The measurement equipment was packed into two Pelican travel cases for protection during transport. The loudspeaker and tripods were packaged in cardboard boxes for transport between Christchurch and Auckland. Figure 1 shows the measurement equipment laid out on the ground at a test site. Further details of the measurement equipment are given in Appendix A.

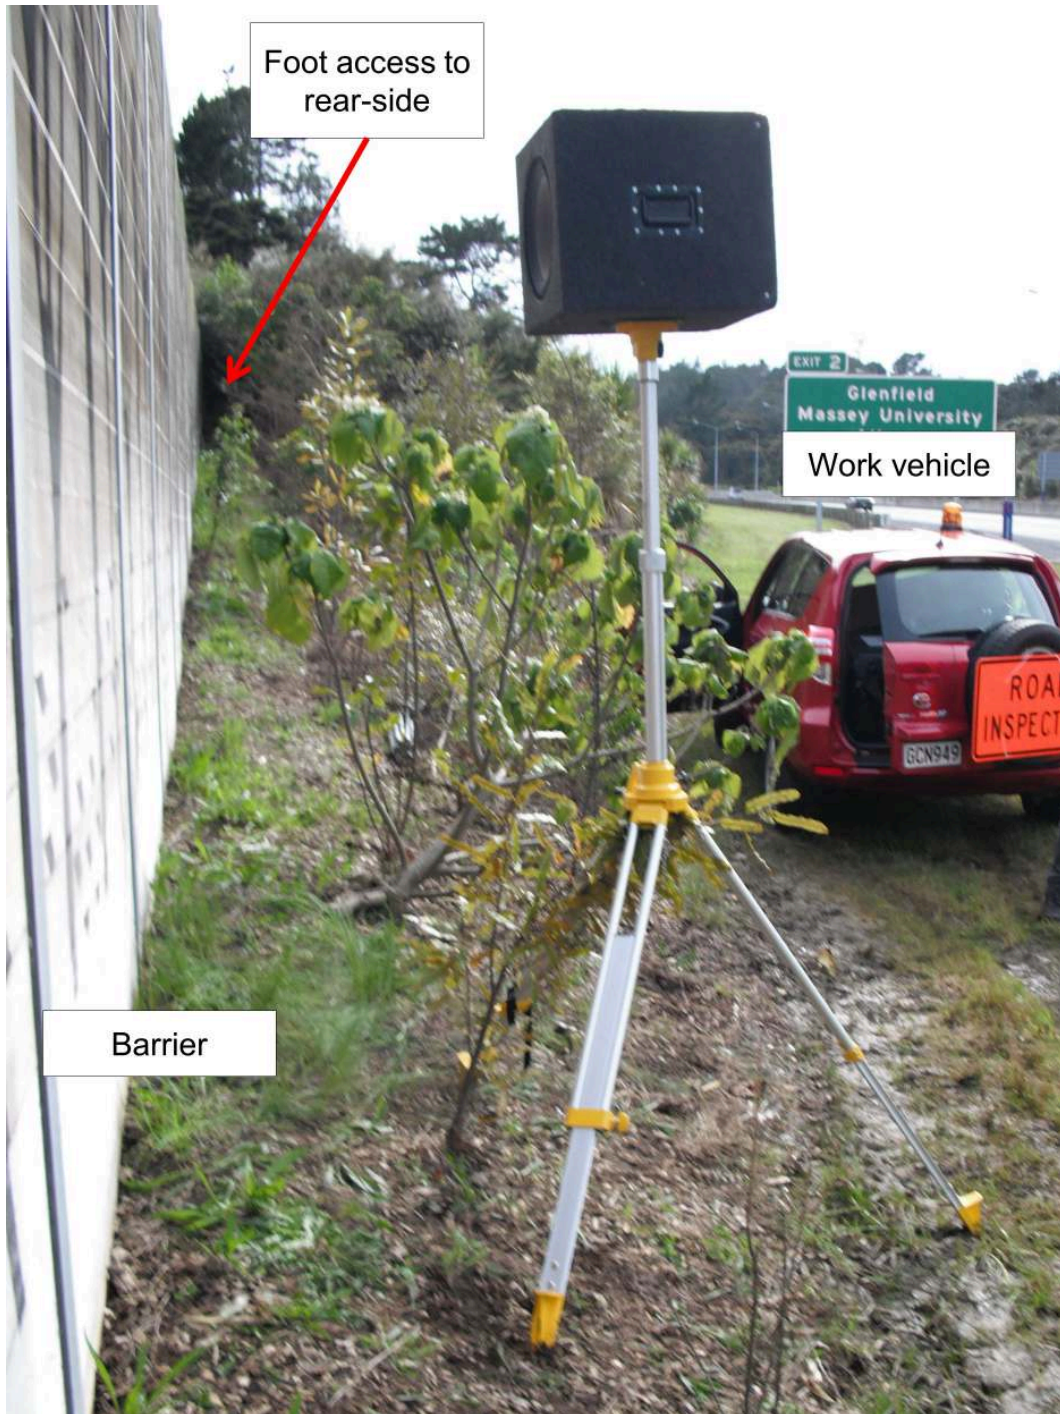
**Figure 3** Road inspection site layout, Greenhithe

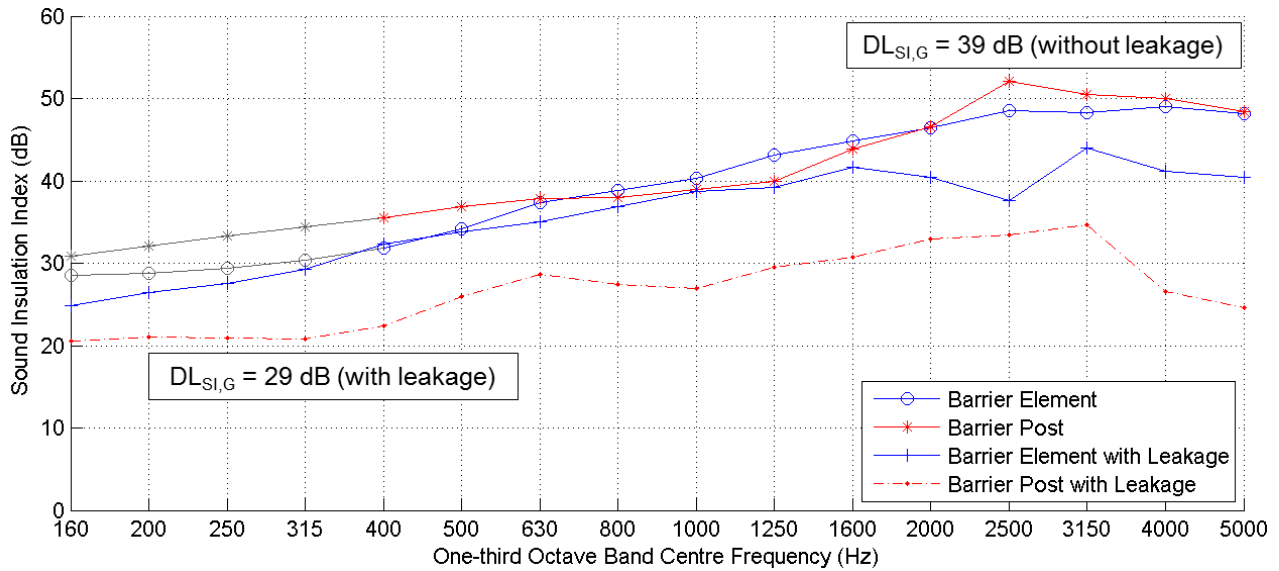
**Figure 6** Airborne sound insulation of the traffic noise barrier at St Marys Bay with and without the leakage components. The global single number ratings are included. The grey lines represent values below the low frequency limit of the measurement.

The loudspeaker/centre microphone height was limited due to the presence of the concrete crash barrier; the leakage components have been excluded from the calculation of the airborne sound insulation in the test report as they would not be present if the test was performed at half the barrier height as intended. The effect of including the leakage components in the time window is shown in Figure 6. Refer to the test report in Appendix B for details of the acrylic barrier at St Marys Bay.

Excluding the leakage components gives the effective airborne sound insulation of the panels and posts, which would be achieved in practice if the air gaps were adequately sealed.

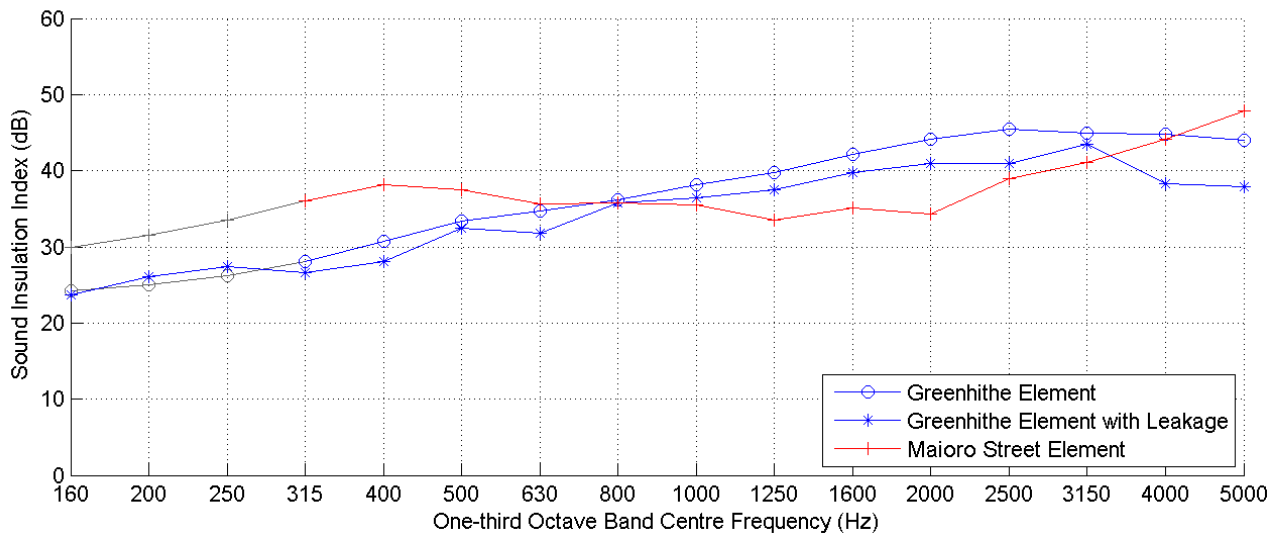
**Figure 7** Airborne sound insulation of the engineered timber barrier elements at Greenhithe and Maioro Street, showing the effect of using a larger time window at the Greenhithe site. The grey lines represent values below the low frequency limit of the measurement.

Some leakage was observed around the panel edges for both the Greenhithe and Maioro Street engineered timber barriers. The shorter barrier at Maioro Street required a time window of 4.5ms in order to eliminate the diffraction component over the top of the barrier. This short time window also removed the leakage components in the element measurement at the Maioro Street site. A window length of 4.5ms was chosen at the Greenhithe site so that a fair comparison could be made between the two engineered timber barriers. The effect of including the leakage components at the Greenhithe barrier elements is shown in Figure 7. Refer to the test report in Appendix C for details of the engineered timber barrier at Greenhithe and Appendix D for details of the engineered timber barrier at Maioro Street.

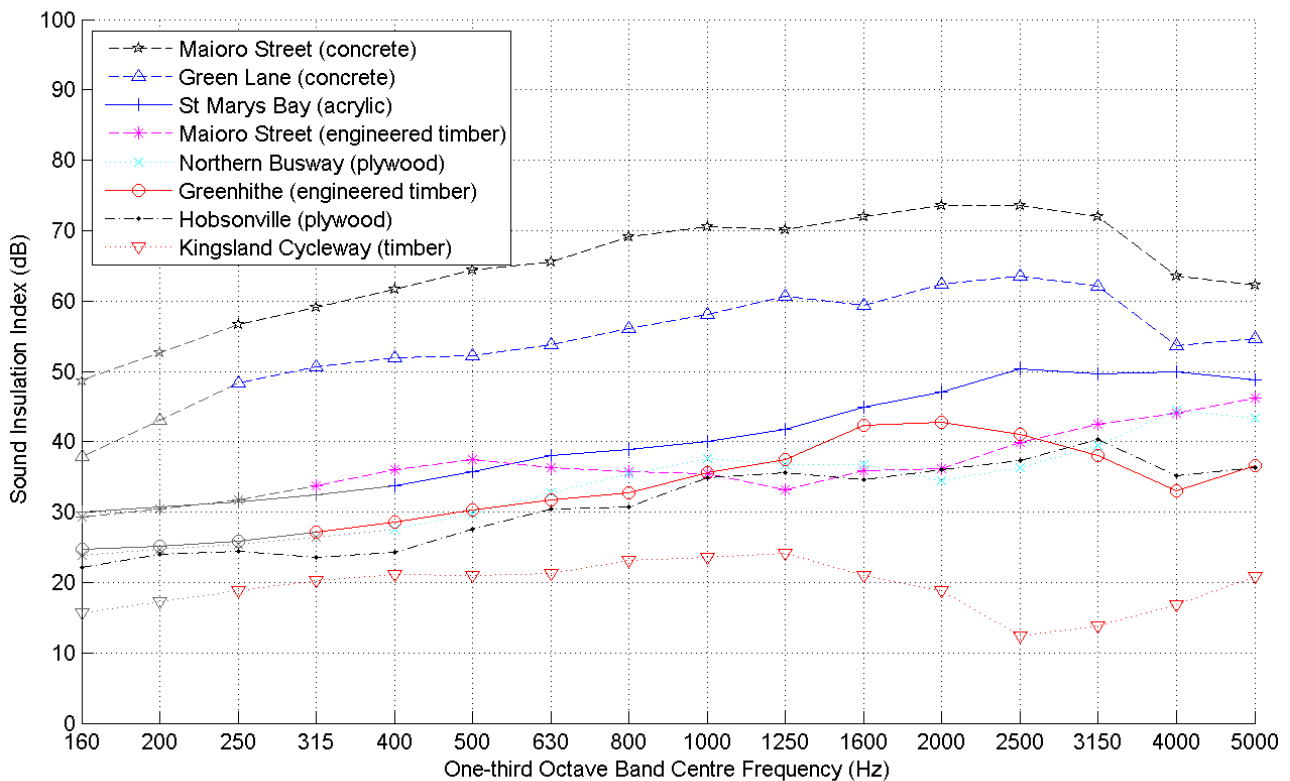
**Figure 10** Global airborne sound insulation of the Auckland traffic noise barriers. The grey lines represent values below the low frequency limit of the measurements.

Name	Material	Global Single Number Rating with Low Frequency Limits	Category
Maioiro Street	concrete	65 dB (250Hz)	D4
Green Lane	concrete	55 dB (250Hz)	D4
St Marys Bay	acrylic	39 dB (400Hz)	D4
Maioiro Street	engineered timber	35 dB (315Hz)	D3
Northern Busway	plywood	34 dB (400Hz)	D3
Greenhithe	engineered timber	33 dB (315Hz)	D3
Hobsonville	plywood	29 dB (160Hz)	D3
Kingsland Cycleway	timber	19 dB (250Hz)	D2

The concrete barriers out perform all of the other traffic noise barriers across the entire frequency range, which is expected due to their mass and lack of significant air gaps. The acrylic barrier at St Marys Bay is the next best performing with a single number rating of 39 dB, however if the gap between the concrete crash barrier and acrylic panel is included then the single number rating falls to 29dB. It is clear that the presence of such gaps can significantly degrade the barrier performance.

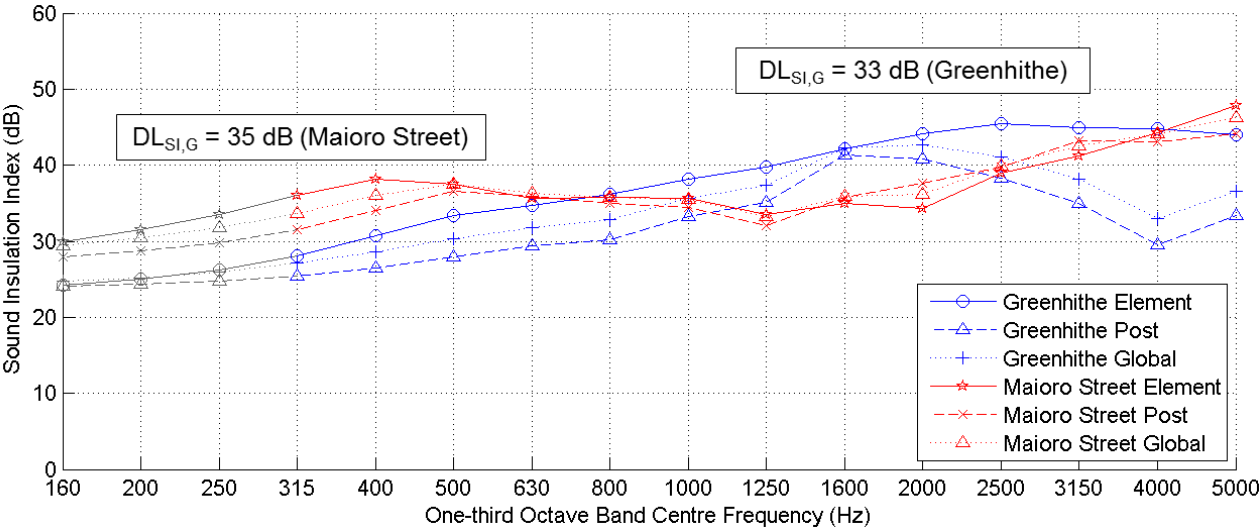
**Figure 11** Comparison between the airborne sound insulation values for the Greenhithe and Maioro Street engineered timber barriers. The global single number ratings are included. The grey lines represent values below the low frequency limit of the measurement.

The engineered timber barriers at Greenhithe and Maioro Street are of the same construction, with the Greenhithe traffic noise barrier being approximately four years older than the barrier at Maioro Street. The single number ratings for the global airborne sound insulation are 33 dB at the Greenhithe site and 35 dB at the Maioro Street site (Table 4). The airborne sound insulation values for each site are plotted in Figure 11.

The newer barrier at Maioro Street is more consistent, with both the element and post measurements giving similar values, while the post measurement at the Greenhithe site shows that some leakage is occurring. During testing it was noticed that some of the Greenhithe barrier panels were loose, rattling in their I-section posts.

There is some variation between the airborne sound insulation values of the elements at each site, with the Greenhithe barrier element performing better above 800Hz. The cause of this variation in airborne sound insulation is unclear.

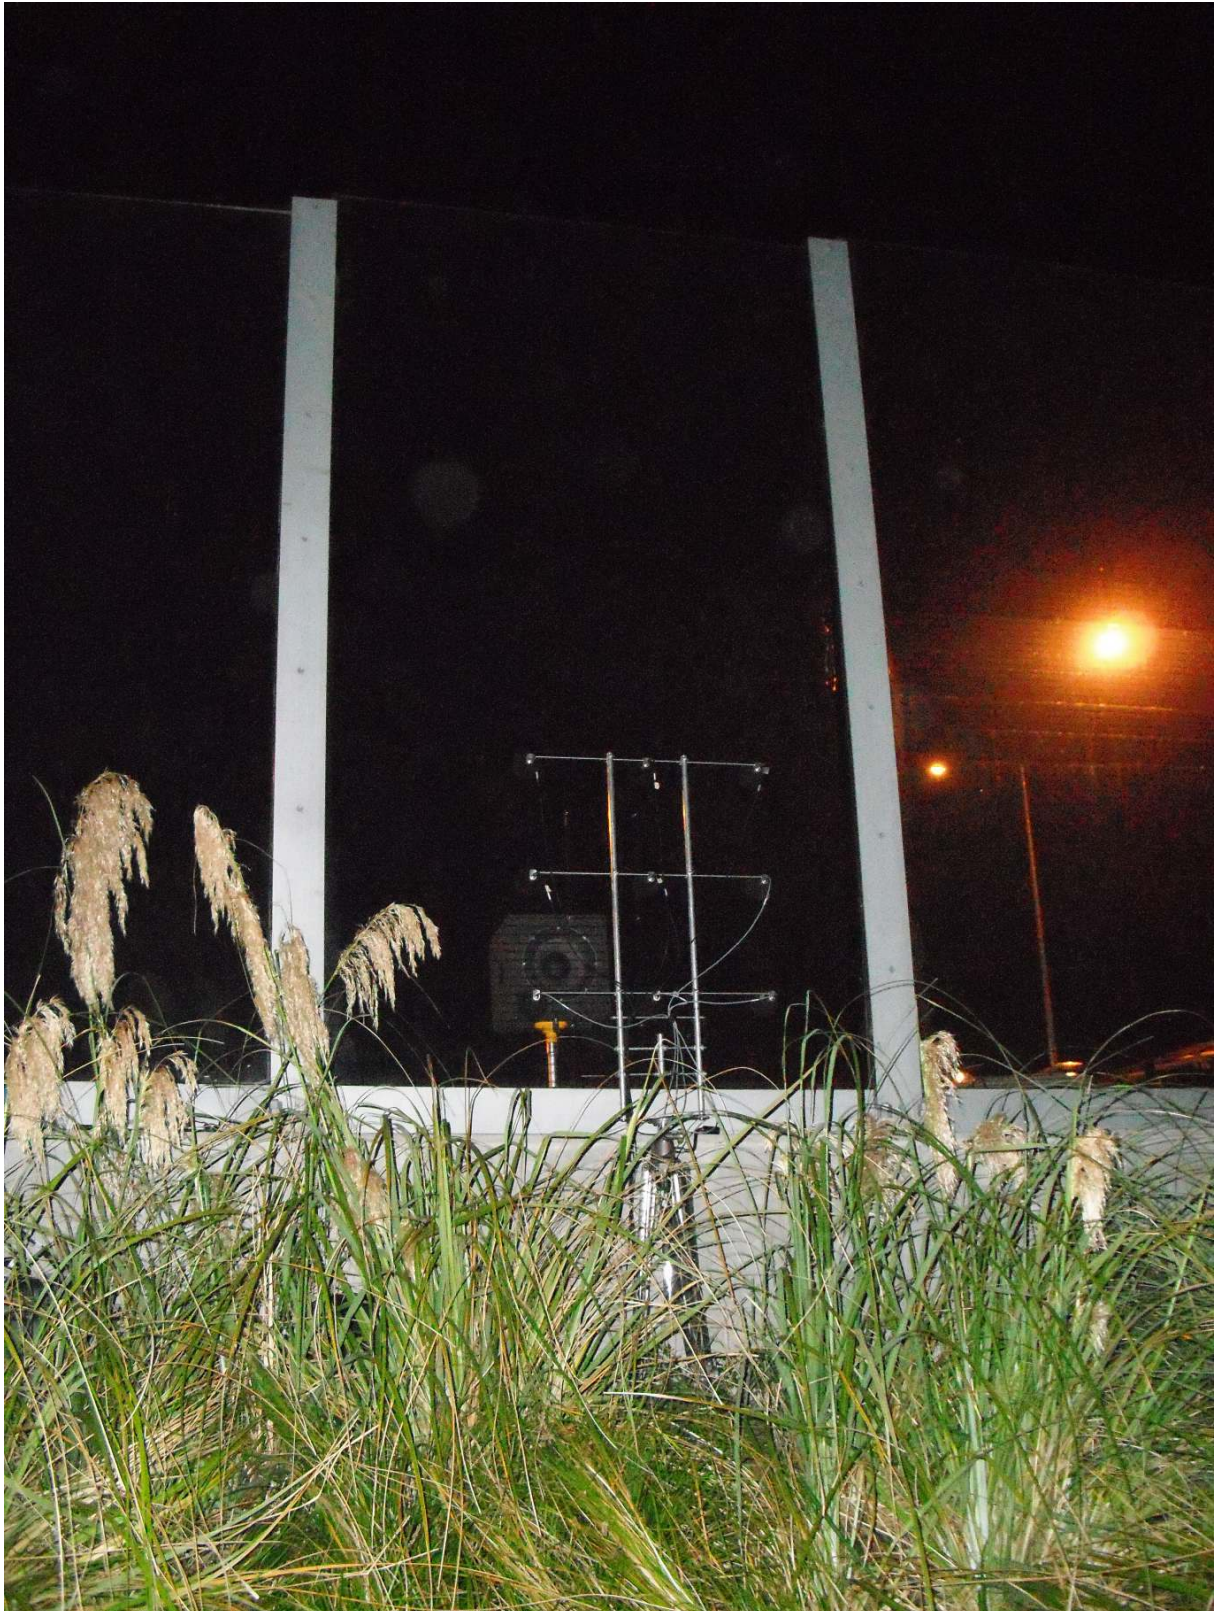
**Figure B.2** Test arrangement showing the microphone array when measuring across an element (position 3)

The loudspeaker and microphone array are shown in Figure B.1 and B.2, respectively.

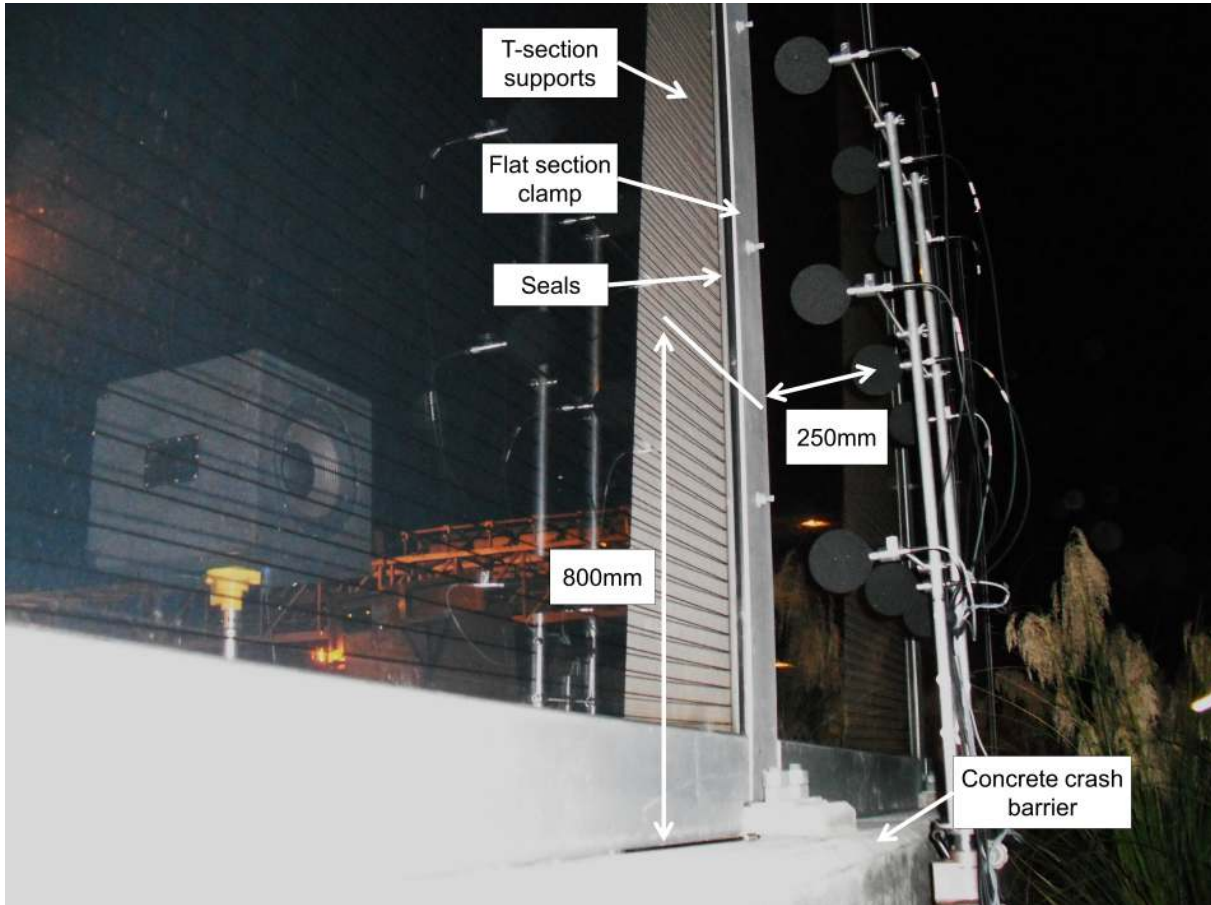
**Figure B.3** Composition of the acrylic traffic noise barrier, test setup during a post measurement (position 2)

Figure B.3 shows the composition of the acrylic traffic noise barrier. Each element of the barrier is constructed from two acrylic panels, the joint in this case is 1.65m above the concrete crash barrier. The acrylic panels are clamped in the T-section posts with a length of flat section as shown in Figure B.3.

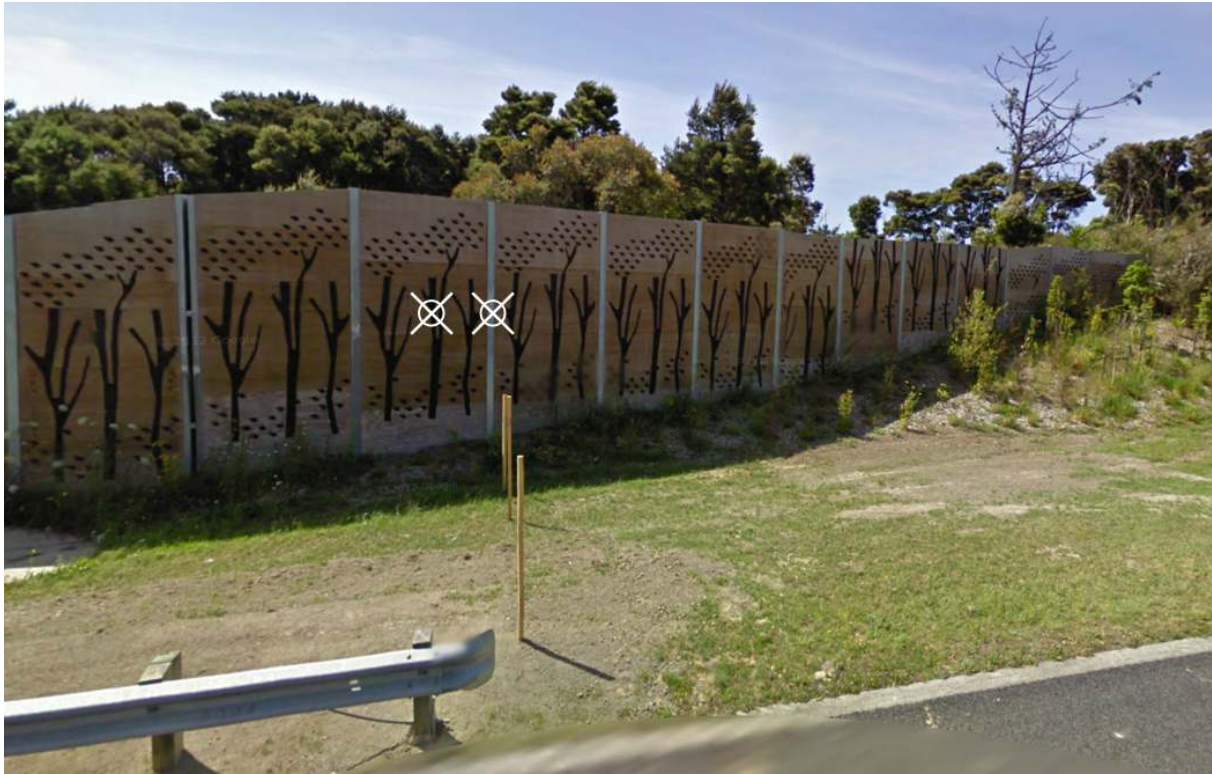
**Figure C.1** General view of the traffic noise barrier under test (road-side), the crosses mark the measurement positions. Image from Google Maps

The barrier under test is a single-leaf, reflective engineered timber traffic noise barrier. Each element is 2.4m wide x 4.2m high, supported by I-section posts which are at 2.4m centres. The section of barrier under test is situated on the northern side of SH18. Figure C.1 shows the traffic noise barrier viewed from the road-side.

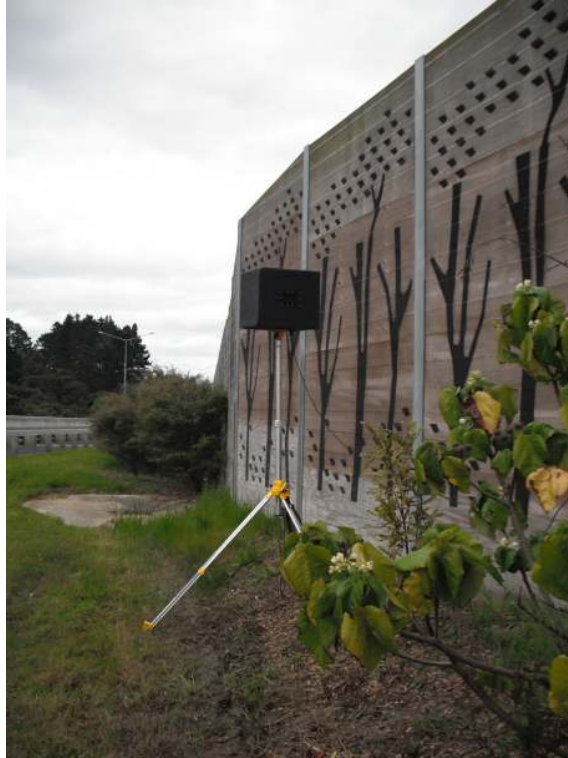
**Figure C.2** Test arrangement showing the loudspeaker when measuring across an element

The loudspeaker and microphone array are shown in Figure C.2 and C.3, respectively.

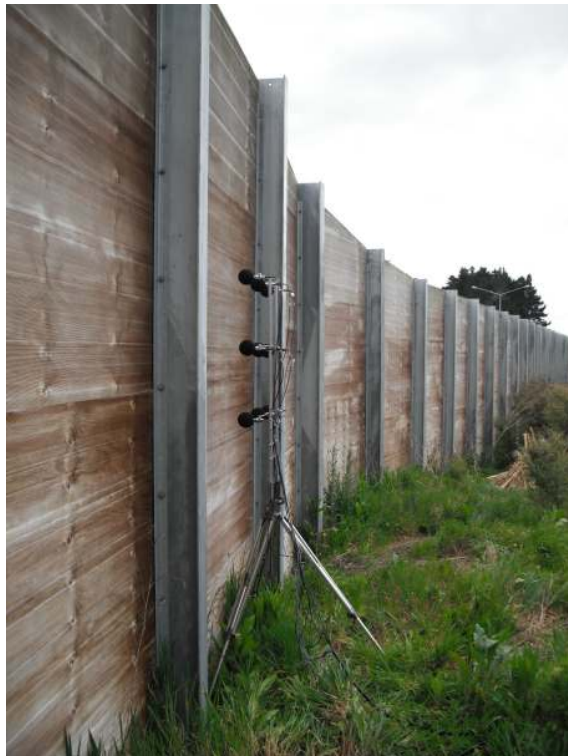
**Figure C.3** Test arrangement showing the microphone array when measuring across an element

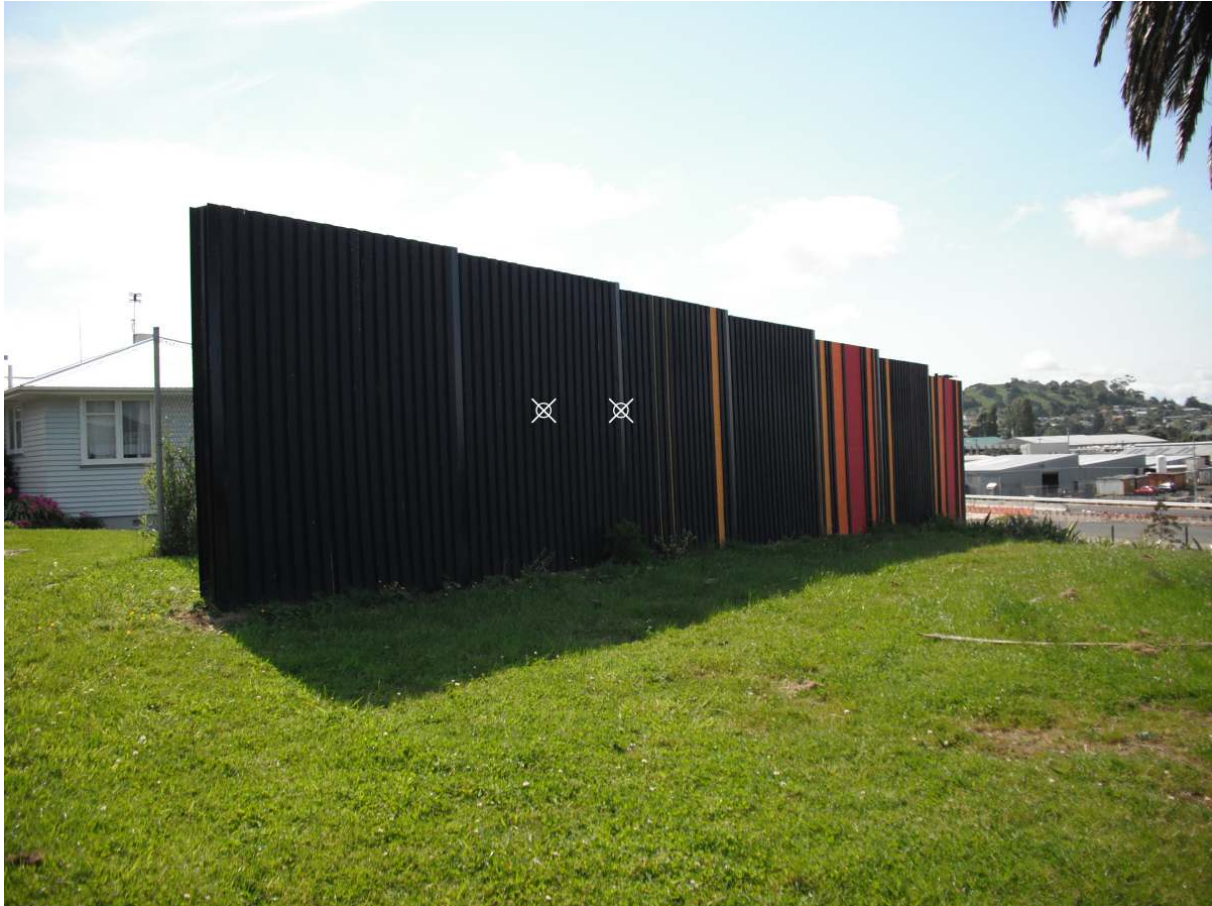
**Figure D.1** General view of the traffic noise barrier under test (road-side), the crosses mark the measurement positions

The barrier under test is a single-leaf, reflective engineered timber traffic noise barrier. Each element is 2.6m wide x 2.9m high, supported by I-section posts which are at 2.6m centres. The section of barrier under test is situated at the eastern end of Ernie Pinches Street. Figure D.1 shows the traffic noise barrier viewed from the road-side.

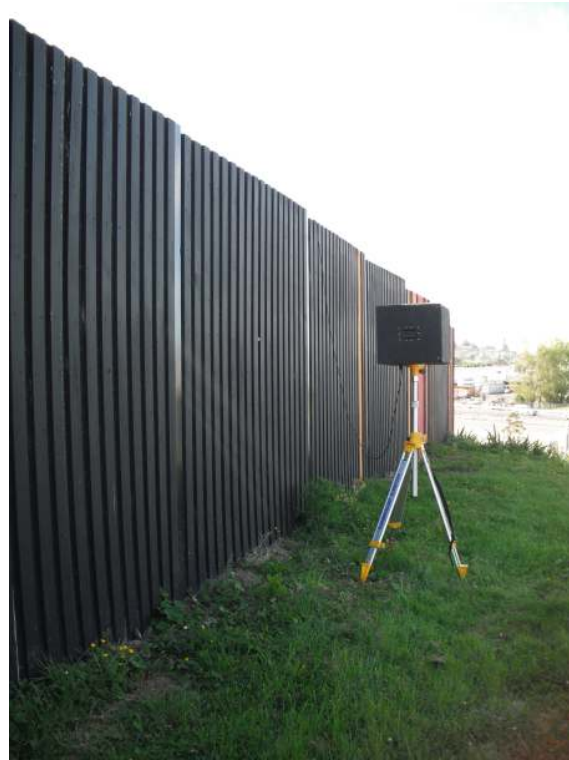
**Figure D.2** Test arrangement showing the loudspeaker when measuring across a post

The loudspeaker and microphone array are shown in Figure D.2 and D.3, respectively.

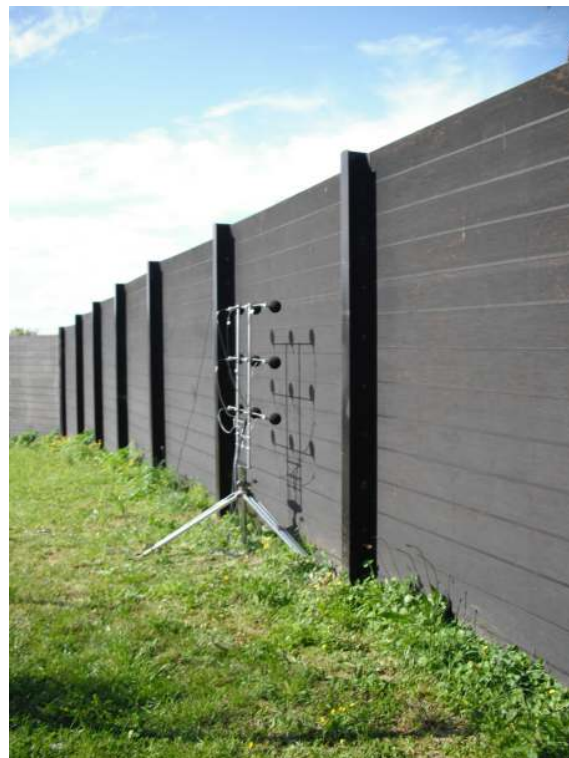
**Figure D.3** Test arrangement showing the microphone array when measuring across an element

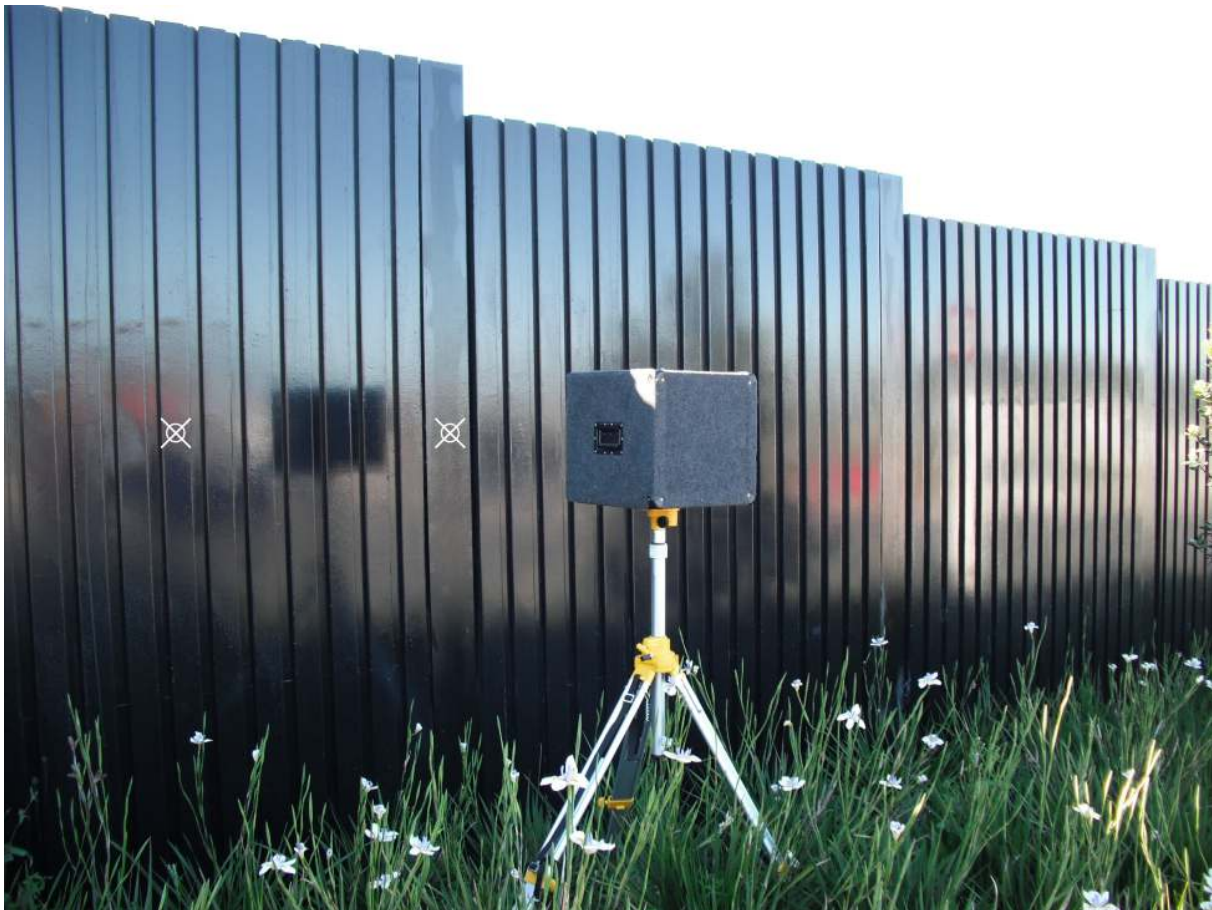
**Figure E.1** Test arrangement showing the loudspeaker when measuring across a post

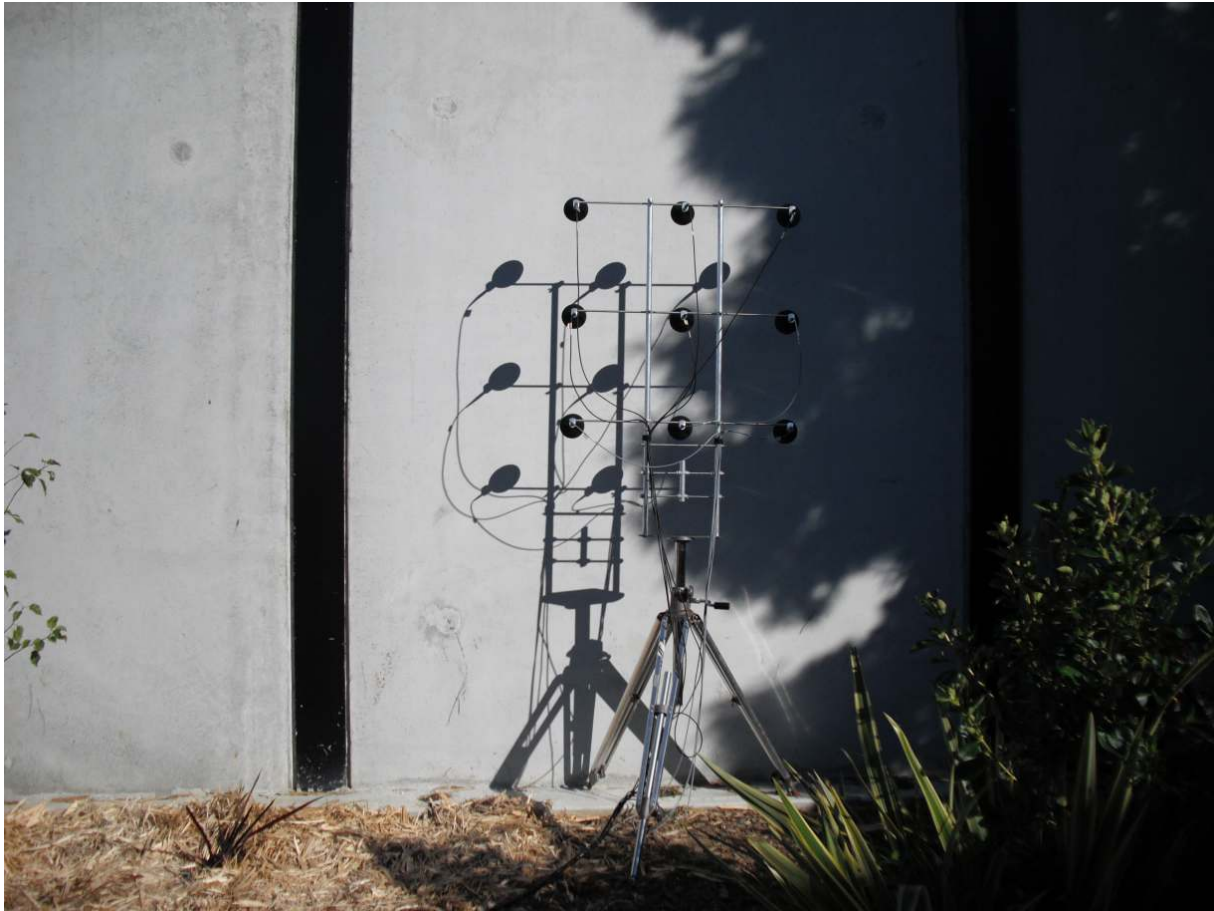
**Figure E.2** Test arrangement showing the microphone array when measuring across an element

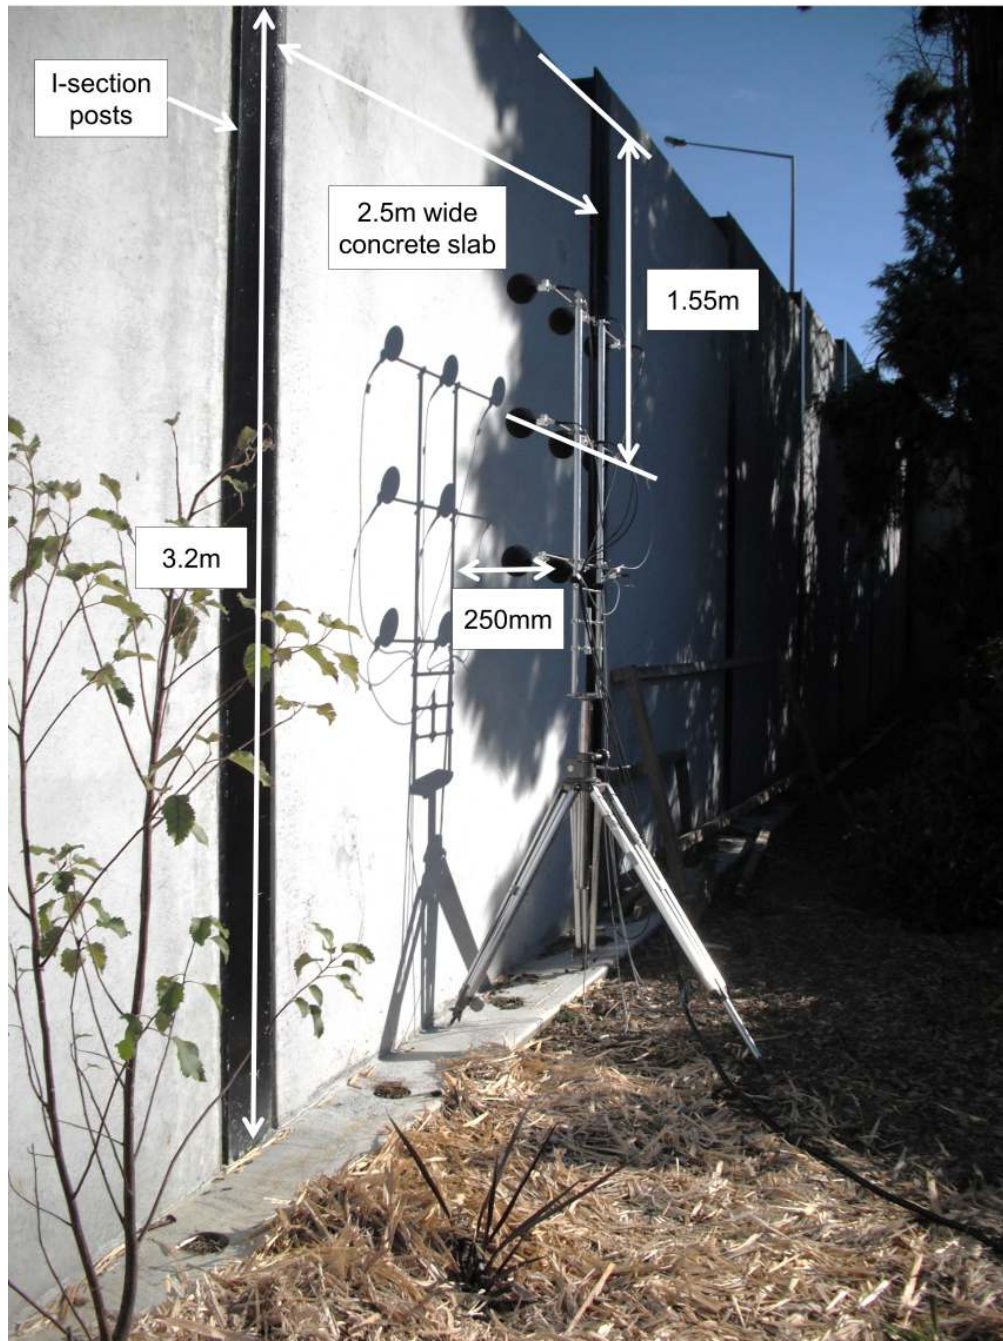
**Figure E.3** Composition of the concrete traffic noise barrier, test setup during an element measurement

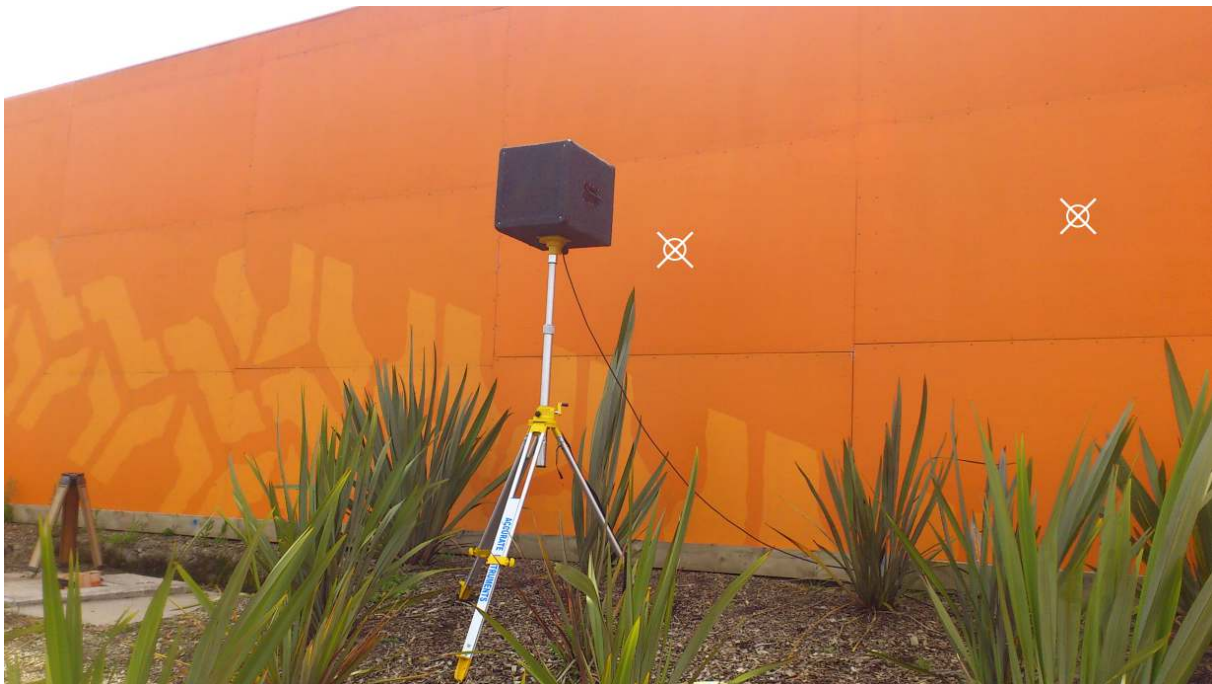
**Figure F.1** Test arrangement showing the loudspeaker when measuring across an element, the crosses mark the measurement positions

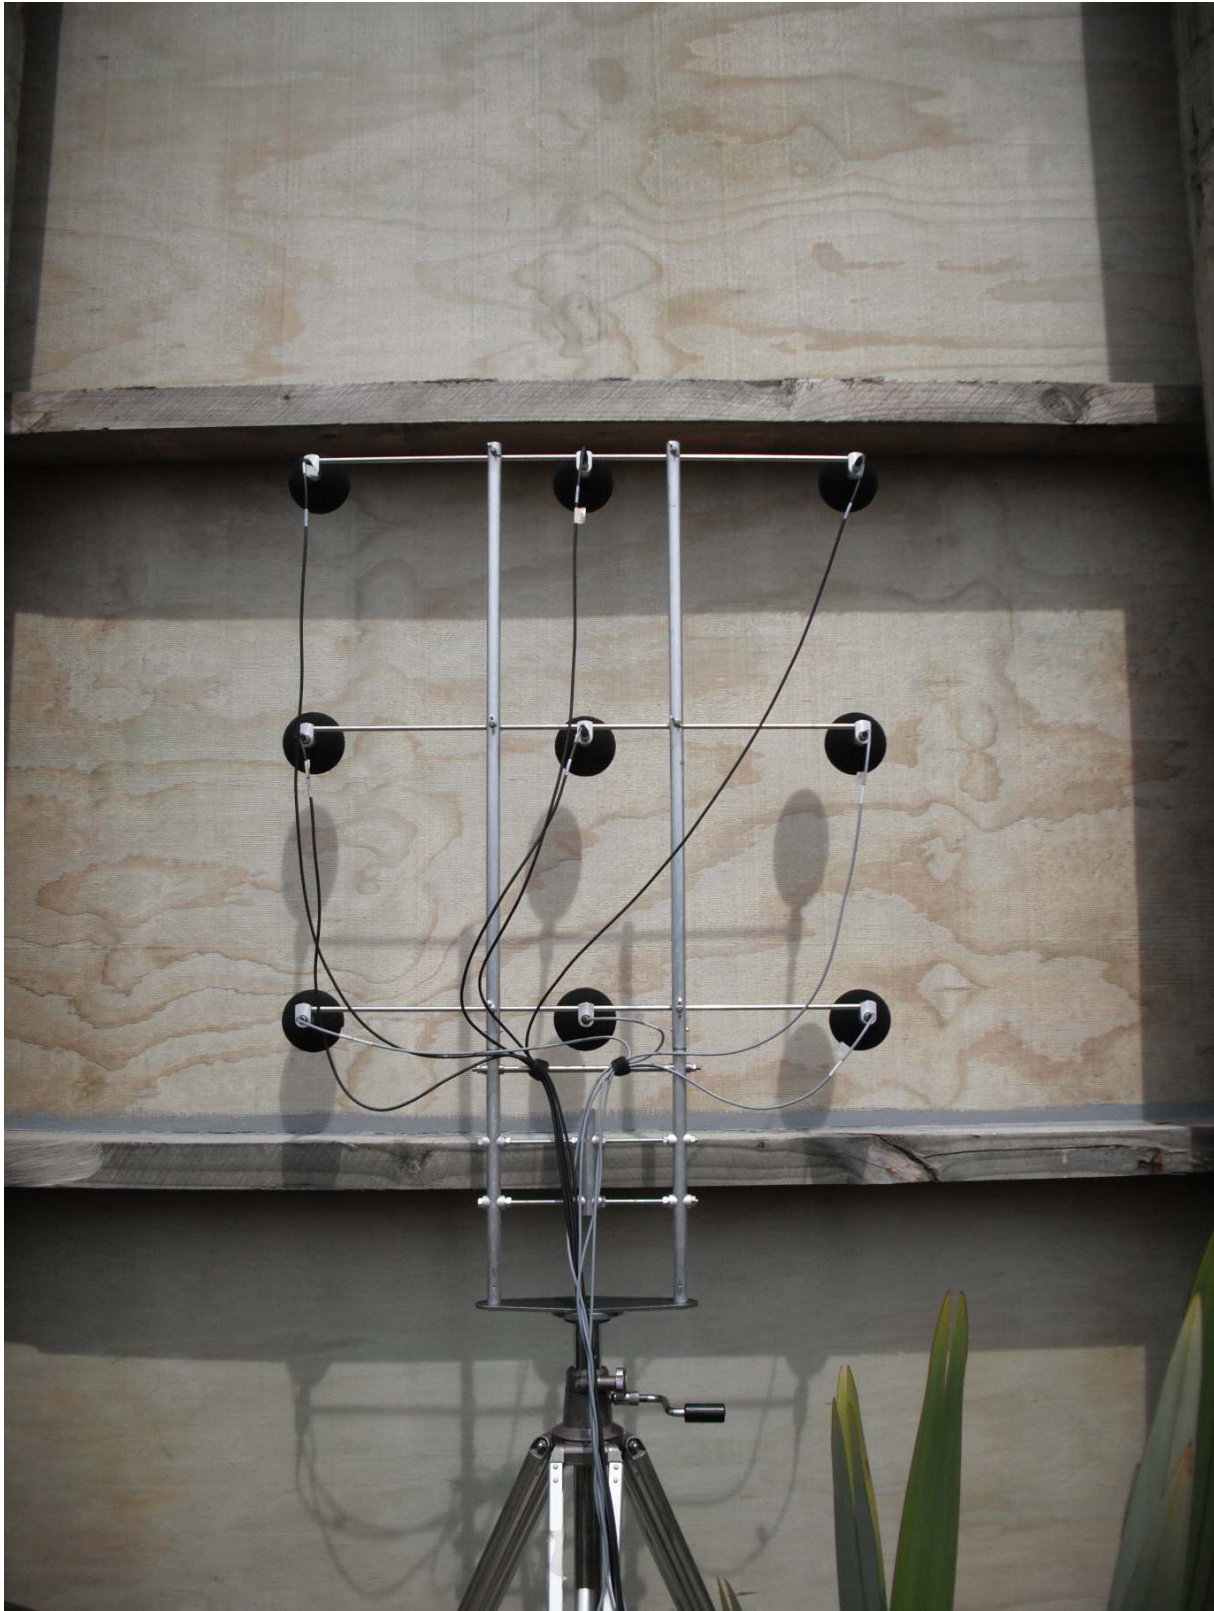
**Figure F.2** Test arrangement showing the microphone array when measuring across an element

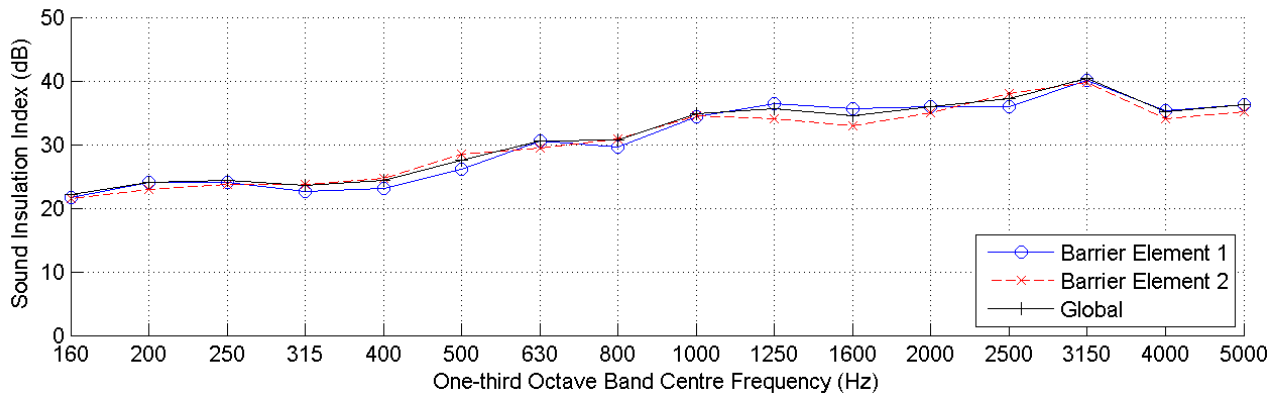
**Figure F.4** Airborne sound insulation values, logarithmically averaged over nine microphone positions

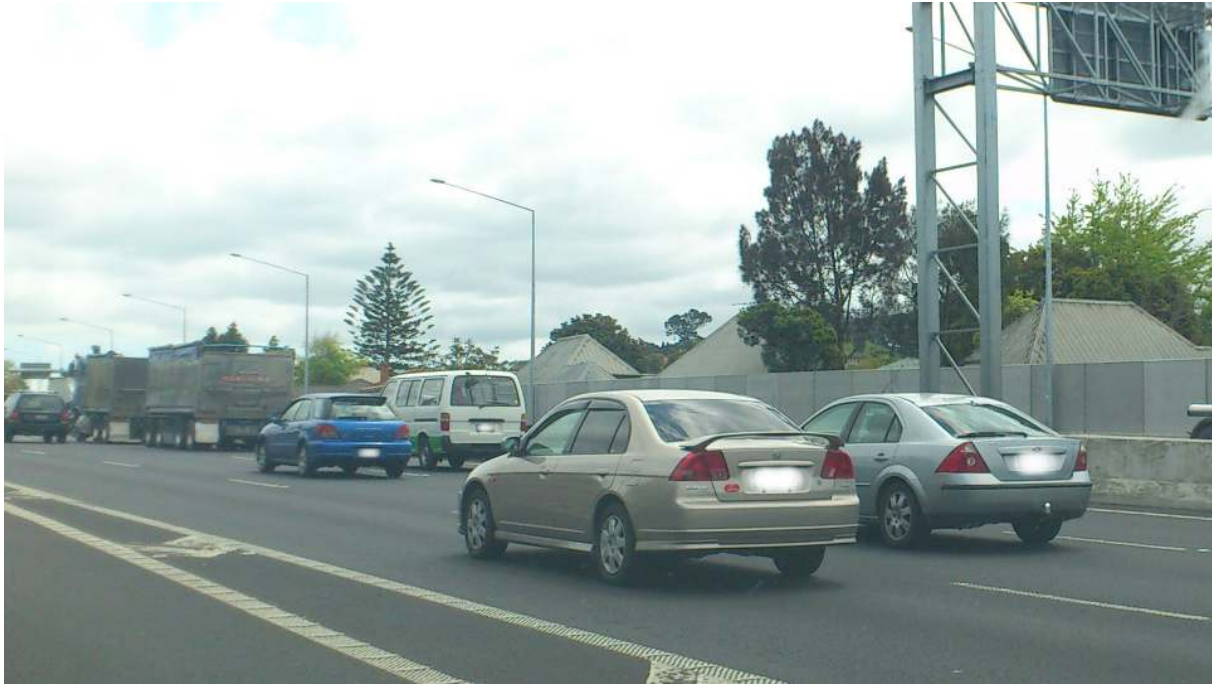
**Figure G.1** General view of the traffic noise barrier under test (road-side)

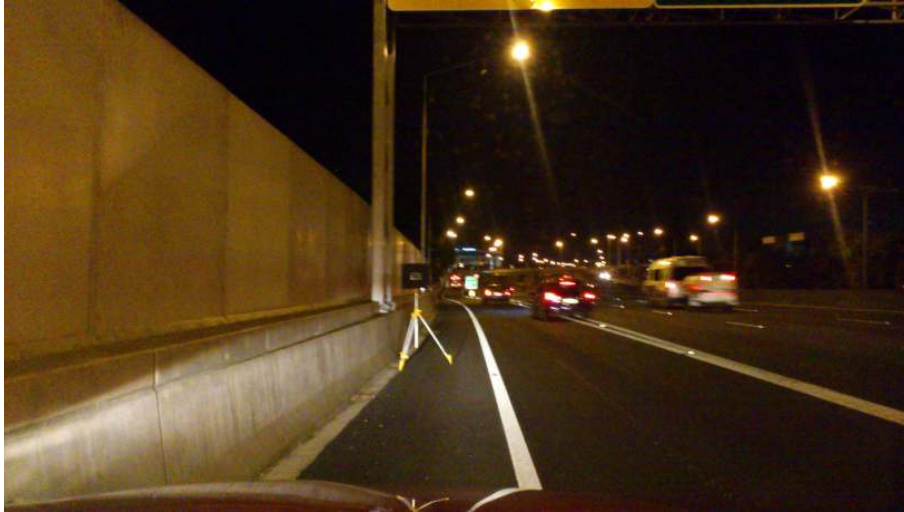
**Figure G.2** Test arrangement showing the loudspeaker when measuring across an element

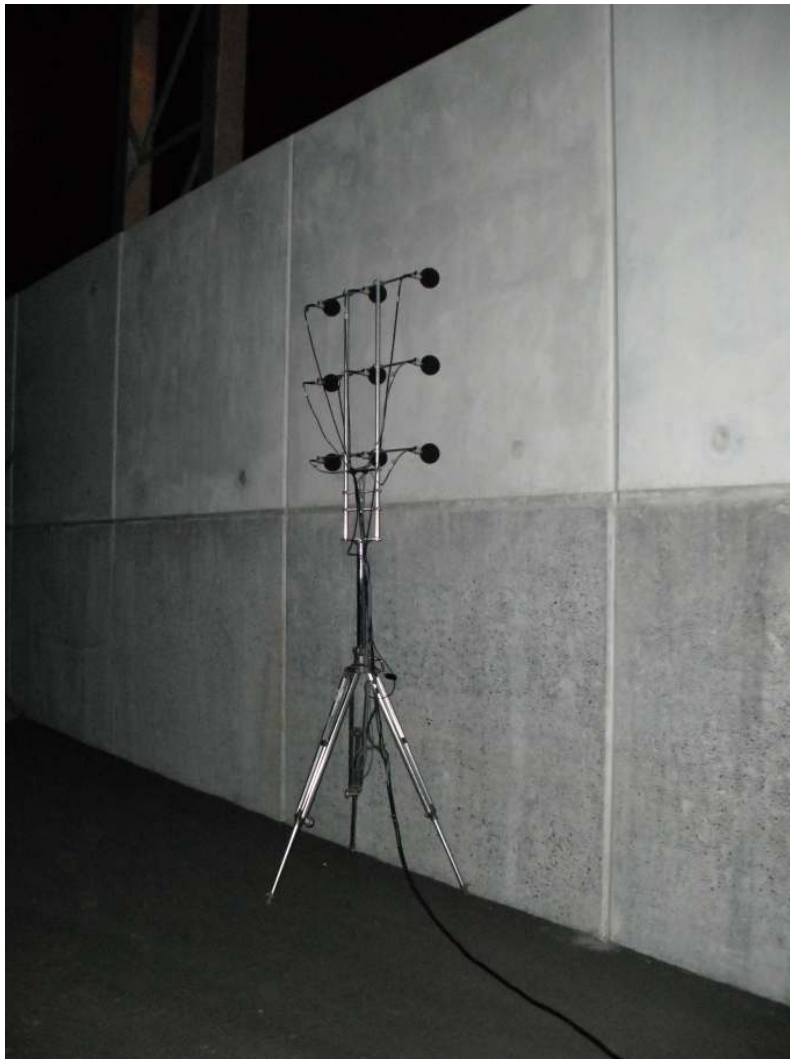
**Figure G.3** Test arrangement showing the microphone array when measuring across an element
