# Acoustics Research Group

## REPORT

Number: **252**

## Measurement of the Acoustic Performance of Traffic Noise Barriers on Auckland Motorways Using prEN1793-6:2011

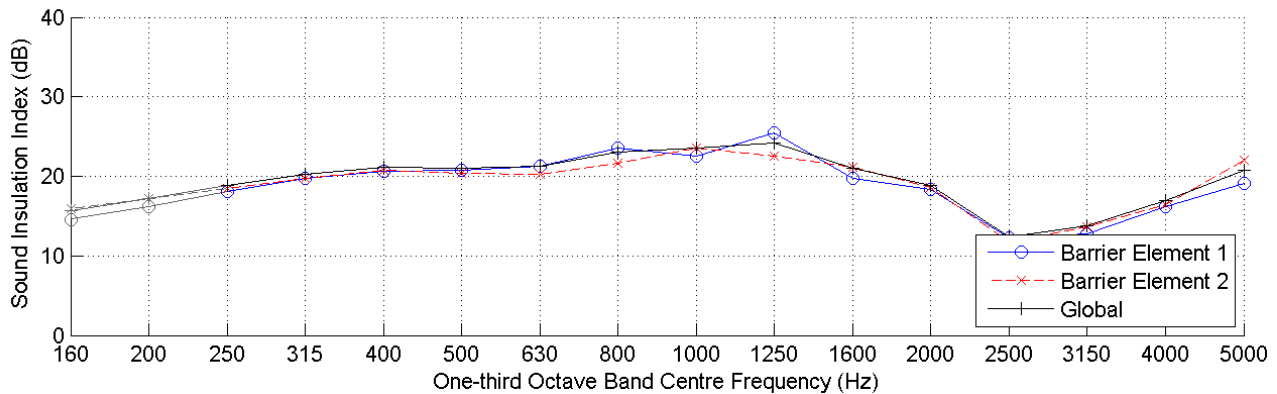
**Figure H.4** Airborne sound insulation values, logarithmically averaged over nine microphone positions. The grey lines represent values below the low frequency limit of the measurement.

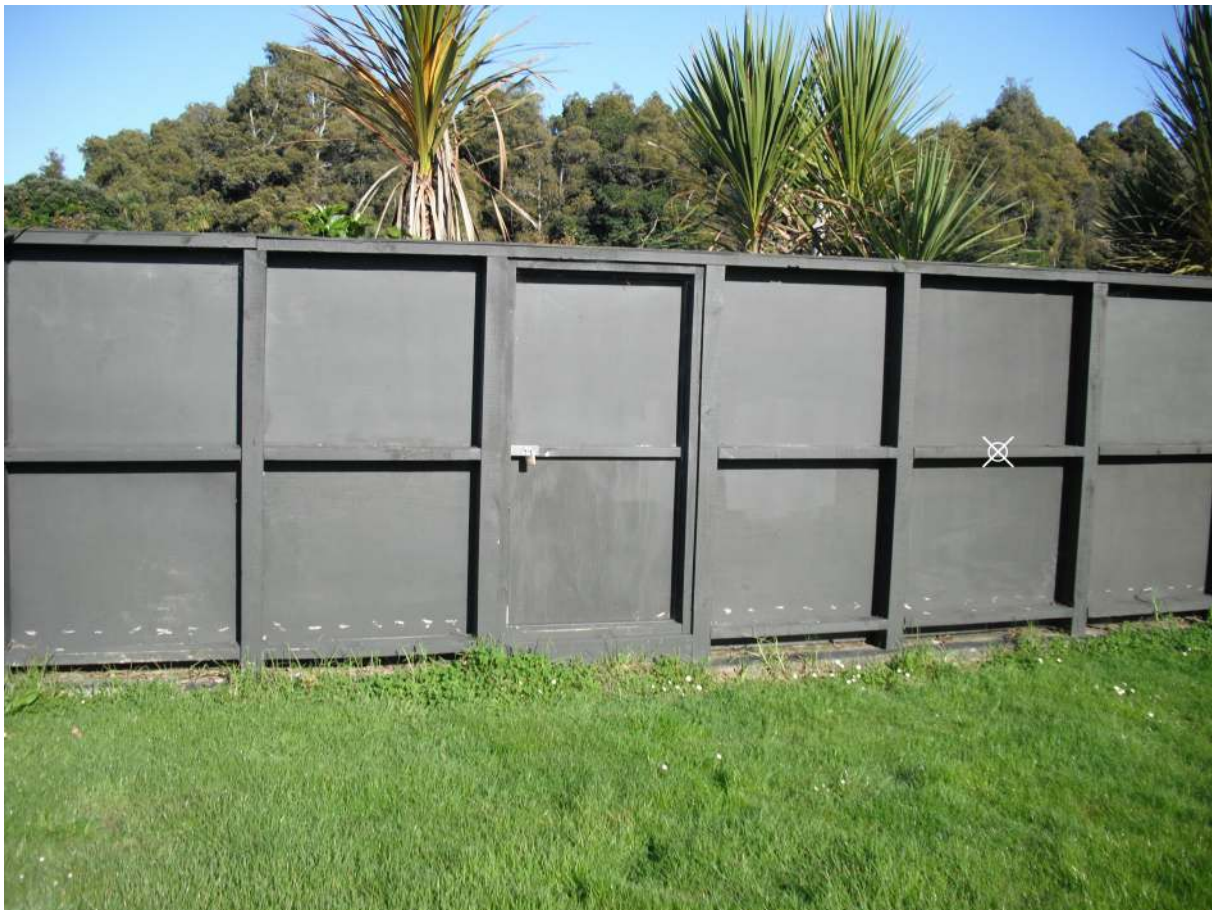
**Figure I.1** Test arrangement showing the microphone array when measuring across an element, the cross marks the measurement position

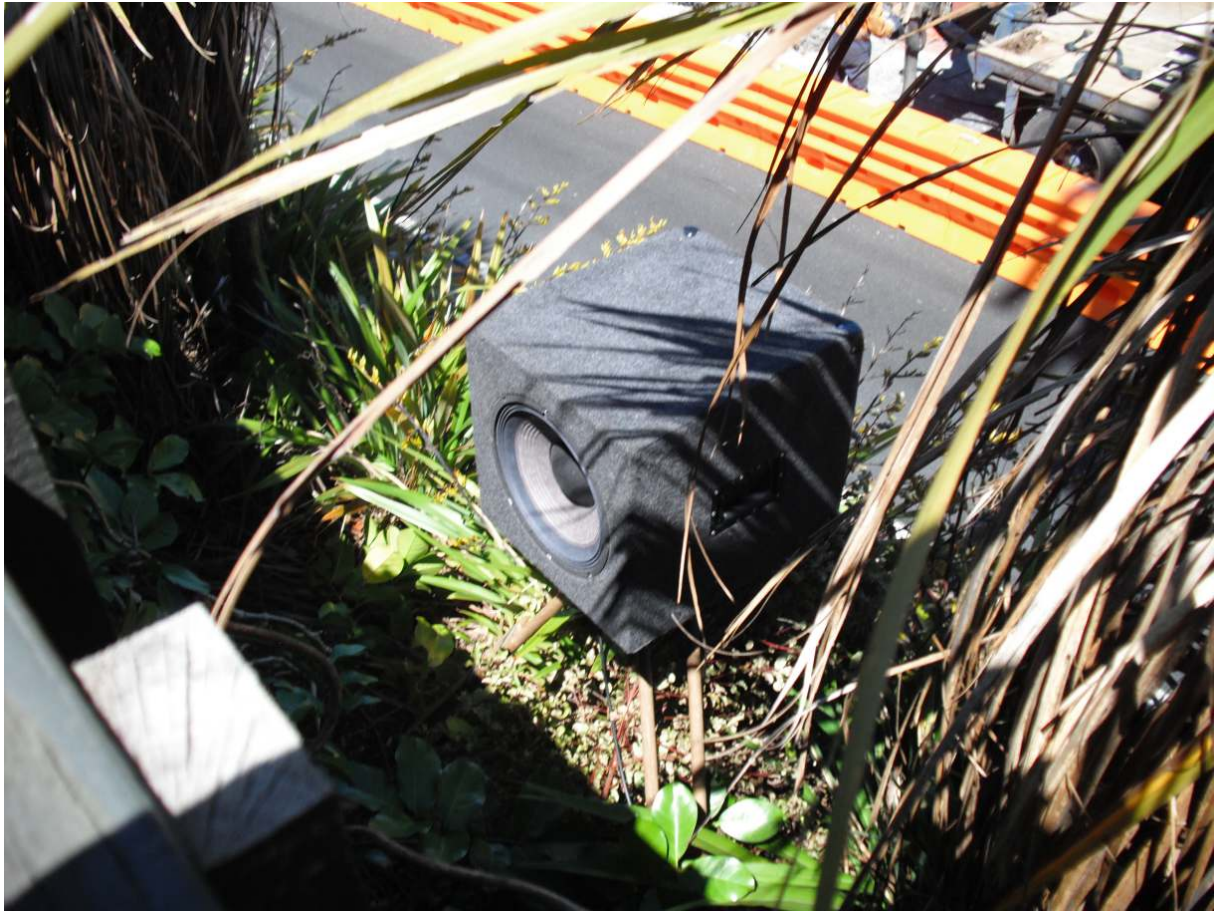
**Figure I.2** Test arrangement showing the loudspeaker when measuring across an element

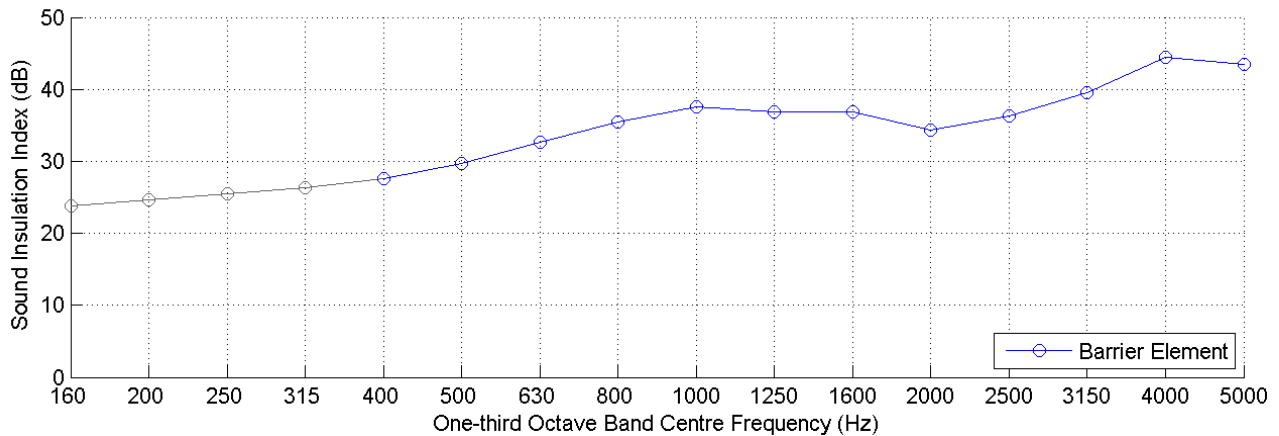
**Figure I.4** Airborne sound insulation values, logarithmically averaged over nine microphone positions. The grey lines represent values below the low frequency limit of the measurement.
