Field Measurement of Noise Barrier Performance: Reflection Index and Sound Insulation

Prepared for
NZ Transport Agency
Victoria Arcade, 50 Victoria Street
Wellington.

Date: 22/08/2019
Ref: 18-103/R13/C

Project: Field Measurement of Noise Barrier Performance
 Reflection and Transmission Loss
Report: Summary of results
Reference: 18-103/R13/C

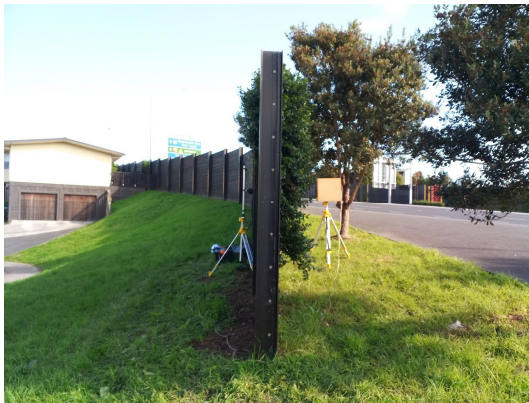
Figure 4: Microphone array and loudspeaker during sound insulation tests at Maioro Street.

The 2019 measurements were performed by Robin Wareing on 18 June 2019. Details of the measurements are presented in Table 1. The test arrangement is shown in Figure 4 and Figure 5.

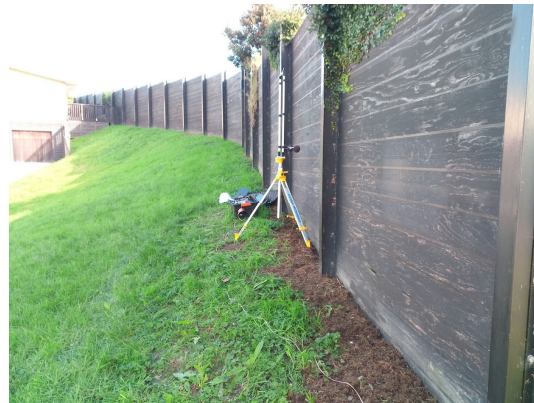
Figure 5: Microphone array during sound insulation tests at Maioro Street.

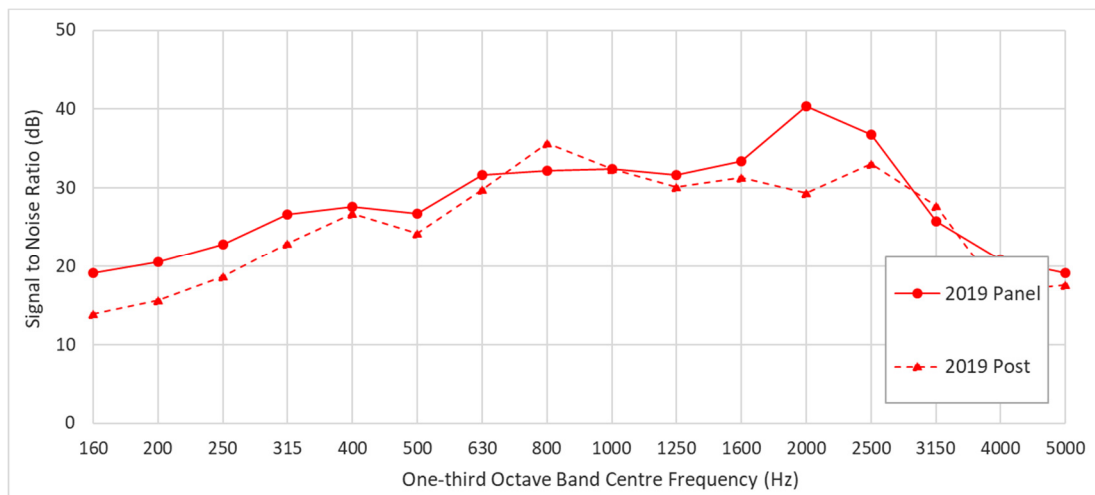
The signal-to-noise ratio for the 2012 and 2019 results are presented in Figure 7. In all the third octave bands measured the signal-to-noise ratio is greater than 10 dB for the 2019 measurements, as required by EN 1793-6. No limitations are placed on the results by the signal-to-noise ratio.

Figure 7: Signal-to-noise ratio of sound insulation measurements of Maioro Street barrier.

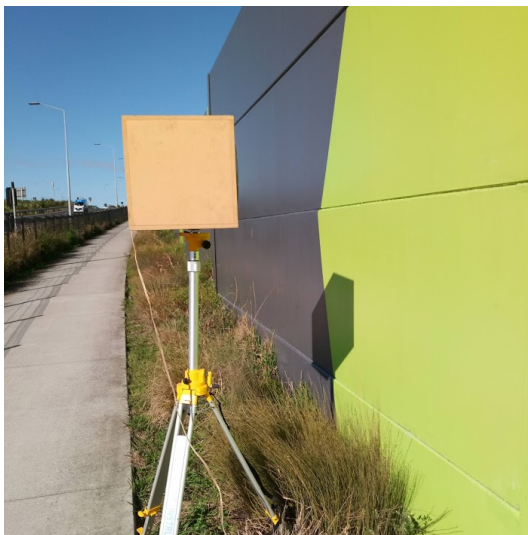
Figure 9: Loudspeaker during sound transmission measurements at McCormick Green.

Details of the measurements are presented in Table 3. The test arrangement is shown in Figure 9 to Figure 12.

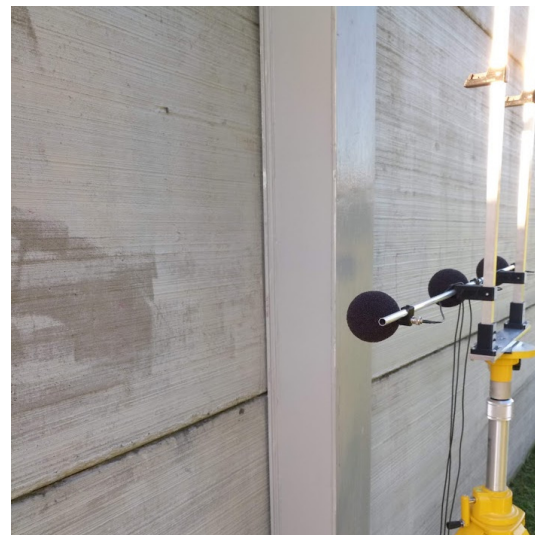
Figure 10: Microphone array during sound insulation and reflection index of posts at McCormick Green.

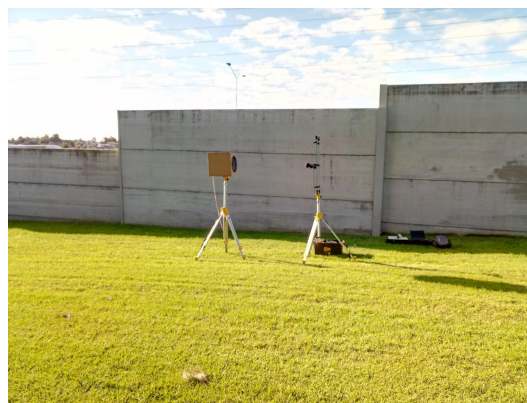
Figure 12: Microphone array and loudspeaker during free-field measurements at McCormick Green.

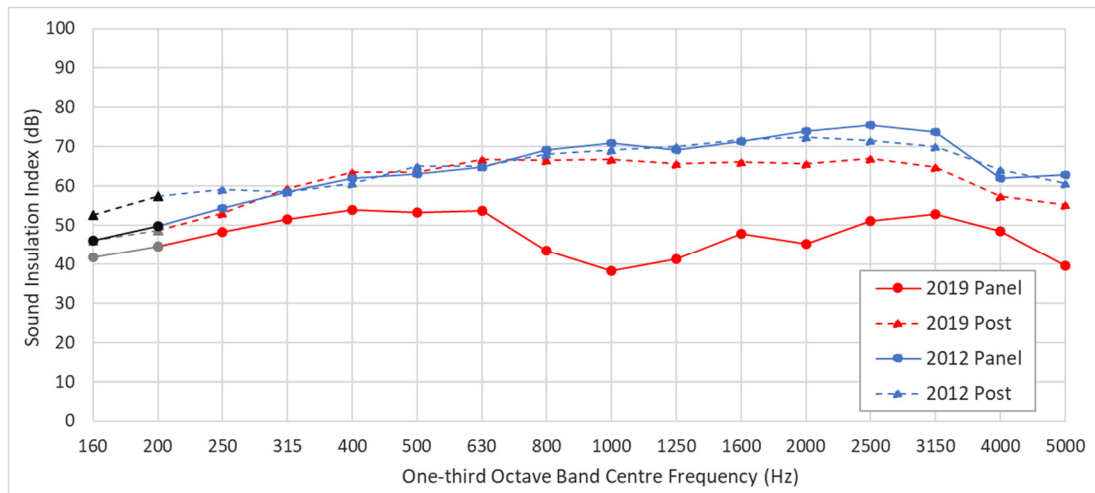
The barrier is constructed from concrete panels between steel posts. The sound insulation of both elements is presented in Figure 13. The barrier height of 4 meters yields a low frequency limit of 160 Hz.

Figure 13: Sound insulation of McCormick Green barrier.

The sound insulation results from the 2012 and 2019 measurements are similar for the post measurements. The panel results deviate widely between the 2012 and 2019 measurements. This is likely due to the following:

- The different construction of the barrier
- The different background noise level
- The low signal to noise ratio
- The different measurement system

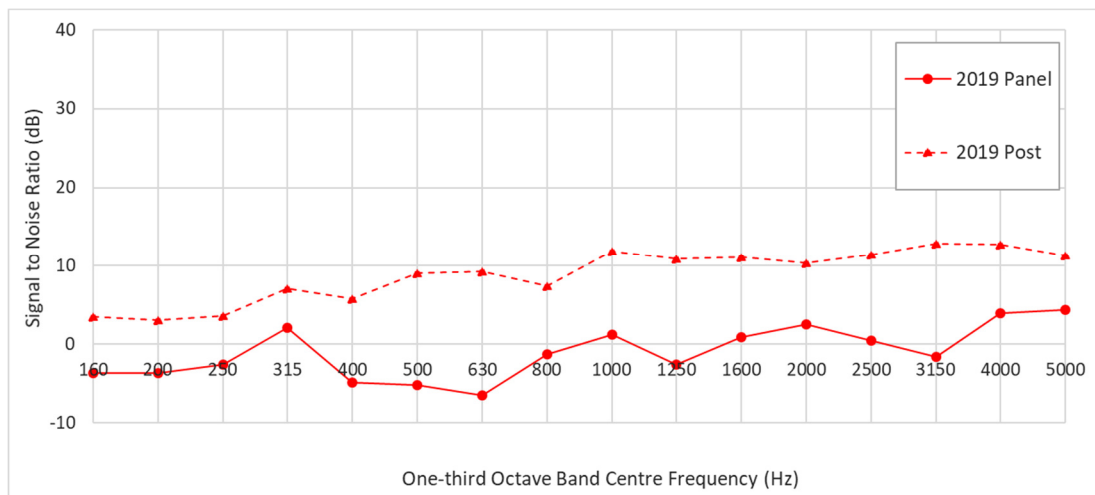
The signal-to-noise ratio is shown in Figure 14. The 2019 signal-to-noise ratio is below 10 dB for the frequency bands below 1,000 Hz for the panel results, and around 0 dB for the post results. The signal to noise ratio in the 2019 measurements is greater than that in the 2012 measurements, due to the use of the exponential swept sine excitation.

The low signal-to-noise ratio for both the 2012 and 2019 measurements indicates that the measured values are not reliable across much of the frequency range. The low signal-to-noise ratio is likely to be the main reason for the deviation between the 2012 and 2019 results. The poor signal-to-noise ratio means that the current results can be considered as a lower limit of performance. The true barrier performance will be better than current results.

Figure 14: Signal-to-noise ratio of sound insulation measurements of McCormick Green barrier.

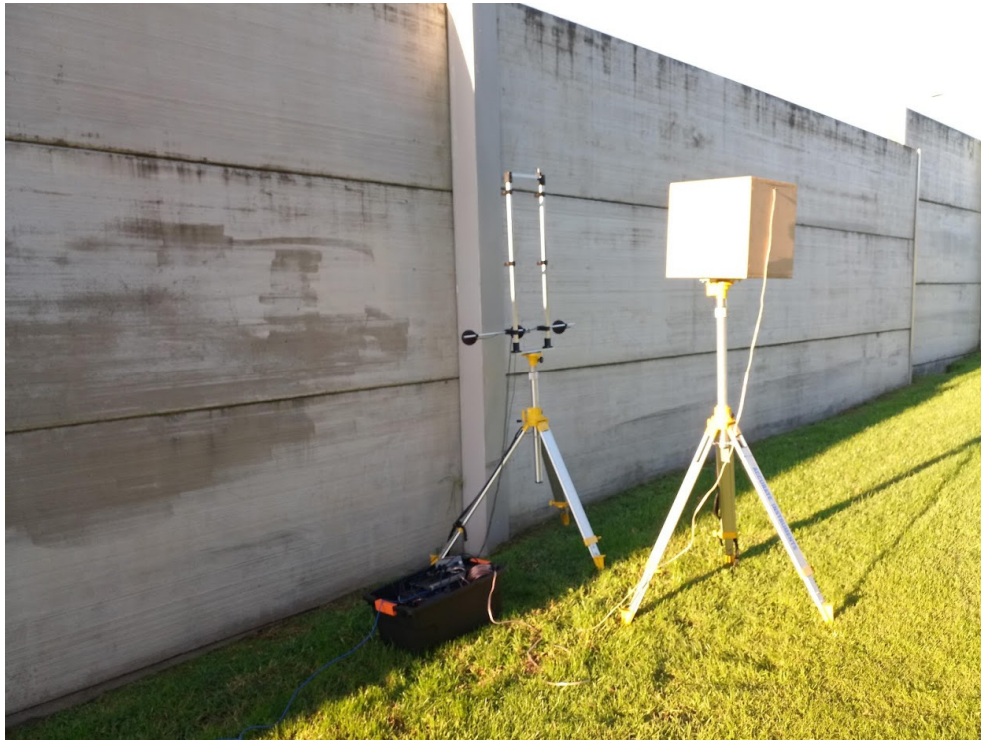
The sound reflection index was measured for the barrier panel and the steel post. The measurement setup is shown in Figure 15.

Figure 15: Microphone array and loudspeaker in place for performing reflection index

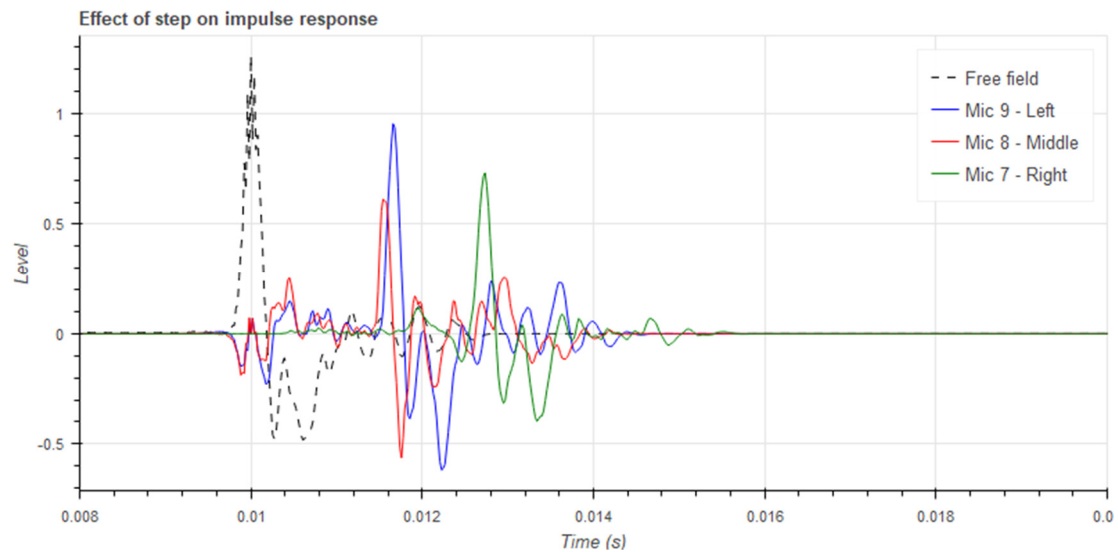
The step shape was evident in the received impulse responses for the post. The increased path length can be clearly seen in the increased time of flight in Figure 19.

Figure 19: Variation in arrival time of reflected signal due to the step.

The time delay shown in Section 4.3 was also seen in the altered measurement, as illustrated in Figure 21 and Figure 22. This time delay is due to the increased path length for reflections off the rear panel.
