# Road surface noise research 2016-2018

Stephen Chiles and John Bull

April 2018

CPX trailer development and initial measurement results

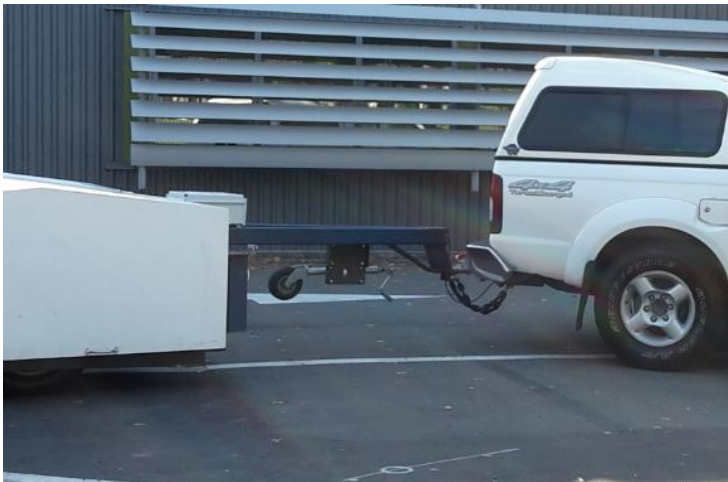
Figure 1 Original fixed height tow bar

The CPX trailer has low skirts and needs to sit level with the ground when in measurement mode. The tow bar height of the CPX trailer was originally designed for it to be towed behind a specific Nissan Navara owned by the University of Canterbury (Figure 1), or to be used with hitch-mount tow ball attachments customised for each alternative towing vehicle. For current research work with measurements in different regions the CPX trailer needs to be towed with a range of different vehicles, and the use of customised tow ball attachments would not be practicable. Instead, with the new adjustable height tow bar (Figure 2) the CPX trailer can now be towed behind any vehicle with a standard 1 7/8" tow ball, regardless of the vehicle's tow ball height relative to the road surface.

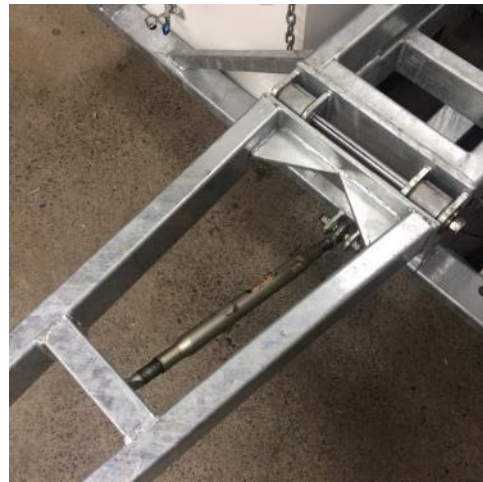
Figure 2 New adjustable height tow bar

The adjustable height tow bar design implemented has the following features:

- *No fasteners* – No fasteners need to be removed when adjusting the tow bar height. This eliminates the risk of incorrectly reattaching the tow bar to the trailer chassis following height adjustments.
- *Continuous height adjustment* – The mechanism makes use of a swing arm and turnbuckle, allowing a continuous rather than incremental choice of tow bar heights.
- *Adjustments on vehicle* – Height adjustments can be made while the trailer is hitched to the tow vehicle, allowing the correct tow bar height to be set with a single adjustment.

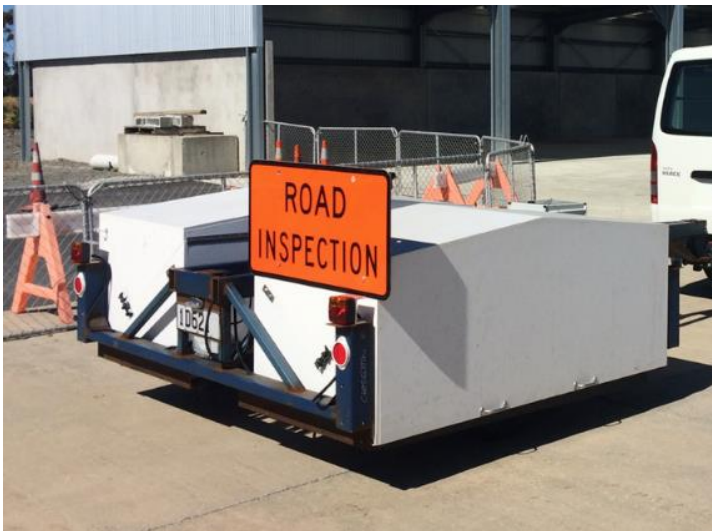
Figure 5 'Road Inspection' sign - original position

The 'Road Inspection' sign was originally placed at an elevated position, resulting in significant aerodynamic forces and potential aerodynamic noise while operating the trailer (Figure 5). The sign was trimmed and moved to a lower position at the rear of the trailer (Figure 6).

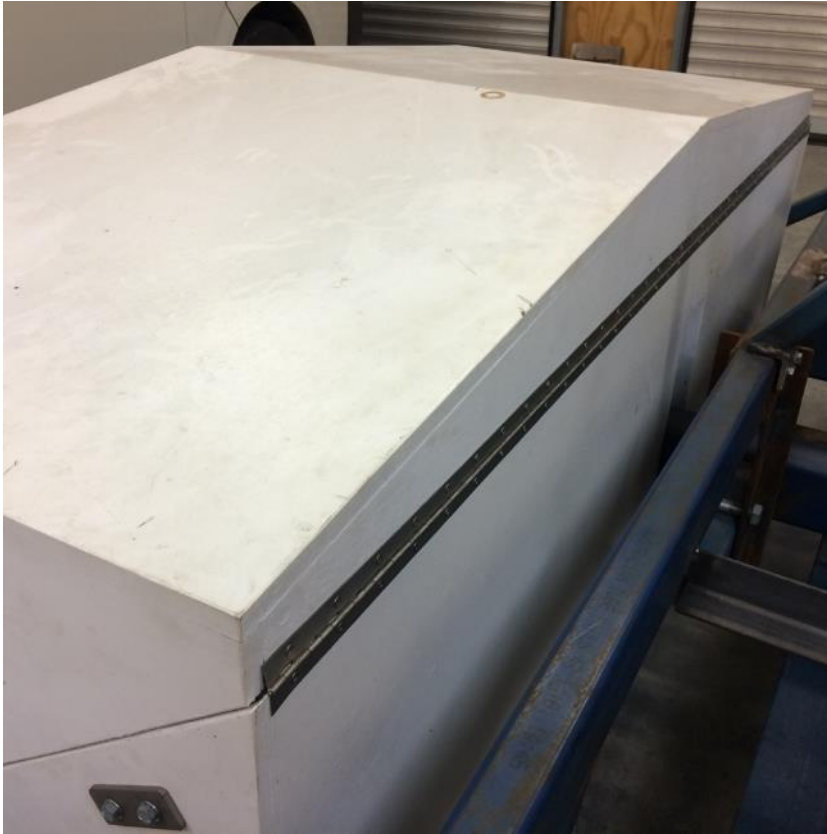
Figure 7 Wheel enclosure hinge originally under significant loads

The wheel enclosures are hinged at their upper edge (Figure 7), allowing the top halves to be lifted when changing the wheels and installing the microphones. The original design resulted in large loads being transferred through the hinges. Pins were installed at the bottom edges of the enclosures to take the weight off the hinges, and the original rubber fasteners were replaced with heavy duty latches to provide a larger clamping force (Figure 8).

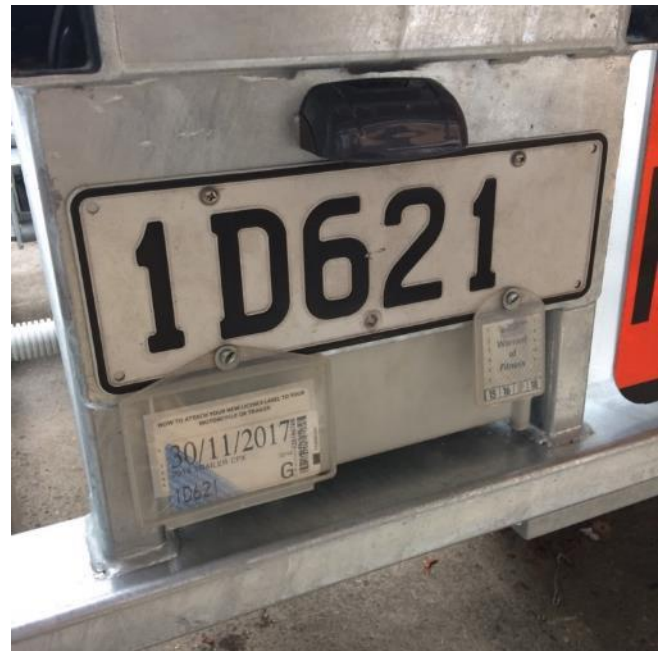
Figure 10 New instrumentation enclosure located behind number plate at rear of trailer

In order to place the instrumentation in a more secure location and shorten the signal cable routes, the instrumentation enclosure was moved to the rear of the trailer and the battery (originally housed in the instrumentation enclosure) was installed in a separate enclosure. This now accommodates two larger capacity batteries and simplifies removal of the battery enclosure for overnight charging.

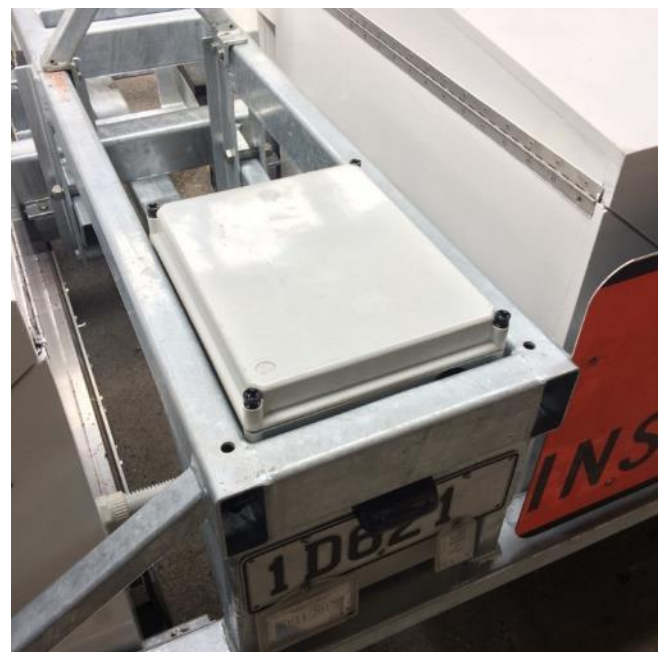
Figure 12 Separate battery enclosure can be removed for overnight charging

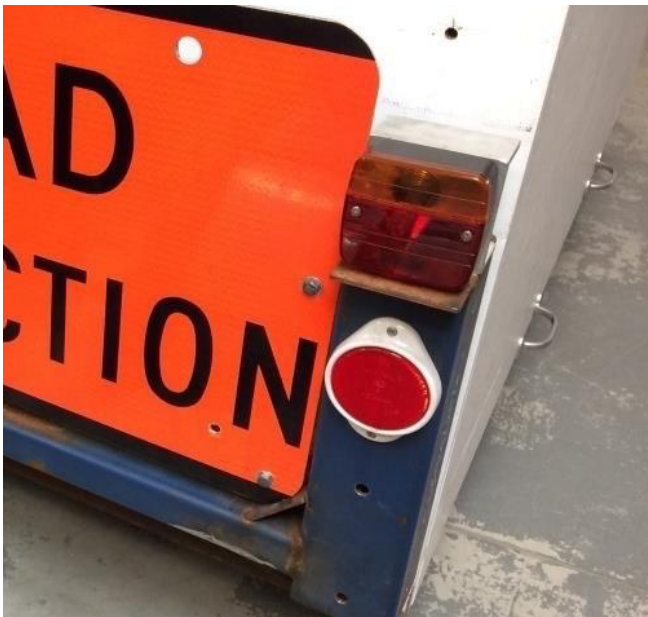
Figure 13 Original lights attached to brackets

The original trailer lights were mounted on brackets rather than directly onto the trailer frame. This complicated the wiring routes back to the tow vehicle and made the lights more vulnerable to accidental damage. The rear lights were replaced with slim LED units and mounted directly to the trailer frame. Holes were drilled in the steel members for internal cable routing. The rear electrical junction box was removed and the cables were spliced together with joints then located inside the steel frame.

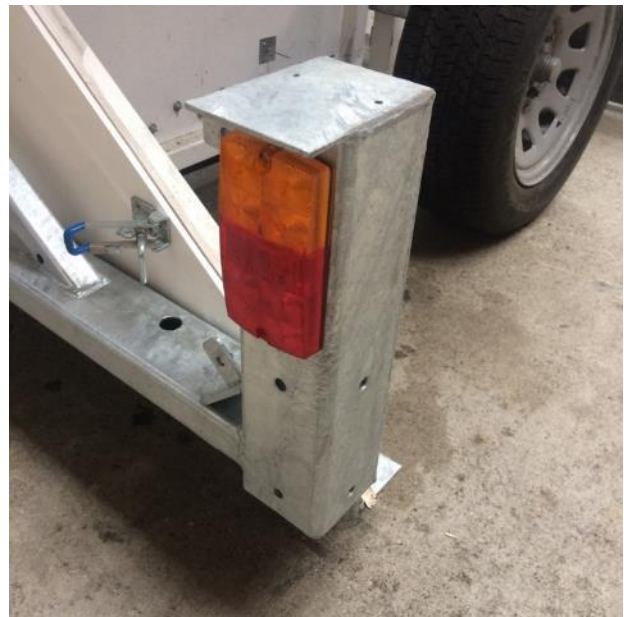
Figure 14 New LED lights attached directly to the frame, with internal cable routing

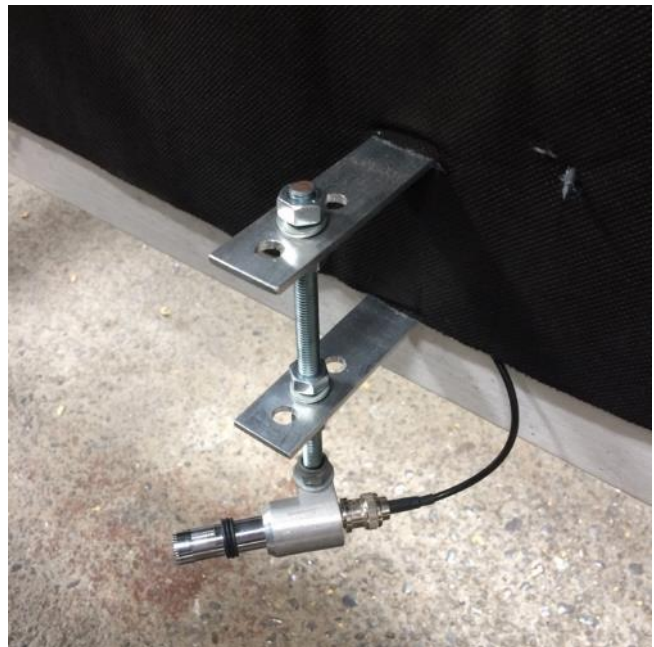
Figure 16 New microphone mounts attached directly to the wheel enclosure

The microphone mounts were originally attached to the trailer such that they remained close to the road surface when the trailer was raised to transport height, requiring the mounts to be removed each time the trailer was raised. New microphone mounting points have been installed that attached to the wheel enclosures and are fully retracted when the trailer is at transport height. The new mounts can remain permanently attached to the trailer and have a low-profile design to reduce sound reflections.

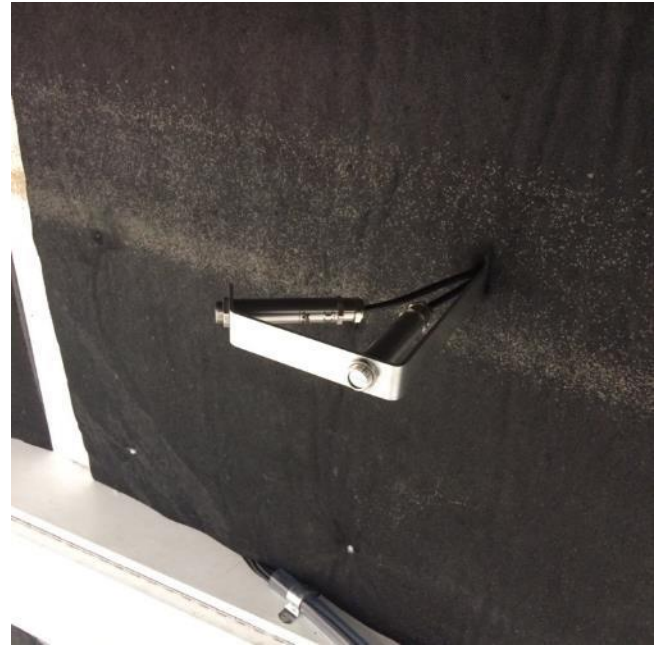
Figure 18 New IR temperature sensor located on wheel enclosure lid

The infrared (IR) temperature sensors were originally mounted to the steel beam that attached to the height adjustment swing arm. The mounting arrangement obstructed access when changing between transport and measurement wheels, and introduced further sound reflecting surfaces near the microphones. The sensors were repositioned on the wheel enclosure lid to swing out of the way during wheel changes.

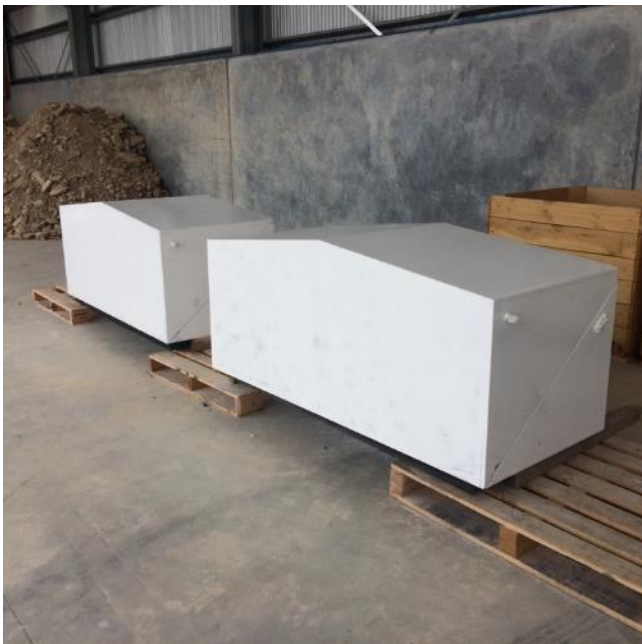
Figure 19 Wheel enclosures after first coat of paint

Both the chassis and wheel enclosures were in need of new protective coatings. The trailer chassis was disassembled and hot-dip galvanised at a facility in Christchurch. While removed from the chassis the wheel enclosures were sanded back and painted with three coats of super-gloss enamel paint to provide a hard-wearing surface.

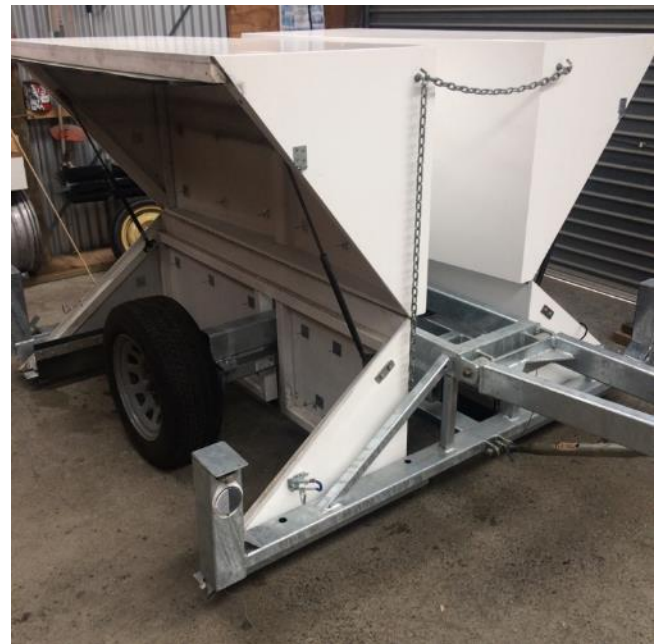
Figure 20 Galvanised chassis

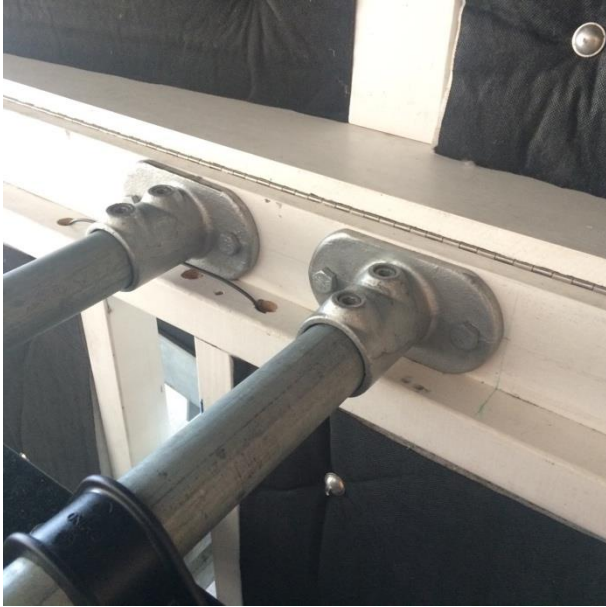
Figure 21 Steel mudguard tubes inserted into brackets

The new mudguard assembly can be installed by one person. The two steel mudguard tubes are slotted into brackets attached to the inner wall of the wheel enclosure. The mudguard tubes are secured by four grub screws, which are tightened using a 8mm allen key.

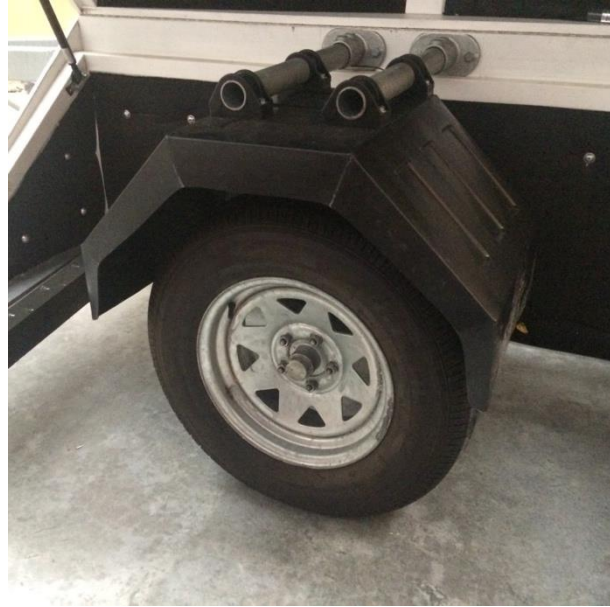
Figure 22 Mudguards fitted to trailer

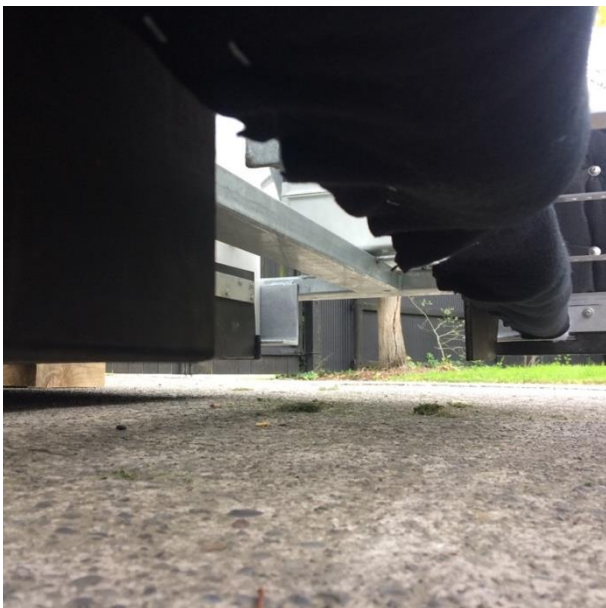
Figure 23 Section of inner rubber skirt removed

The left wheel enclosure had to be modified as part for the April 2018 certification tests after it was found the enclosure did not meet the requirements of ISO 11819-2 A.2. The following modifications were made:

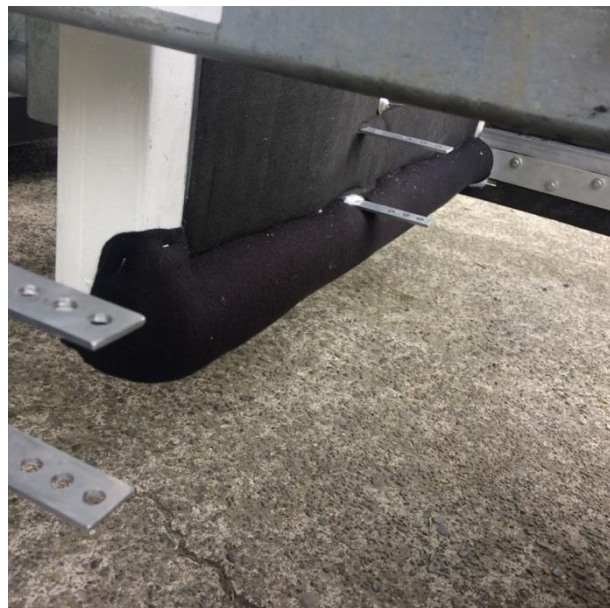
Figure 24 Felt-polyester layer added to lower timber member

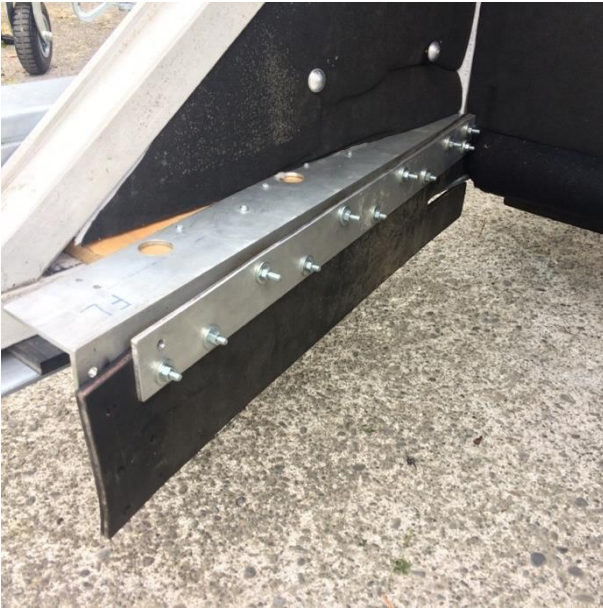
Figure 25 Front and rear rubber skirts angled

The reflection tests were repeated and showed that the enclosure still had an unacceptable effect on the measured sound pressure levels in the 2,000Hz one-third octave band. Investigation showed that reflections off the front and rear rubber skirts were likely to be the cause, and the front and rear skirts were placed on an angle to alter the direction of reflected sound away from the microphones.

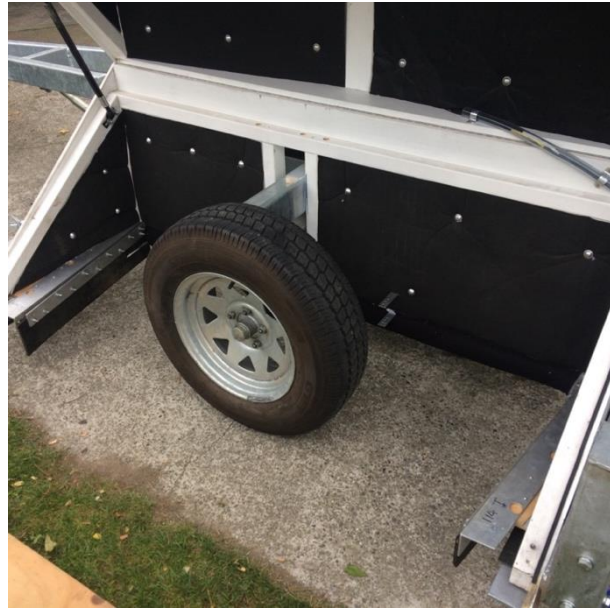
Figure 26 Enclosure configuration following modifications

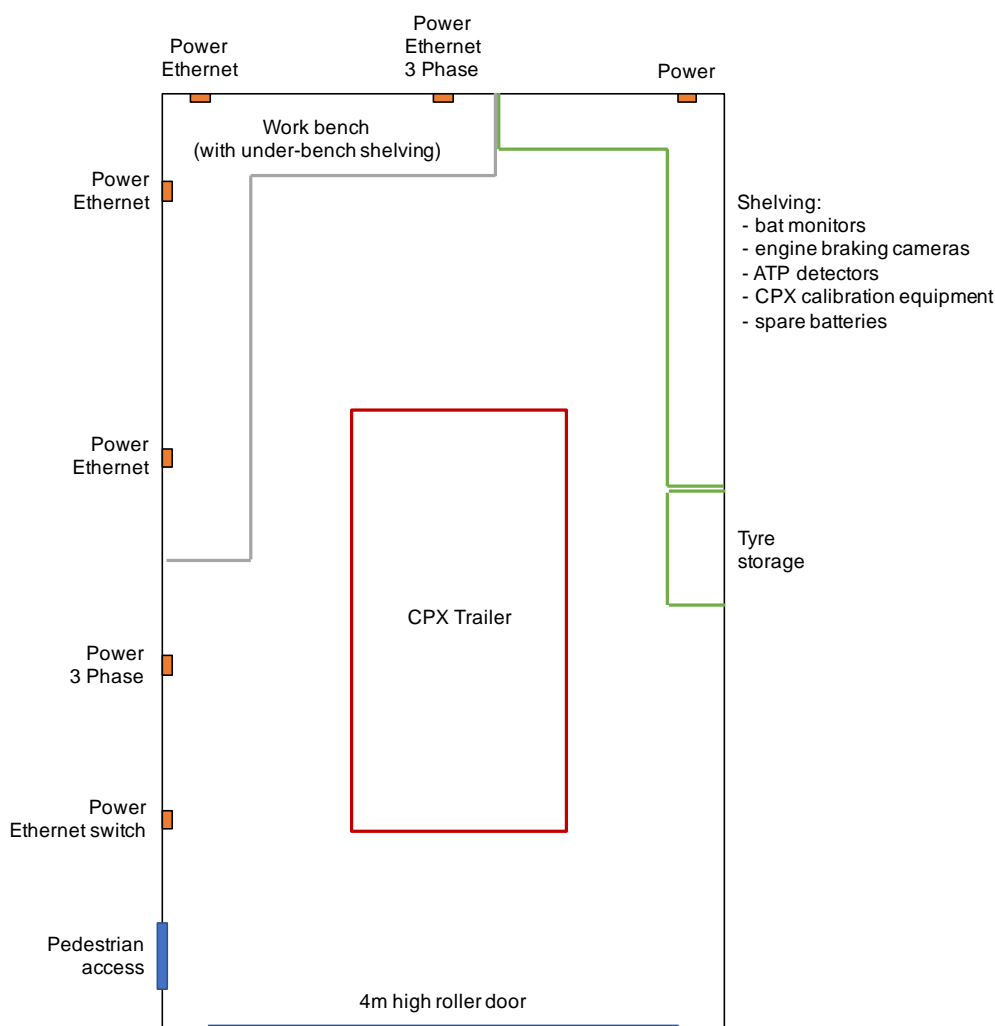
Figure 27 Layout of environmental equipment store

The store is lit with a section of clear roofing sheet and two high powered LED bar lights. The plan below details the locations of benches, shelving and services. The total floor area is 60m<sup>2</sup> (6 metres x 10 metres).

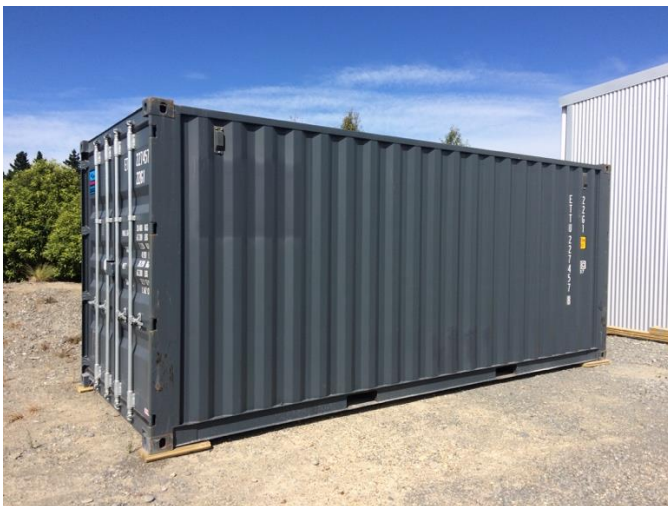
Figure 28 Dedicated shipping container

A dedicated 20-foot shipping container having doors at both ends was purchased for transport and to serve as a secure weatherproof shelter for the trailer while away from CAPTIF (Figure 28). The shipping container has been fitted out with mounting points for the trailer and ancillary equipment to provide a complete measurement system that can be shipped between sites. The container is stored at CAPTIF.

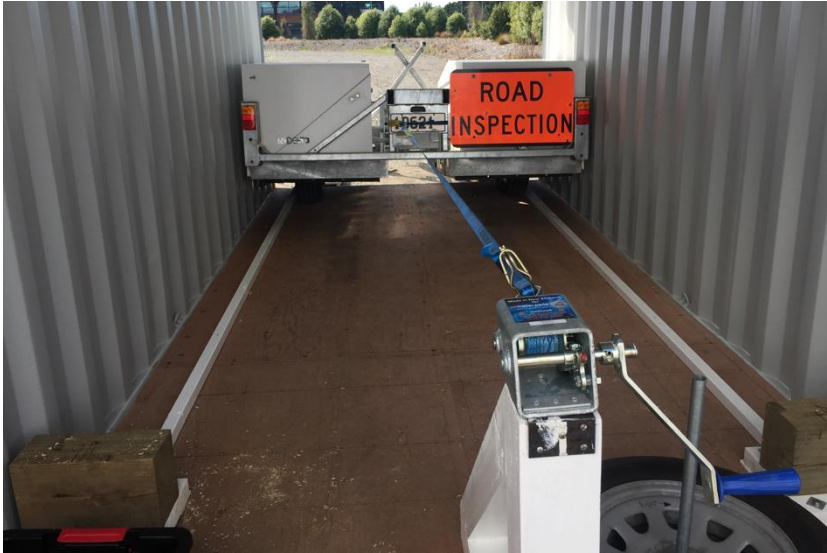
Figure 30 CPX trailer being loaded into the dedicated 20-foot shipping container

Figure 30 shows the trailer being loaded into the container using the winch.

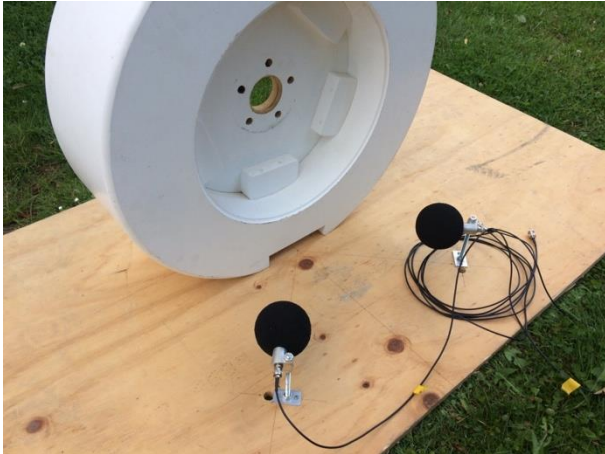
Figure 31 Mounting plate for A.2 certification test

A mounting plate was built as part of the current work program to hold the artificial sound source and microphones, and fix their relative positions during measurements (Figure 31 and Figure 32).

An artificial sound source was built by the University of Canterbury during construction of the CPX trailer. The artificial sound source was based on the design described in ISO 11819-2 A.2.3.

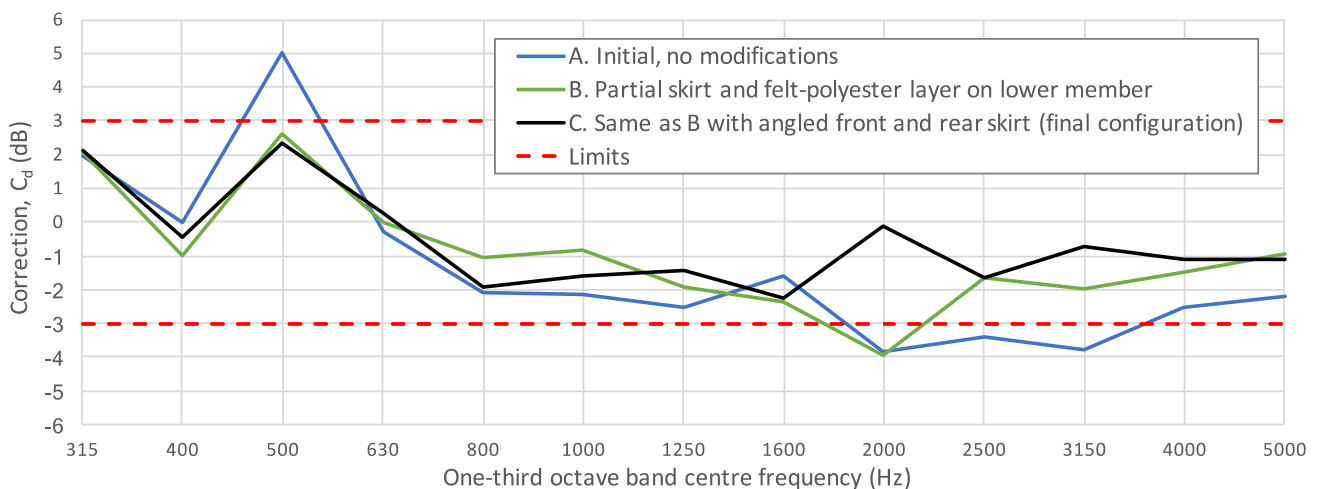
Figure 34 Device dependent corrections for the various enclosure configurations

The results from the three scenarios are shown graphically below, with scenario C being used as the final device dependent corrections. The final enclosure configuration is detailed in Section 3.2 above.

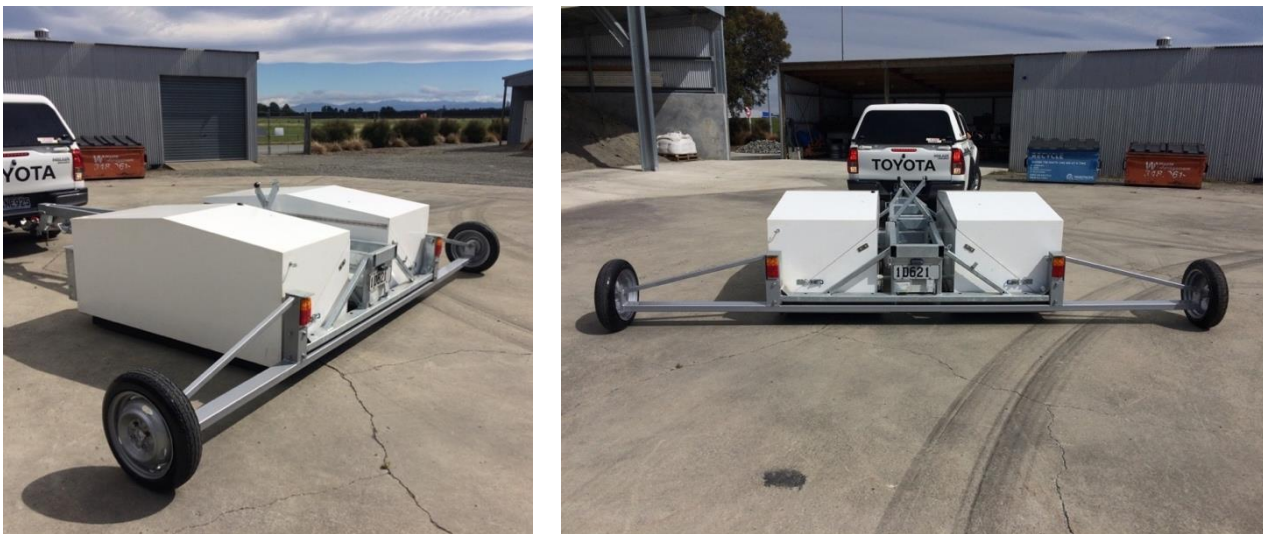
Figure 35 External wheel assembly

One drawback of this external wheel design is that it requires a tow vehicle rated for a vertical tow ball load of 250 kg. This exceeds the tow ball load limits of most cars and compact SUVs, meaning that in some cases it will not be possible to have a system fully certified to ISO 11819-2.

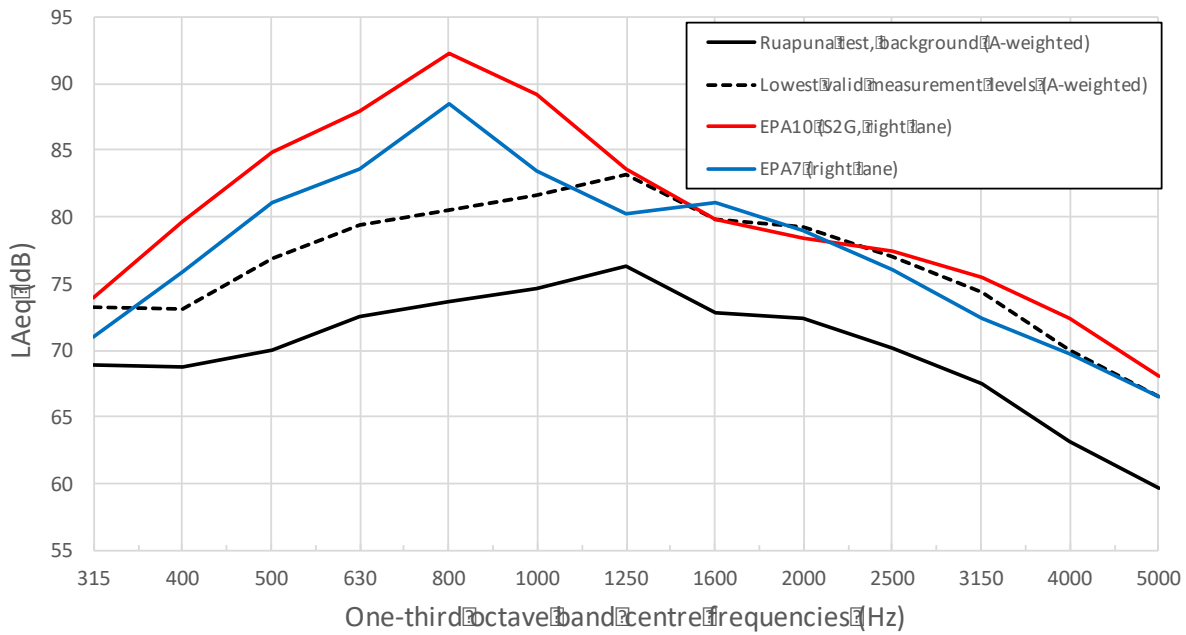
Figure 36 Lowest valid measurement spectrum and comparison with reference surfaces for 80km/h reference speed

LOWEST VALID MEASUREMENT LEVELS													
	315	400	500	630	800	1000	1250	1600	2000	2500	3150	4000	5000
LAeq (dB), 80km/h	73.3	73.1	76.9	79.4	80.5	81.6	83.1	79.8	79.2	77.1	74.4	70.1	66.6
LAeq (dB), 50km/h	68.1	69.3	71.9	73.3	74.8	75.1	76.4	73.2	71.7	69.7	67.6	63.6	60.3

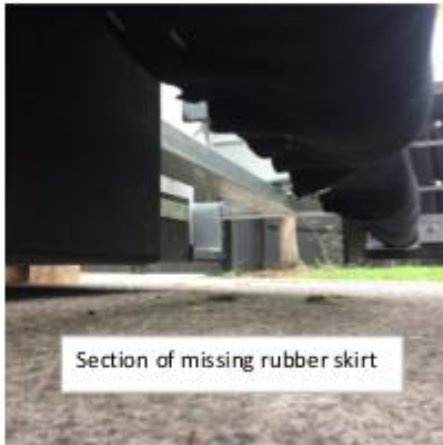
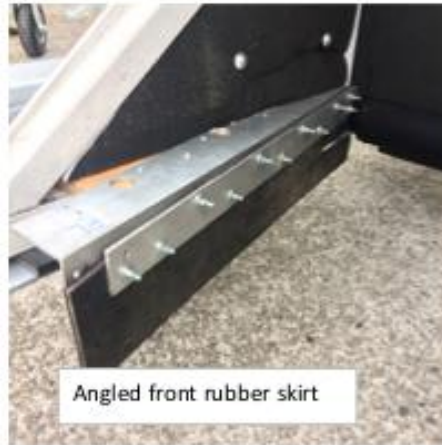
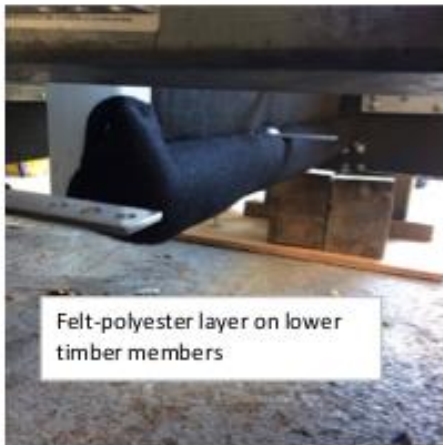
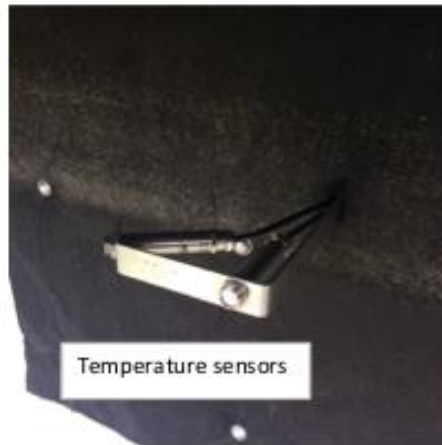
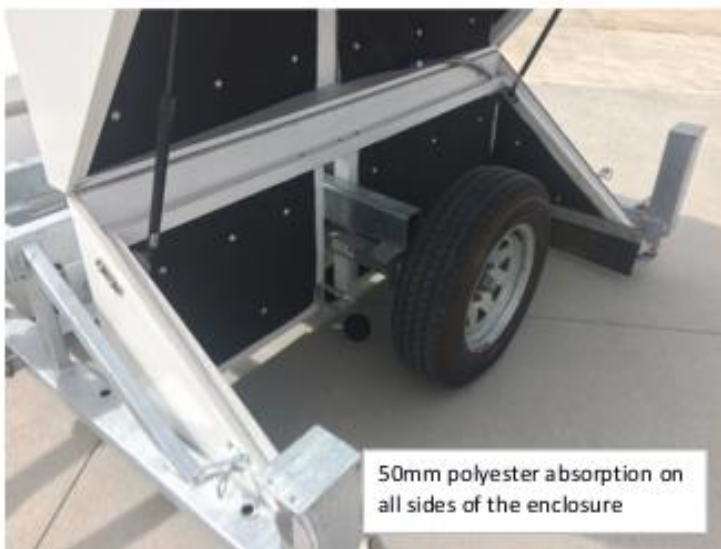
Trailer configuration - photographs

50mm polyester absorption on sides of the enclosure. Rubber skirt on all four sides, apart from the area immediately behind the microphone, which has been removed. Front and rear rubber skirts angled inwards. Felt polyester layer on the lower timber members in the vicinity of the microphones. Small aluminium microphone bracket mounted to the enclosure. Road and tyre temperature sensors mounted to the enclosure roof.

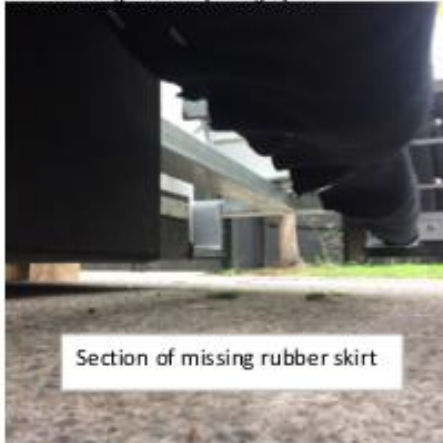
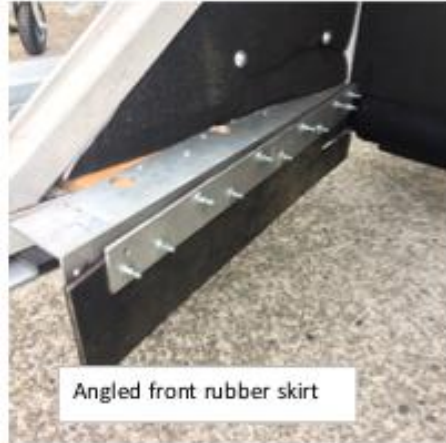
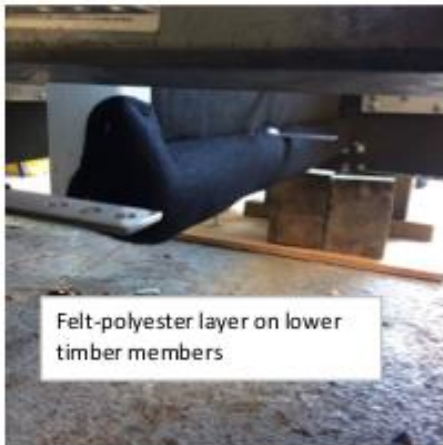
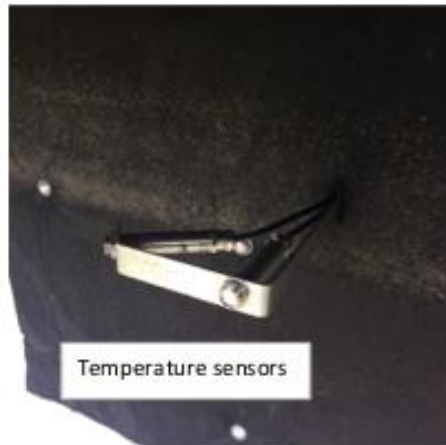
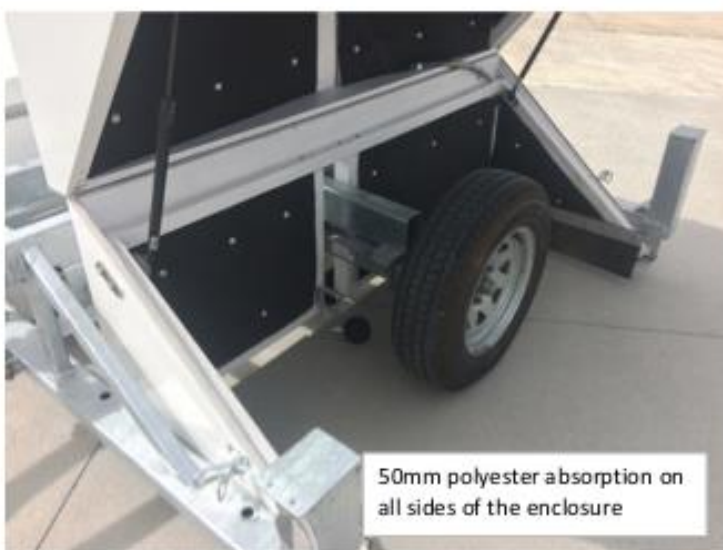
Trailer configuration - photographs

*Test A.3 & A.4 - Background noise from the test vehicle itself or its operation,  
and background noise from towing vehicle*
