Road surface noise measurements of porous
asphalt on the Waikato Expressway and Tauranga
Eastern Link

Date: 17/1/2019
Ref: 18-103/R10/A

Project: Road surface noise measurements of porous asphalt on the Waikato
Expressway and Tauranga Eastern Link
Report: Summary of results
Reference: 18-103/R10/A

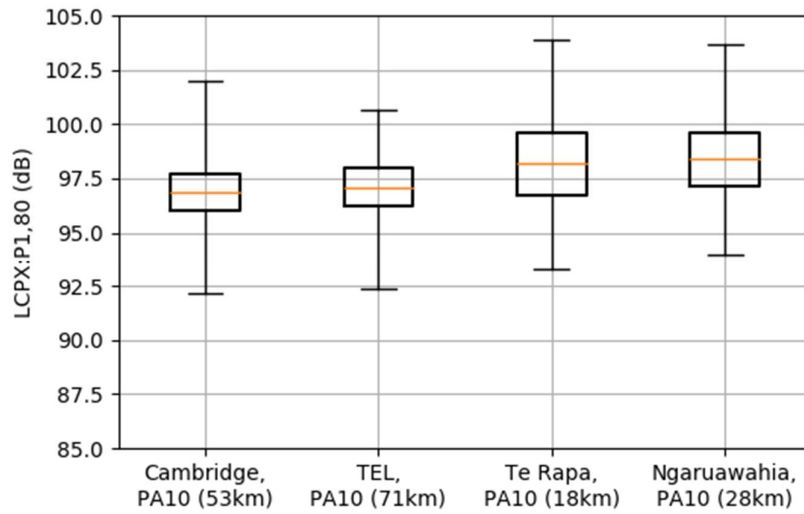
Figure 1 Median, Q1, Q2, maximum and minimum 20 metre road segment data for each location. Distances indicate the total length of surface surveyed.

For convenience, the summary results are provided below. The reported sections have four lanes and are all surfaced with PA10.

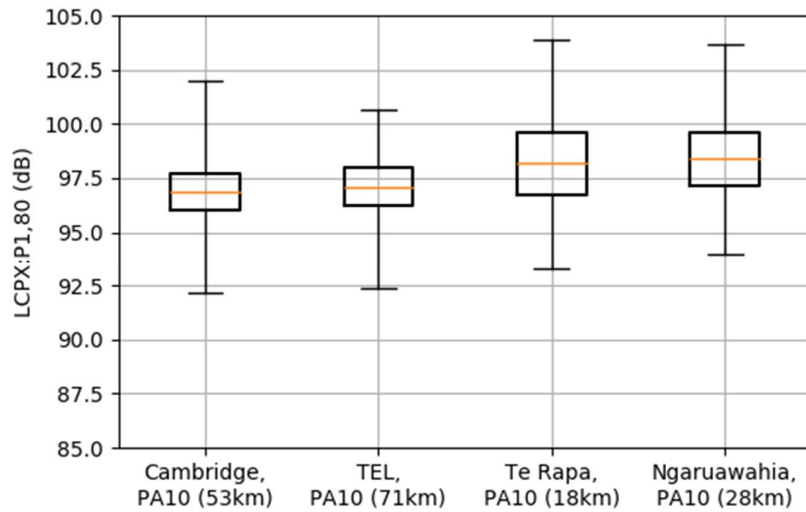
Figure 6 Median, Q1, Q2, maximum and minimum 20 metre road segment data for each location. Distances indicate the total length of surface surveyed.

The results by lane and direction are included in Table 7 to Table 10, and the overall results for each site (combining all lanes and directions) are given in Table 11. Figure 6 provides the median, Q1, Q2, maximum and minimum 20 metre road segment LCPX:P1,80 values for each location.

The measured levels on the three sections of the Waikato Expressway are all higher than measured in 2017. The cause of this increase has not been investigated, but it is likely due to improvements in the measurement system.

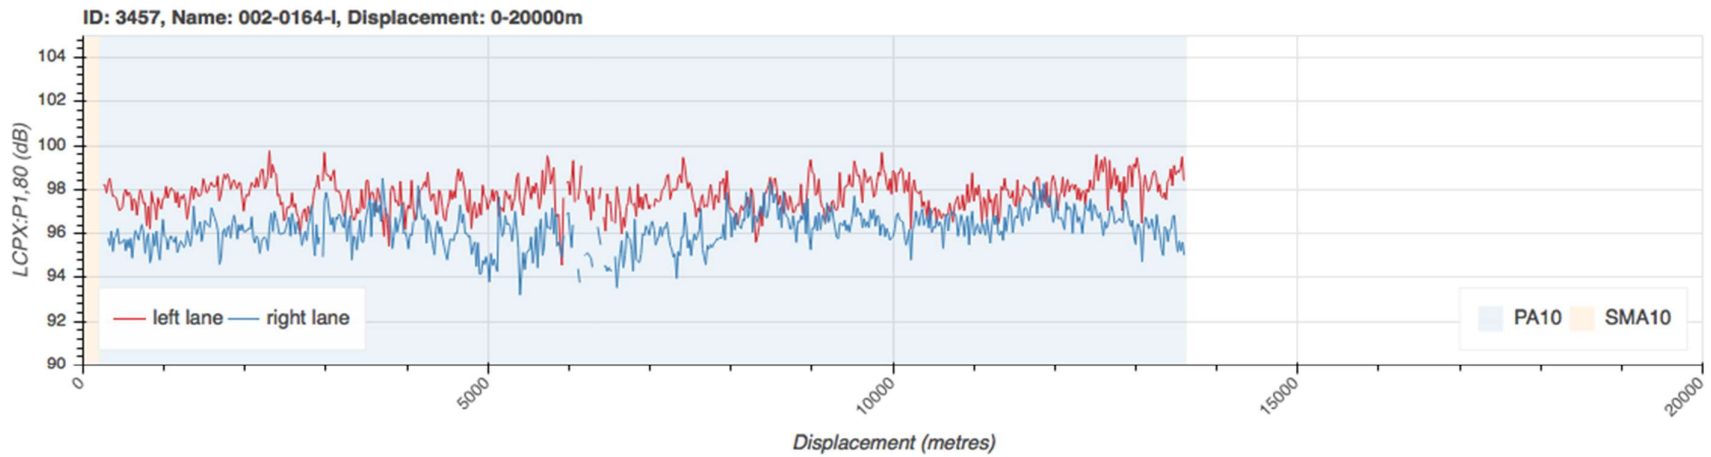
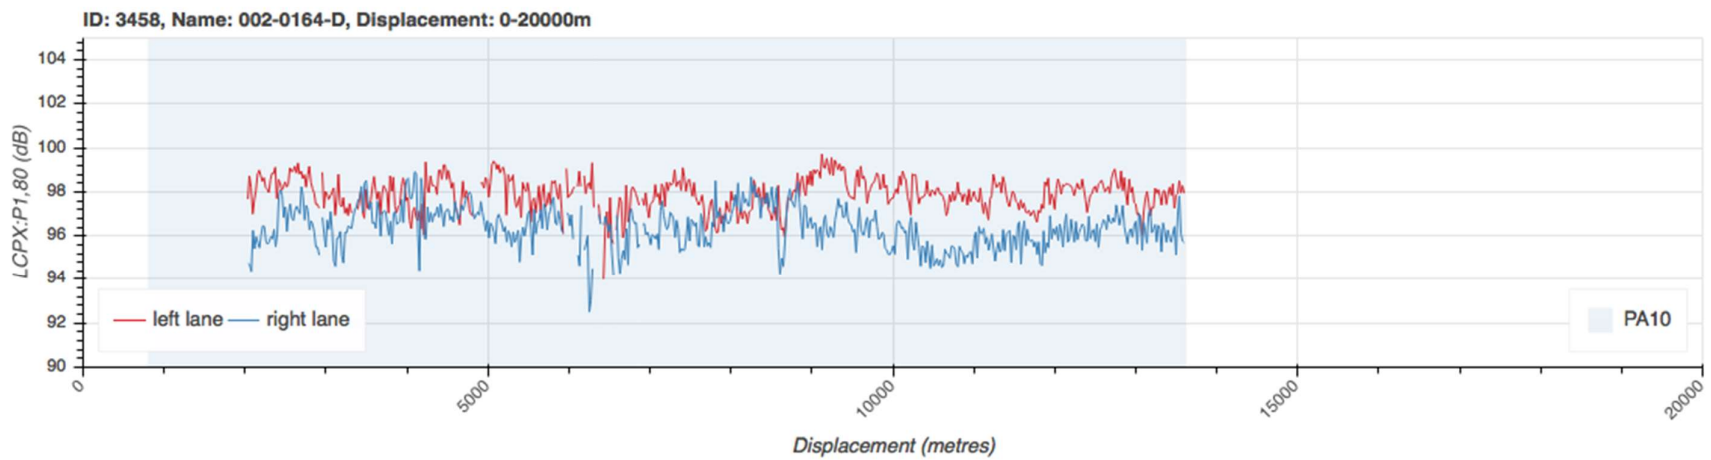
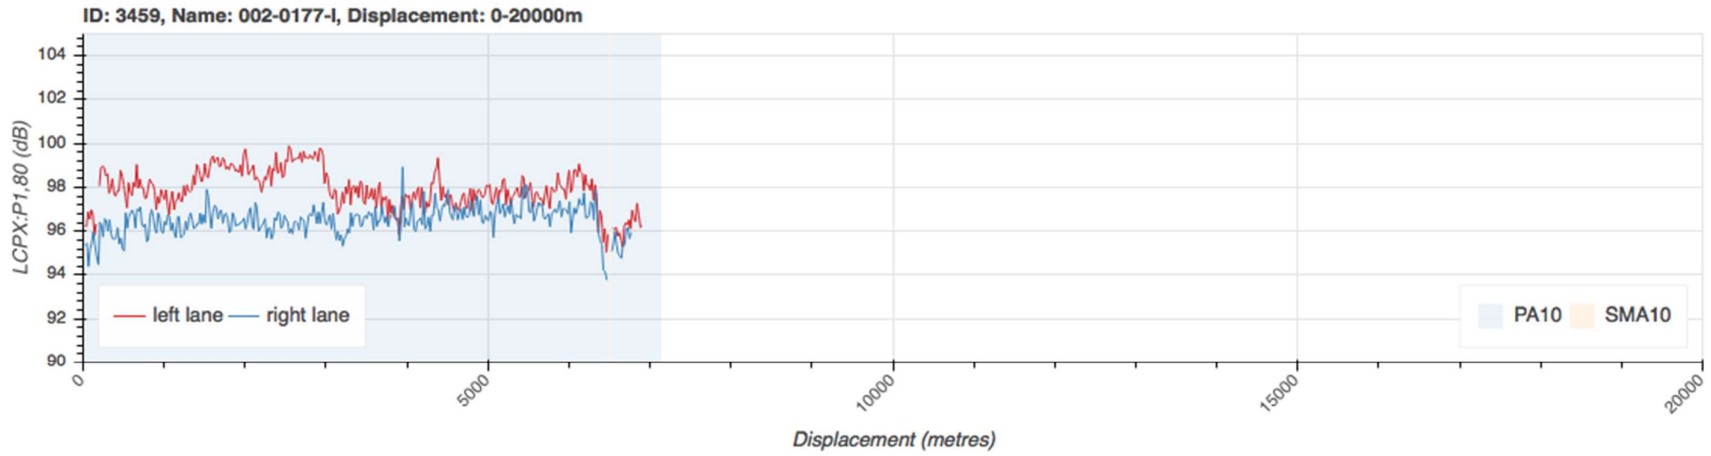
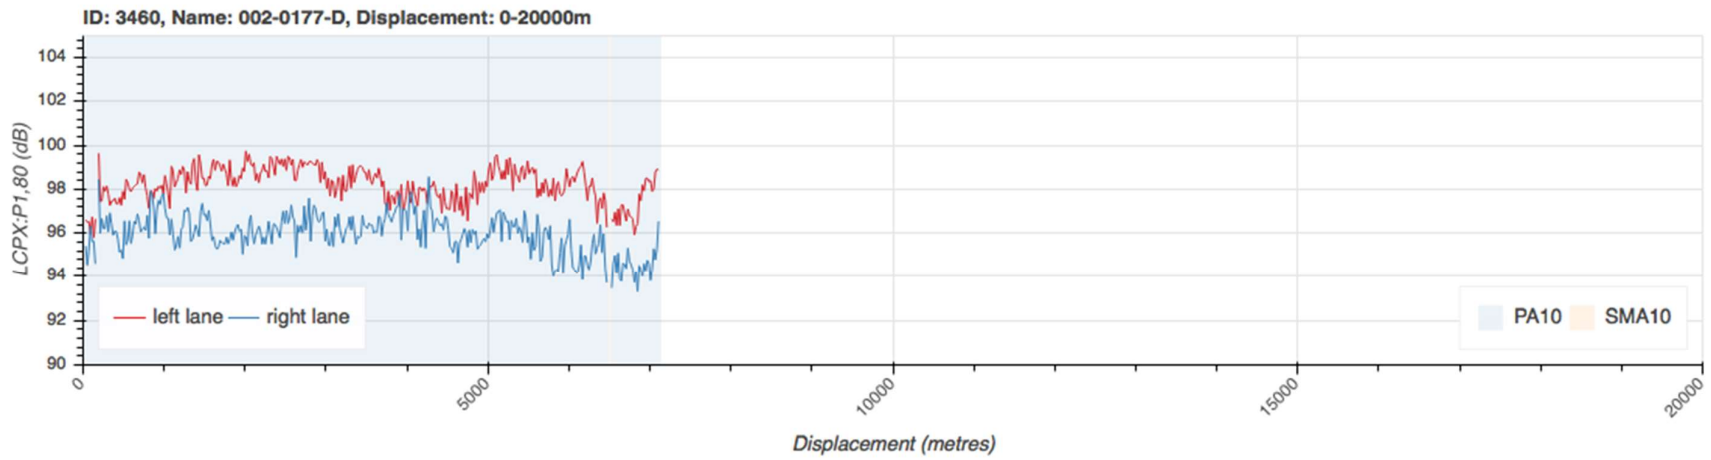
A.1 Tauranga Eastern Link

Longitudinal plots are included in the Appendix A.
