Road surface noise – Measurements of porous asphalt on the Auckland Motorways

Prepared for
NZ Transport Agency
Victoria Arcade, 50 Victoria Street
Wellington.

Date: 11 July 2019
Ref: 18-103/R12/A

Project: Road surface noise
Report: Measurements of porous asphalt on the Auckland Motorways
Reference: 18-103/R12/A

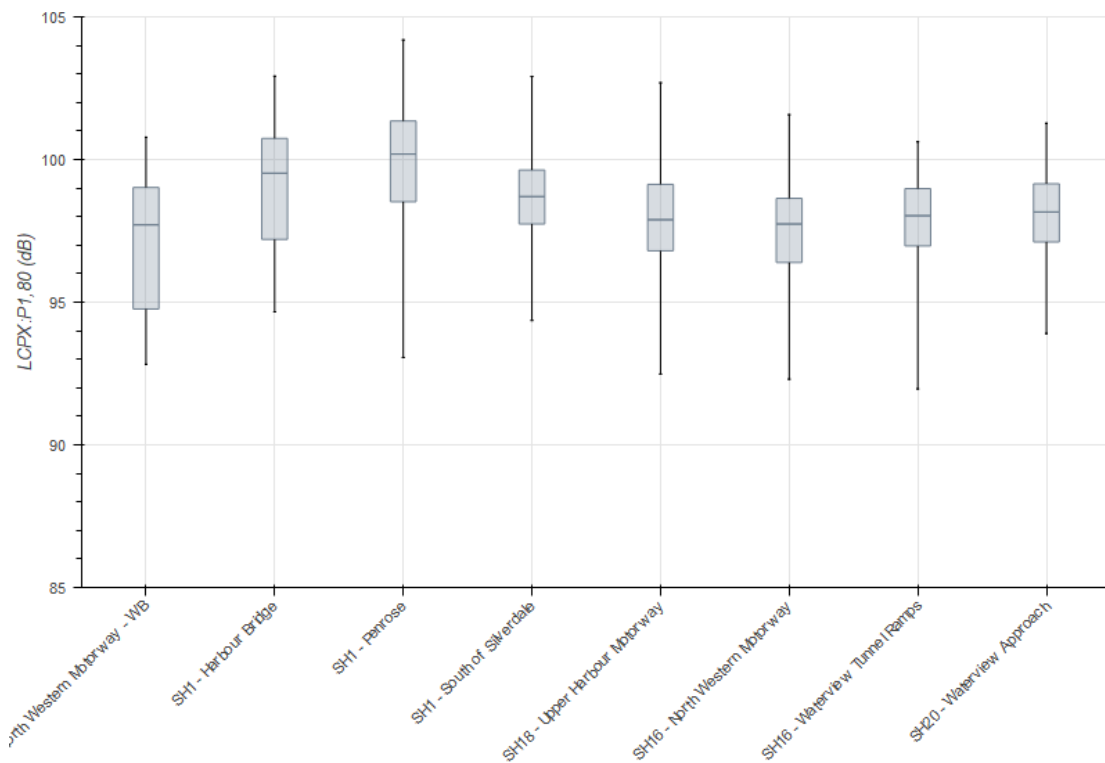
Figure 1 Median, Q1, Q2, maximum and minimum 20 metre road segment data for all locations.

For convenience, the summary results are provided below. The reported sections have four lanes and are all surfaced with PA10.

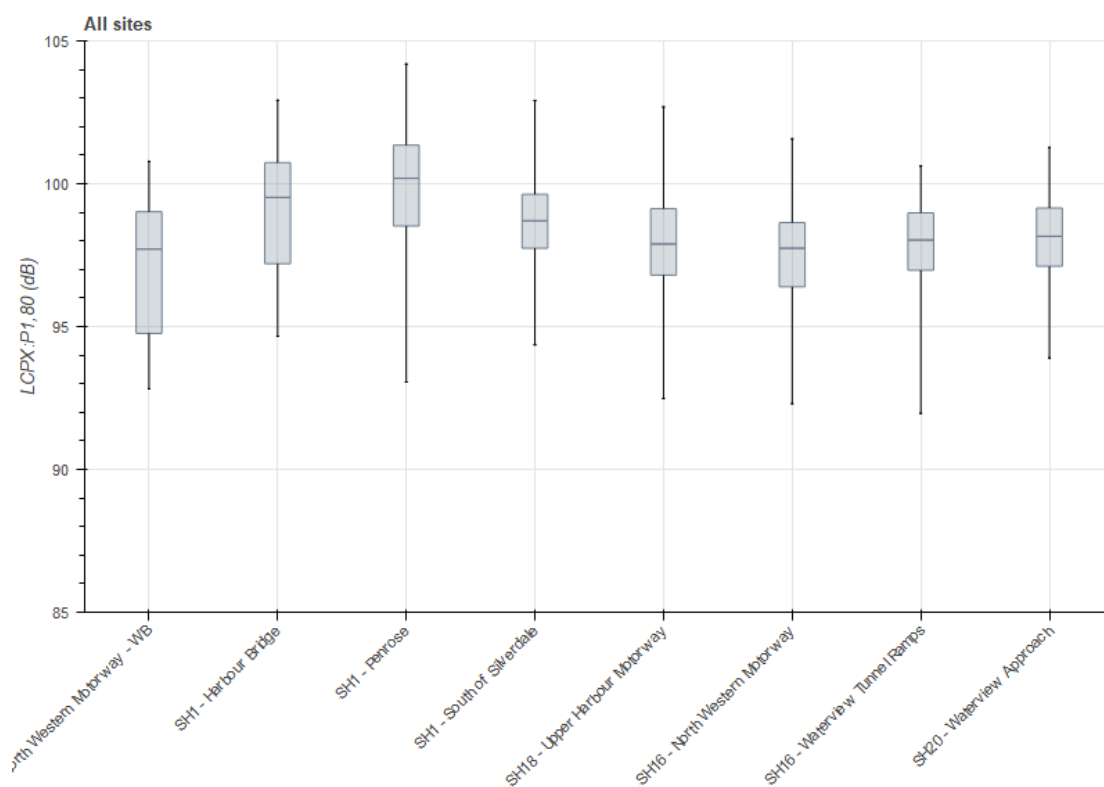
Figure 41 Median, Q1, Q2, maximum and minimum 20 metre road segment data for each location.
